# **Annual Environmental Management Report**

**2019**

**Enhance Place Mine**

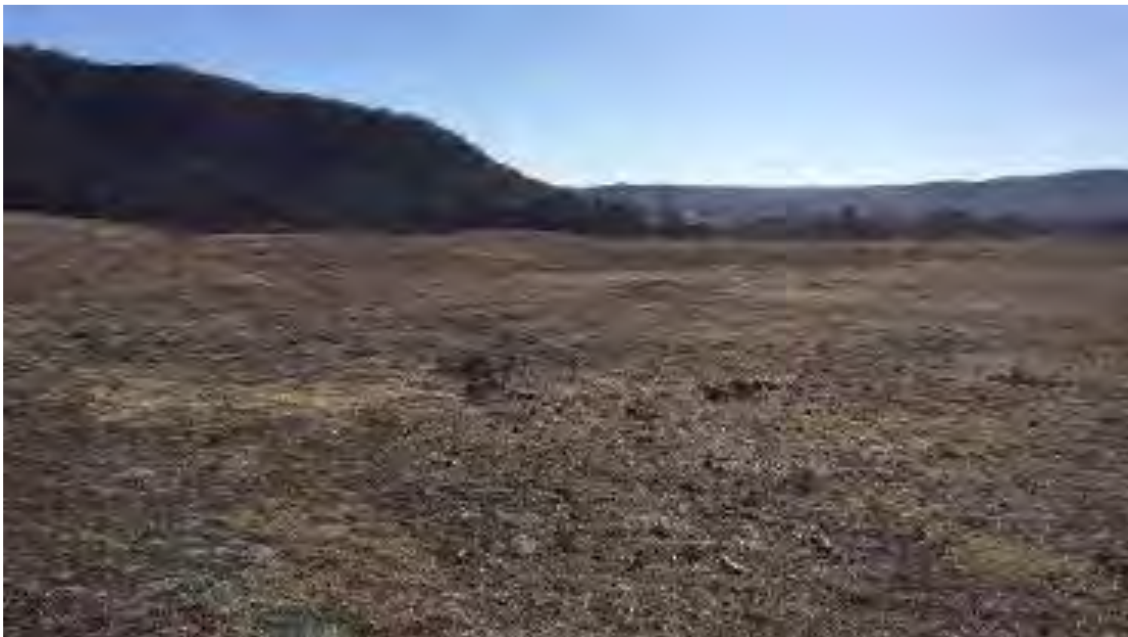
**Plate 1      Pasture Area – Quadrat 1 September 2019**

Monitoring of pasture conditions was undertaken September 2019 and detailed in the *Enhance Place Mine Rehabilitation Monitoring Report 2019 (First Field Environmental, 2019)*. Monitoring of pasture conditions is undertaken at four quadrats location; refer to Plan 3, **Appendix B**). Groundcover in quadrats 1, 2 and 4 have decreased from 90% total living ground cover in 2018 to 85% in 2019. This decrease is considered to be due to below average rainfall (refer **Section 9**). Groundcover during the September 2019 field survey is shown in **Plate 1**, **Plate 2**, **Plate 3** and **Plate 4**.

As groundcover conditions were considered satisfactory, and due to the dry conditions application of fertilizer was not required during the 2019 reporting period, as per the First Field Environmental (2018 & 2019) rehabilitation monitoring reports.

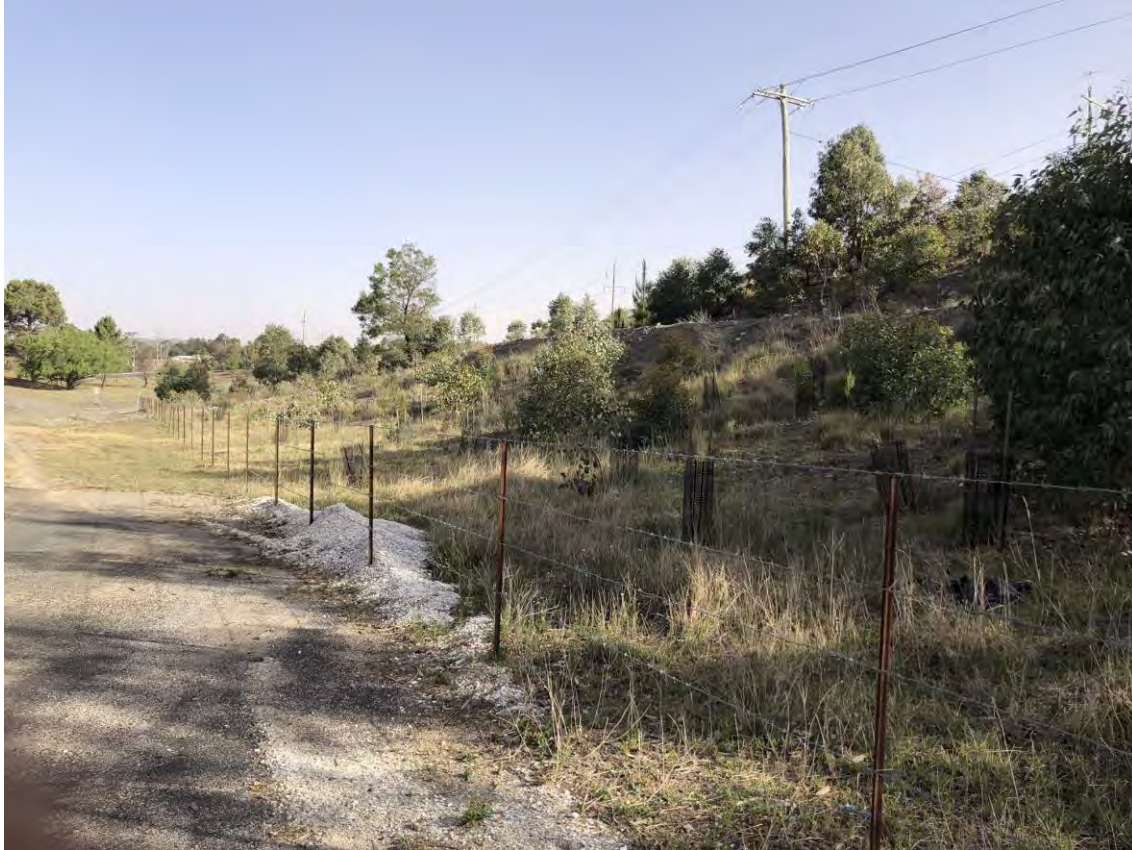
**Plate 5 Treed Rehabilitation Area – December 2019**

Total living groundcover in the treed rehabilitation areas was noted to decrease from 90% in 2018 to 80% at both transect 7 and 8 (First Field Environmental, 2019). This decrease in groundcover is due to drought conditions and is not considered significant. Establishment of vegetation in the treed rehabilitation areas is considered good with more than 80% of native forest indicator species represented. A photo of the treed area during December 2019 is shown in **Plate 5**.

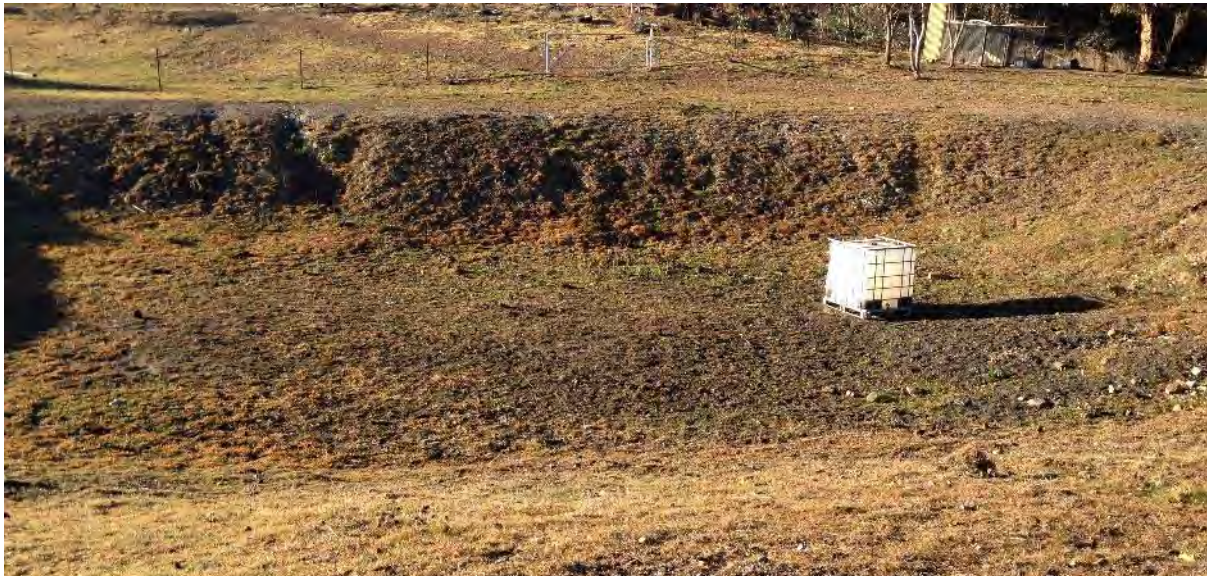
Figure 2 Indicative condition of sediment retention basins

**Ponding of water** – Sediment ponds and contour drains were established prior to 2013 and generally remain in good operational condition. Figure 2 shows the condition of sloping retention basin walls.

Field inspection was conducted following days of intermittent rain. Soils showed no signs of waterlogging or significant ponding. Seasonal waterlogging accounts for less than 1% of the rehabilitated pasture area.

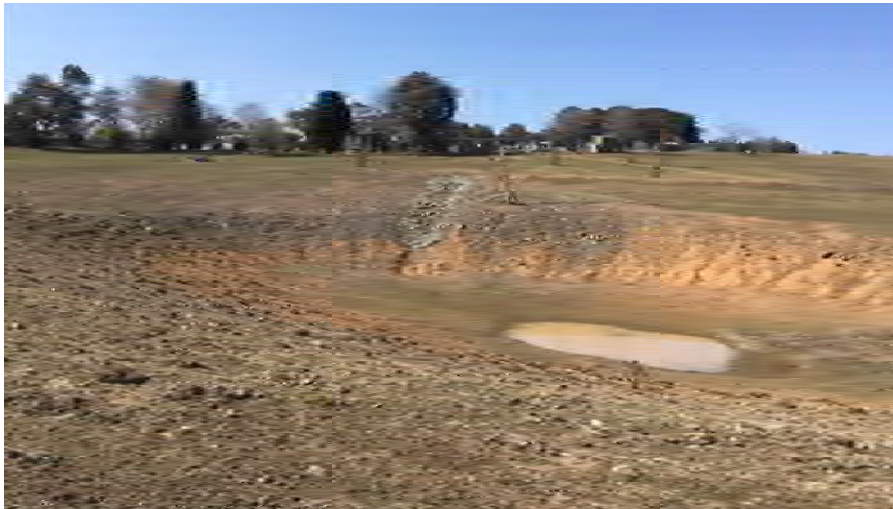
Figure 2 Indicative condition of sediment retention basins

**Ponding of water** – Sediment ponds and contour drains were established prior to 2013 and generally remain in good operational condition. Figure 2 shows the condition of sloping retention basin walls.

Field inspection was conducted following days of intermittent rain. Soils showed no signs of waterlogging or significant ponding. Seasonal waterlogging accounts for less than 1% of the rehabilitated pasture area.

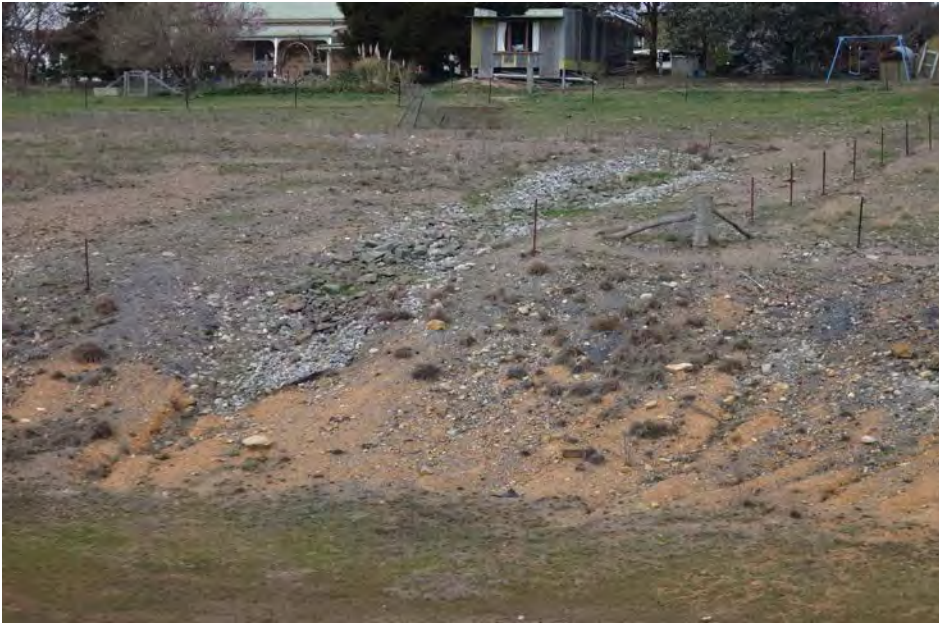
Figure 6 Minor erosion of sediment retention basin wall

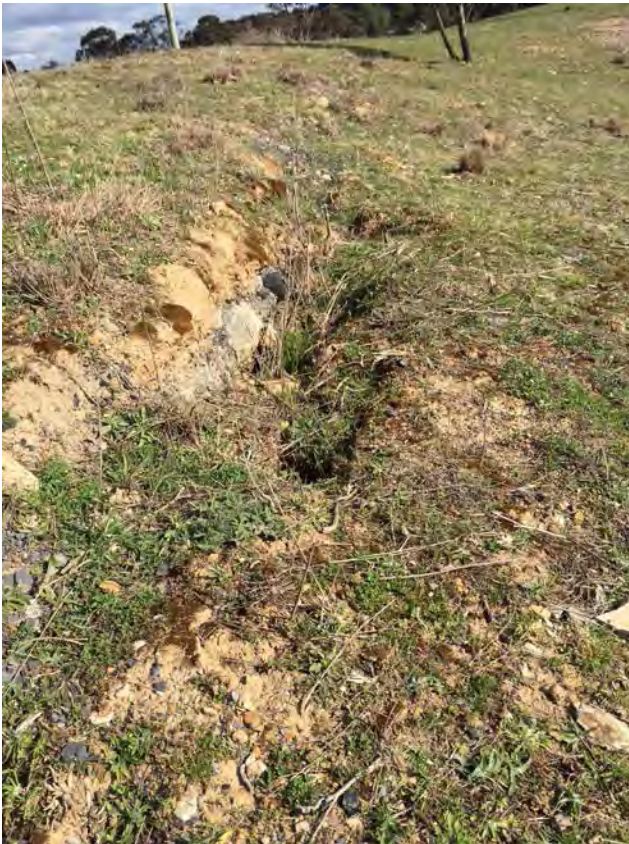
Figure 7 Example of soil cracking on slope crests

Surface cracking to 20 cm is evident along slope crests in the northern extent of the pasture area (see Figure 7). Soil samples taken to a depth of 20 cm indicate that soils are not prone to cracking through swelling and shrinking and suggest that cracking is indicative of soil settling.

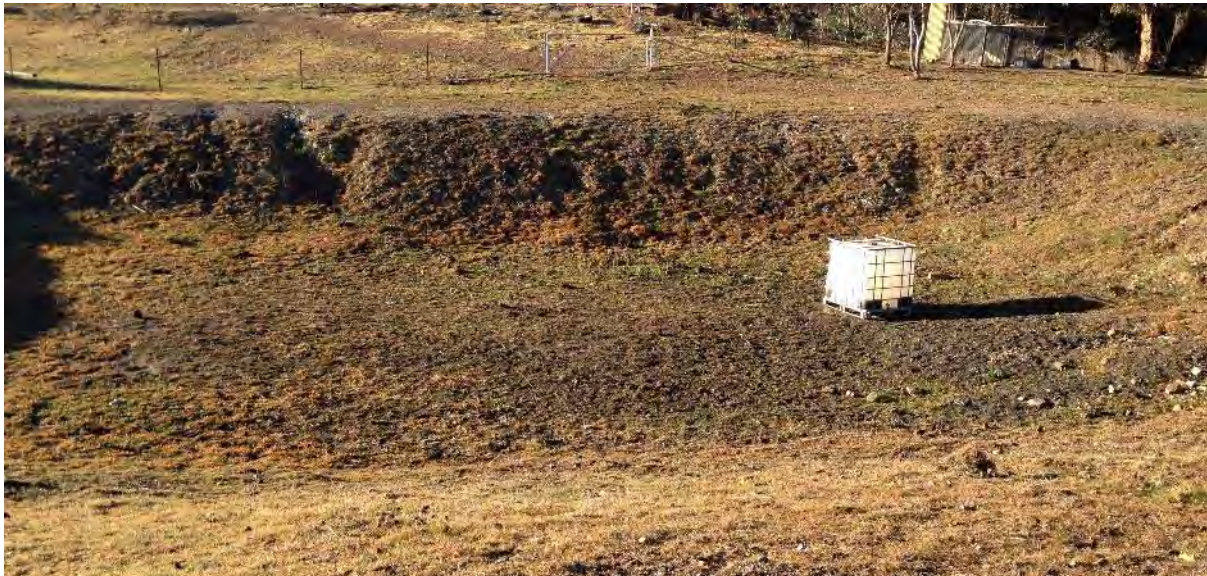
Figure 2 Indicative condition of sediment retention basins

**Ponding of water** – Sediment ponds and contour drains were established prior to 2013 and generally remain in good operational condition. Figure 2 shows the condition of sloping retention basin walls.
