ENHANCE PLACE MINE

2020

**ANNUAL ENVIRONMENTAL
MANAGEMENT REPORT**

(Small Mine Version)

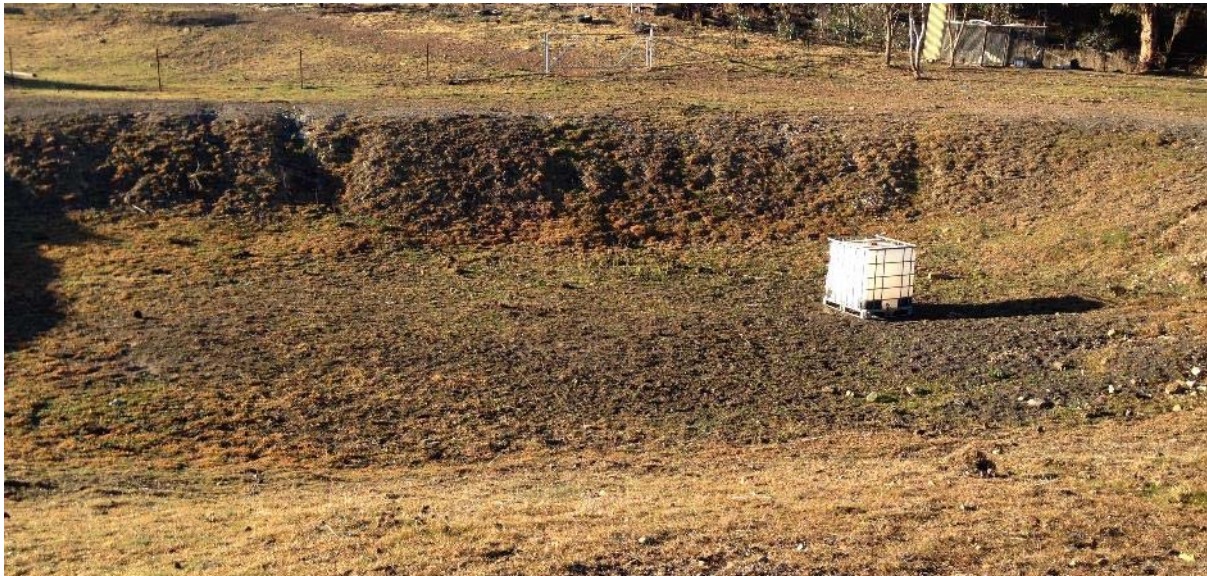
Ponding of water – Sediment ponds and contour drains were established prior to 2013 and generally remain in good operational condition. Figure 2 shows the condition of sloping retention basin walls.

Figure 2 Indicative condition of sediment retention basins
