ENHANCE PLACE MINE

2021

**ANNUAL ENVIRONMENTAL
MANAGEMENT REPORT**

(Small Mine Version)

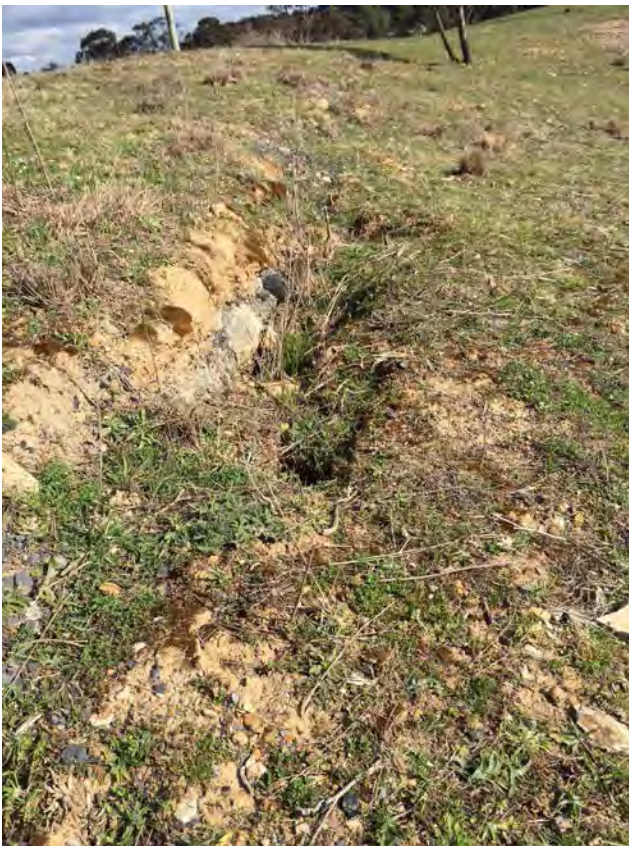
Surface cracking to 20 cm is evident along slope crests in the northern extent of the pasture area (see Figure 7). Soil samples taken to a depth of 20 cm indicate that soils are not prone to cracking through swelling and shrinking and suggest that cracking is indicative of soil settling.

Figure 7 Example of soil cracking on slope crests

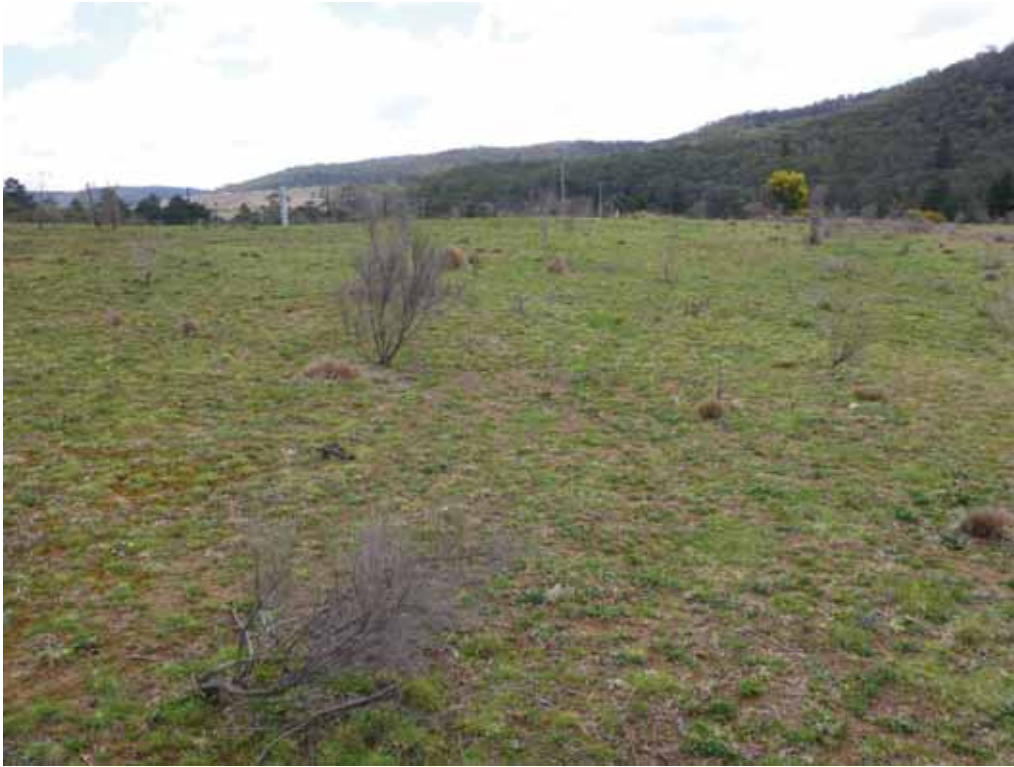
Overgrazing is still a major land management issue here, however increase in perennial grass pasture density have been achieved nonetheless.

Photo 4 Rehabilitated Site EP1 March 2018

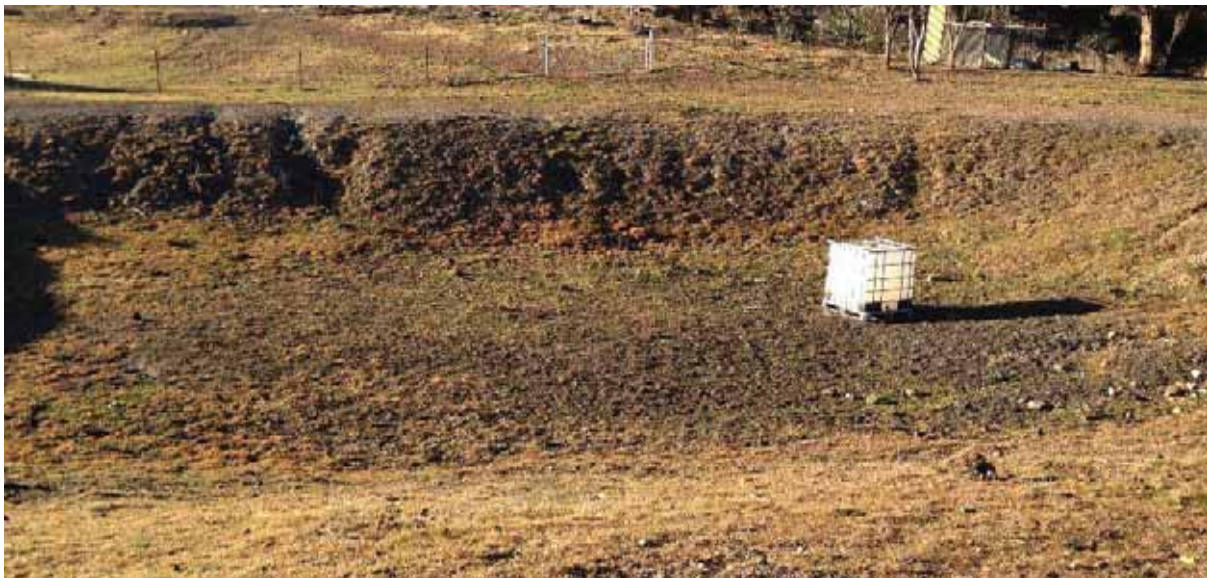
Ponding of water – Sediment ponds and contour drains were established prior to 2013 and generally remain in good operational condition. Figure 2 shows the condition of sloping retention basin walls.

Figure 2 Indicative condition of sediment retention basins
