Independent Environmental Audit 2014

Pine Dale Mine / Yarraboldy Extension

15 October 2014
43177926/IEA/01

Prepared for:
Enhance Place Pty Ltd

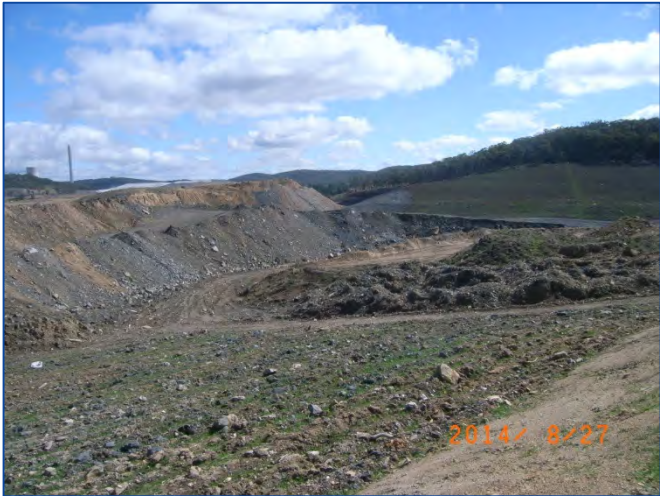
Photo #	Comment	Photo
4-1.	View from NE corner of pit towards west showing subsoils and topsoils stockpiled behind the visual bund and (to the right of the photo) materials pushed up against the highwall, topsoiled and grass seeded.

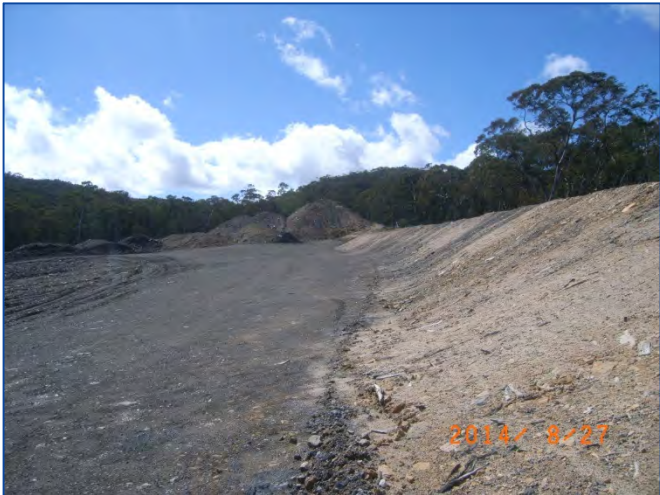
4-2.	Topsoil stockpile and bunding was observed at the northern and north east boundary of the Yarraboldy extension.

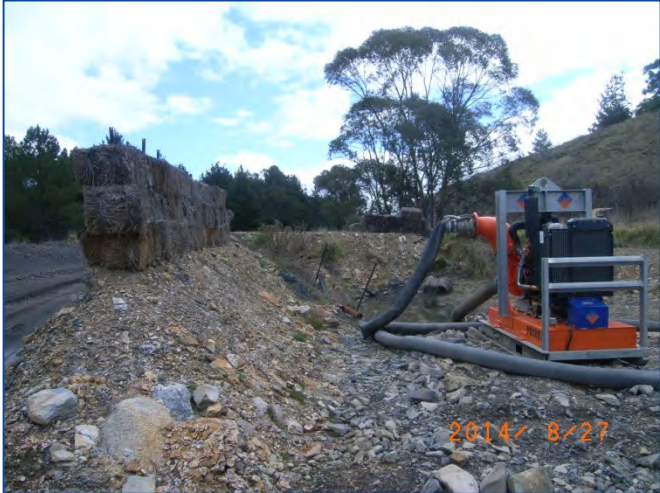
Photo #	Comment	Photo
4-3.	<p>The diesel water pump for the 'bong' water pumping point. Hay bales have been placed around the pump following a noise complaint from a local resident. During care and maintenance the pump is operated infrequently (less than once a month) for maintenance purposes.</p>

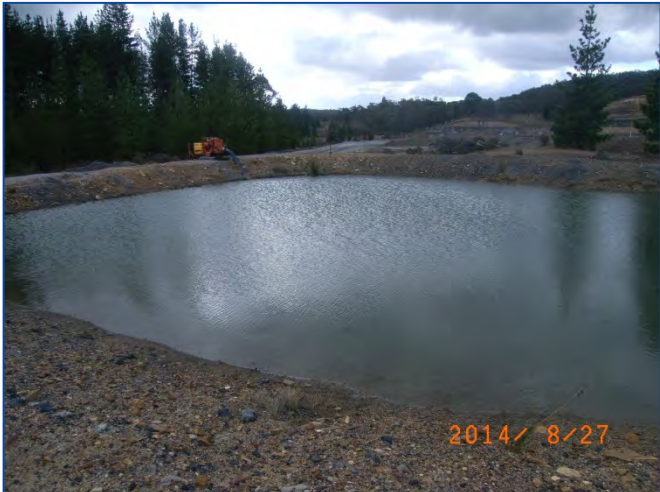
4-4.	<p>The surface water dam and pump that collects water from the amenity bund. During care and maintenance the pump is operated once a month for maintenance purposes.</p>

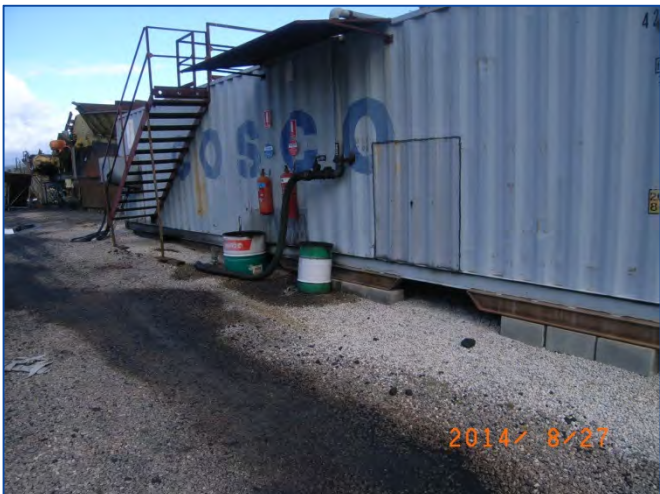
4-5.	<p>The double skinned diesel above ground storage tank located to the rear of the workshop. The tank was empty at the time of the Site inspection.</p> <p>Observations made during the Site inspection noted open drip trays (half a 200 Litre (L) steel drum and redundant equipment such as used vehicle batteries at the workshop. Localised staining was also observed on the</p>

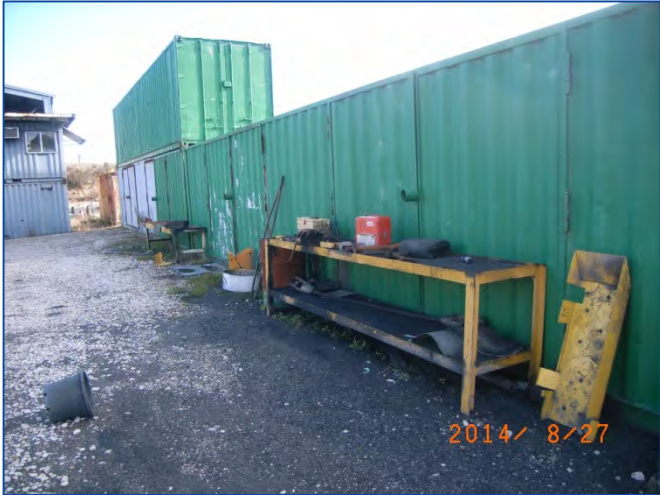
Photo #	Comment	Photo
	<p>gravel hardstand.</p> <p>Materials at the Worksop</p> <p>Refer to Recommendation 2014/IEA/001, Appendix A, PA 10_ - 041, Condition 3.39</p>

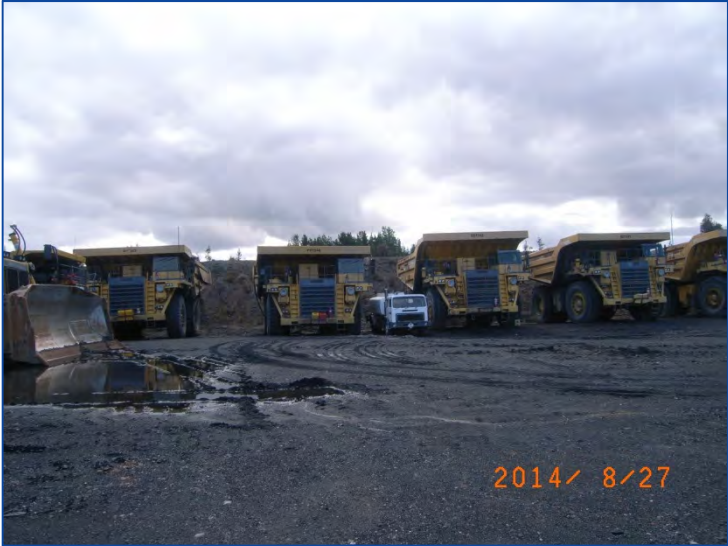
4-6.	<p>Mining plant and equipment was parked at the Site in the workshop area. The machinery is owned and maintained by the Pine Dale contractor (Dukes) who were reported to visit the Site periodically to maintain the equipment.</p>

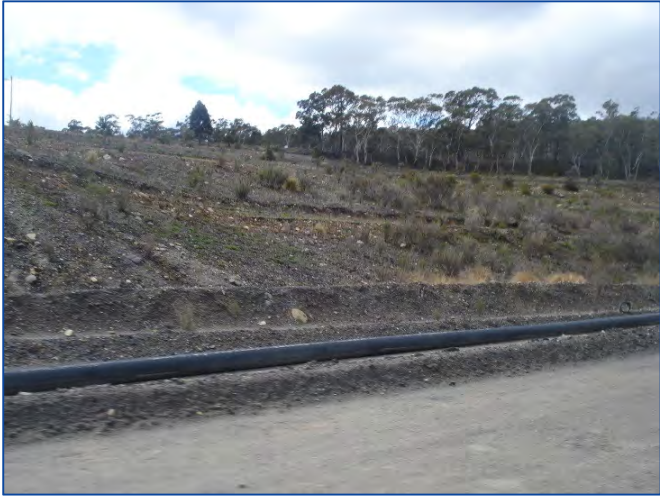
Locality	Photo
<p>Area A</p>	
<p>Area A is immediately south of the Angus Place Coal Haul Road, Ben Bullen State Forest and the south-east corner of the Yarraboldy extension.</p> <p>Area A is currently being rehabilitated to replicate "Native Woodland" as per the PA 10_0041 and the approved MOP. Since the last IEA, the area has been mulched with a mixture of charcoal and mushroom compost and had been fertilised with gypsum and agricultural lime. Area A was covered with cover crop in April 2014 (sighted during the audit) and a second stage of Direct Seeding of native species was scheduled for Spring 2014. Proposed native species in the direct seeding includes <i>Bursaria spinosa</i> spp.</p> <p>Pine Dale management acknowledged that rehabilitation in this area was not progressing as quickly as expected. Pine Dale indicated that one potential reason for poor rehabilitation performance was the potential for acid soils in the area and noted some soil sampling in the area had indicated acid soils.</p> <p>Pine Dale indicated that the advice to be provided by SLR will assist them to form a long term approach to achieving compliance with closure criteria to be developed for the area and to help enable rehabilitation to be achieved in accordance with PA 10_0041 and</p>

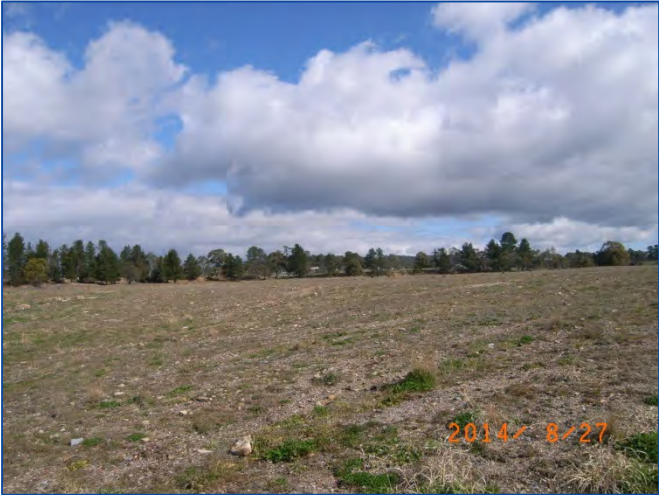
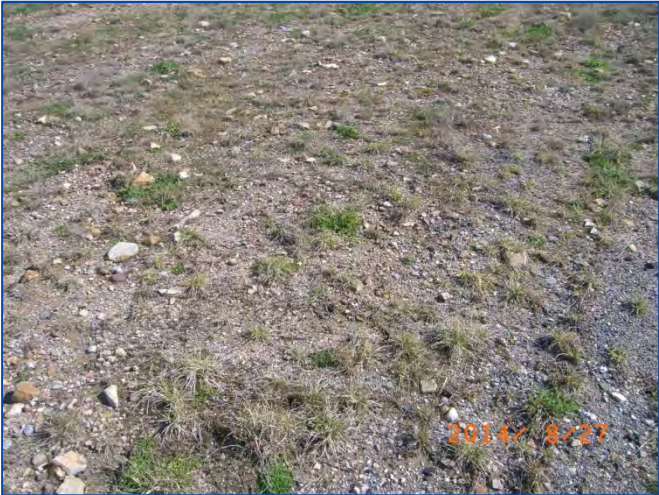
<p>Area B</p>	
<p>The Area B rehabilitation is located immediately south of Neubecks Creek and Area C.</p> <p>Area B has been rehabilitated to "Pasture" as per the Project Approval. Pine Dale management reported that no rehabilitation occurred in Area B during the audit period.</p> <p>The area was noted to have sparse vegetation cover in many areas; was rocky and had some erosion in drainage lines.</p> <p>The overall rehabilitation performance was considered low.</p> <p>Pine Dale indicated that the advice to be provided by SLR will assist them to form a long term approach to achieving compliance with closure criteria to be developed for the area.</p>

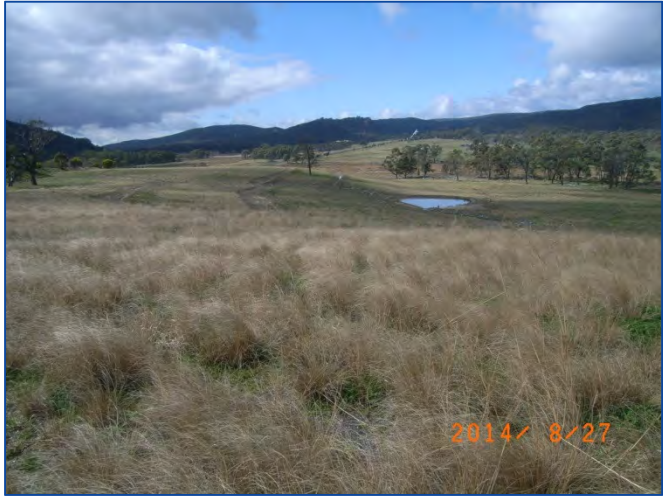
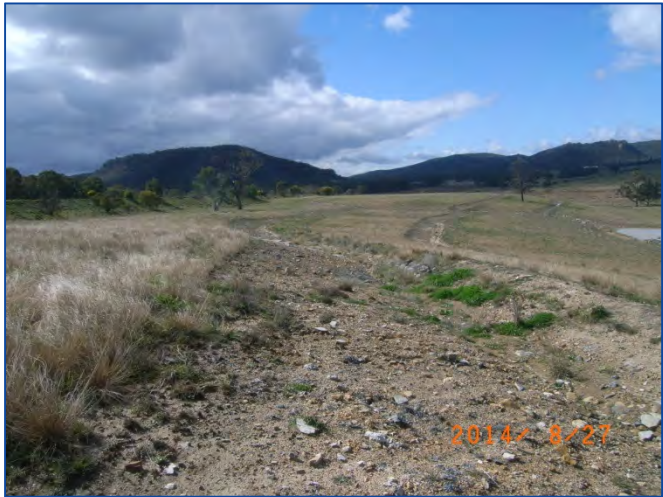
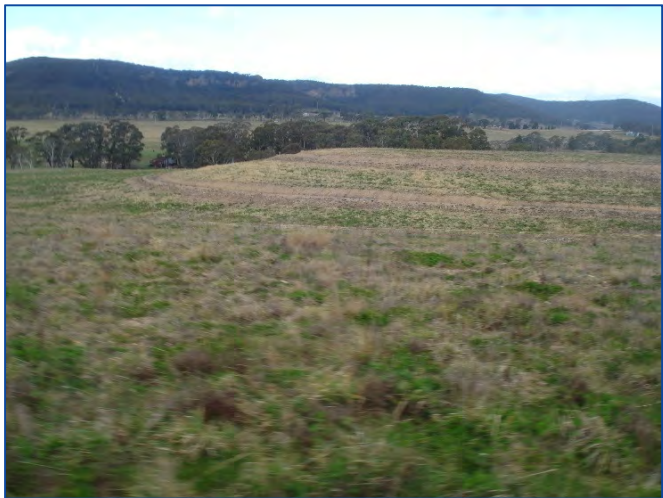
Pine Dale management reported that the landowner attempted to graze cattle in Area C during the audit period; however this was stopped by the mine to prevent damage to the pasture.

A key area of need for further rehabilitation, also noted during AEMR inspections, was that the rehabilitation of contour banks was poor (see photo) and required work. Pine Dale suggested one approach was to push in and revegetate the contour drains, given the extent of pasture growth.

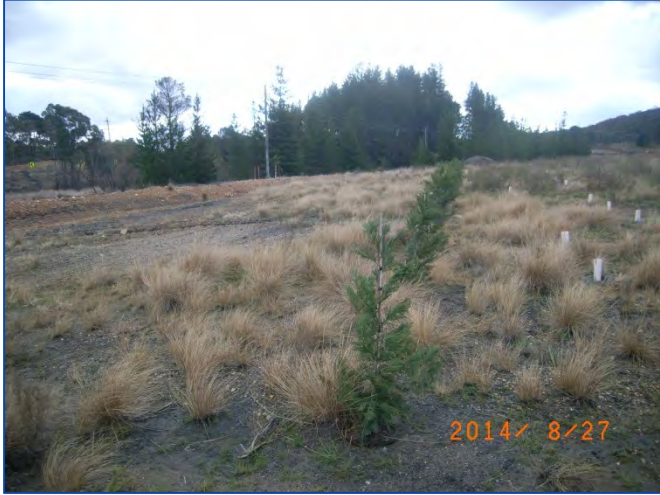
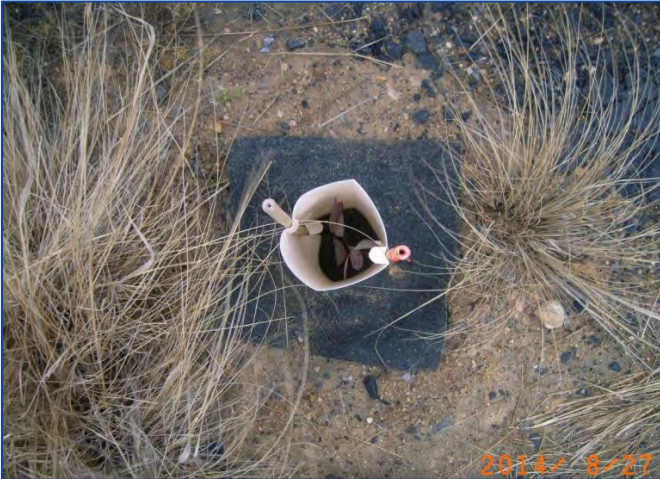
Locality	Photo
Other Areas of the Site	
<p>Leylandii (an exotic pine) and native tube stock planting occurred during the audit period on areas of the Site that may be impacted by any future mining operations.</p> <p>The leylandii has been planted in front of the native tube stock and is intended as a short-term measure to screen exposed areas of the Site from Castlereagh Highway. It is planned that the leylandii will be removed during site closure leaving the established native species.</p> <p>It was noted that at the time of the audit there had been good success with the screening planting.</p>

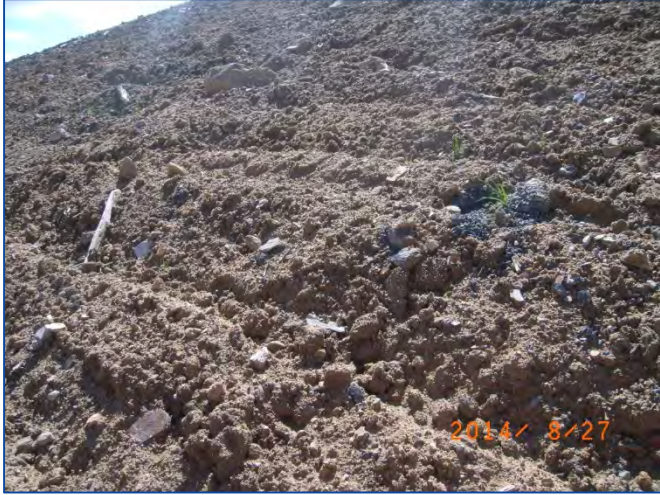
<p>The amenity bund was reshaped during the audit period to a 1 in 3 slope from the former angle of repose of 1 in 1. A cover crop was planted; however, this did not germinate. Global Soil Systems Pty Ltd had been engaged to hand seed approximately 2 hectares of the bund with native tree seed in September 2014.</p>

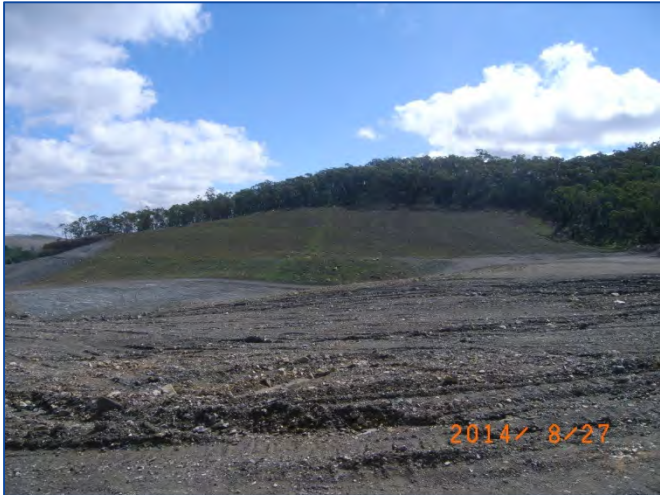
<p>A grass cover crop was planted on shaped landform in the north-west corner of the Yarraboldy extension to reduce windblown dust. The reshaping is not considered permanent and may be removed should mining operations recommence. The majority of the remainder of the pit area had been compacted and prepared for topsoil. Various topsoil and subsoil stockpiles existed around the site for use in future rehabilitation.</p>

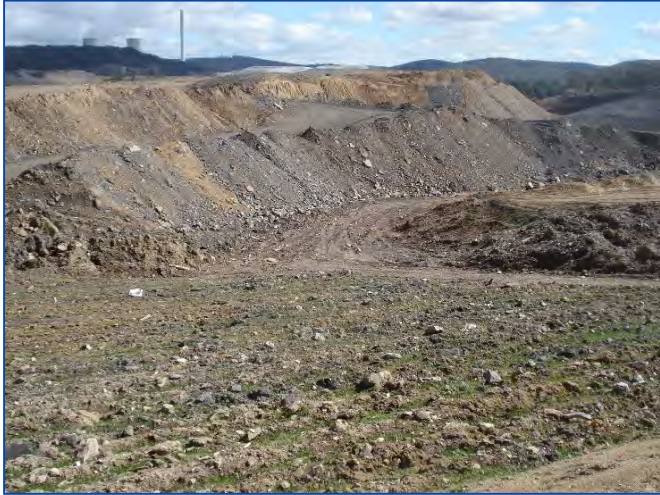
<p>The other side of the visual bund was not contoured. Pine Dale indicated the soil in the bund was to be used in the remaining void if no further mining occurred and the Site was rehabilitated. If mining was to recommence, the area was to be filled with waste from future mining areas.</p>

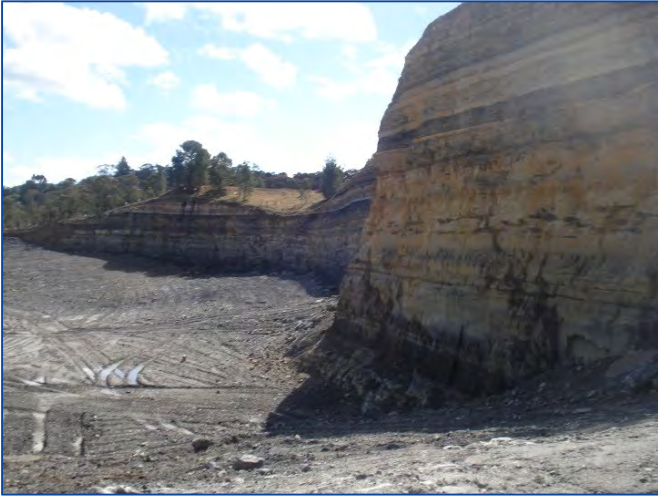
Locality	Photo
<p>The remaining void to the western end of the mine. Pine Dale indicated that should the Site be closed as it is, the intention is to relocate the visual bund into this void and push material up to the high wall. If further mining was approved, this void would be used for waste materials/over burden.</p>

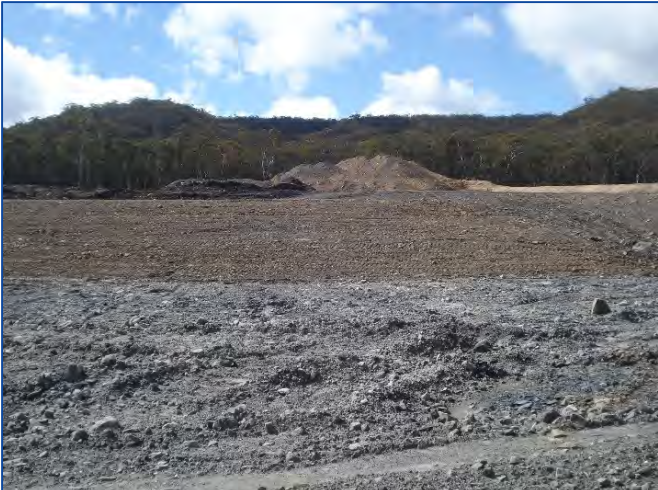
<p>Topsoil stockpile in distance with contoured landform in foreground. While some areas have been seeded as temporary rehabilitation, other areas have been left with overburden at the surface awaiting either closure, whereby they will be topsoiled and revegetated, or further mining approvals, whereby the area would be likely used for waste rock dumps.</p>

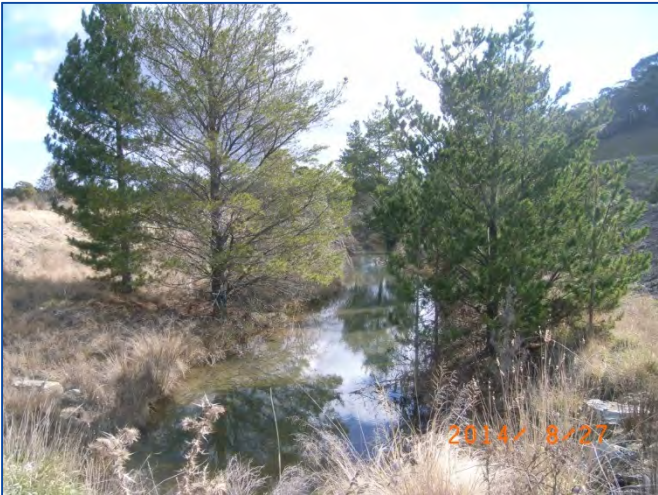
<p>Nuebecks Creek has been significantly altered due to mining activities. In addition, Pines were observed along the bank to Nuebecks Creek and in numerous areas of the site. Pine Dale reported that there was no formal rehabilitation plan for the creek at the time of the Site inspection. Ref to Appendix A, ML 1569, Condition 2.</p>
