**Mt Piper Ash Placement Project Lamberts North  
Annual Operation Compliance Report  
September 2021 – August 2022**

## Annual Operation Compliance Report

<b>Project Name</b>	<b>Mt Piper Ash Placement Project Lamberts North</b>
<b>Project Application Number</b>	<b>09_0186</b>
<b>Description of Project</b>	
<b>Project Address</b>	<b>Mt Piper Power Station, 350 Boulder Road, Portland 2847</b>
<b>Proponent</b>	<b>EnergyAustralia NSW</b>
<b>Title of Compliance Report</b>	<b>Annual Operation Compliance Report</b>
<b>Reporting Period</b>	<b>1 September 2021 – 31 August 2022</b>
<b>Version</b>	<b>1.0</b>
<b>Date</b>	<b>30 November 2022</b>
<p>I declare that I have reviewed the contents of the attached Compliance Report and to the best of my knowledge:</p> <p><b>i. the Compliance Report has been prepared in accordance with all relevant conditions of consent;</b></p> <p><b>ii. the Compliance Report has been prepared in accordance with the Compliance Reporting Requirements;</b></p> <p><b>iii. the findings of the Compliance Report are reported truthfully, accurately and completely;</b></p> <p><b>iv. due diligence and professional judgement have been exercised in preparing the Compliance Re

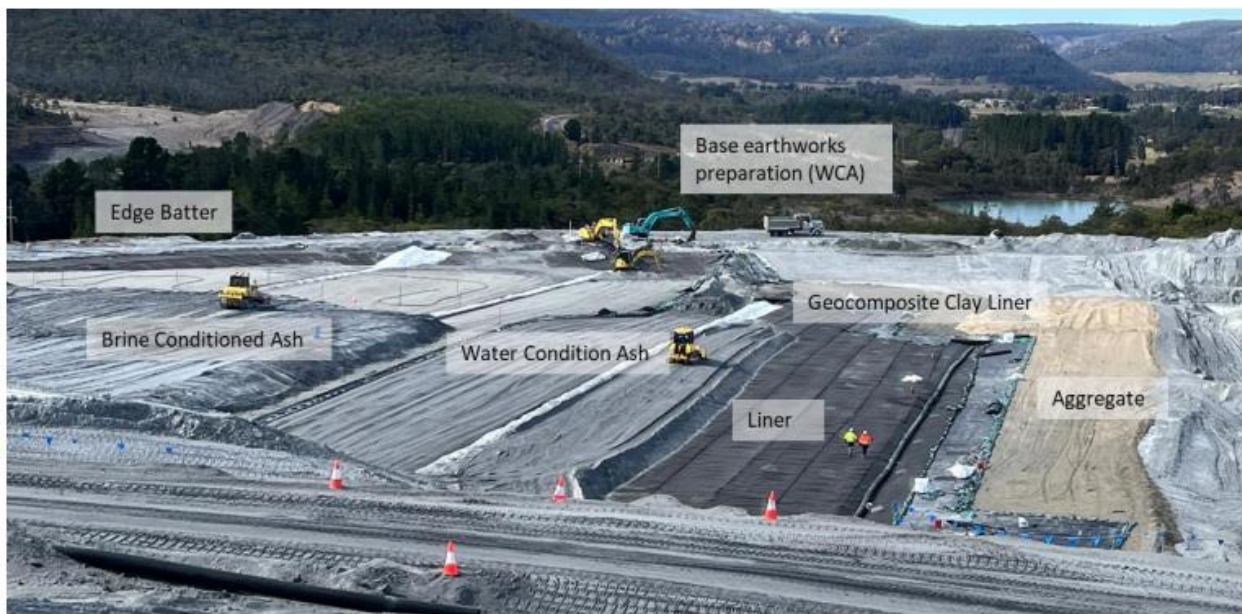
Plate 1 Construction of the Leachate Barrier

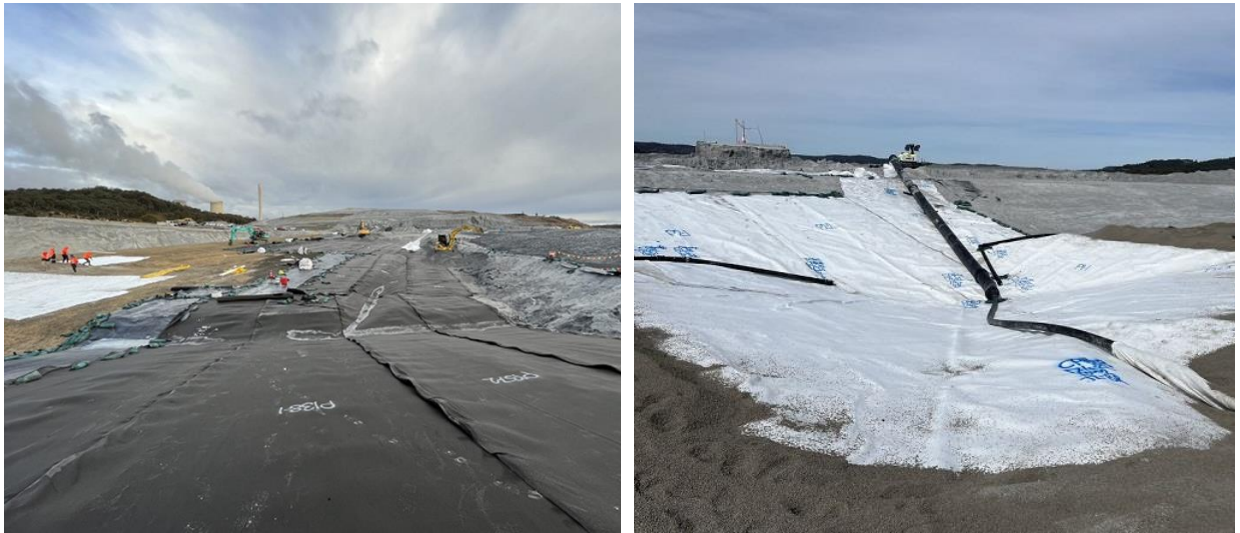
*Plate 2 and 3 Leachate Barrier installation and interconnecting drainage pipe work*

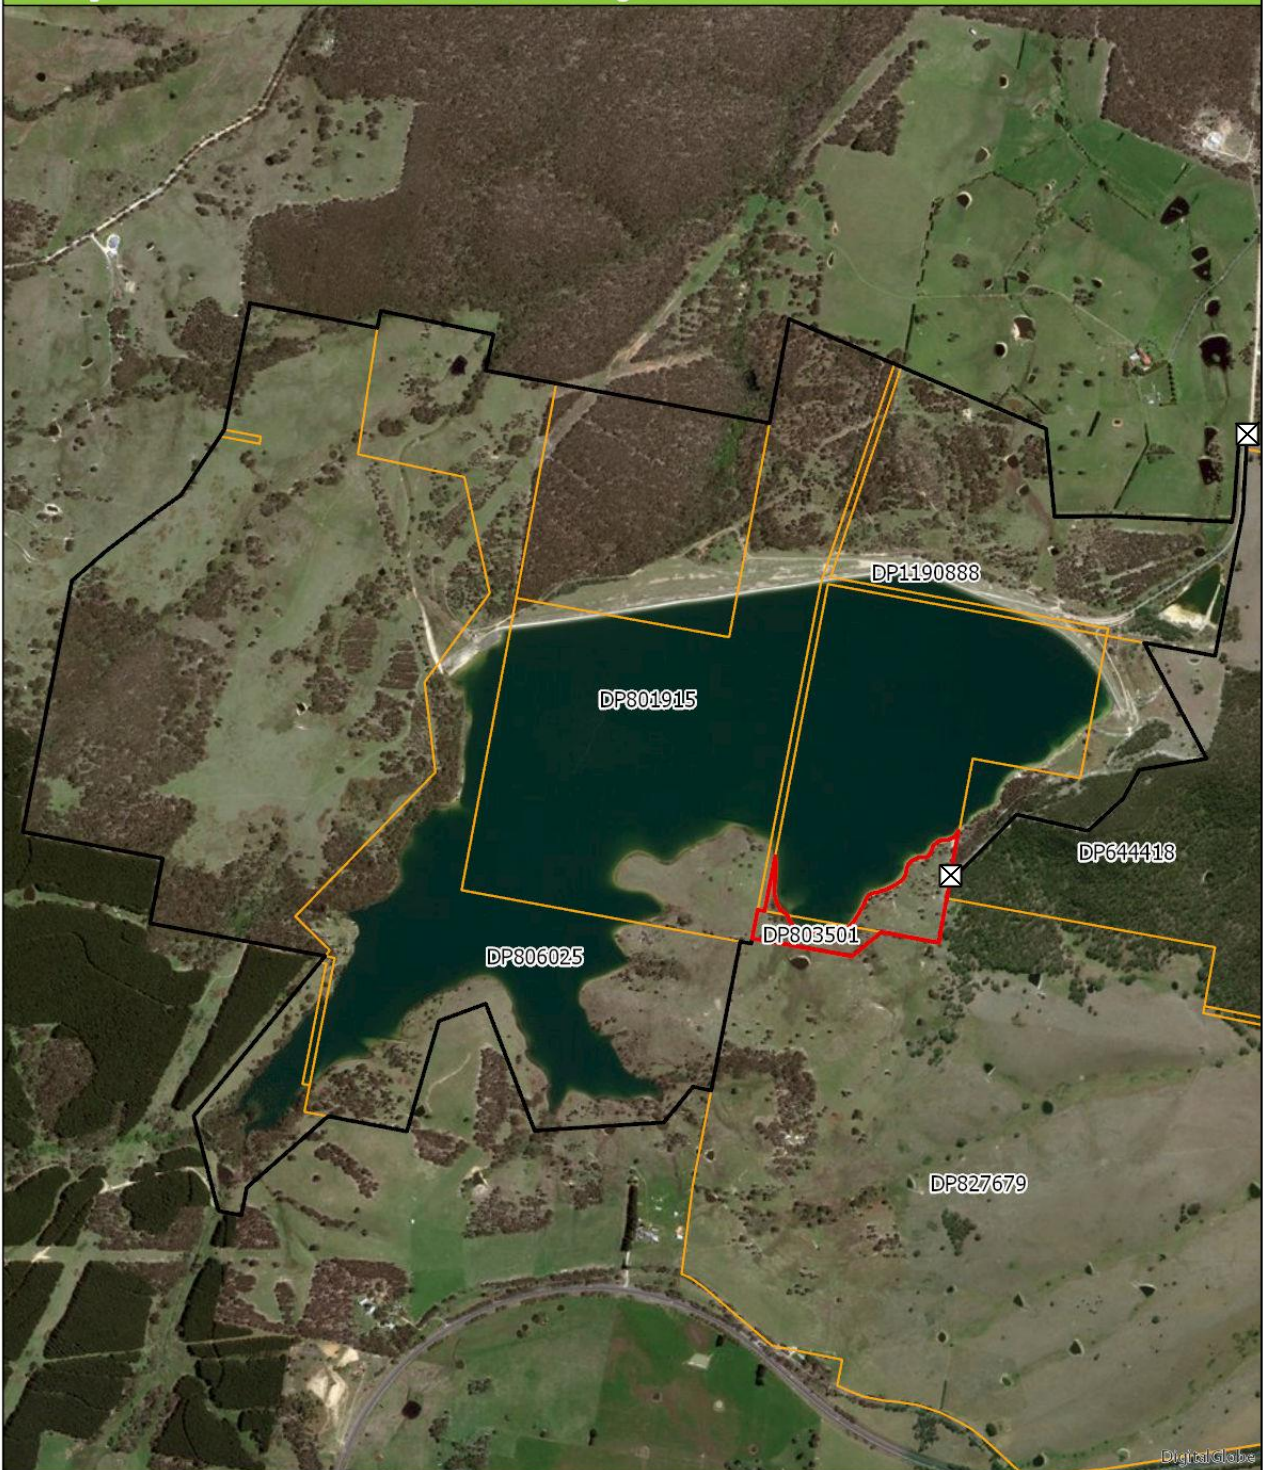
### Thompsons Creek Reservoir BOA boundary

The Biodiversity Conservation Agreement (BCA) (BCT, 2022) details the management actions to be performed within the BOA to enhance habitat for native flora and fauna species through site rehabilitation and revegetation. Biennial, i.e. two-yearly, flora and fauna monitoring within the BOA is required to be performed in accordance with the BCA.

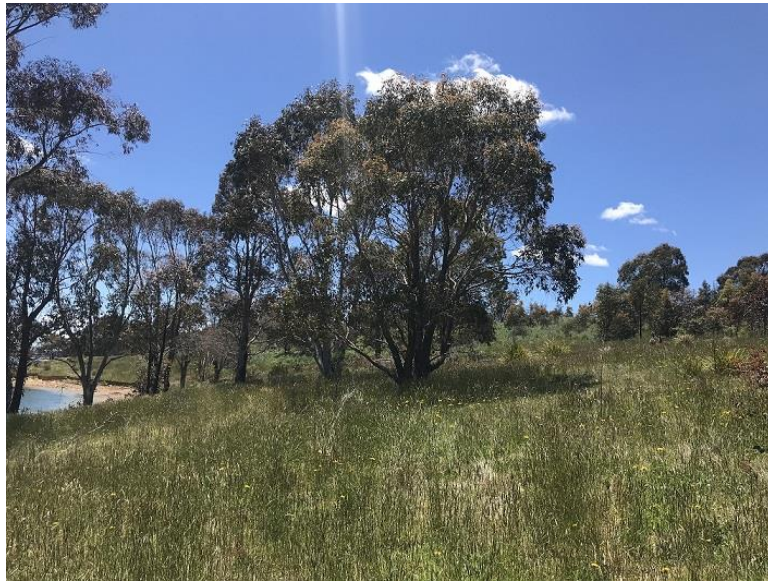
*Plate 4 Established species from revegetation undertaken in 2017 (Photo taken November 2022).*

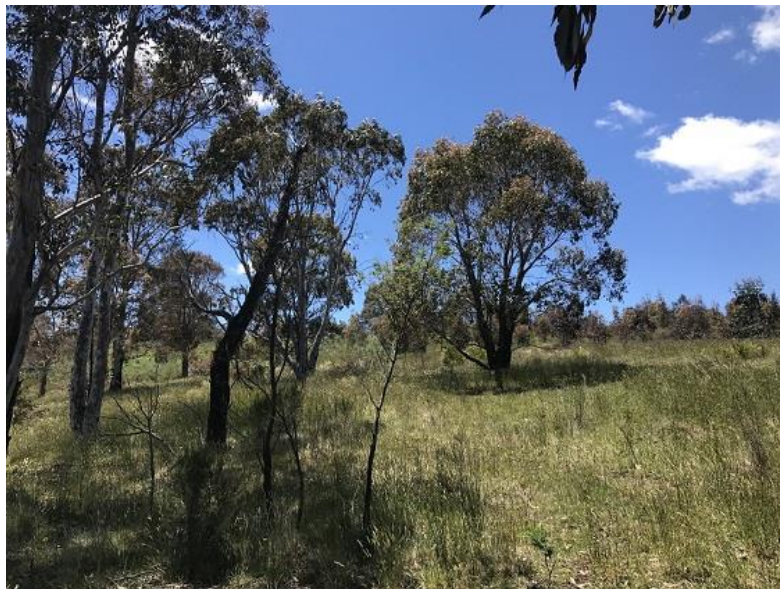
*Plate 5 Current vegetation within the BOA (Photo taken November 2022).*

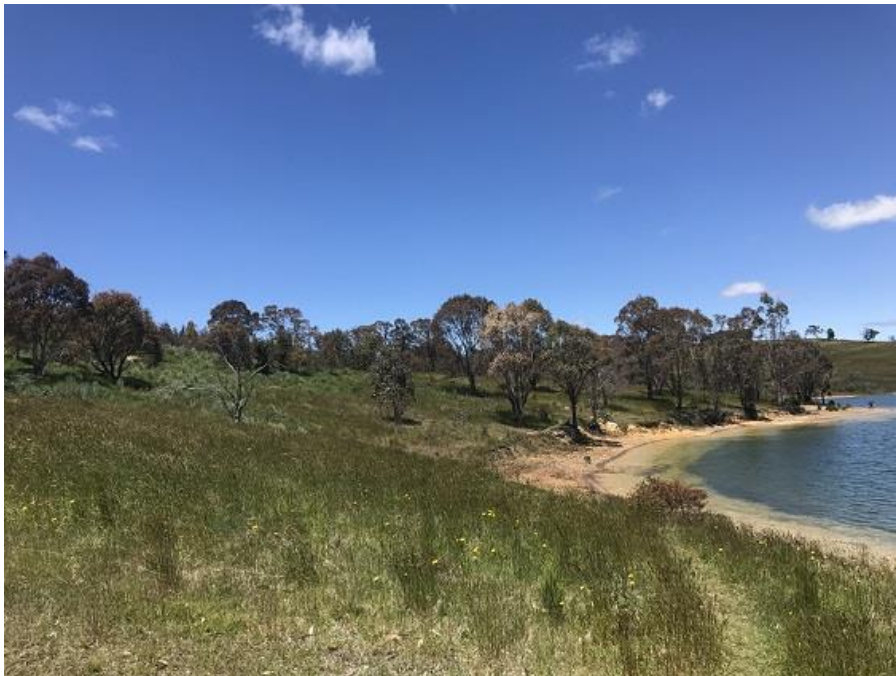
*Plate 6 Established species within the BOA (Photo taken November 2022)*<sup>1</sup>

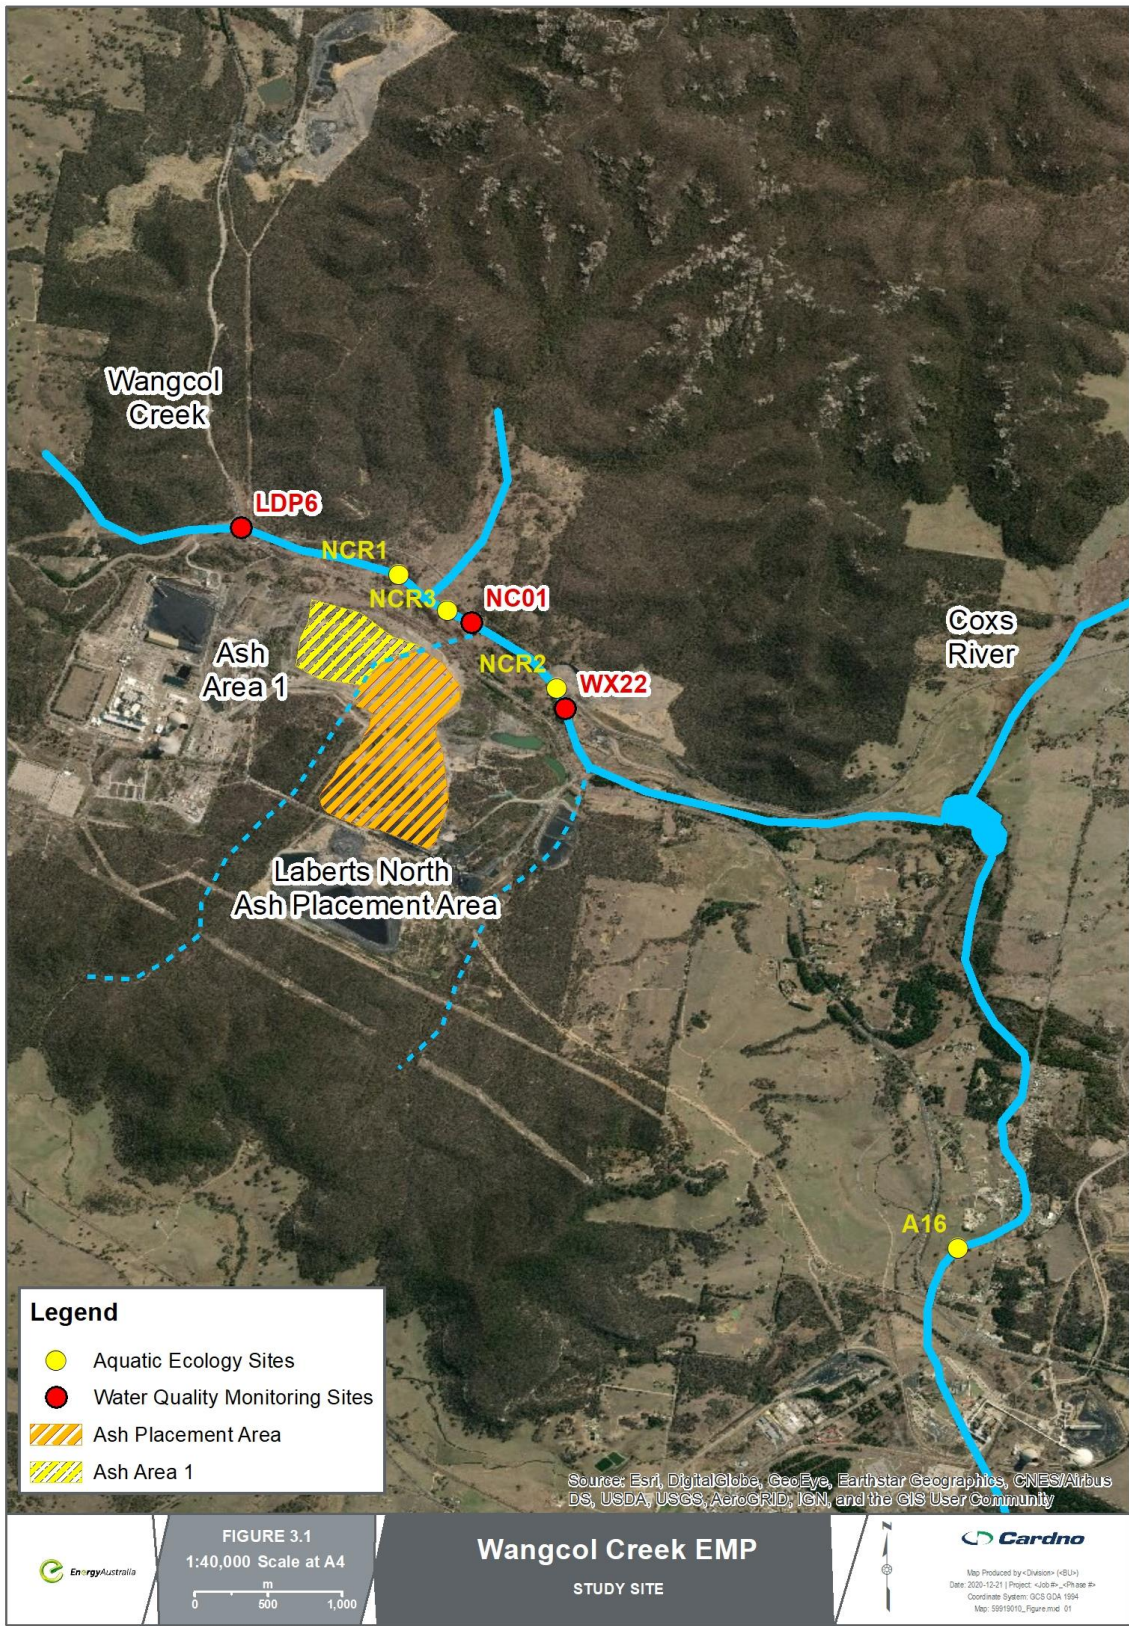
Figure 6 Aquatic ecological monitoring sites and long-term water quality monitoring sites

The EMP was implemented in November 2012 prior to construction activities and then during construction in April 2013. In November 2020, the sample sites included in the program were, NCR1 downstream of surface water discharge point, NCR2 which is downstream of the gauging site (WX22), NCR3 on Wangcol Creek upstream of LN and Control A16 on the Cox River downstream of the confluence with Wangcol Creek (Figure 6). The EMP aims to monitor and quantify the impacts on the ecology of Wangcol Creek and the associated riparian environment.

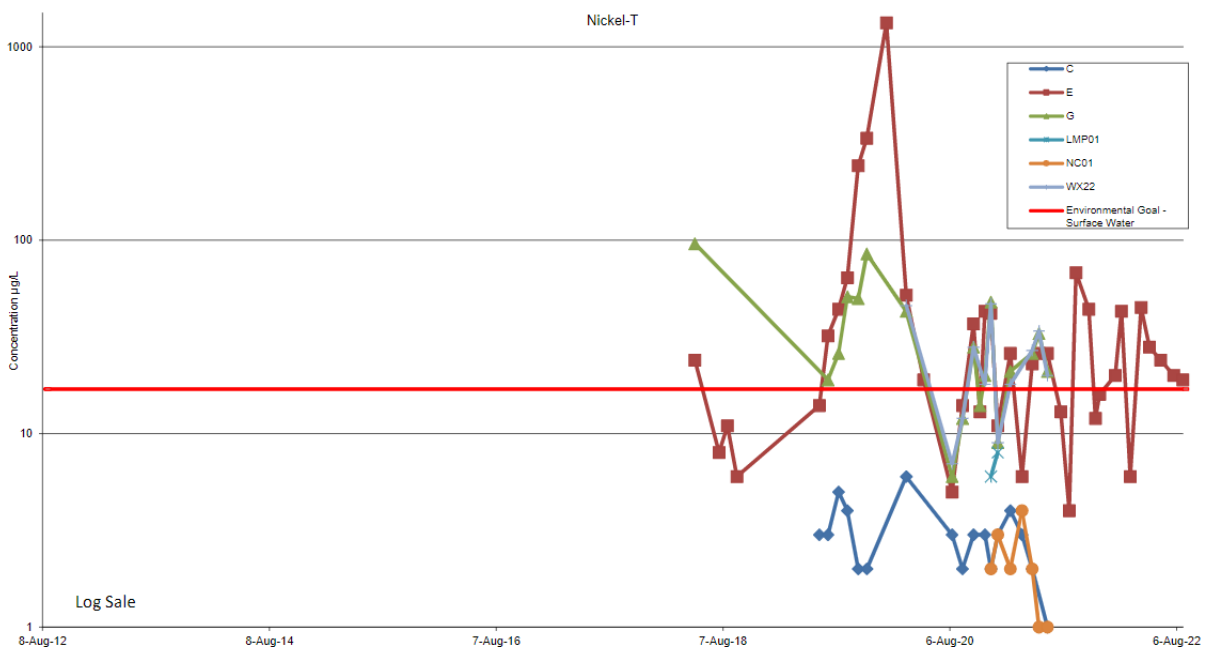
**Figure 16 Nickel Concentrations in Surface Water**

Nickel concentrations at LMP01 and NC01 have been generally stable since monitoring commenced in 2012. These upstream monitoring locations have reported concentrations of nickel equal to the Environmental Goal for surface water in March 2014 (NC01 – 17 µg/L) and February 2020 (LMP01 - 17 µg/L); other concentrations at these locations were below the Environmental Goal. No concentration trend is apparent in the data (Figure 16).

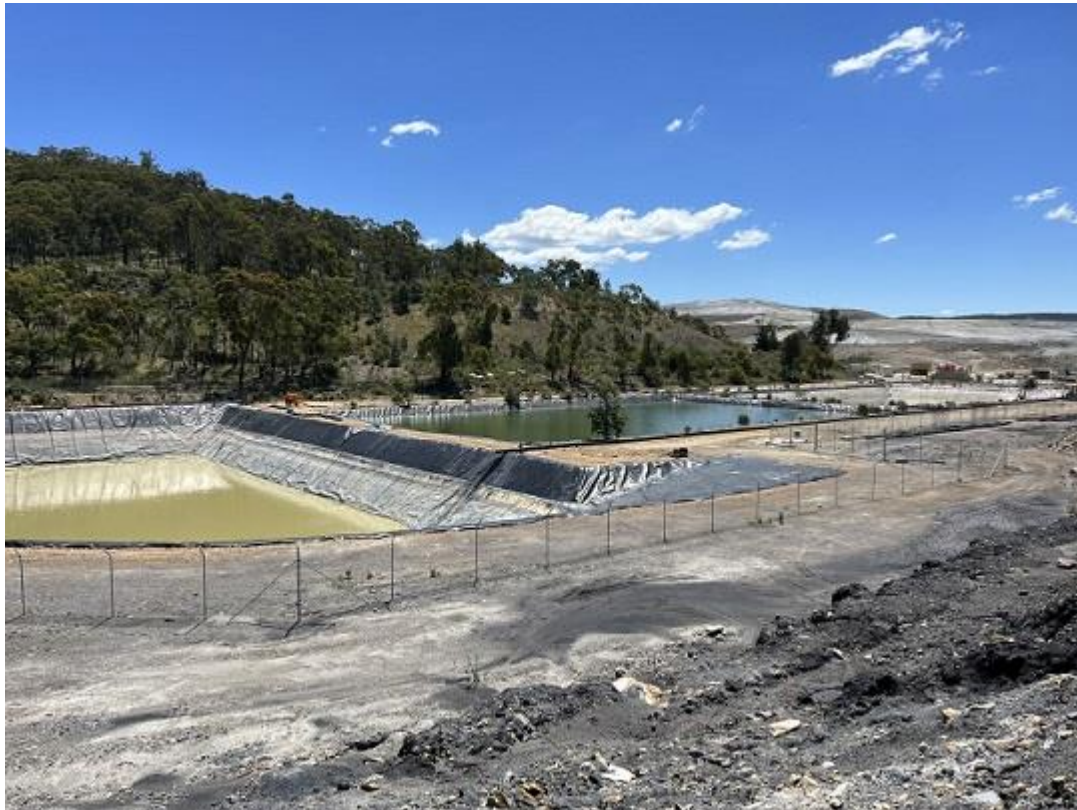
The location of water retention within the LNAR has remained unchanged since 2014 in that surface water flow is retained over the original drainage line installed on the base of the placement site. All water collected on the LNAR is directed to the west side retention location. Free water is drained through the ash via a furnace bottom ash drainage line previously installed at the original floor level of the North LN placement area. Seepage reports to the lined LN Pond 2 (Plate 4). Perimeter pipeline for surface water to report to additional lined storage ponds is in place.

**Plate 2 Lined LN Pond 3, 2, 1 (left to right) (Photo taken February 2022)**

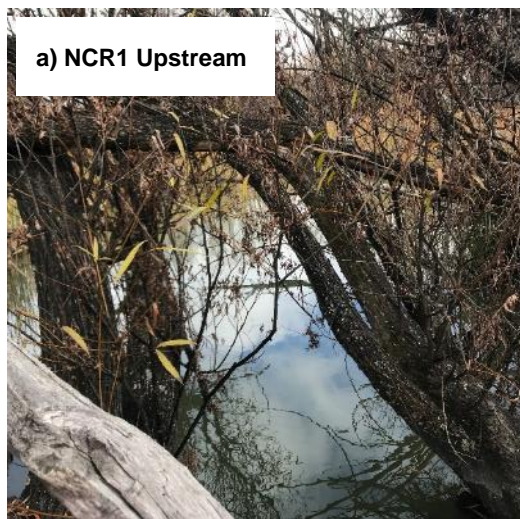
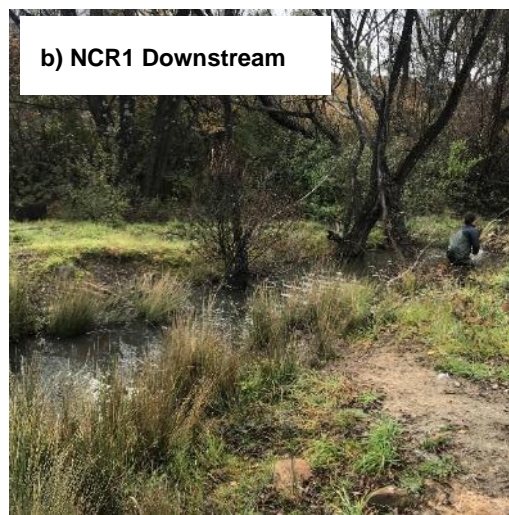
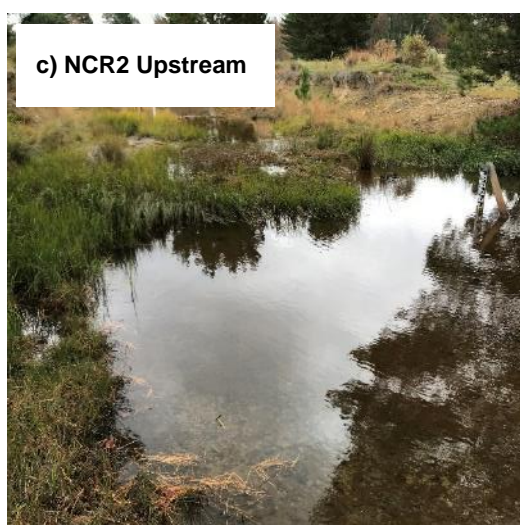
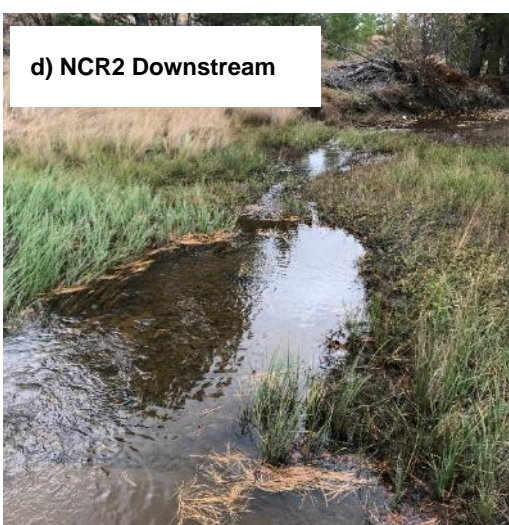
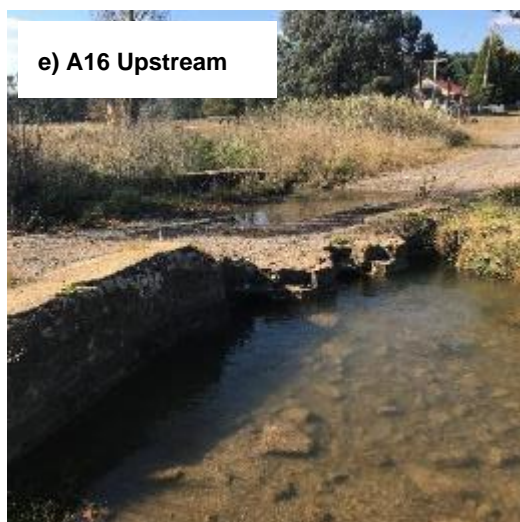
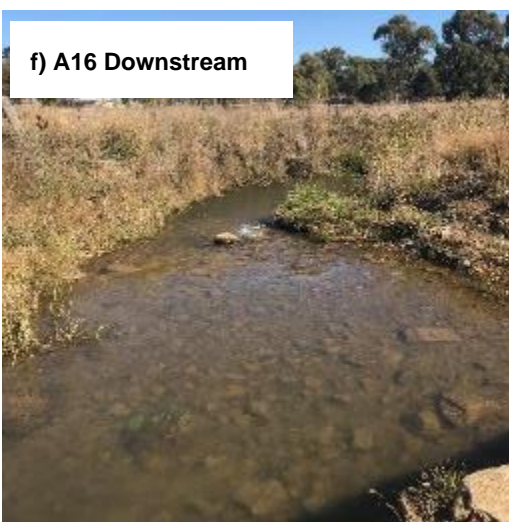
Plate 1: Photographs of NCR1 looking a) upstream and b) downstream, NCR2 looking c) upstream and d) downstream and A16 looking e) upstream and f) downstream.

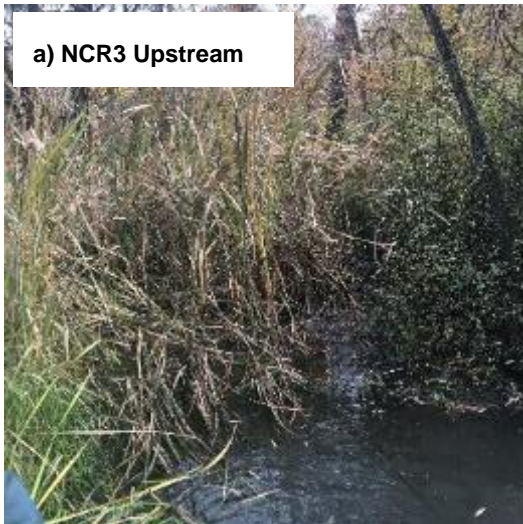
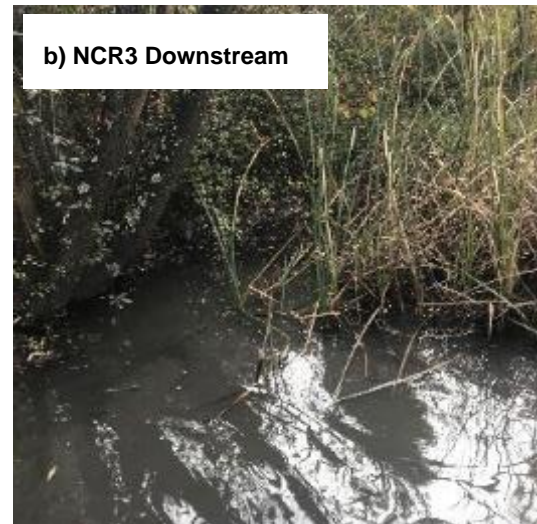
Plate 2: Photographs of NCR3 looking a) upstream and b) downstream.

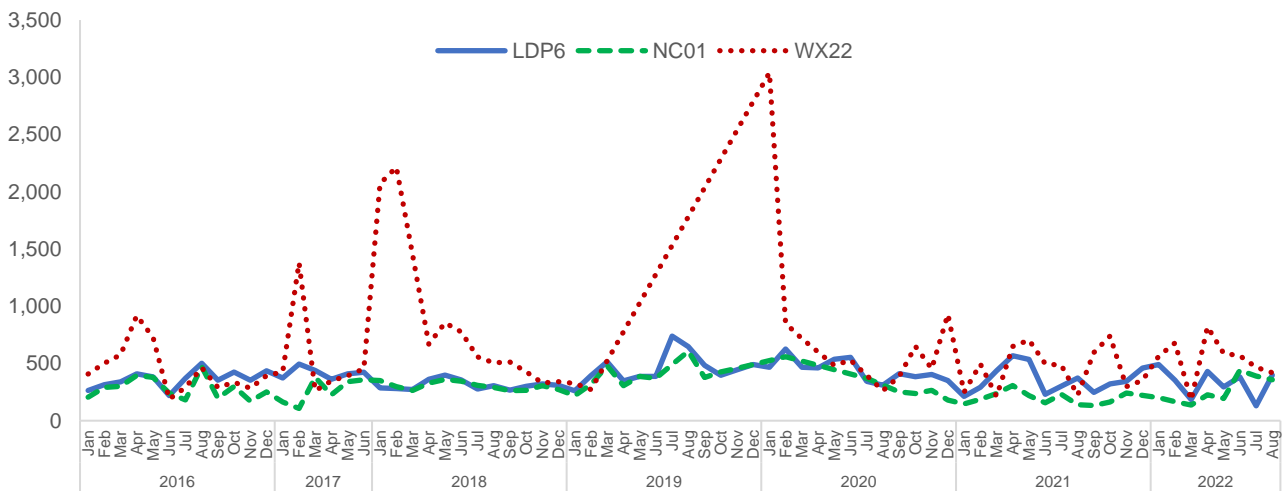
Figure 5-2 a) Electrical conductivity (EC), b) pH and c) concentration (mg / L) of boron measured at LDP6, NC01 and WX22 on Wangcol Creek by EnergyAustralia from January 2014 to June 2020.

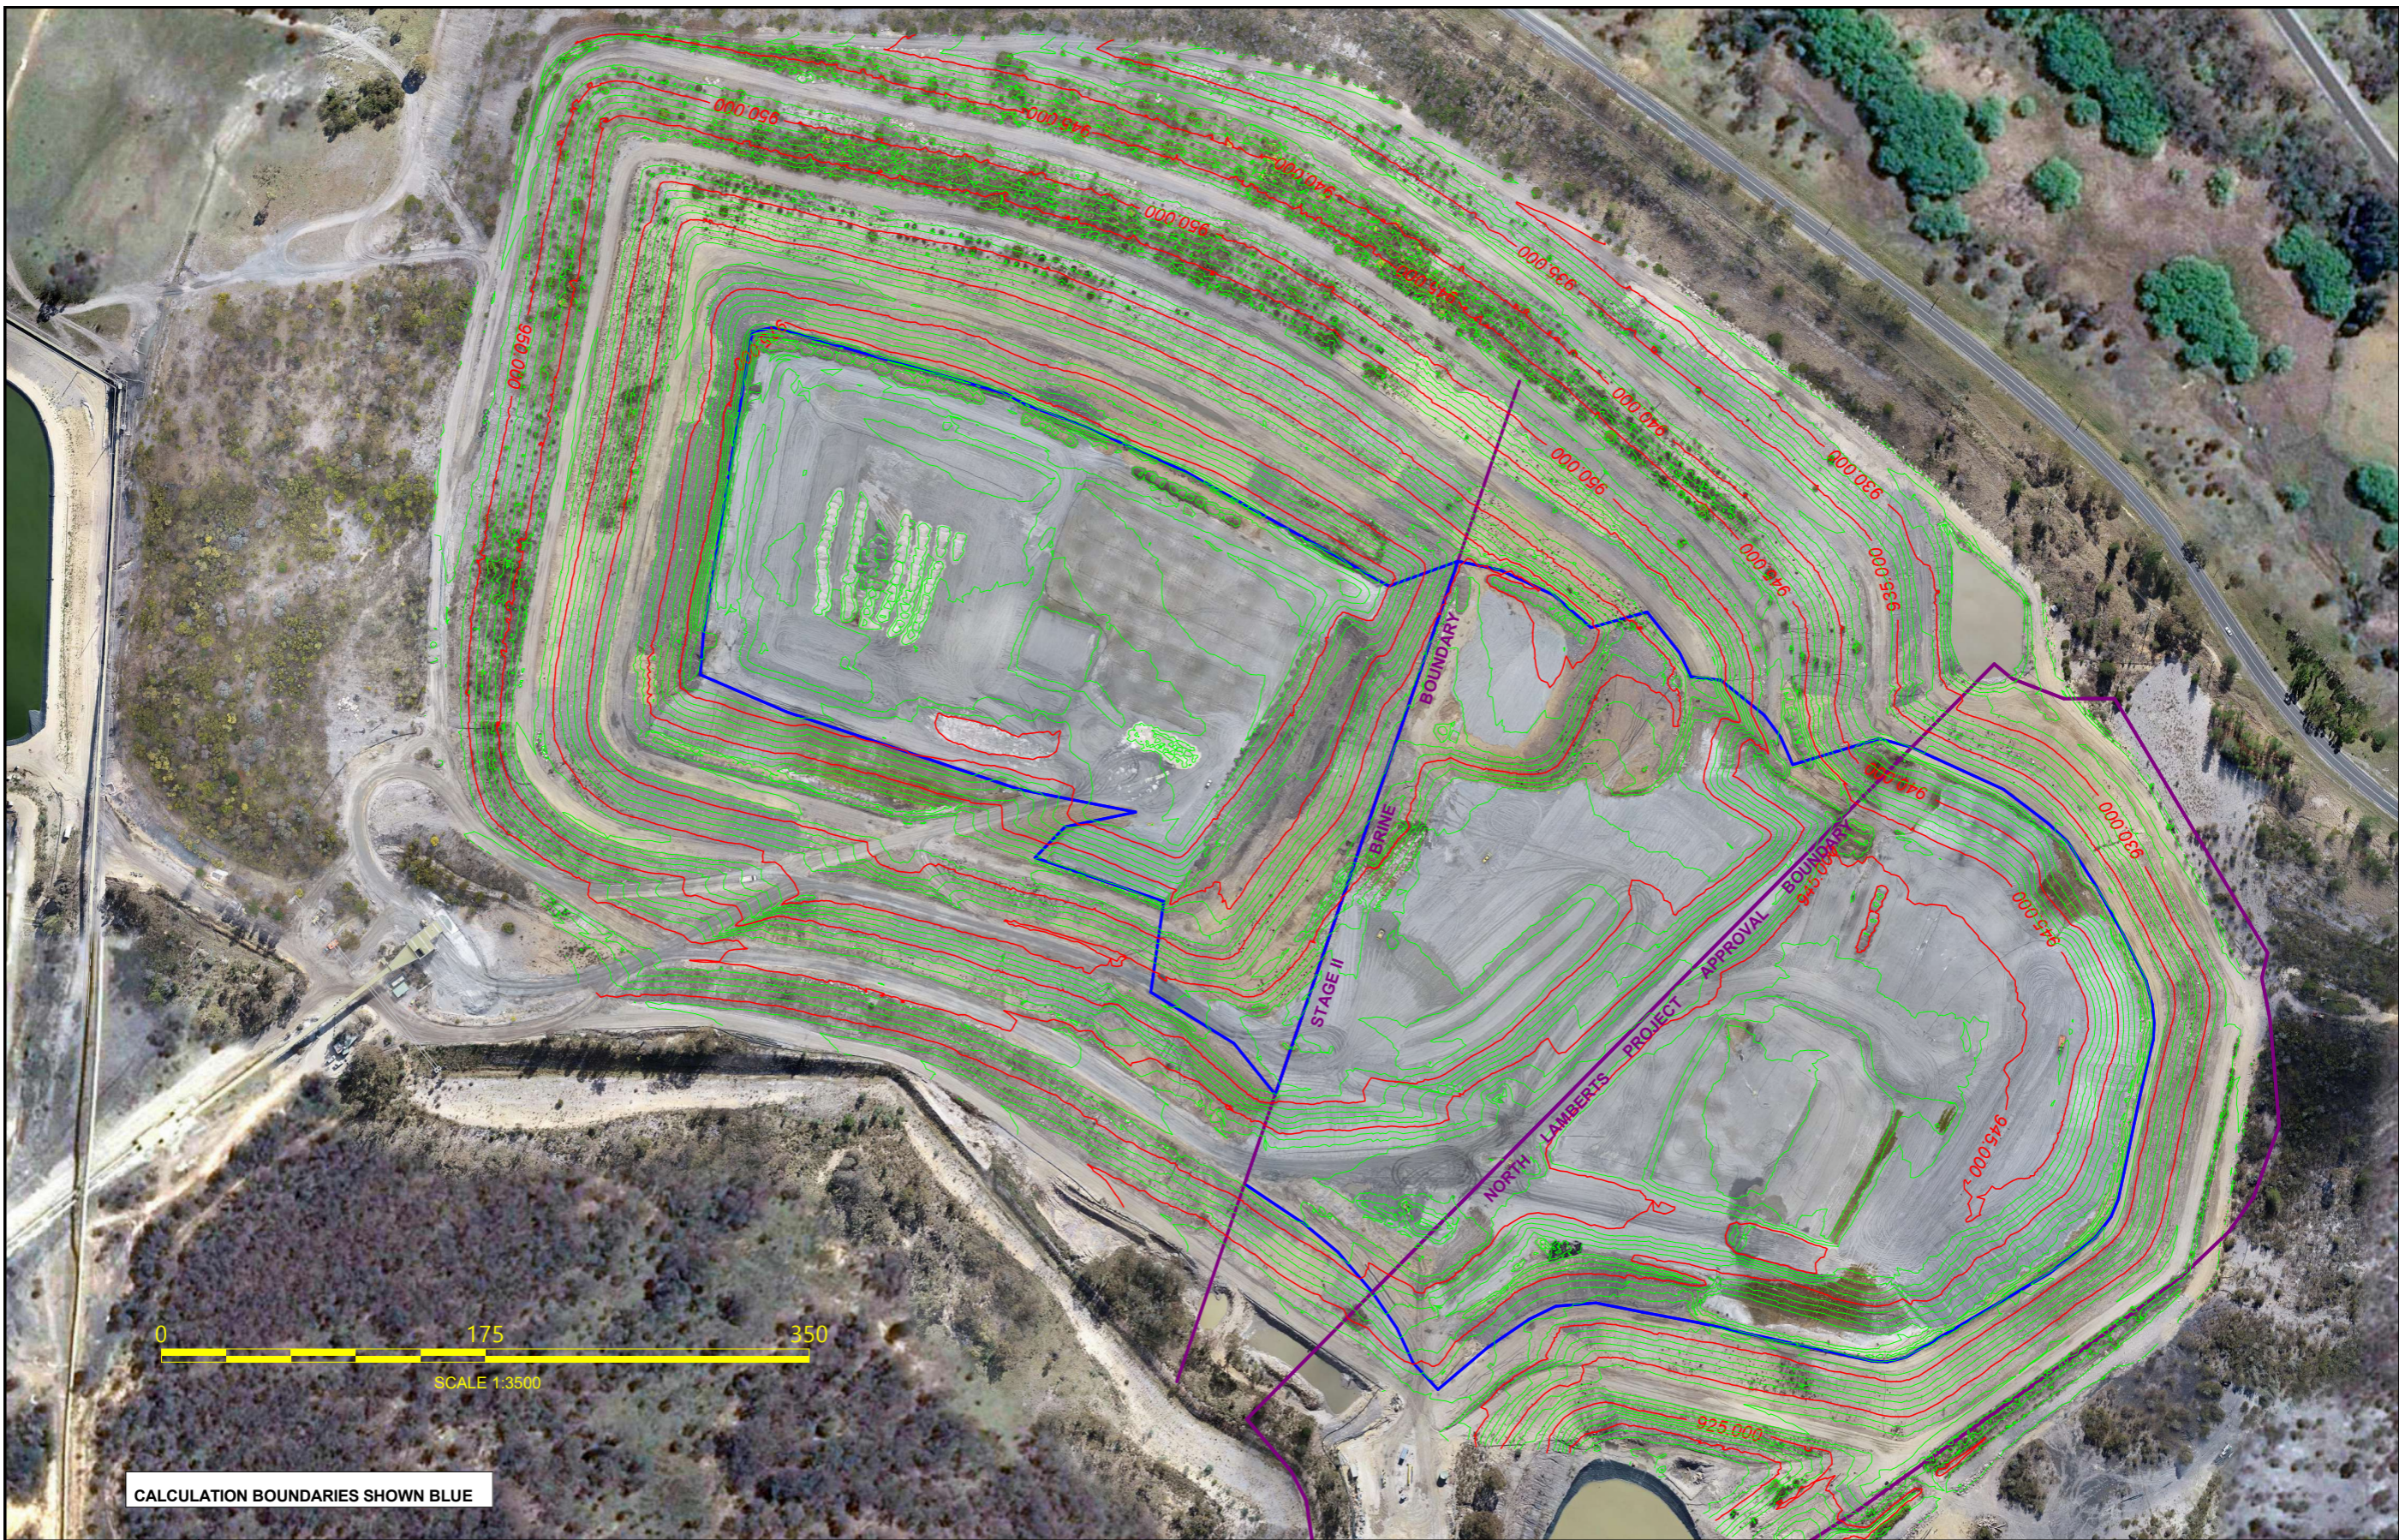
CALCULATION BOUNDARIES SHOWN BLUE
