Community Consultative Committee (CCC) Pine Dale Coal Mine – Yarraboldy Extension

Minutes of the Meeting of Members of the Pine Dale Coal Mine-Yarraboldy Extension & EL7621

PINE DALE MINE & ENHANCE PLACE MINE

**REPORT COMPILED FOR
PINE DALE MINE COMMUNITY CONSULTATIVE COMMITTEE
DETAILING SURFACE WATER, GROUNDWATER DEPOSITIONAL DUST,
HVAS AND METEOROLOGICAL MONITORING
OCTOBER 2014**

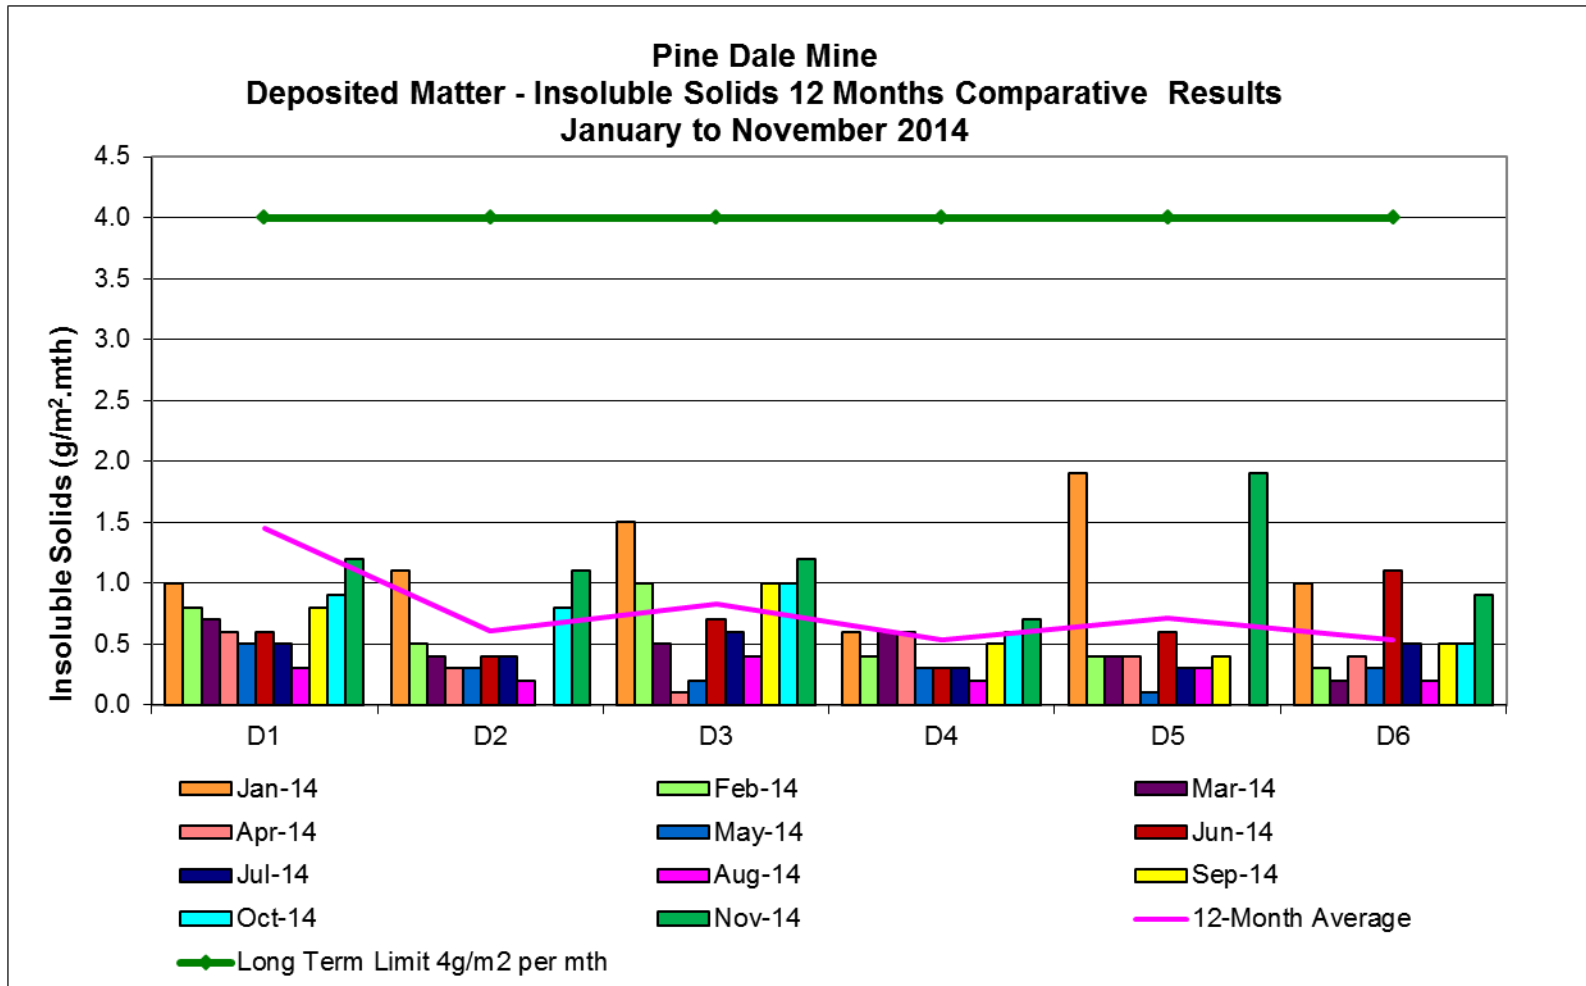
Air Quality

- Long term performance consistently below approval limits
- Proven track record on managing dust levels effectively

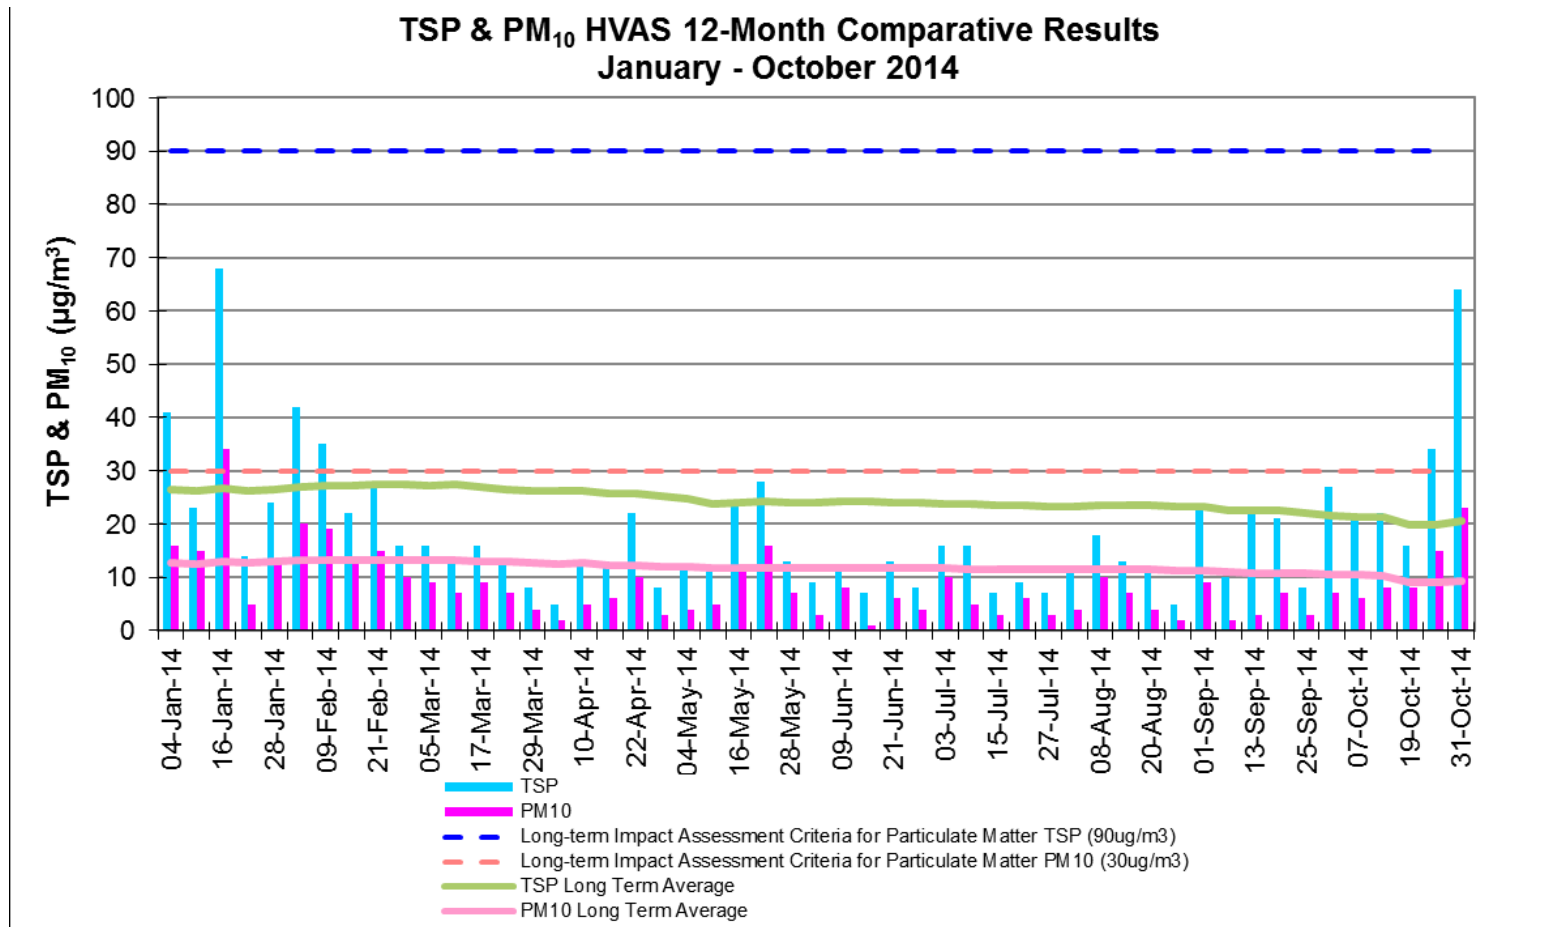
Air Quality

- No exceedance of the PM₁₀ short term (24hr) Impact Assessment Criteria *EnergyAustralia* (IAC) of 50 µg/m³
- No exceedance of the Particulate Matter (PM)₁₀ long term IAC of 30 µg/m³
- No exceedance of the TSP long term IAC of 90 µg/m³

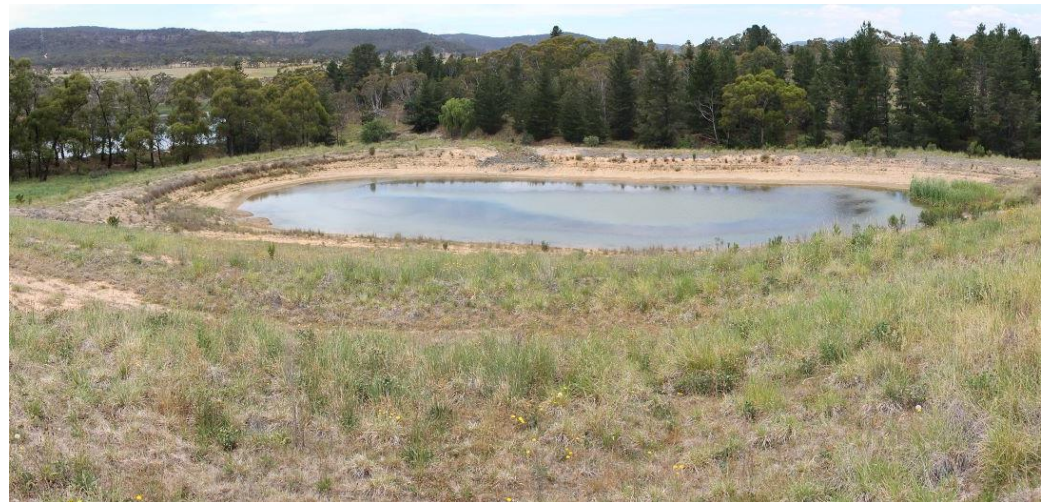
Water Management

- PDM is generally a net user of water
- No surface water discharges occurred during 2014
- No adverse results were recorded at points 2, 3 & 14 during the reporting period
- There has been no significant change or adverse trends identified relating to water depth or quality in 2014

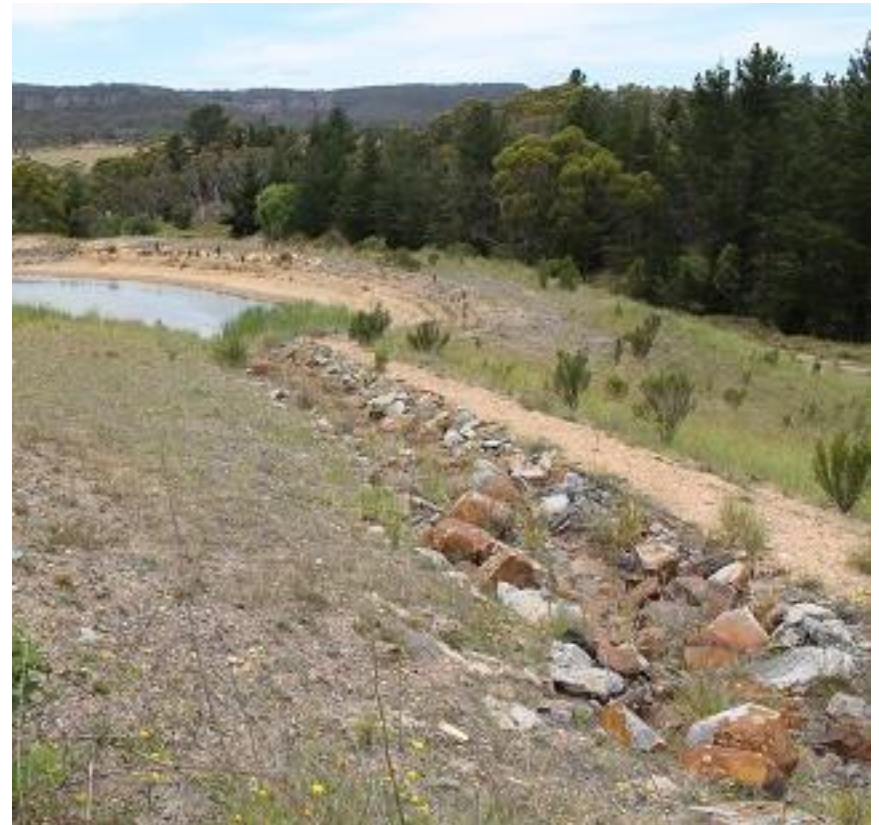
Sediment Control

- Closed water management system to ensure no uncontrolled discharge of water from site
- Windrows and silt fencing installed
- Sediment removed from haul road drains
- Rock lined drains and contour drains maintained in rehabilitation areas
- Temporary sediment ponds to capture 'dirty' water maintained
- Ongoing water monitoring, erosion control & maintenance

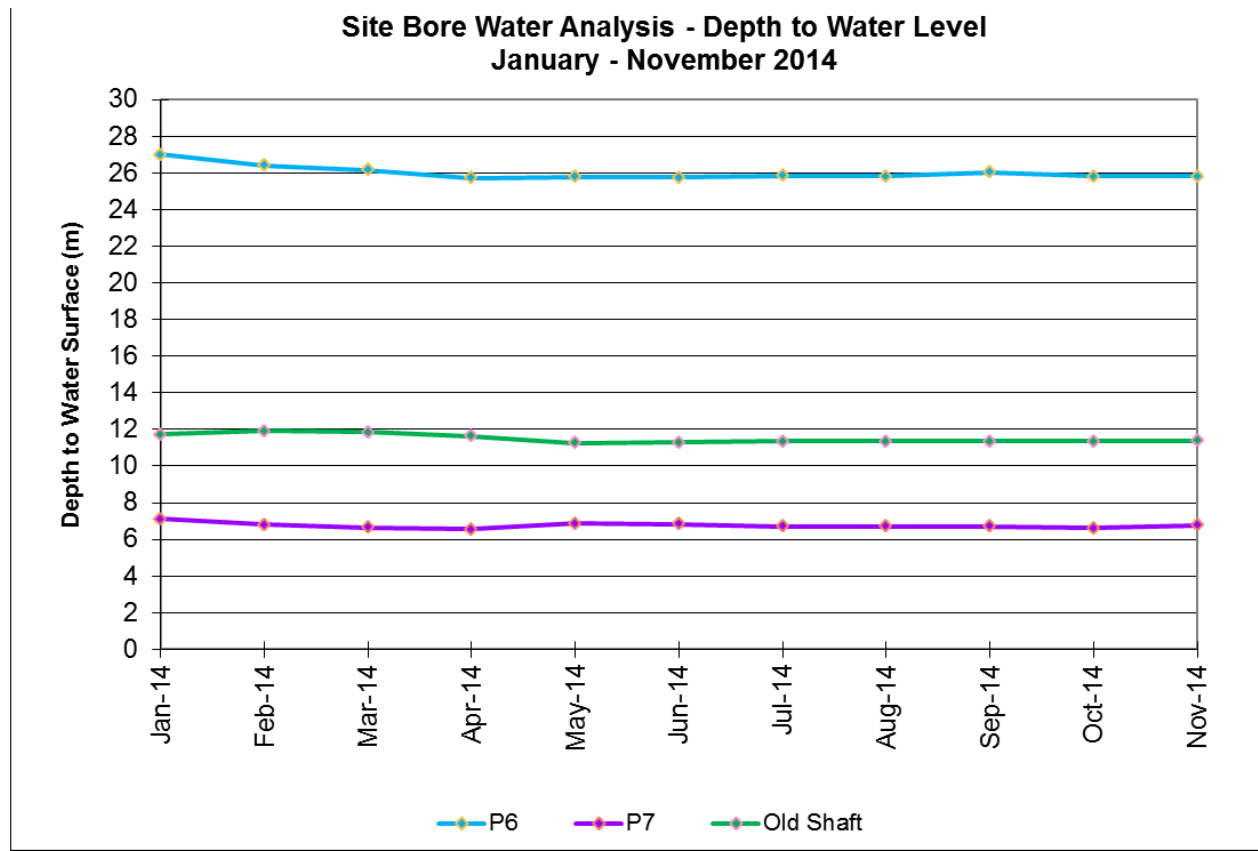
- Groundwater monitoring generally show water quality that complies with the adopted trigger levels (PH, EC and Standing Water Level)
- All site bores exhibited consistent standing water levels in 2014
- Water levels were not exceeded at any time at the onsite groundwater bores

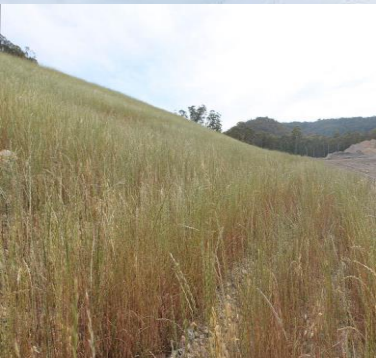
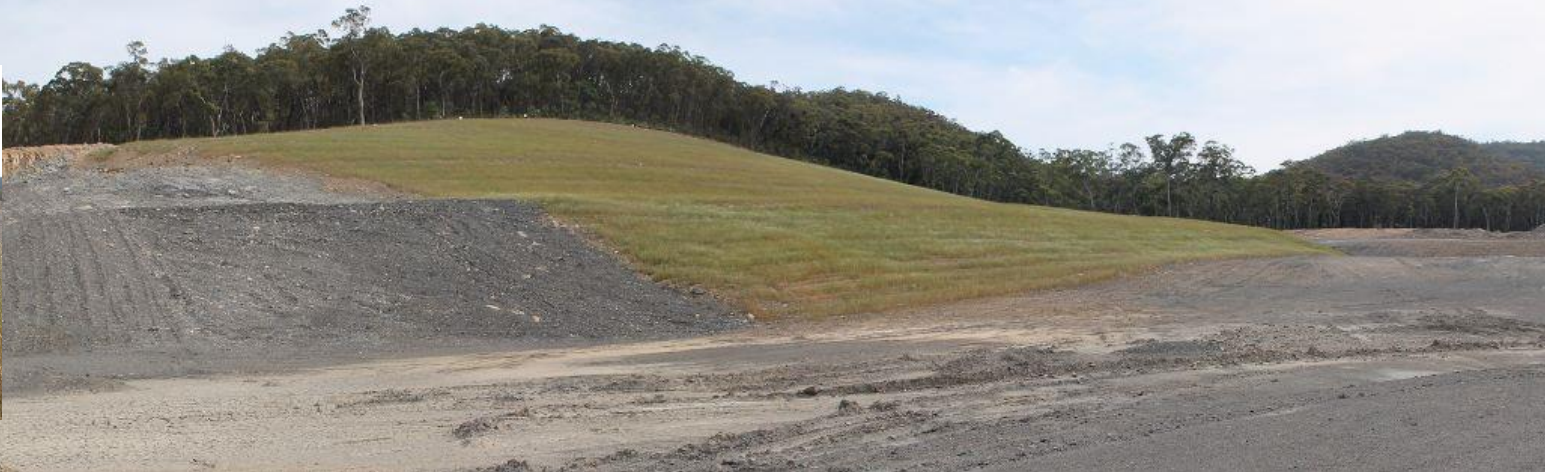
Temporary Rehab Nov 2014

- Annual Rehabilitation Surveys conducted in Nov 2014
 - Targeted weed spraying has been effective
 - Mulching & fertilising has improved vegetation cover in rehab areas
- Rehabilitation areas inspected by Agronomist from SLR Consulting in Oct 2014, recommendations will be implemented moving forwards
- Visual bund reshaped Apr 2014 and seeded in Oct 2014
- Up to 500 tube stock trees planted in Jul 2014 to assist with rehabilitation around the infrastructure area (office and workshop)
- Ongoing weed control throughout 2014

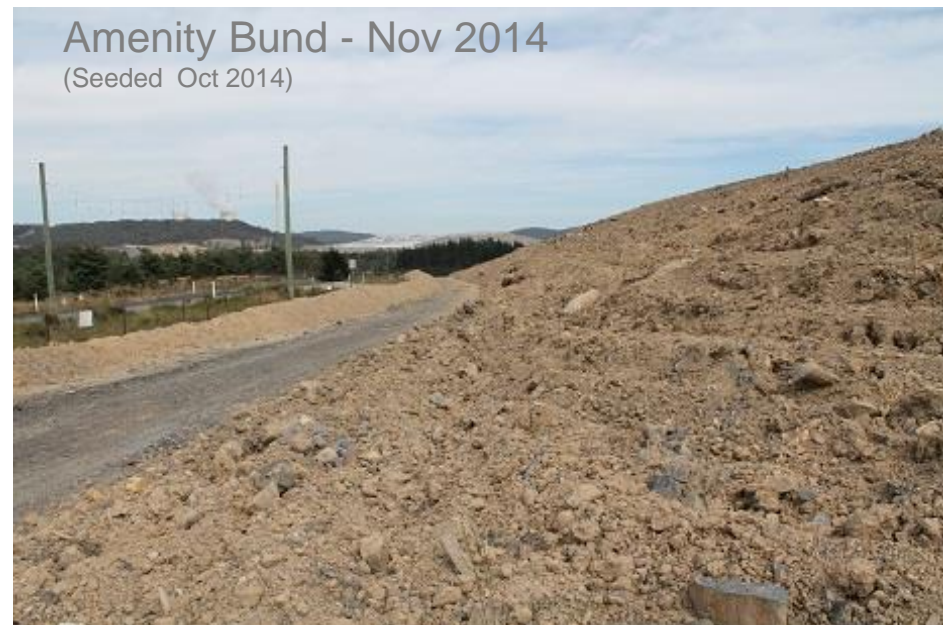
Amenity Bund - Nov 2014
(Seeded Oct 2014)

- Through the year progress had been made on improving the vegetation cover in various areas of the rehabilitation.
- It was also noted that the visual bund had been reshaped into a more sustainable land form, and that this has been seeded during spring to create a longer term cover.
- Weed control processes were conducted through the year.
 - In response to a question, the Company confirmed that local people were being used for this work.

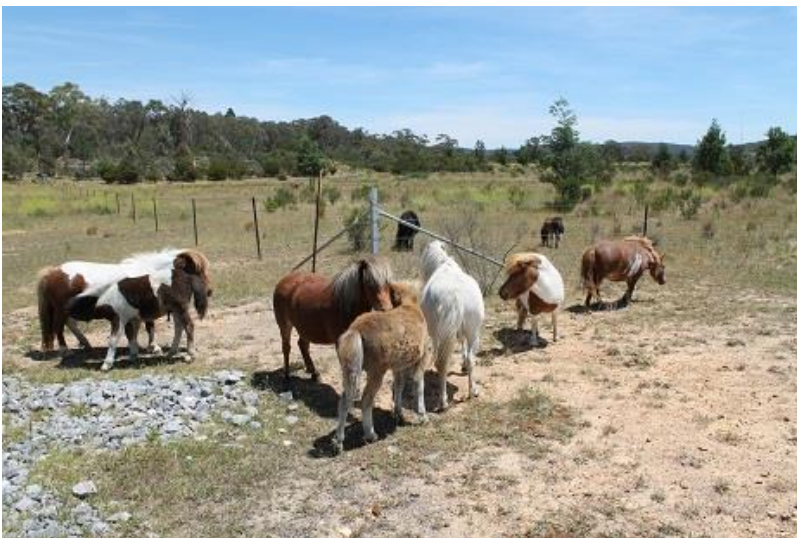
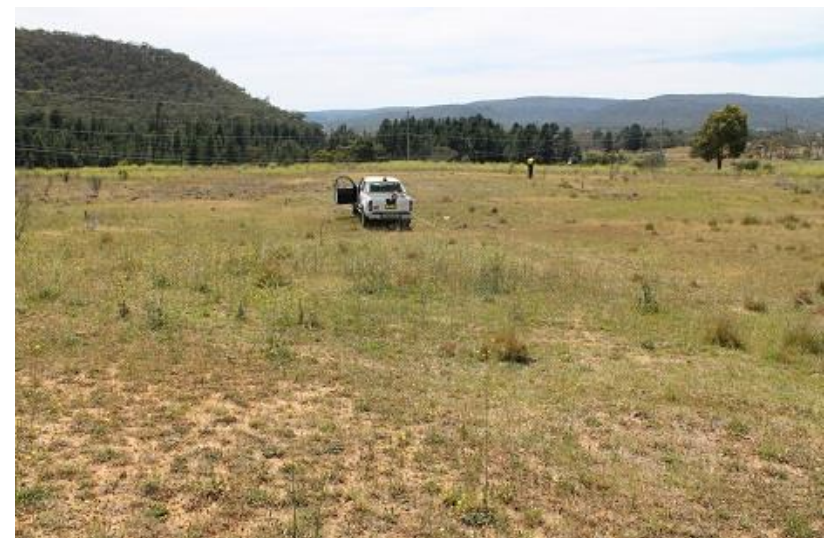
Enhance Place Mine

- Mine rehabilitation complete, no additional rehabilitation works occurred during the reporting period
- Maintenance work undertaken including weed spraying and fencing of rehabilitated areas
- Rehabilitated land demonstrated to support livestock grazing by current property owner during
- Annual monitoring of rehabilitated land will continue while Enhance Place hold mining authorities over the area

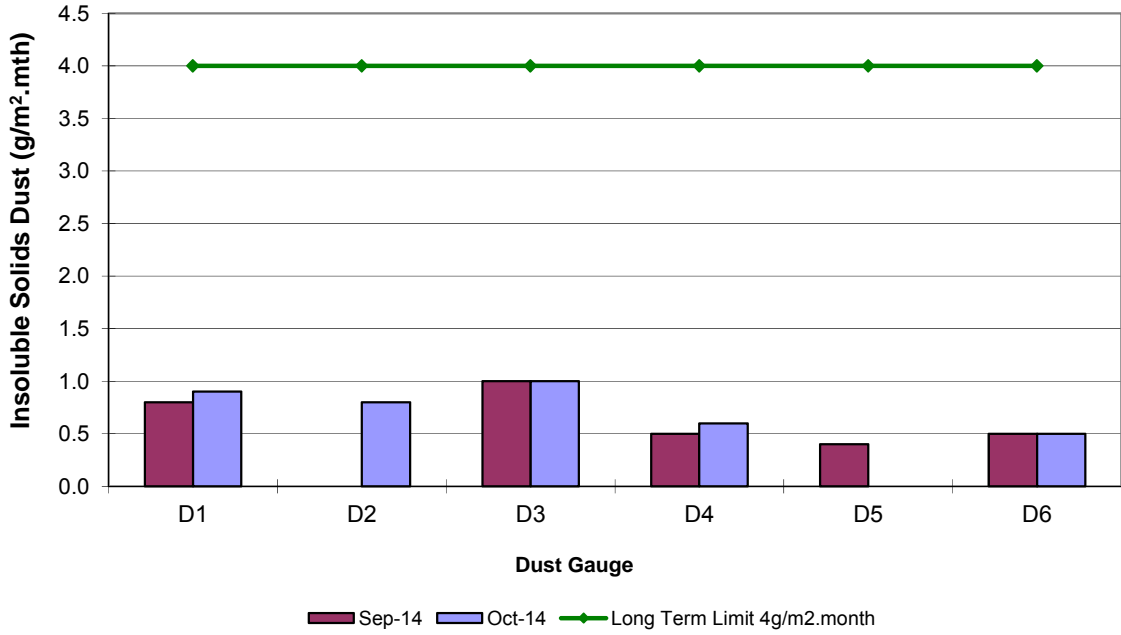
**Pine Dale Mine
Depositional Dust Gauge Comparative Results
September 2014 to October 2014**

The EPA Long Term (Annual Average) Dust Limit is 4g/m² per month. All Depositional Dust results during this monitoring period are in compliance with consent conditions. The Annual Average for Dust Gauges D1, D2, D3, D4, D5 and D6 are all less than or equal to 1.5g/m² per month, which is below the allowable Annual Average Long Term Limit of 4g/m² per month.
