**Enhance Place Pty Limited**

# **Annual Environmental Management Report**

## **2014**

## **Enhance Place Mine**

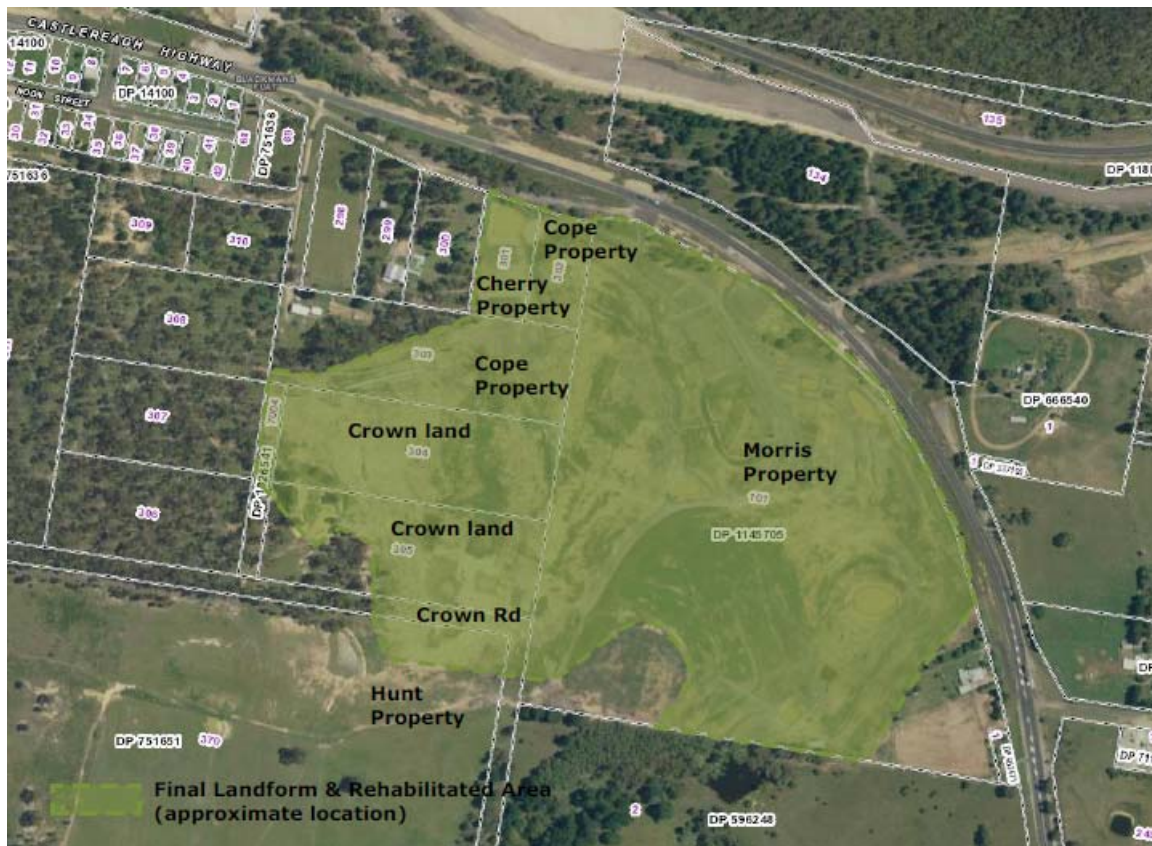
**Figure 1**  
**Land Ownership Plan**

Land ownership of the Enhance Place Mine consists of private freehold and crown land. The current status of land ownership, tenure and pre-mining land use at the Enhance Place Mine is summarised in **Table 2** and shown on **Figure 3**.

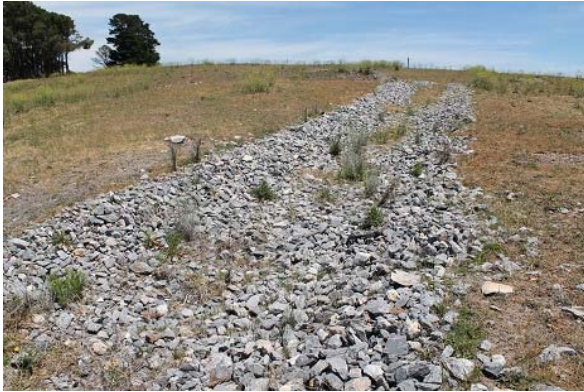
**Plate 1: Water Drop Structures**

The survey was conducted following a period of low rainfall and very dry conditions, there was no evidence of surface water pooling during the survey. Previous land-forming and the establishment of drainage structures throughout the study area appear to be appropriate and in good condition (see **Plate 1**).

*Water drop structure above SD5 in good condition and stable*

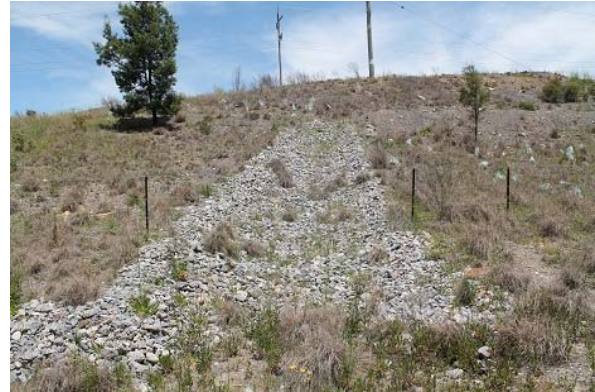
*Water drop structure in treed area adjacent transect 8 in good condition and stable*

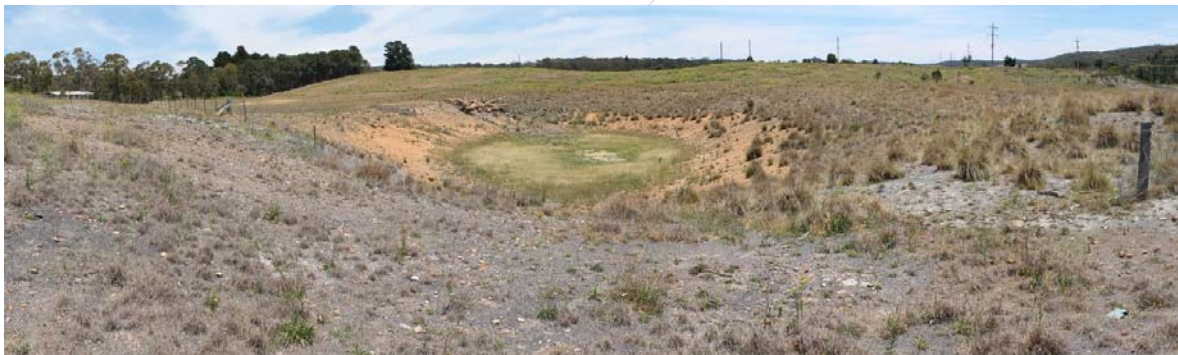
**Plate 2: Sediment Dam 5 (SD5)**

Surface water flows to several sediment dams before flowing to the abandoned underground workings located to the north east of the site. Some rill erosion and bare ground was evident at Sediment Dame (SD) 5, and SD4 see **Plate 2** and **Plate 3**.

*SD5 some rill erosion and bare ground evident during very dry conditions*

- c) Implement soil and pasture management strategies and treatment methods as recommended by SLR (2014);
- d) Remove minor waste material (plastics) from pasture rehabilitated areas;
- e) Treat bare ground adjacent sediment basins.

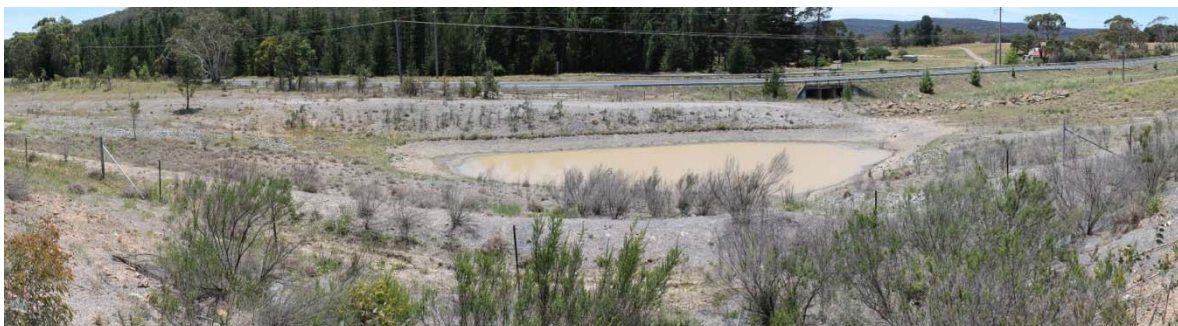
**Plate 3: Sediment Dam 4 (SD4)**

*SD4 some rill erosion and bare ground during very dry conditions*

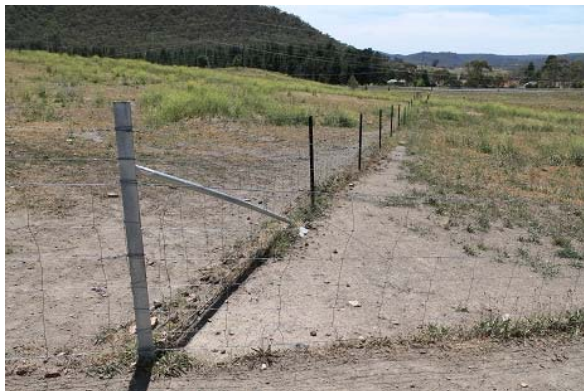
**Plate 4: Fencing**

Infrastructure at Enhance Place generally includes power lines, fence lines and access tracks. The power lines are not owned or managed by Enhance Place and were not inspected as part of this audit. The access tracks were generally in good condition with limited erosion or other water damage. Fence lines were generally in good condition and a number of new fence lines had been installed by Enhance Place to create several additional paddocks to assist with stock management (see **Plate 4**).

*New fencing installed near quadrat 2, generally in good condition.*

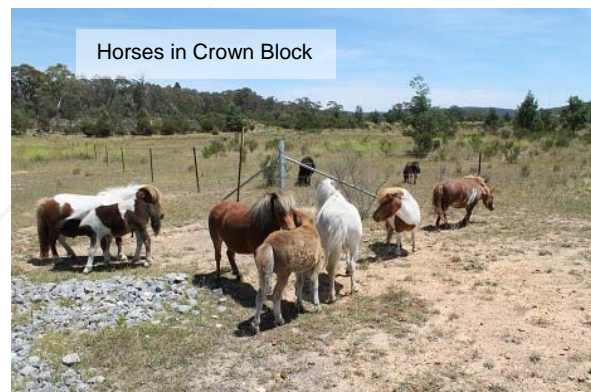
*Stock found within Crown Blocks*

- a) Consult with the horse owner to recommend reducing stock rate and implement stock management practices to allow better establishment of pasture.
- b) Continue to implement integrated weed management control methods for noxious weeds as recommended in First Field (2014). This has been reproduced in Appendix D.

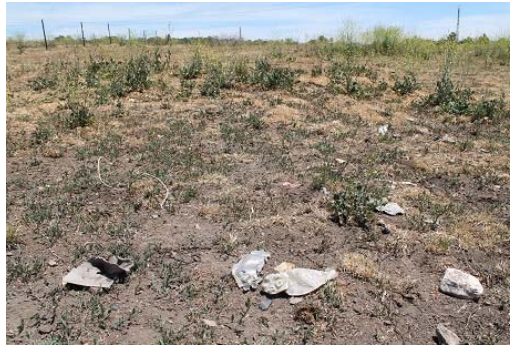
*Rubbish adjacent Quadrant 2 in pasture rehabilitated area*

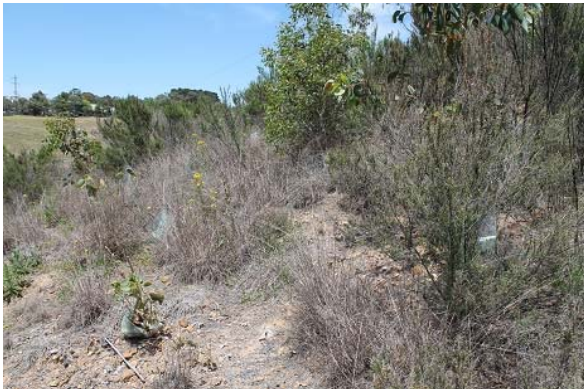
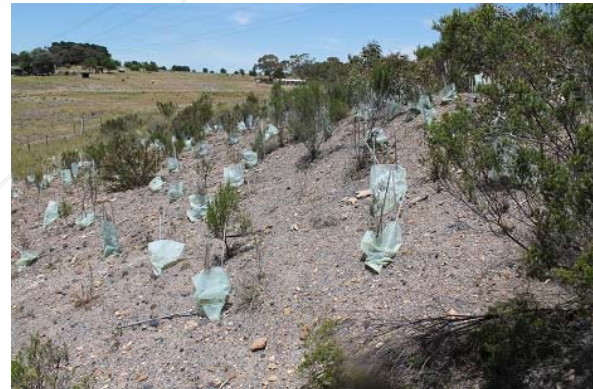
#### Plate 6: Transect 7

Species density and diversity were generally consistent with previous survey efforts. The area of transect 7 continues to support scattered trees and a sparse shrub layer dominated by *C. acuta*. An improvement was noted in the reduction of *E. curvula* following the successful targeted spraying for this species in this area. Approximately 20% of the area was exposed soil and surface erosion was evident. Greater than 45 flora species were identified within transect 7.

Native tree plantings along transect 7 interspersed with *C. acuta*.

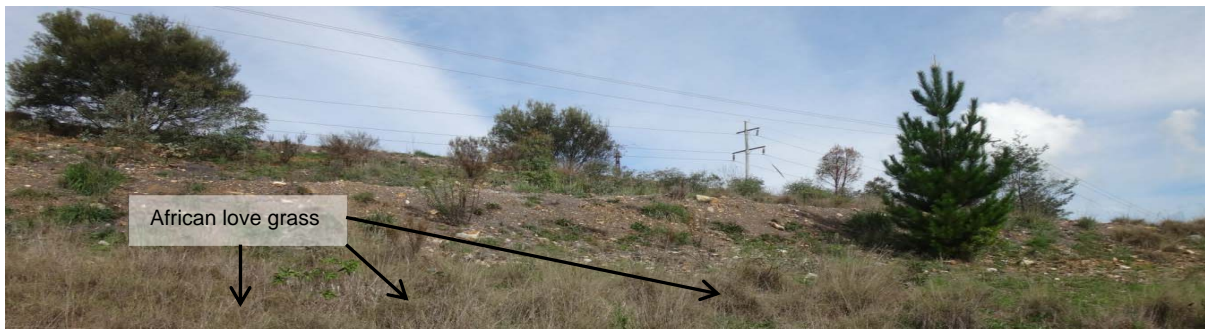
**Plate 7: Transect 8, view South**

*Transect 8 – African love grass prior to treatment (Apr 2014), growing well*

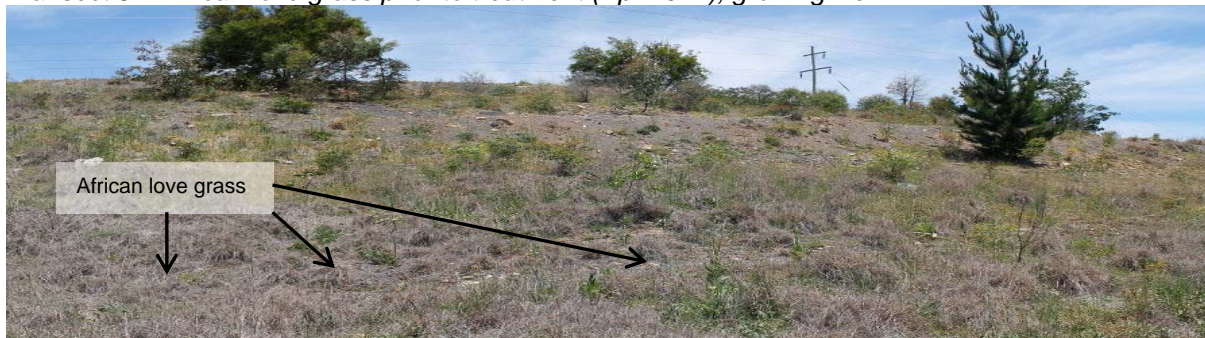
*Transect 8 – African love grass following treatment (Nov 2014), >98% strike rate*

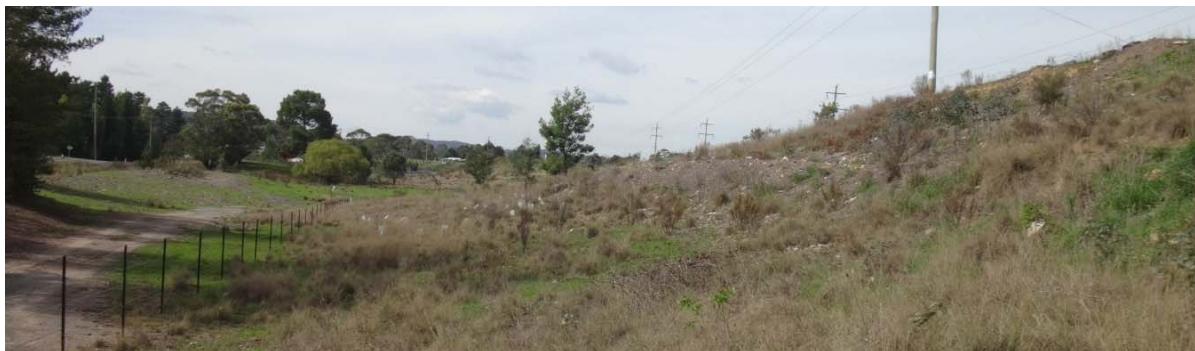
**Plate 8: Transect 8, view East**

*View along transect 8 (Apr 2014)*

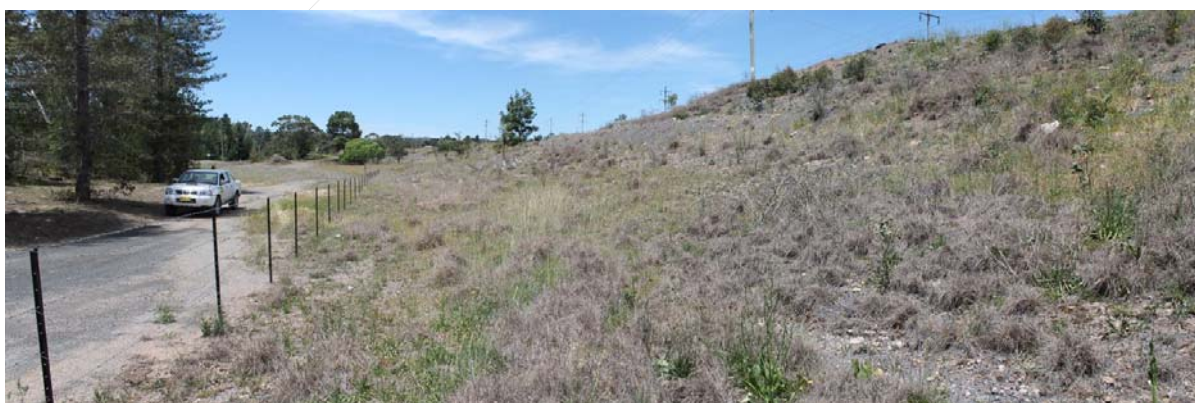
*View along transect 8 (Nov 2014), note dryer conditions and effectiveness of targeted spraying of African love grass.*

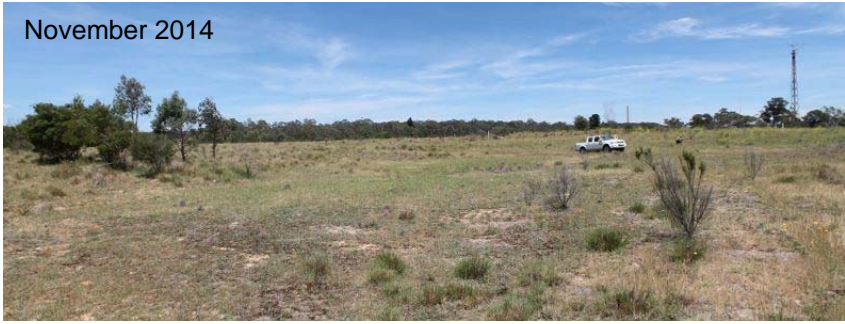
Transect location		
Easting	Northing	
227161	6304091	
227194	6304070	
Landform and soils		
Slope	Transect located along contour of upper slope moderately inclining (~15%) to the southwest.	
Erosion	Not significant. Some sedimentation present on exposed soils. Limited by slope and ground cover.	
Cracking soils	Not present.	
Surface drainage impediments	No significant drainage impediments.	
Vegetation		
Vegetation structure	Sparse shrub layer dominated by <i>C. acuata</i> . Groundcover dominated by exotic broadleaf herbs with a mix of native and exotic grass species.	
Species diversity	Groundcover consisting of >30 broadleaf herb species. 6 native and 6 exotic grass species identified.	
Cover classification	% cover at each observation	
	Apr 2014	Nov 2014
Total living cover	95	78
Annual living cover		
Perennial living cover		
Litter cover	5	22
Bare surface		
Noxious & other weed presence		
<i>Eragrostis curvula</i>

<i>Hypericum perforatum</i>		
<i>Cassinia acuata</i>		
<i>Rapistrum rugosum</i>		
<i>Rubus fruticosus</i> sp. agg.		
<p>November 2014</p>

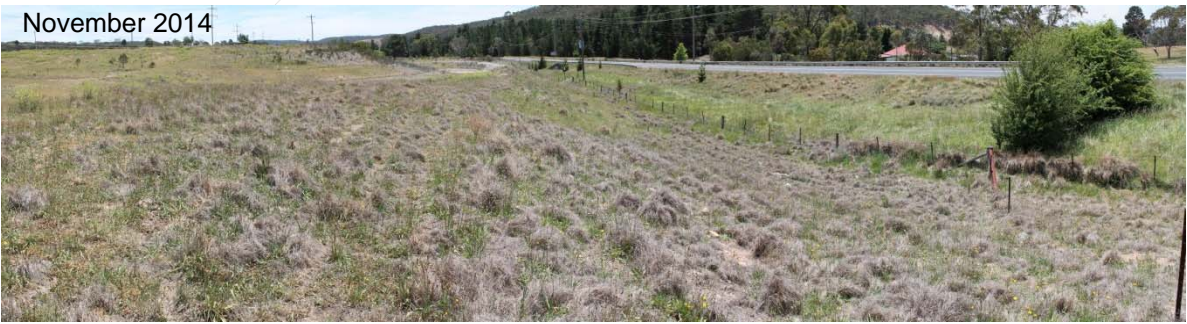
Transect location		
Easting	Northing	
227421	6304003	
227447	6303954	
Landform and soils		
Slope	Transect located along contour of upper slope gently inclining (4-10%) to the southwest.	
Erosion	Not significant. Some sedimentation present on exposed soils. Limited by slope and ground cover.	
Cracking soils	Not present.	
Surface drainage impediments	No significant drainage impediments.	
Vegetation		
Vegetation structure	Groundcover dominated by exotic broadleaf herbs with a mix of native and exotic grass species.	
Species diversity	Groundcover consisting of >30 broadleaf herb species. 6 native and 6 exotic grass species identified.	
Cover classification	% cover at each observation	
	Apr 2014	Nov 2014
Total living cover	90	92
Annual living cover		
Perennial living cover		
Litter cover	10	8
Bare surface		
Noxious weed presence 2014		
<i>Eragrostis curvula</i>		
<i>Hypericum perforatum</i>		
<p>November 2014</p>

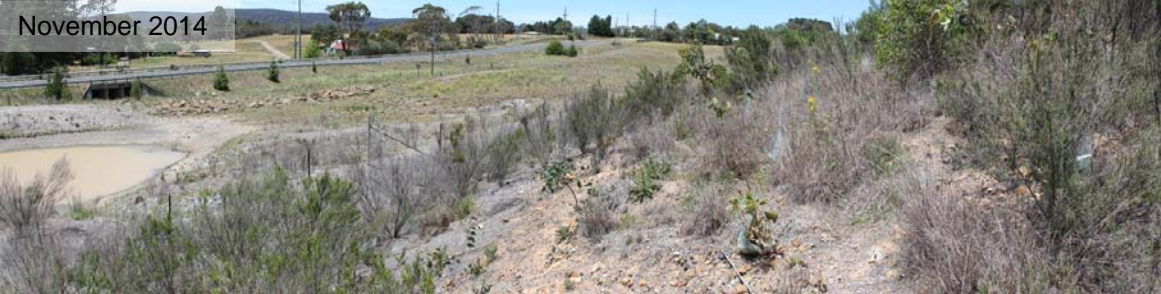
## Transect 7 monitoring data

Transect location		
Easting	Northing	
227325	6304082	
227362	6304060	
Landform and soils		
Slope	Transect located along contour of mid slope, moderately inclining (~30%) to the southwest.	
Erosion	Active erosion is evident in areas of exposed soils and is associated with increased slope angle.	
Cracking soils	Not present.	
Surface drainage impediments	No significant drainage impediments.	
Vegetation		
Vegetation structure	<ul style="list-style-type: none"> <li>• &lt;5% tree cover, 4-8 m height</li> <li>• 15% shrub cover, Mixed juvenile native trees and <i>Cassinia acuata</i>, 1.5 m height</li> <li>• 73% groundcover with some mixed native and exotic broadleaf herbs and grasses</li> </ul>	
Species diversity	<ul style="list-style-type: none"> <li>• ~4 native tree species</li> <li>• ~8 native and exotic shrub species</li> <li>• Groundcover of &gt;30 native and exotic broadleaf and grass species</li> </ul>

Cover classification	% cover at each observation	
	Apr 2014	Nov 2014
Total living cover	90	73
Annual living cover		
Perennial living cover		
Litter cover	10	27
Bare surface		
Noxious weed presence 2014		
<i>Eragrostis curvula</i>		
<i>Hypericum perforatum</i>		
<i>Cassinia acuata</i>

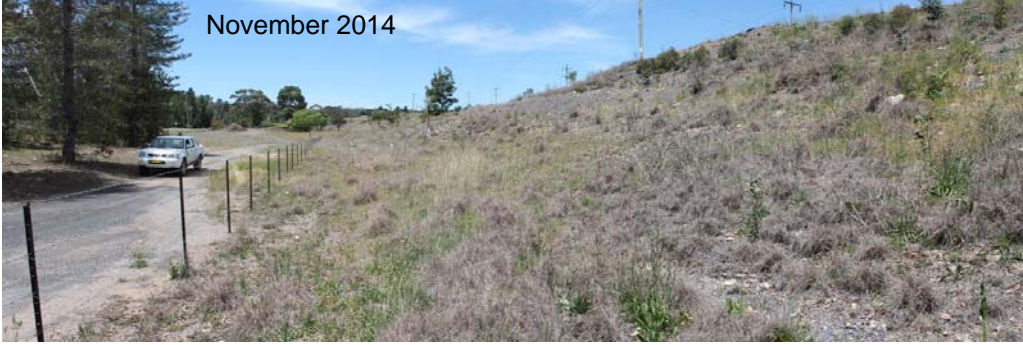
## Transect 8 monitoring data

Transect location		
Easting	Northing	
227150	6304234	
227192	6304205	
Landform and soils		
Slope	Transect located along contour of mid slope, moderately inclining (~30%) to the southwest.	
Erosion	Active erosion is evident in areas of exposed soils and is associated with increased slope angle.	
Cracking soils	Not present.	
Surface drainage impediments	No significant drainage impediments.	
Vegetation		
Vegetation structure	<ul style="list-style-type: none"> <li>• &lt;5% tree cover, 5 m height</li> <li>• &lt;10% shrub cover, Mixed juvenile native trees and <i>Cassinia acuata</i>, 1 m height</li> <li>• 90% groundcover with some mixed native and exotic broadleaf herbs and grasses</li> </ul>	
Species diversity	<ul style="list-style-type: none"> <li>• ~3 native tree species</li> <li>• ~8 native and exotic shrub species</li> <li>• Groundcover of &gt;30 native and exotic broadleaf and grass species</li> </ul>

Cover classification	% cover at each observation	
	Apr 2014	Nov 2014
Total living cover	90	88
Annual living cover		
Perennial living cover		
Litter cover	10	12
Bare surface		
Noxious weed presence 2014		
<i>Eragrostis curvula</i>		
<i>Cassinia acuata</i>		
<p>November 2014</p>

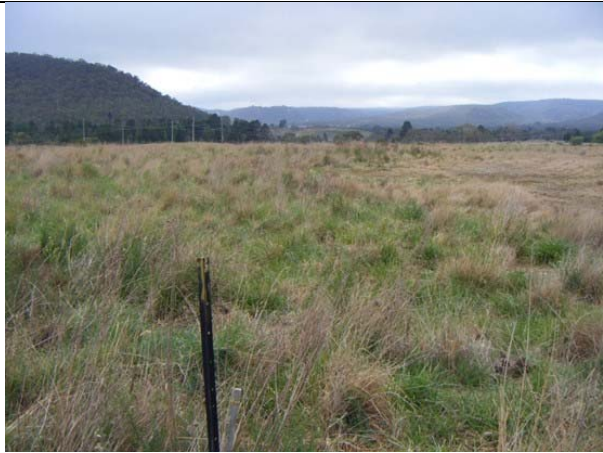
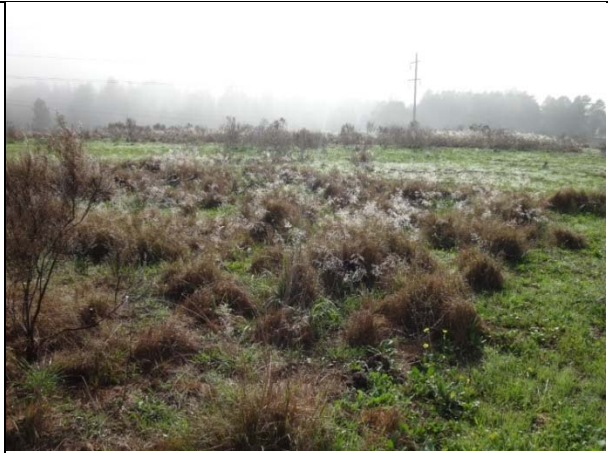
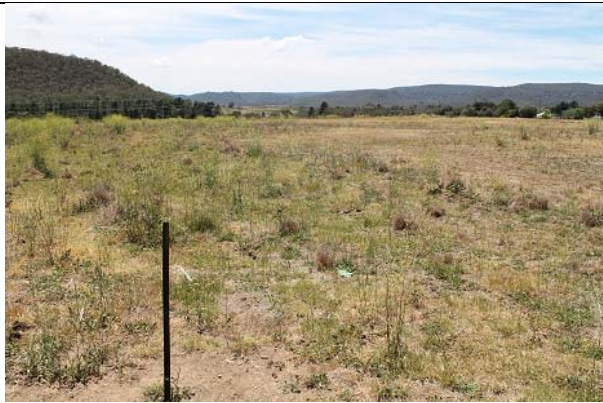
**Quadrat 1 – View from southwest looking northeast**

Quadrat location				
Corner peg	Easting		Northing	
Northwest	227099		6303904	
Southwest	227099		6303804	
Southeast	227199		6303804	
Northeast	227199		6303904	
Landform and soils				
Slope	Upper slope gently inclining (4-10%) to the southwest.			
Erosion	Not significant. Some sedimentation present on exposed soils. Limited by slope and ground cover.			
Cracking soils	Not present.			
Surface drainage impediments	No significant drainage impediments. Some surface water pooling limited to localised open depressions.			
Vegetation				
Vegetation structure	Sparse <i>Cassinia acuata</i> dominated low shrub layer. Groundcover dominated by exotic broadleaf herbs. Grasses dominated by exotic species.			
Species diversity	Shrub layer consists of <5 species, including <i>C. acuata</i> and <i>Rubus fruticosus sp. agg.</i> Diverse groundcover dominated by >40 broadleaf herb species. 13 exotic and 6 native grass species identified.

Cover classification	% cover at each observation			
	Sep 2011	Nov 2012	Apr 2014	Nov 2014
Total living cover	90	94	90	78
Annual living cover	22.75	14.5		
Perennial living cover	67.25	79.5		
Litter cover	7	6	10	22
Bare surface	3	0		
Noxious & other weed presence				
Weed species	% cover		Area (m <sup>2</sup> )	
<i>Eragrostis curvula</i>	<5		<50	
<i>Hypericum perforatum</i>	Present		<20	
<i>Rubus fruticosus sp. agg.</i>	Present		<10	
<i>Rapistrum rugosum</i>	~20		>100

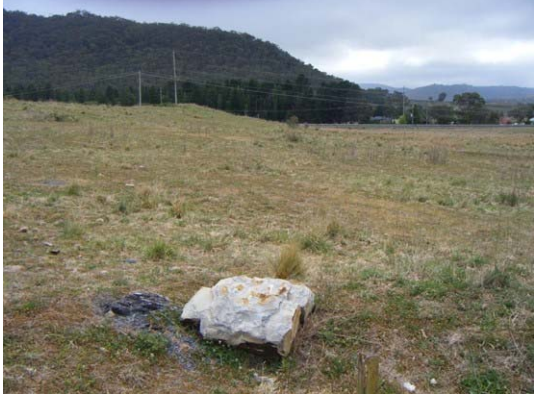
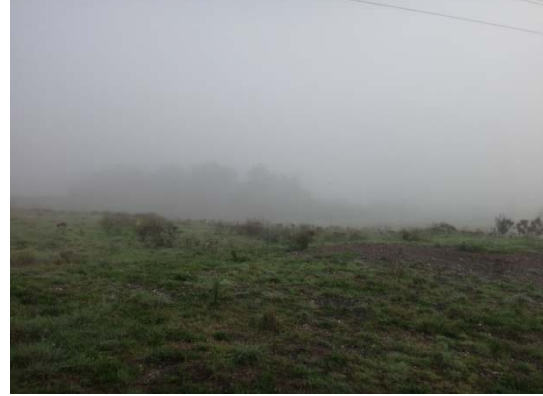
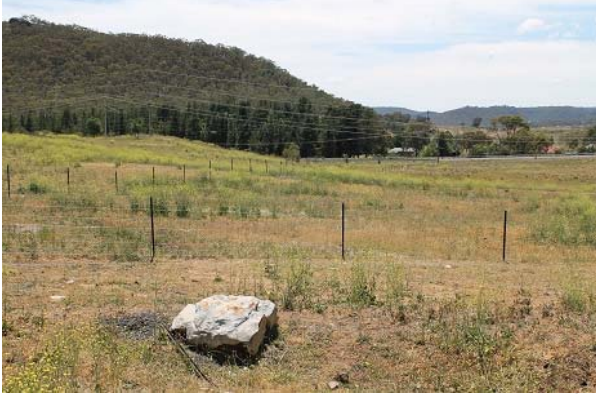
**Qadrat 2 – View from southwest looking northeast**

Quadrat location				
Corner peg	Easting		Northing	
Northwest	227264		6303966	
Southwest	227264		6303866	
Southeast	227364		6303866	
Northeast	227364		6303966	
Landform and soils				
Slope	Upper slope gently inclining (4-10%) to the east.			
Erosion	Not significant. Some sedimentation present on exposed soils. Limited by slope and ground cover.			
Cracking soils	Not present.			
Surface drainage impediments	No significant drainage impediments. Some surface water pooling limited to localised open depressions.			
Vegetation				
Vegetation structure	Groundcover dominated by exotic broadleaf herbs with a mix of native and exotic grass species.			
Species diversity	Diverse groundcover dominated by >34 broadleaf herb species. 6 native and 6 exotic grass species recorded.			
Cover classification	% cover at each observation			
	Sep 2011	Nov 2012	Apr 2014	Nov 2014
Total living cover	94.5	91	90	72
Annual living cover	27.75	14.5

Perennial living cover	66.75	76.5		
Litter cover	3.5	6.5	10	28
Bare surface	2	2.5		
Noxious & other weed presence				
Weed species	% cover		Area (m <sup>2</sup> )	
<i>Eragrostis curvula</i>	<5		<50	
<i>Hypericum perforatum</i>	Present		<20	
<i>Rubus fruticosus sp. agg.</i>	Present		<10	
<i>Rapistrum rugosum</i>	~20		>100

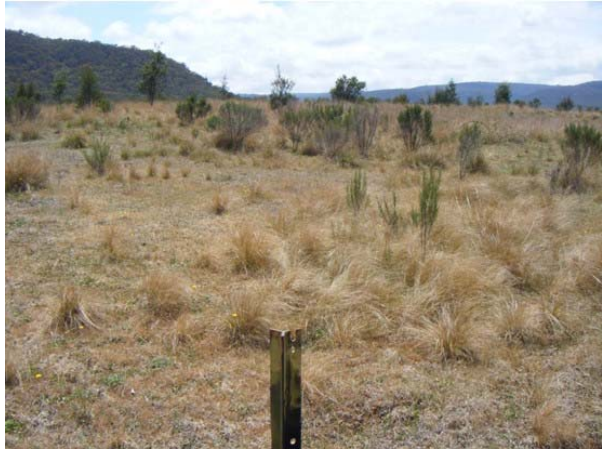
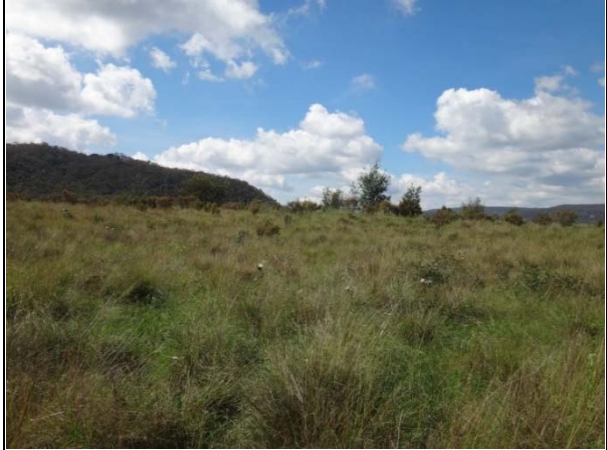
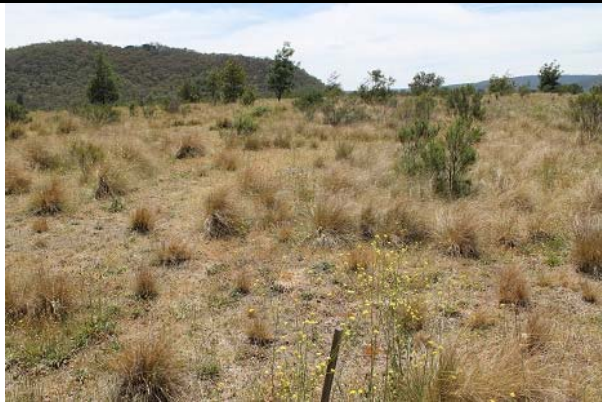
**Qadrat 3 – View from southwest looking northeast**

Quadrat location				
Corner peg	Easting		Northing	
Northwest	226973		6304068	
Southwest	226960		6303971	
Southeast	227060		6303962	
Northeast	227083		6304052	
Landform and soils				
Slope	Relatively flat.			
Erosion	Not significant. Some sedimentation present on exposed soils. Limited by slope and ground cover.			
Cracking soils	Not present.			
Surface drainage impediments	No significant drainage impediments. Some surface water pooling limited to localised open depressions.			
Vegetation				
Vegetation structure	Sparse <i>Cassinia acuata</i> dominated low shrub layer. Groundcover dominated by exotic broadleaf herbs with a mix of native and exotic grass species.			
Species diversity	Shrub layer consists of <10 species, including <i>C. acuata</i> , <i>Acacia spp.</i> and <i>Rubus fruticosus sp. agg.</i> Diverse groundcover consisting of >38 broadleaf herb species. 7 native and 7 exotic grasses identified.

Cover classification	% cover at each observation			
	Sep 2011	Nov 2012	Apr 2014	Nov 2014
Total living cover	87.5	92	90	93
Annual living cover	21.75	17		
Perennial living cover	65.75	75		
Litter cover	6	2.5	10	7
Bare surface	6.5	5.5		
Noxious & other weed presence				
Weed species	% cover		Area (m <sup>2</sup> )	
<i>Eragrostis curvula</i>	<10		<100	
<i>Hypericum perforatum</i>	Present		<20	
<i>Rubus fruticosus sp. agg.</i>	Present		<100	
<i>Rapistrum rugosum</i>	<5		<20	
<i>Cassinia acuata</i>	~15		2,500

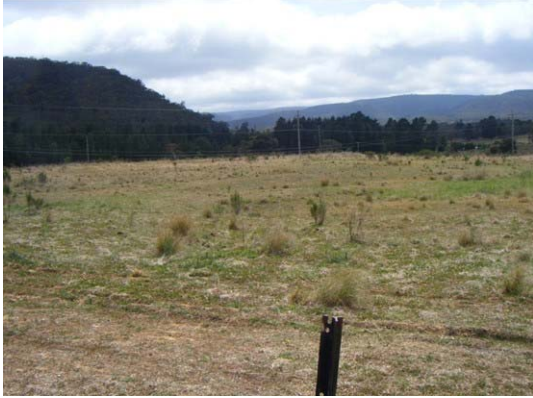
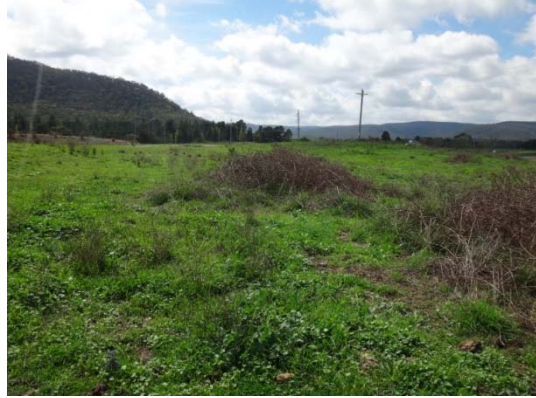
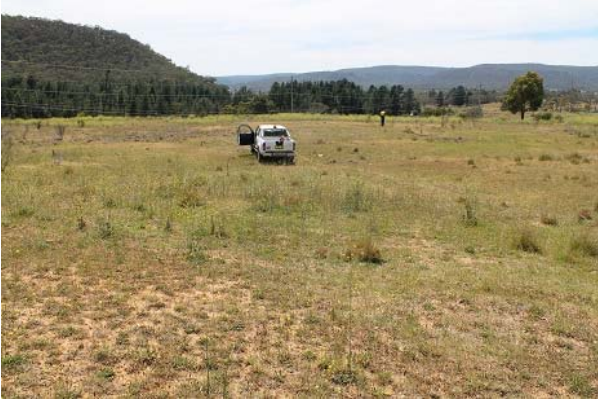
**Qadrat 4 – View from southwest looking northeast**

Quadrat location				
Corner peg	Easting		Northing	
Northwest	227102		6304154	
Southwest	227088		6304054	
Southeast	227188		6304054	
Northeast	227202		6304154	
Landform and soils				
Slope	Upper slope gently inclining (4-10%) to the southwest.			
Erosion	Not significant. Some sedimentation present on exposed soils. Limited by slope and ground cover.			
Cracking soils	Not present.			
Surface drainage impediments	No significant drainage impediments. Some surface water pooling limited to localised open depressions.			
Vegetation				
Vegetation structure	Sparse <i>Cassinia acuata</i> dominated low shrub layer. Groundcover dominated by exotic broadleaf herbs with a mix of native and exotic grass species.			
Species diversity	Shrub layer consists of <10 species, including <i>C. acuata</i> , <i>Acacia dealbata</i> subsp. <i>dealbata</i> and <i>Rubus fruticosus</i> sp. agg. Diverse groundcover consisting of >38 broadleaf herb species. 6 native and 6 exotic grass species identified.

Cover classification	% cover at each observation			
	Sep 2011	Nov 2012	Apr 2014	Nov 2014
Total living cover	88.5	89.5	85	86
Annual living cover	22.75	13		
Perennial living cover	65.75	76.5		
Litter cover	5	6.5	15	14
Bare surface	6.5	4		
Noxious & other weed presence				
Weed species	% cover	Area (m <sup>2</sup> )		
<i>Eragrostis curvula</i>	<5	<10		
<i>Hypericum perforatum</i>	Present	<20		
<i>Rubus fruticosus</i> sp. agg.	Present	<10		
<i>Rapistrum rugosum</i>	~25	2,500
