Annual Environmental Management Report

2016

Enhance Place Mine

Enhance Place Mine Rehabilitation Monitoring Report 2016

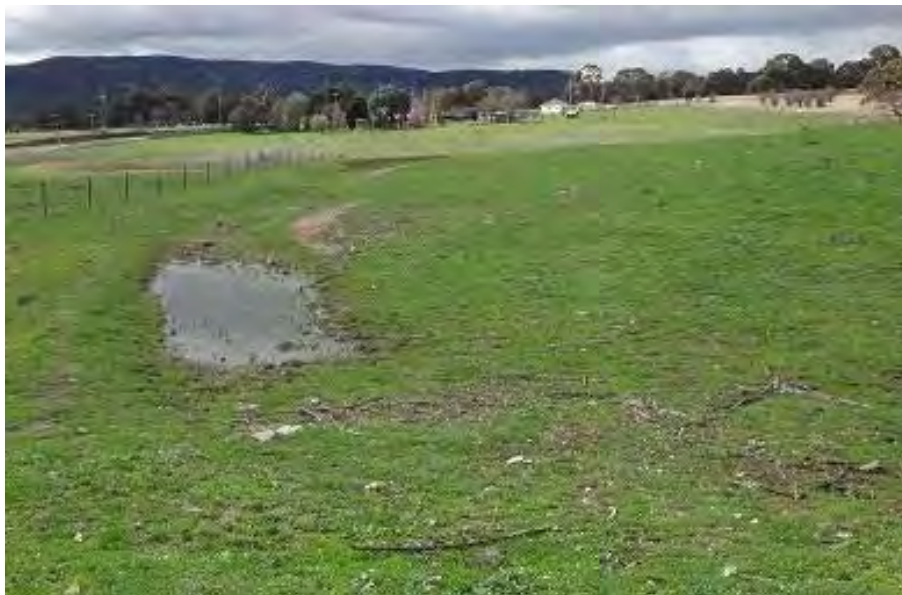
Plate 1 Pooled water in a depression in the Pasture area.

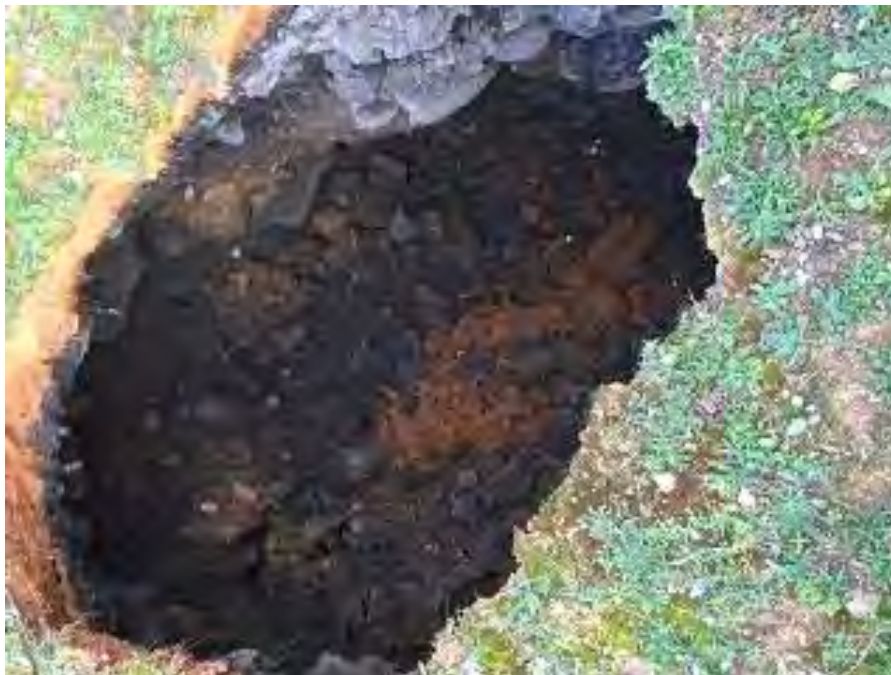
Cracking soils and waterlogging may occur in areas of overgrazing; where rehabilitation has not been successful; or adjacent the highwall as a result of subsidence and soil movement. During the 2016 reporting period, several small depressions containing pooled water were observed immediately after rainfall events, however, the depth of water was less than 10cm and the seasonal waterlogging was determined to account for less than 1% of the pasture rehabilitation area (refer **Plate 1**). A soil settling event occurred in September 2016 whereby a hole opened in the western portion of the pasture area (**Plate 2**). This hole was subsequently remediated by filling with earth (**Plate 3**).

Plate 2 Soil settling hole in Pasture area

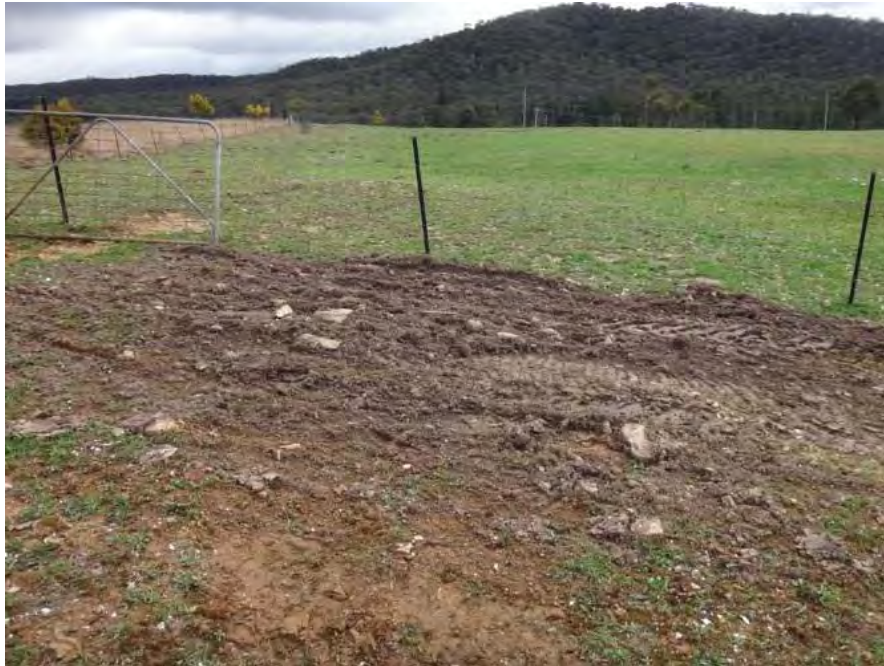
Plate 3 Soil settling hole repaired

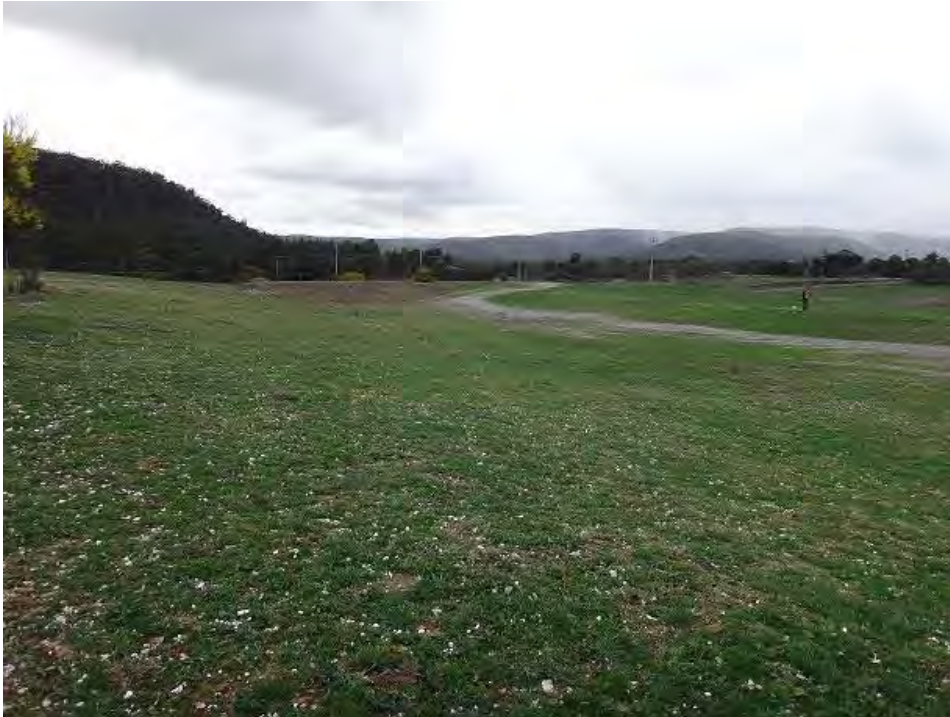
Plate 4 Pasture area showing white gypsum fertiliser on surface

During the reporting period pasture areas were treated in accordance with the recommendations of the *Enhance Place Mine Rehabilitation Monitoring Reports* (First Field Environmental, 2015 & 2016). Works undertaken included the application of fertilizer to all pasture areas (**Plate 4**) at the rates prescribed in **Section 7.1.2**.

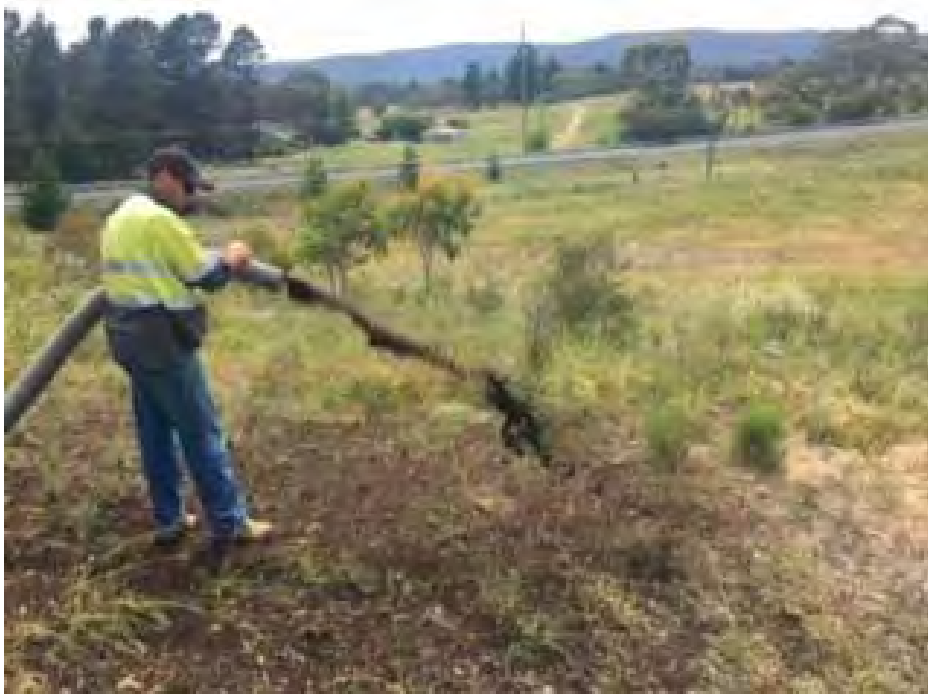
Plate 5 *Application of organic mulch to Treed area*

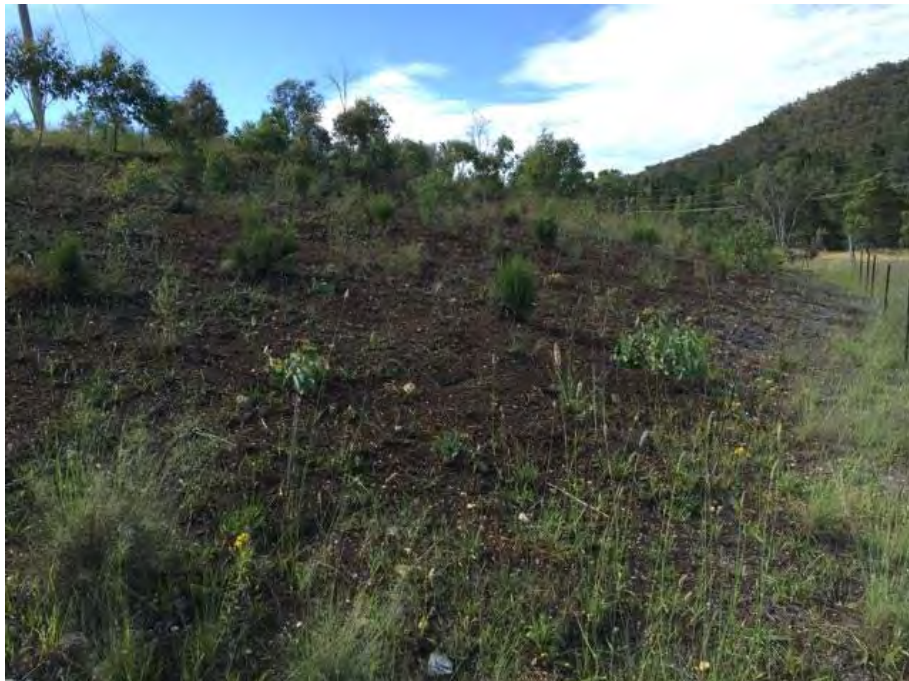
Plate 6 *Organic mulch in Treed area*

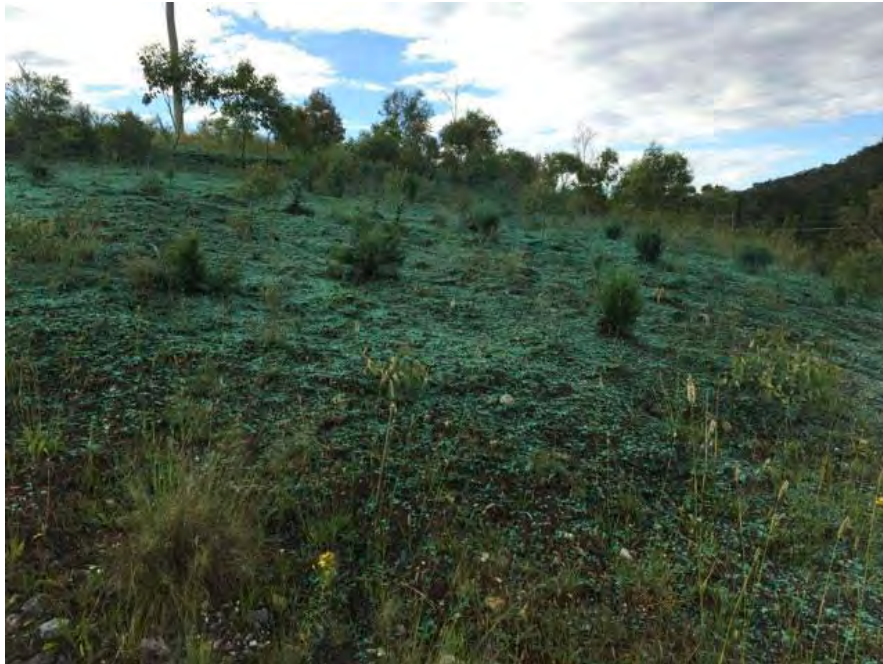
Plate 7 *Hydromulch mixture applied to Treed area*

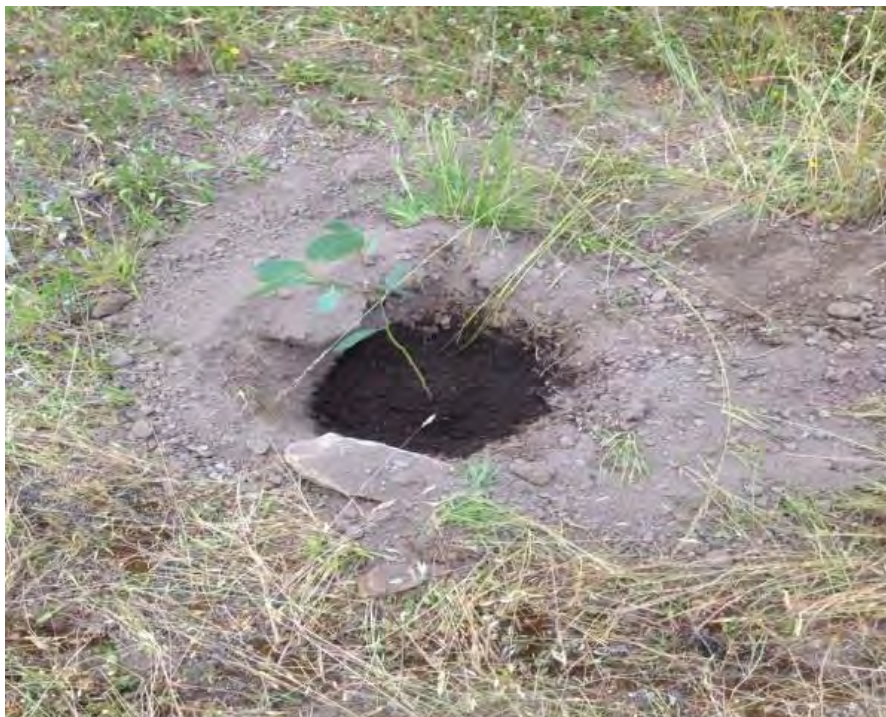
Plate 8 *Deep rooted seedlings planted in Treed area*

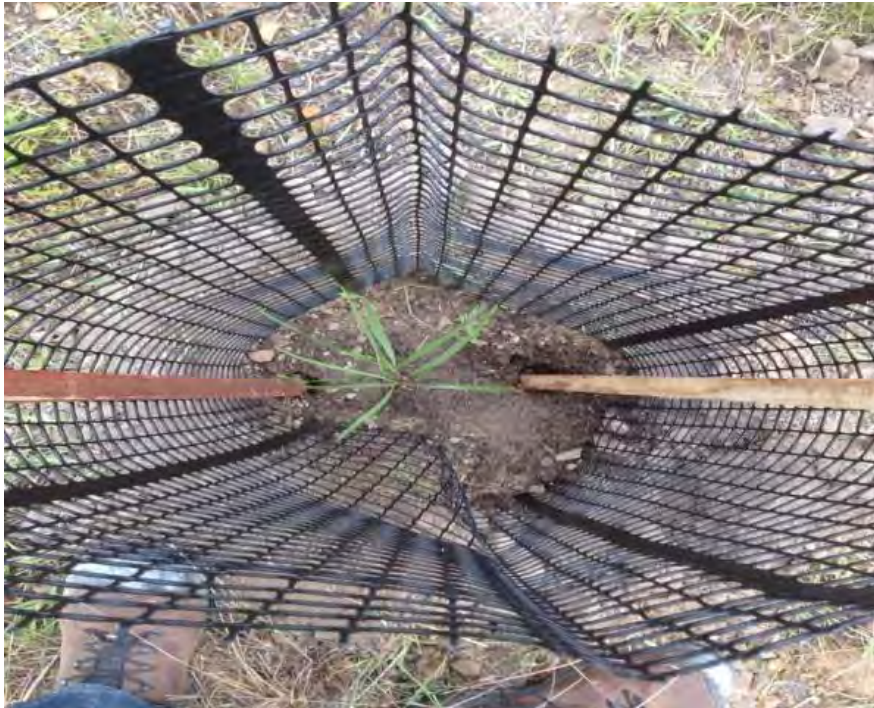
Plate 9 Mesh guards on seedlings planted in Treed area

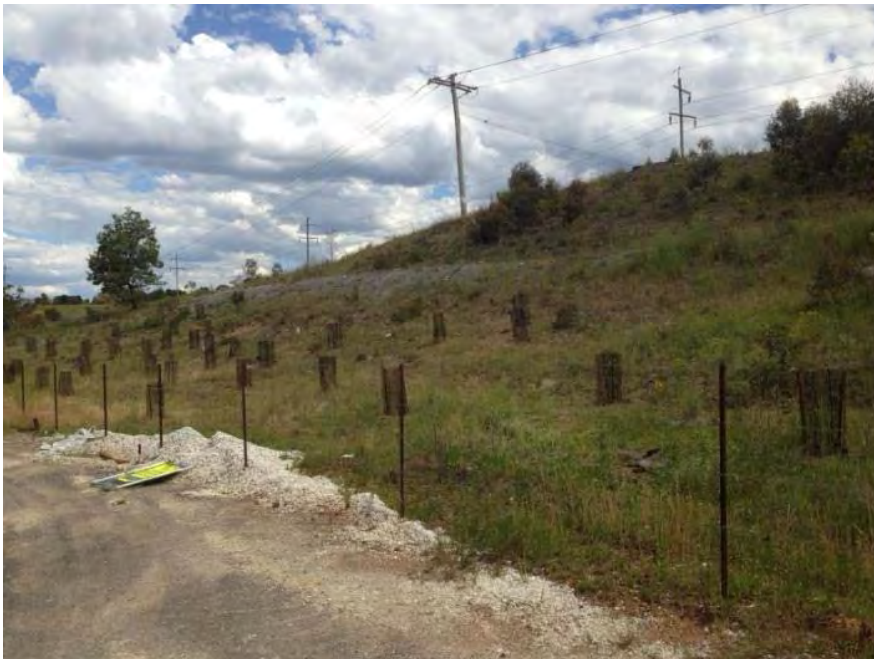
Plate 10 Seedlings in Treed area

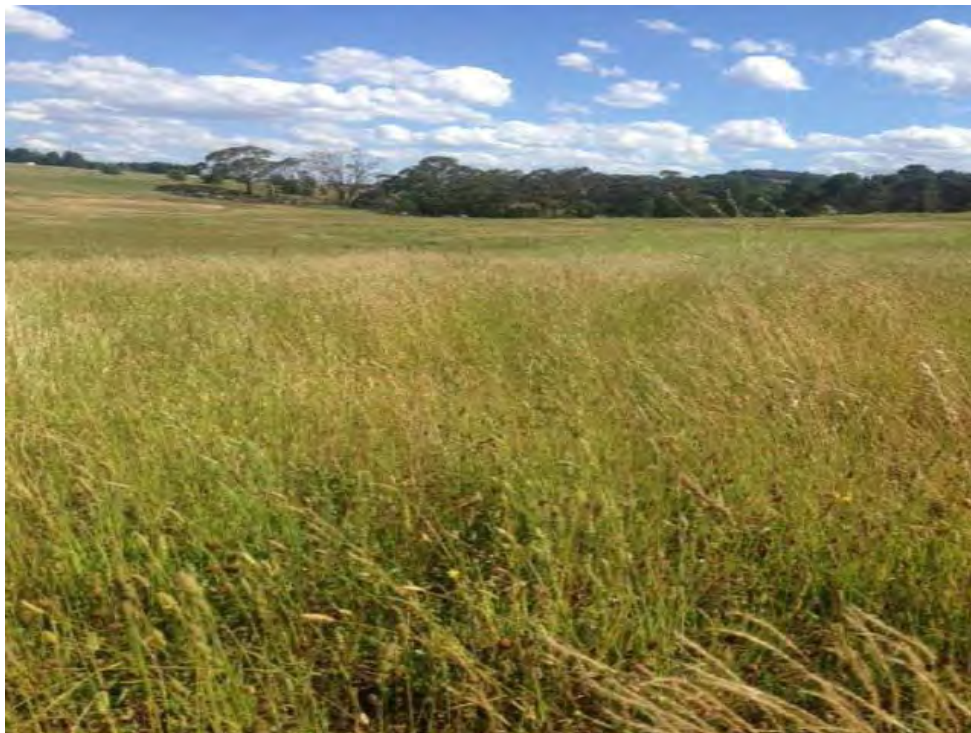
The *Enhance Place Mine Stock Management Plan (First Field Environmental, April 2016)* included the utilisation of the existing fencing layout to assist with time control or rotational grazing to improve pasture. A collaboration between Enhance Place Mine Pty Ltd and the landowners, Mr & Mrs Morris, led to the exclusion of grazing stock from paddock 1 of the site during the period 16 September to 8 December 2016 in an effort to improve pasture conditions. A *Monitoring and Evaluation Report into Rehabilitated Pasture (First Field Environmental, January 2017)* has since been prepared to evaluate the success of rehabilitation following the Stock Management Plan's implementation over one pasture-growing season. The findings of the *Monitoring and Evaluation Report into Rehabilitated Pasture* indicated the stock exclusion of paddock 1 was beneficial for the site's pasture rehabilitation, with pasture growth in paddock 1 increasing from <3cm in height to approximately 80cm during the exclusion period (**Plate 11**). Additionally, exposed soil patches were observed to decrease and no active erosion was evident in the exclusion paddock.

Plate 11 *Regeneration of pasture in Paddock 1 during stock exclusion*

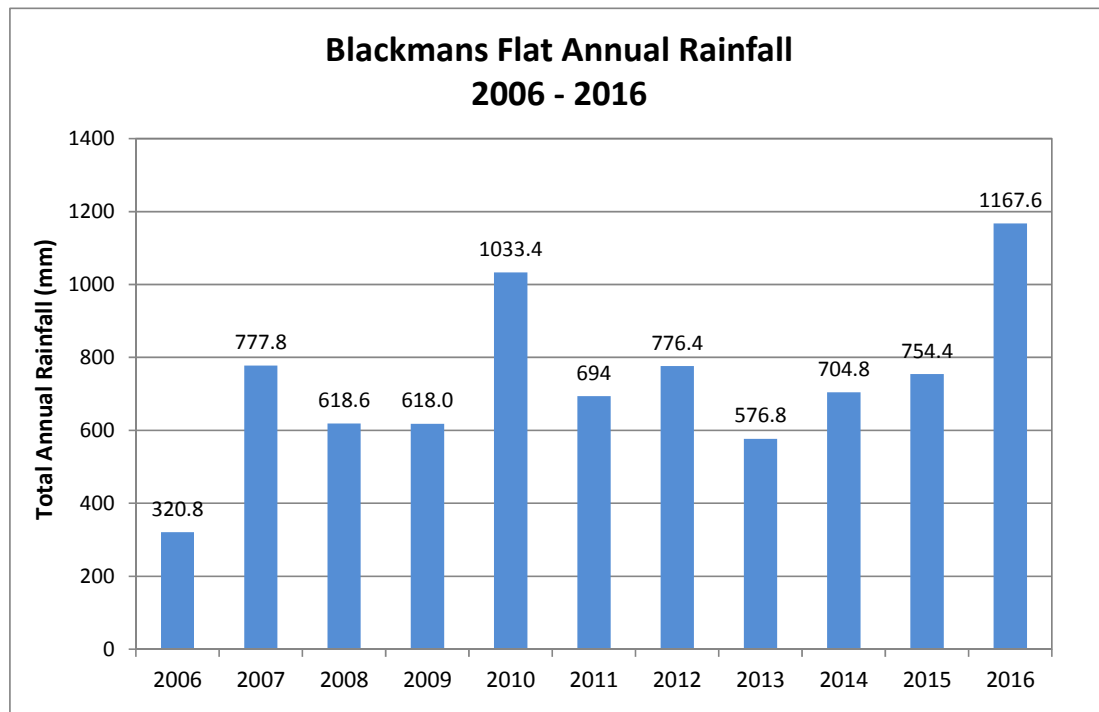
The average annual rainfall for the area is 786.9mm recorded at the Lithgow (Coerwull) Station, situated approximately 15km to the south east of the Enhance Place Mine (Source: Bureau of Meteorology, based on the rainfall period 1878 – 2016). During the 2016 reporting period Pine Dale Mine received 1167.6mm of rainfall and experienced 147 rainfall days. Rainfall during this period was observed to be greater than rainfall recorded in 2015 (754.4mm and 144 rainfall days), and greater than the area’s long term annual average. The Annual Rainfall for the period 2006 – 2016 recorded at the Pine Dale Mine meteorological monitoring station is shown in Error! Reference source not found., whilst the monthly rainfall for 2016 is presented in **Figure 2** Blackmans Flat Annual Rainfall 2006- 2016

Figure 2
Blackmans Flat Annual Rainfall 2006- 2016

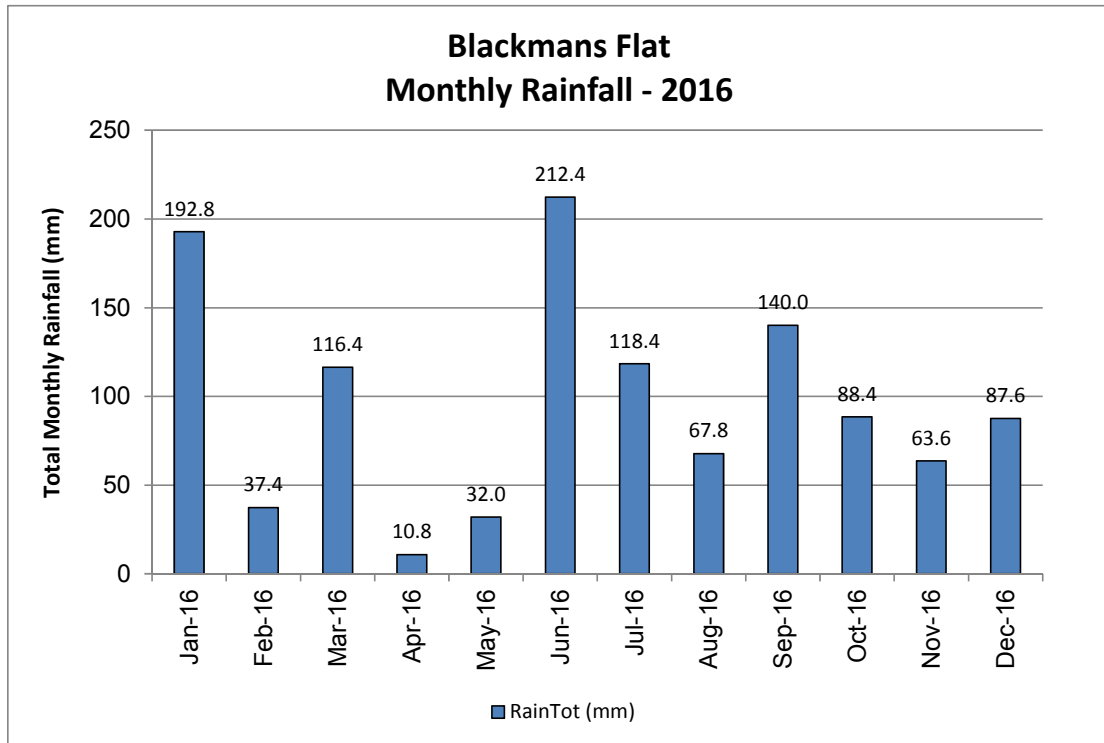
Figure 3
Blackmans Flat Monthly Rainfall 2016

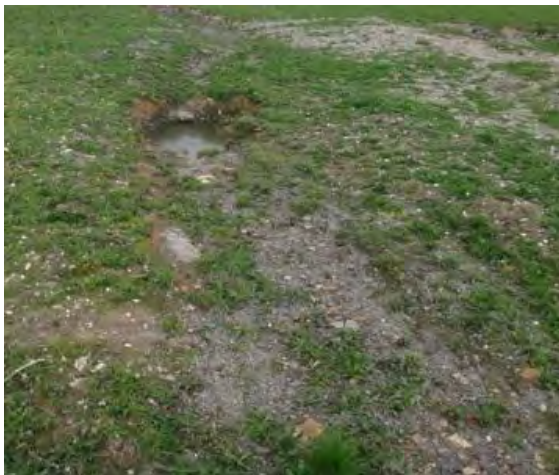
Pasture rehabilitation areas - The pasture rehabilitation areas support evidence of minor surface erosion where groundcover is poorly established or absent. However overall combined bare surfaces do not exceed 20m² per hectare. The groundcover shown in Figure 2 is typical of rehabilitated pasture areas.

Figure 2 Exposed soils in quadrat 2

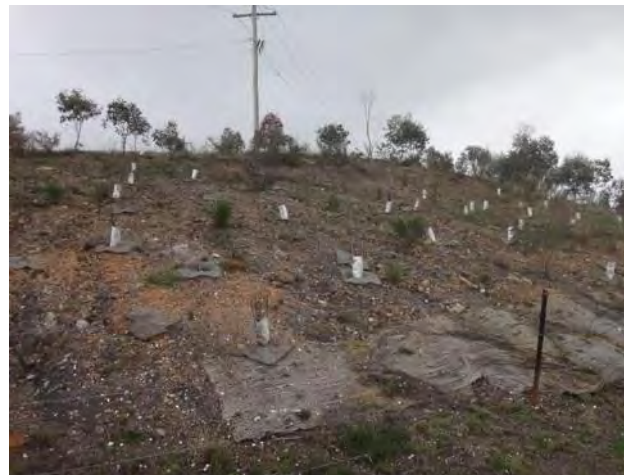
Figure 3 Exposed soils in transect 8

Treed rehabilitation areas – Exposed soils within the treed rehabilitation areas have been subject to wind and minor rill erosion (as shown in Figure 3).

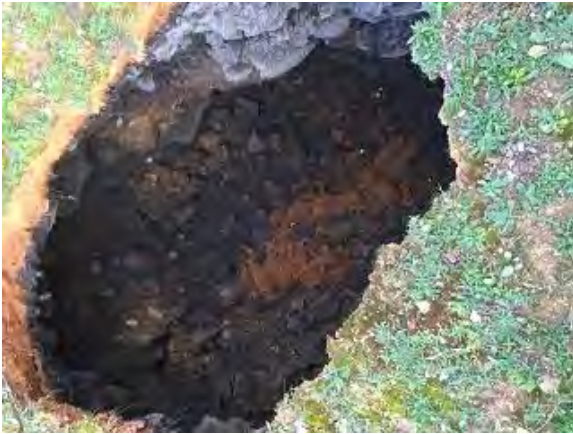
Evidence of soil settling was observed in September, as a hole opened along a portion of the fence line immediately north of quadrat 1. The hole (Figure 4) was reported to the Manager of Enhance Place Mine as soon as it was detected. The landholders were advised to remove stock from the area and arrangements were made for immediate remediation works. Figure 5 shows the area later that week following remediation works.

Figure 4 Hole north of quadrat 1

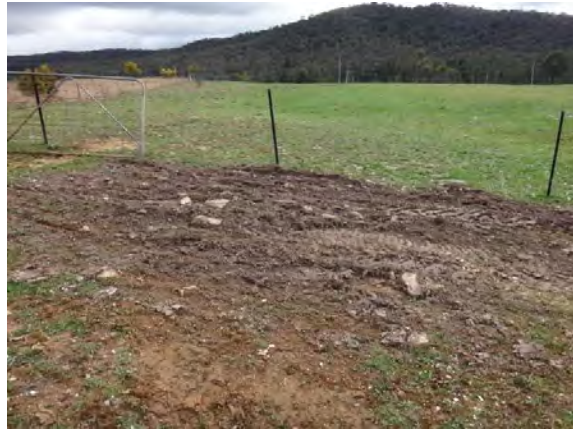
Figure 5 Results of remediation

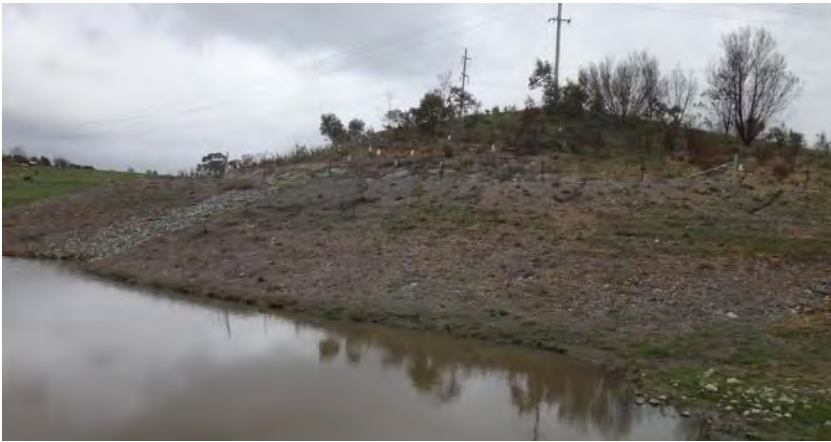
Ponding of water – Sediment ponds and contour drains were established prior to 2013 and generally remain in good operational condition. Figure 6 shows the condition of sloping retention basin walls. Active surface erosion was observed on the sides of the sediment retention basin east of quadrat 2.

Figure 6 Sediment retention basin east of quadrat 2

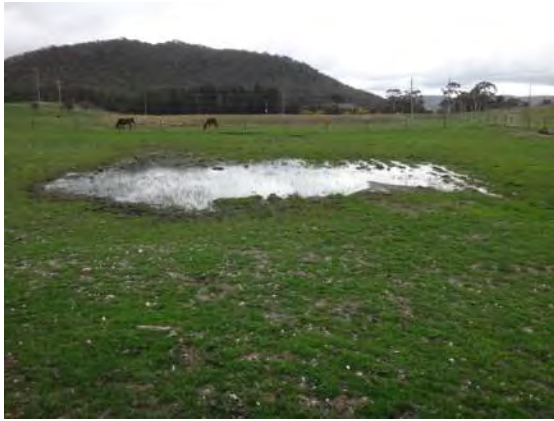
Surface water pooling was evident in some areas, likely to be associated with surface erosion and sedimentation and existing land forming. It is noted that the area received light rainfall in the 48 hours preceding the survey. In all cases, water depth did not exceed 10cm. Figure 7 and Figure 8 provide examples of pooled water in the pasture area. Seasonal waterlogging accounts for less than 1% of the rehabilitated pasture area. Overall the relief ensures that water flows as designed and directs water off site and there is little evidence of surface water flow occurring outside of established contour drainage lines.

Figure 7 Pooled water in quadrat 1

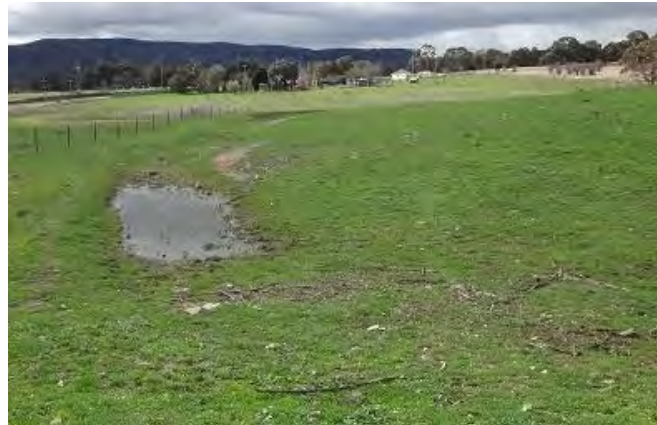
Figure 8 Pooled water north of quadrat 1

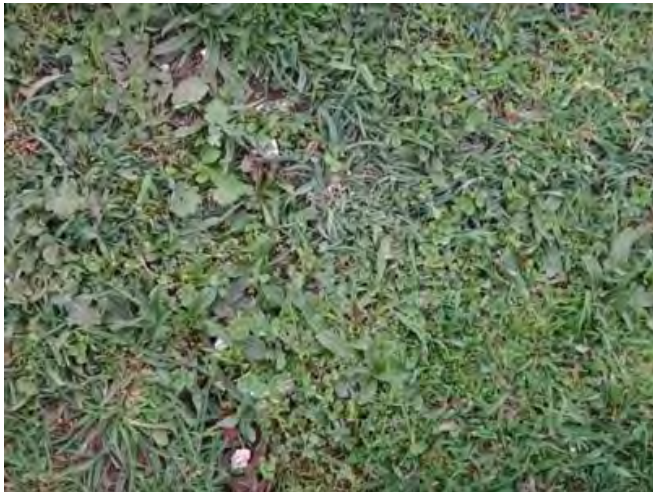
Species composition at pasture rehabilitation areas – Pasture rehabilitation areas are established with a mix of 70% perennial grasses and 20% annual legumes and are representative of species composition at the analogue pasture site. An example of rehabilitated pasture is shown in Figure 9.

Figure 9 Pasture composition representative of rehabilitated pasture areas

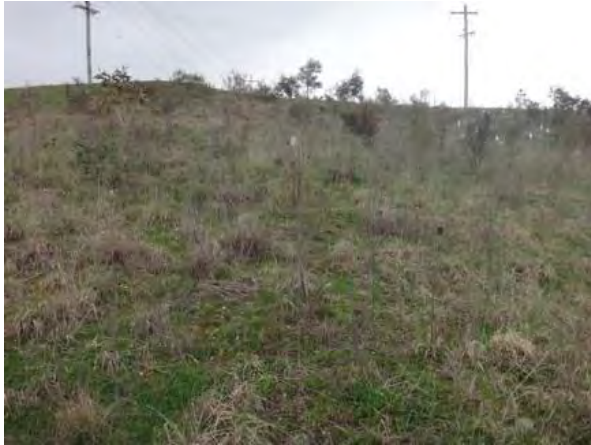
The areas of transects 7 and 8 (represented in Figure 10 and 11) support scattered juvenile trees and sparse mixed native shrub layers. The ground layers are dominated by mixed native grasses.

Groundcover at treed rehabilitation areas – Transect 7 supports groundcover of 90%. Transect 8 supports groundcover of 60%.

Figure 10 Vegetation structure and groundcover at transect 7

Canopy cover is absent in treed rehabilitation areas. A sparse mid-storey of isolated juvenile trees and shrubs exists over a sparse, low, shrubby understorey (seen in Figure 10). Groundcover is a sparse mix of broadleaf herbs and grasses. Changes in vegetation structure over time (as shown in Appendix B) are not considered significant.

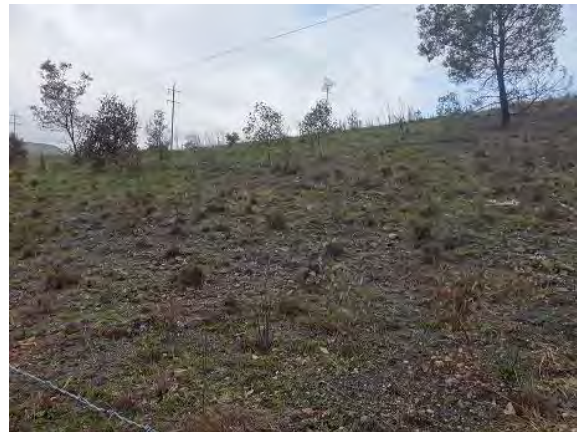
Figure 11 Vegetation structure and groundcover at transect 8

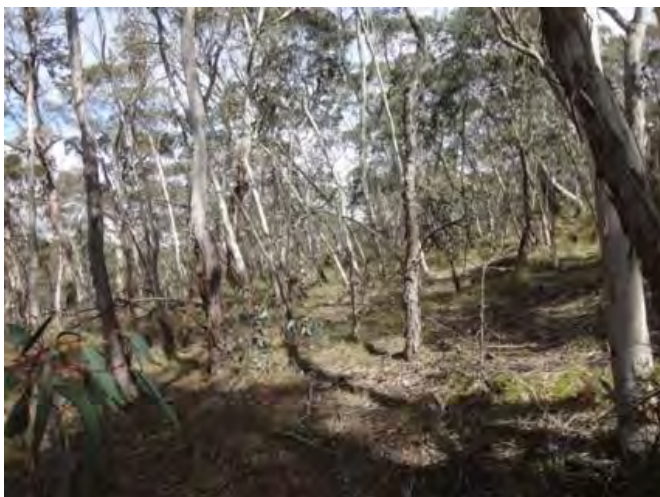
The treed analogue site is characterised by a canopy to 12m height with 40% canopy cover over a sparse shrubby mid-storey to 3m height and isolated shrubs to 1.5m height in the understorey. Groundcover consists of grasses and herbs with a cover of 90% (Figure 12).

Figure 12 Vegetation structure of treed analogue site (transect 7)

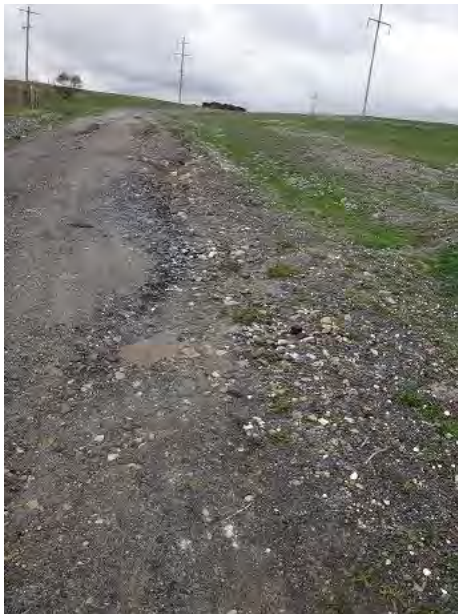
Isolated areas of trail erosion are occurring due to concentrated surface water flow (as shown in Figure 13).

Figure 13 Rill erosion on main access trail

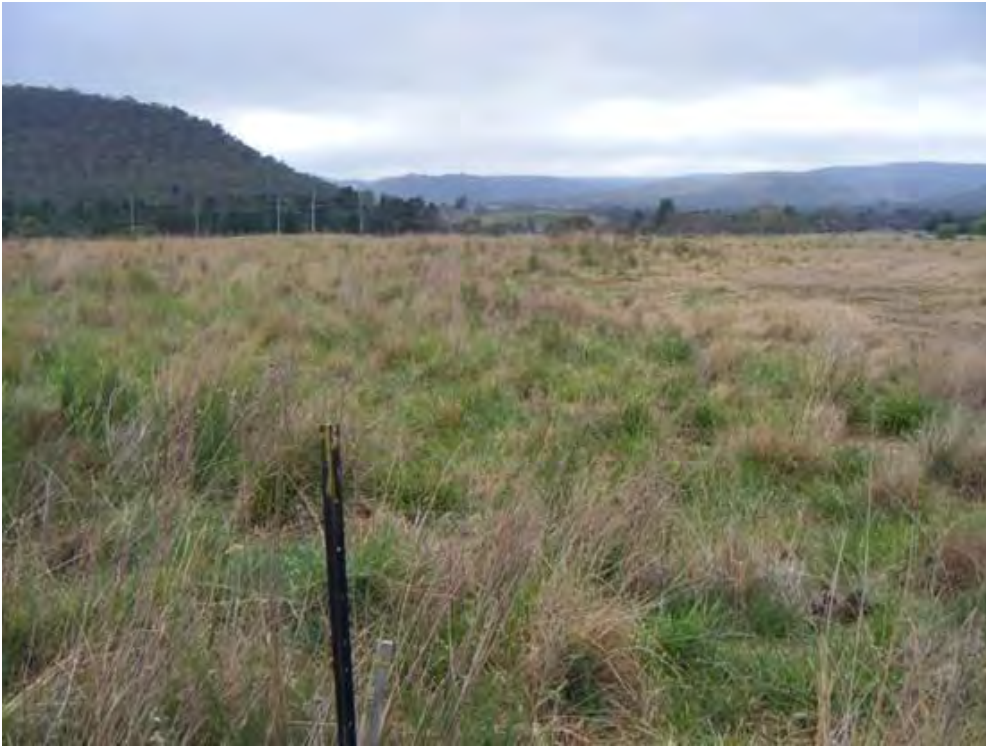
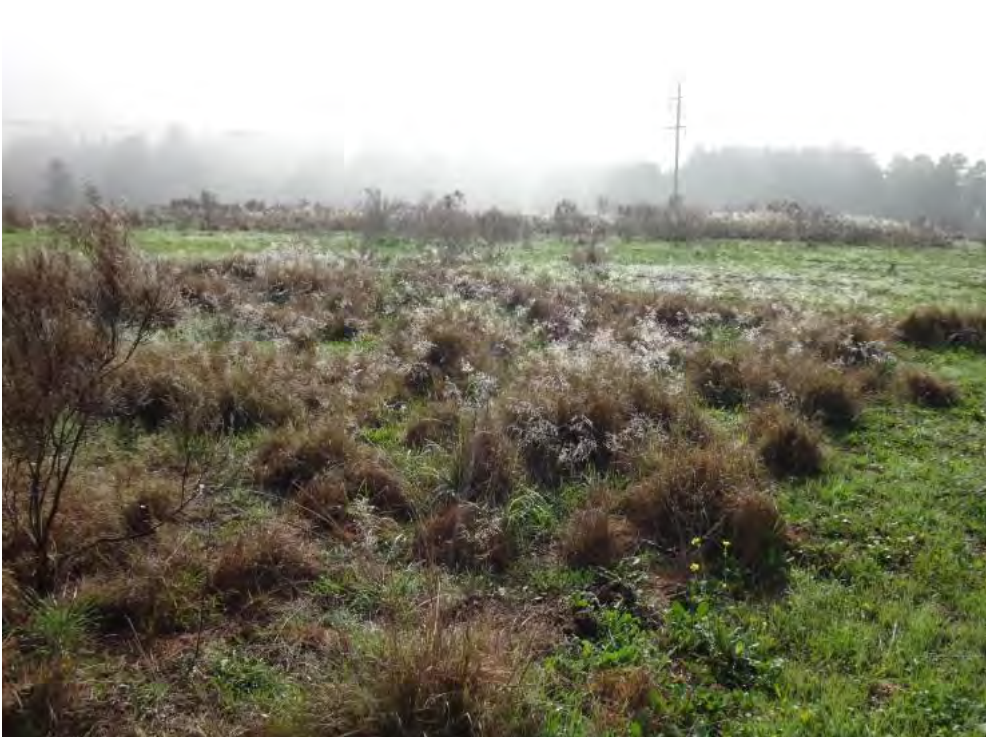
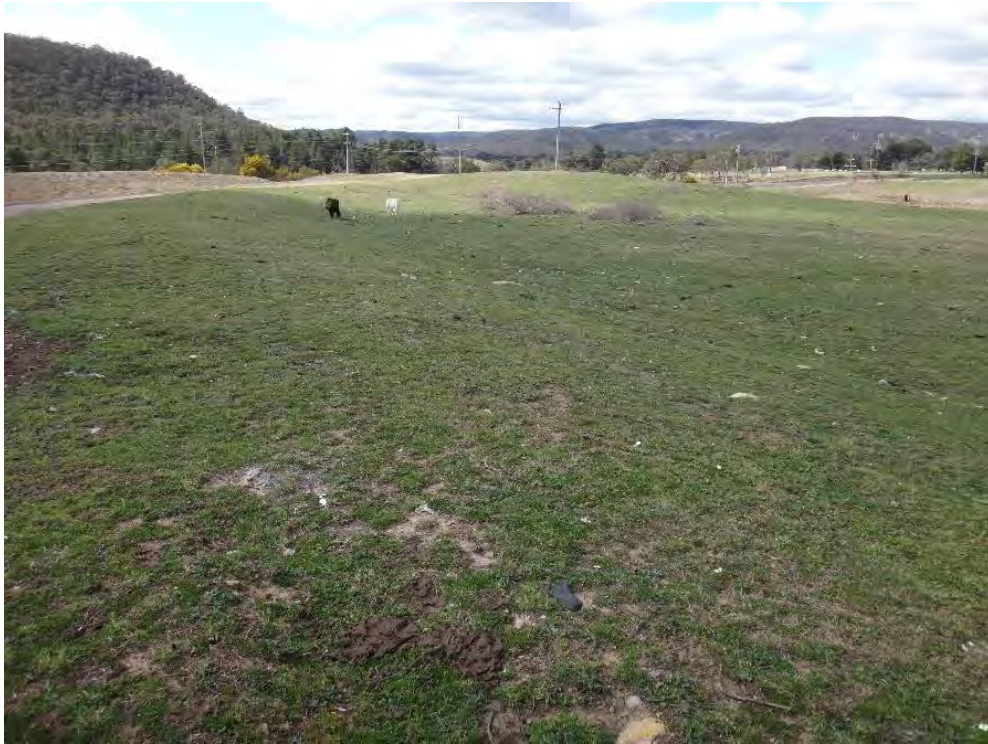
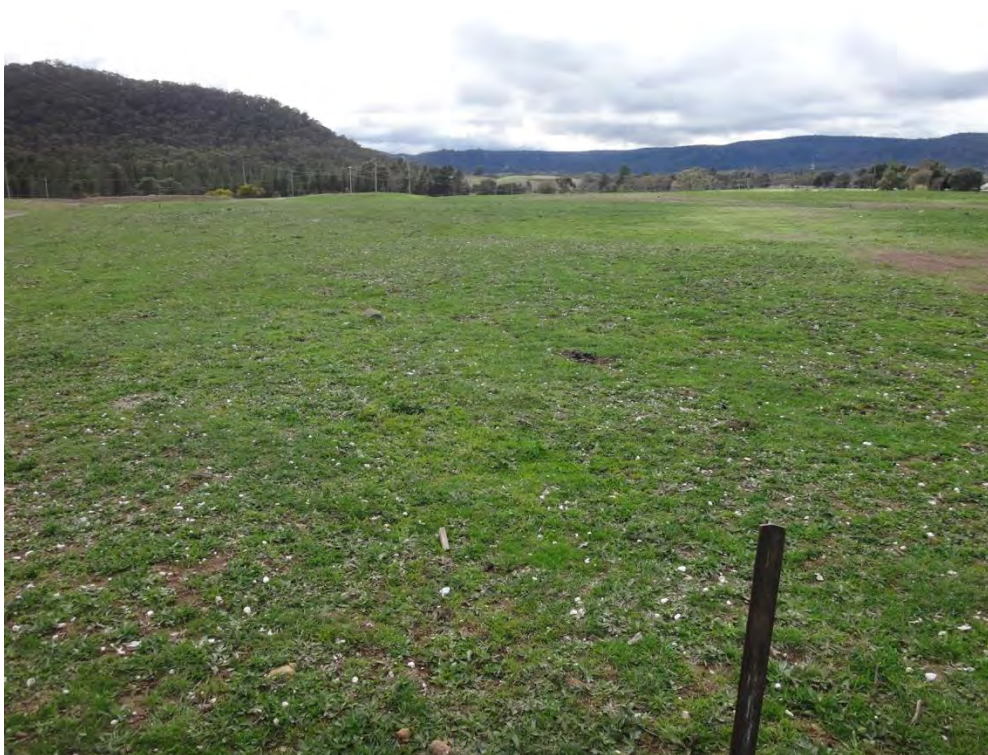
Quadrat 1 from southwest looking northeast 2012

Quadrat 1 from southwest looking northeast 2014

Quadrat 1 from southwest looking northeast 2015

Quadrat 1 from southwest looking northeast 2016

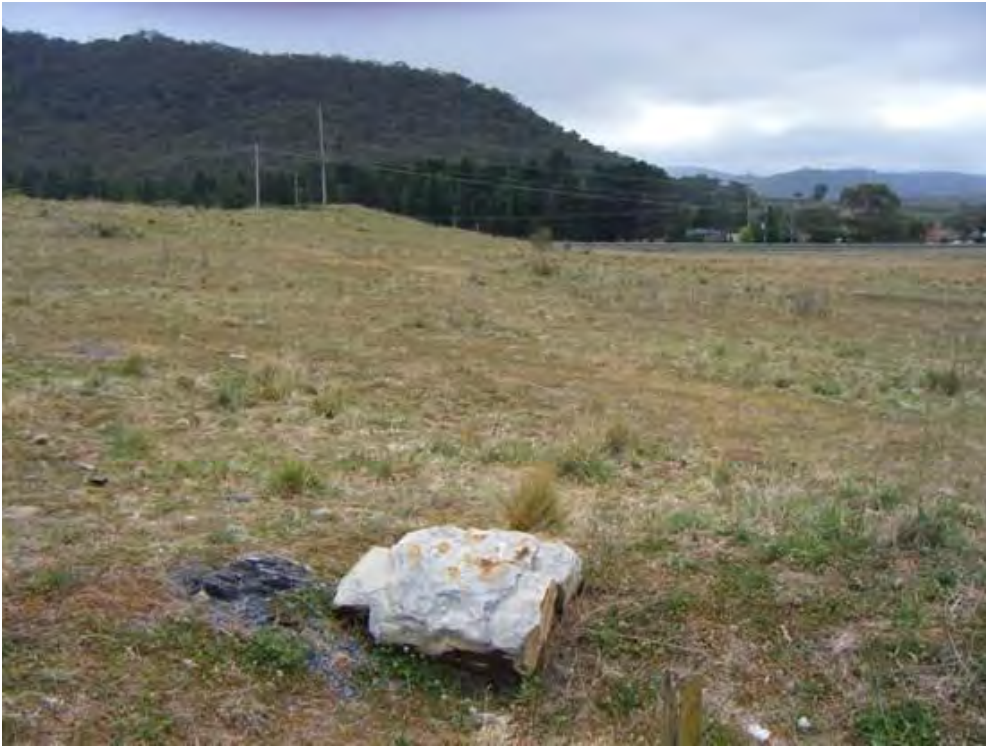
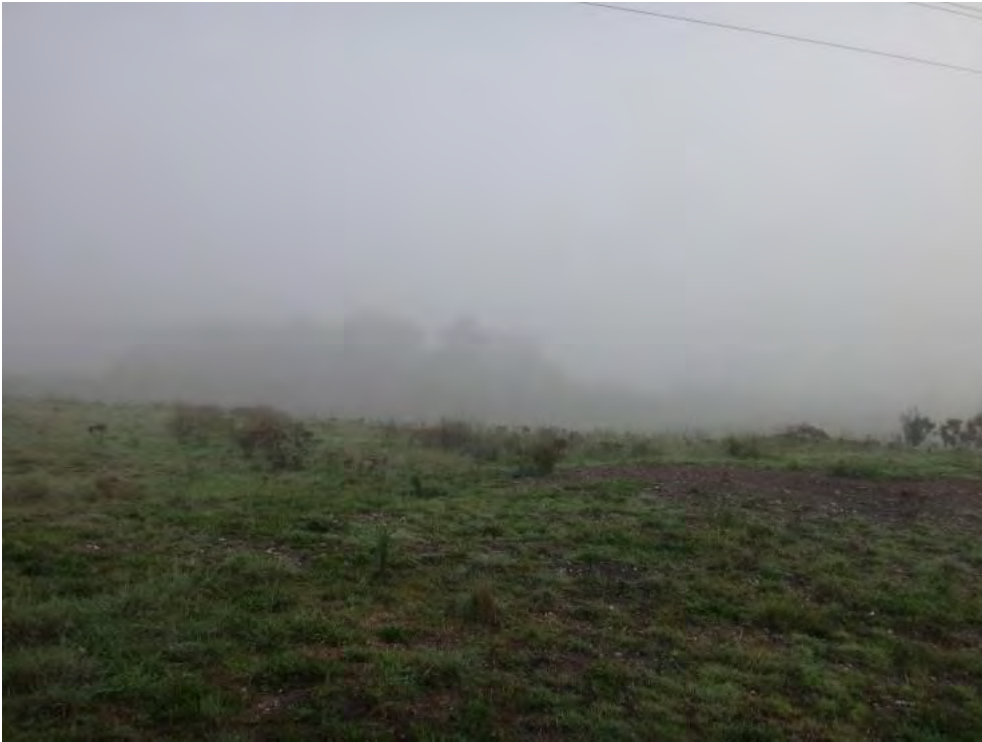
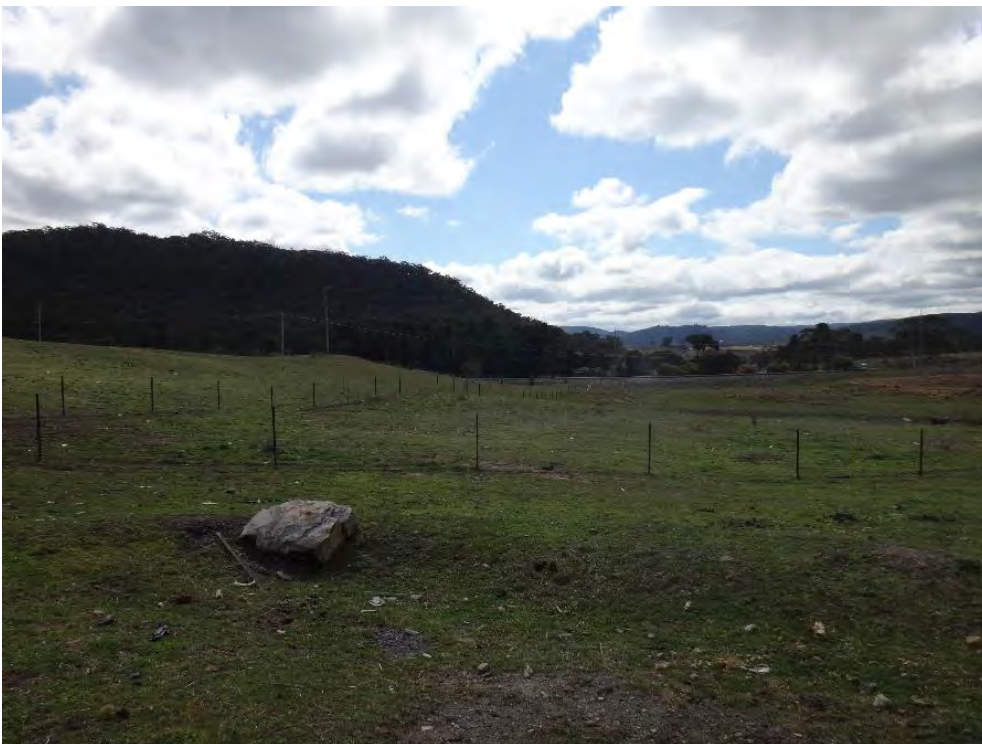
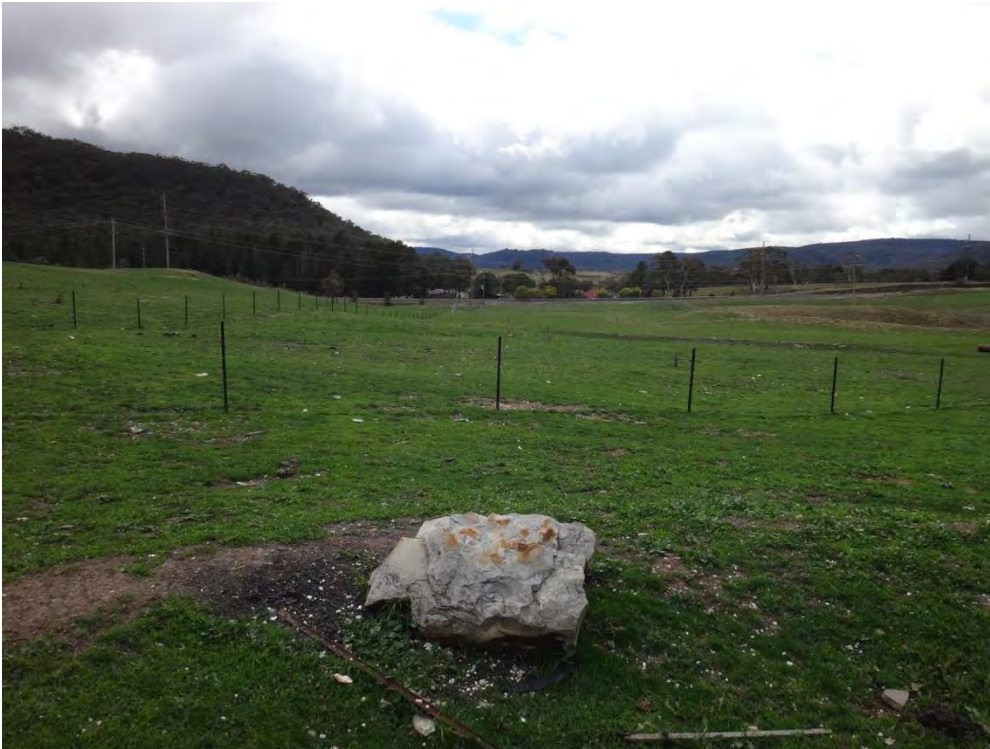
Quadrat 2 from southwest looking northeast 2012

Quadrat 2 from southwest looking northeast 2014

Quadrat 2 from southwest looking northeast 2015

Quadrat 2 from southwest looking northeast 2016

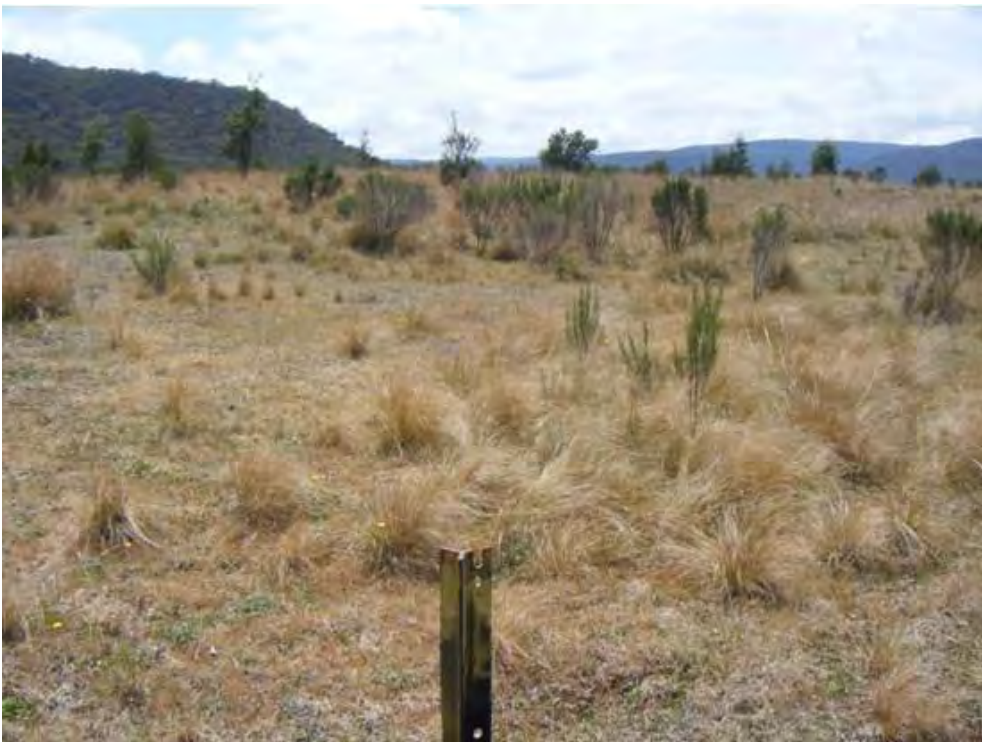
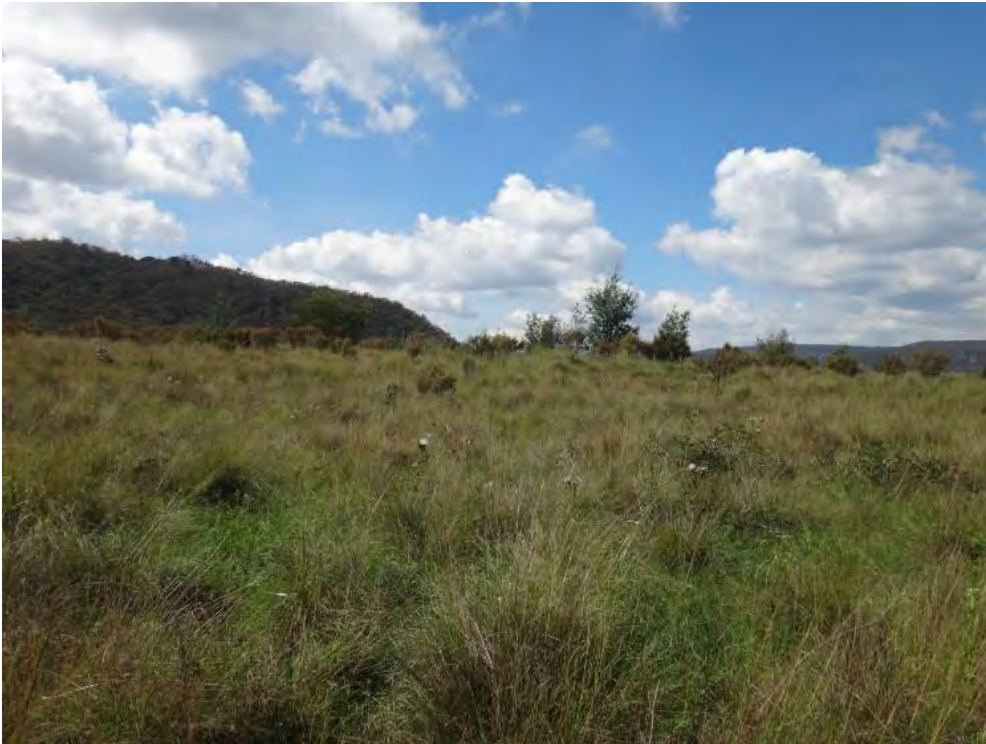
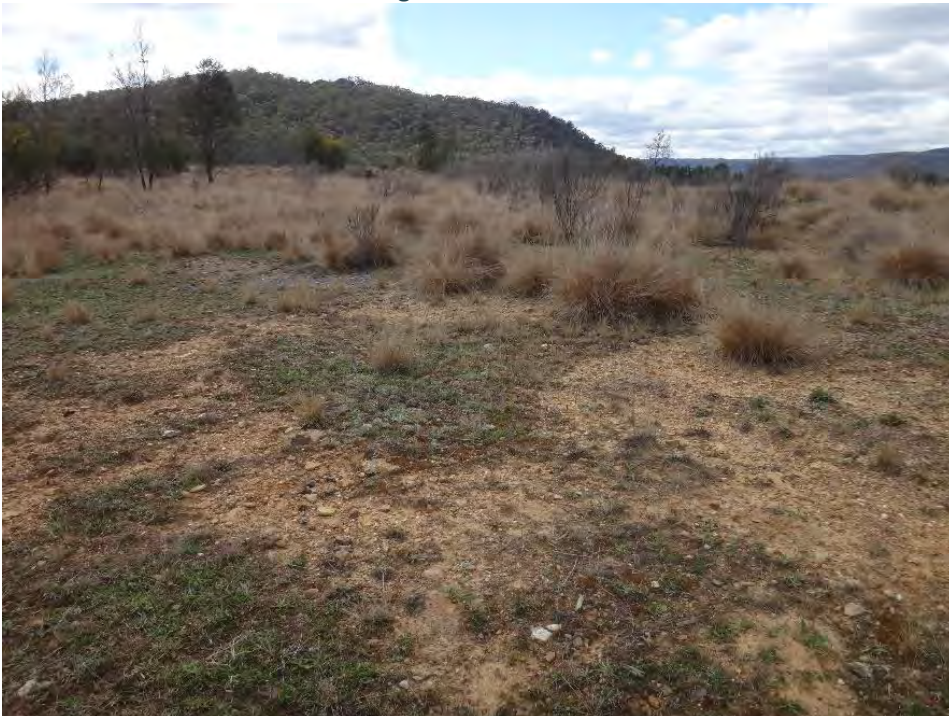
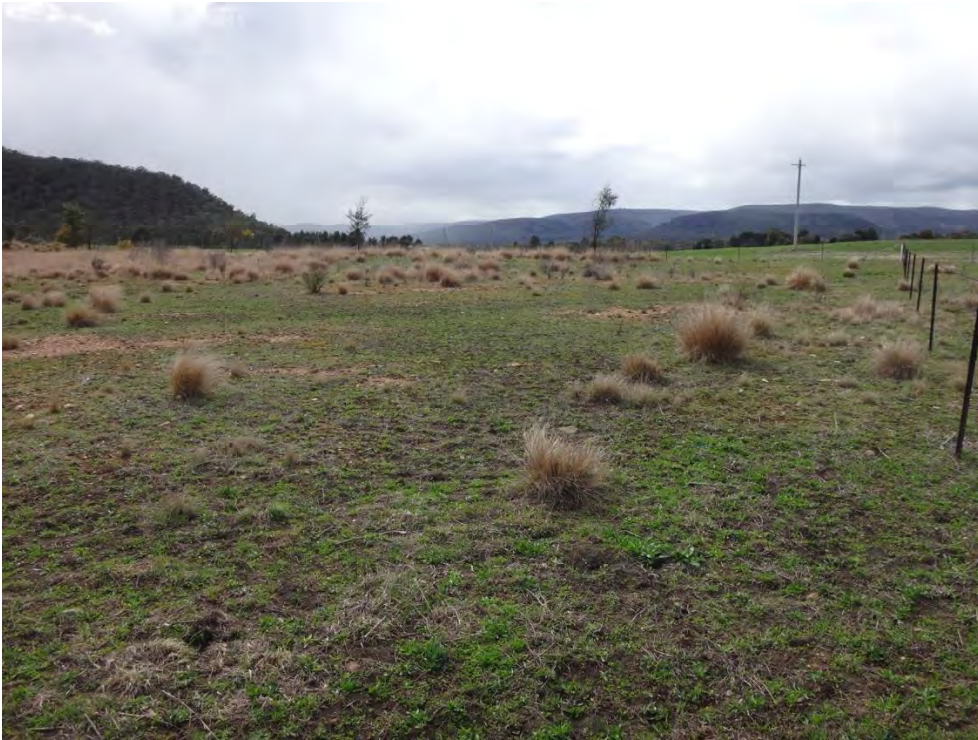
Quadrat 3 from southwest looking northeast 2012

Quadrat 3 from southwest looking northeast 2014

Quadrat 3 from southwest looking northeast 2015

Quadrat 3 from southwest looking northeast 2016
