Annual Environmental Management Report

2016

Enhance Place Mine

Enhance Place Mine Rehabilitation Monitoring Report 2016

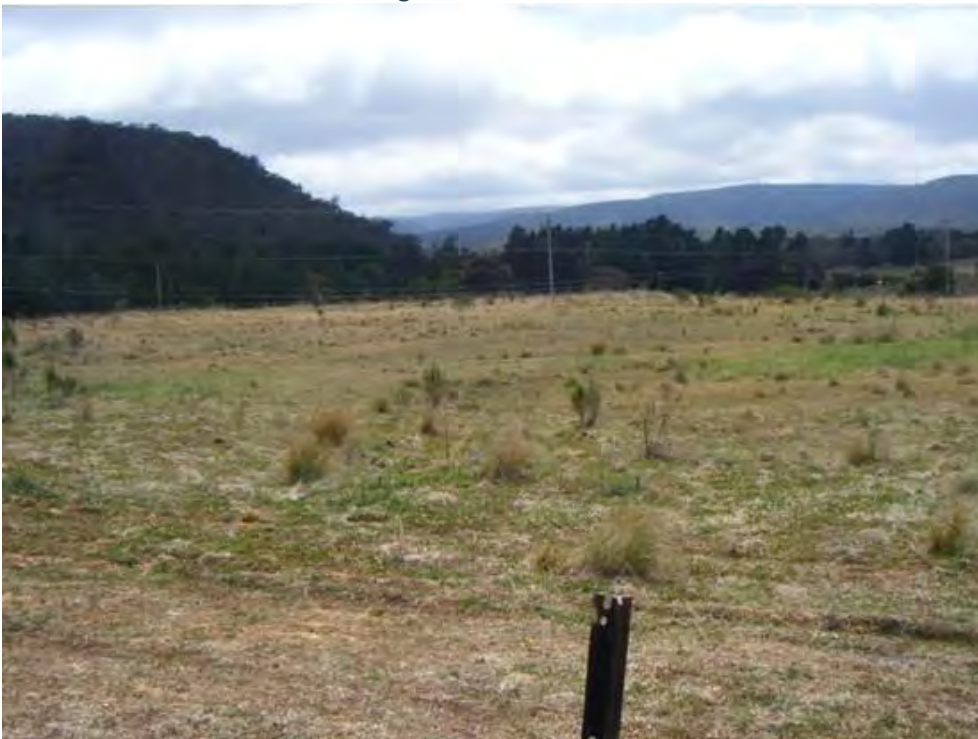
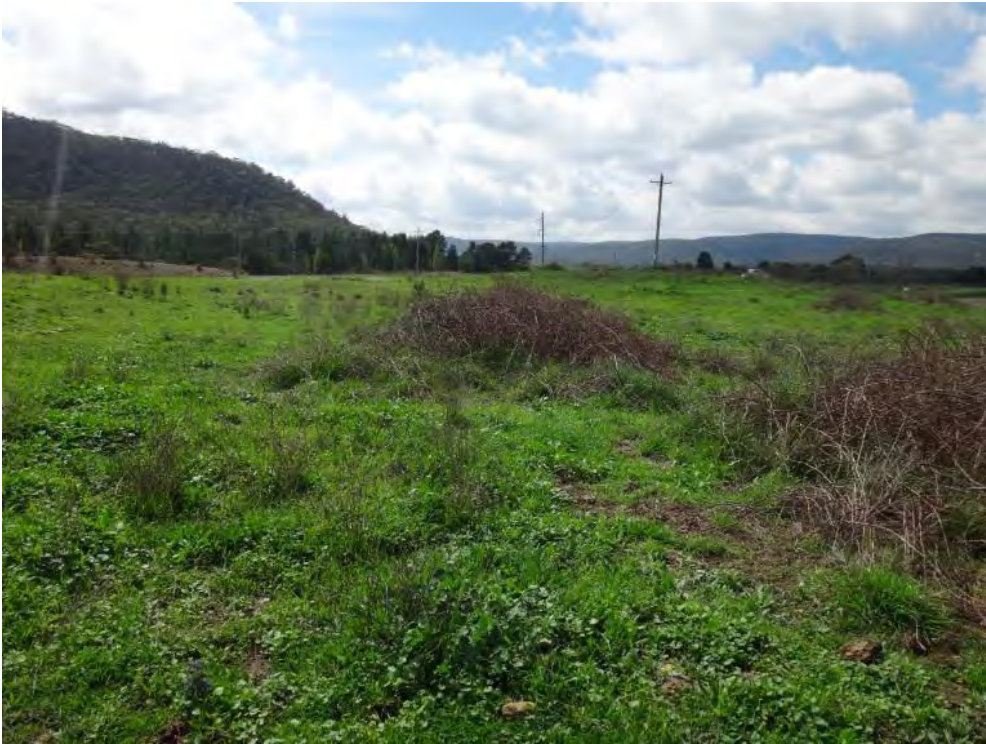
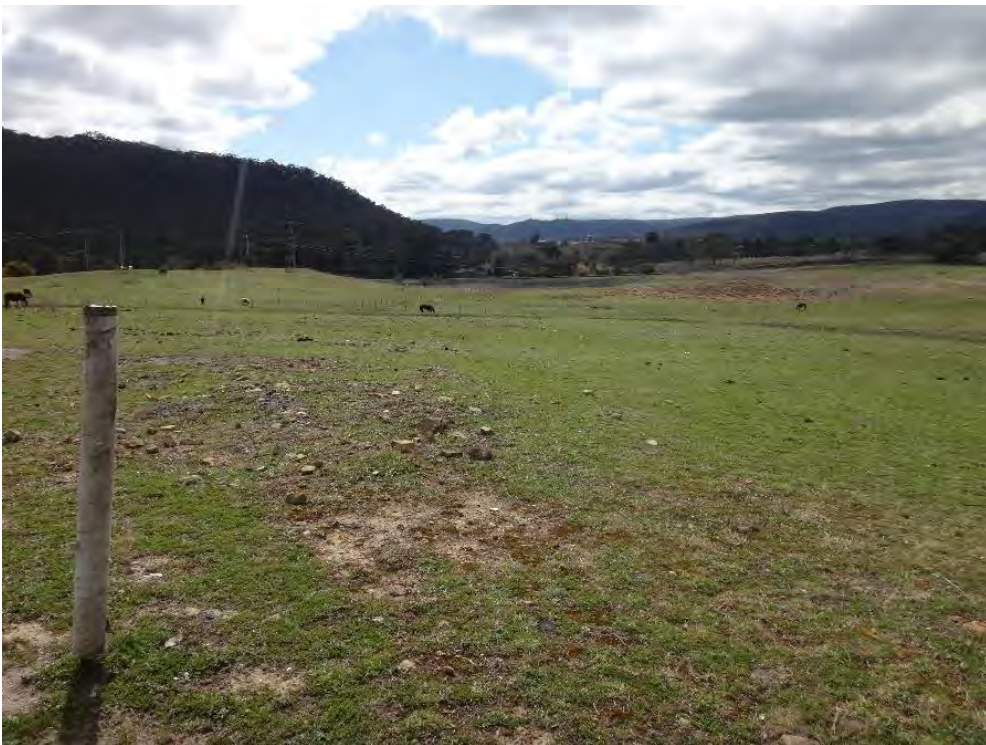
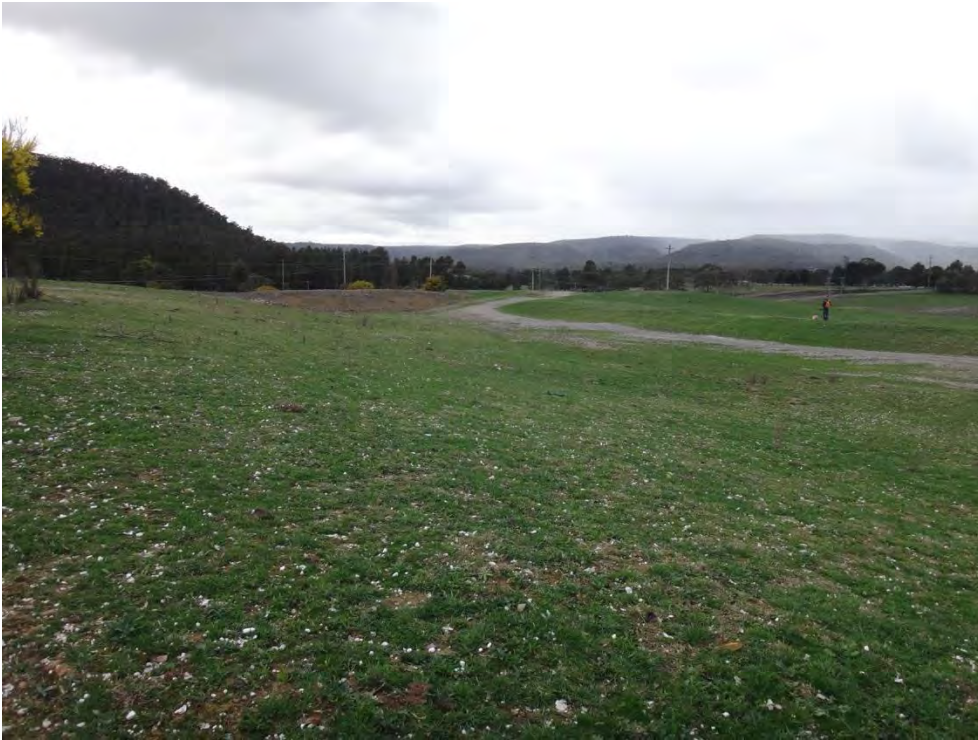
Quadrat 4 from southwest looking northeast 2012

Quadrat 4 from southwest looking northeast 2014

Quadrat 4 from southwest looking northeast 2015

Quadrat 4 from southwest looking northeast 2016

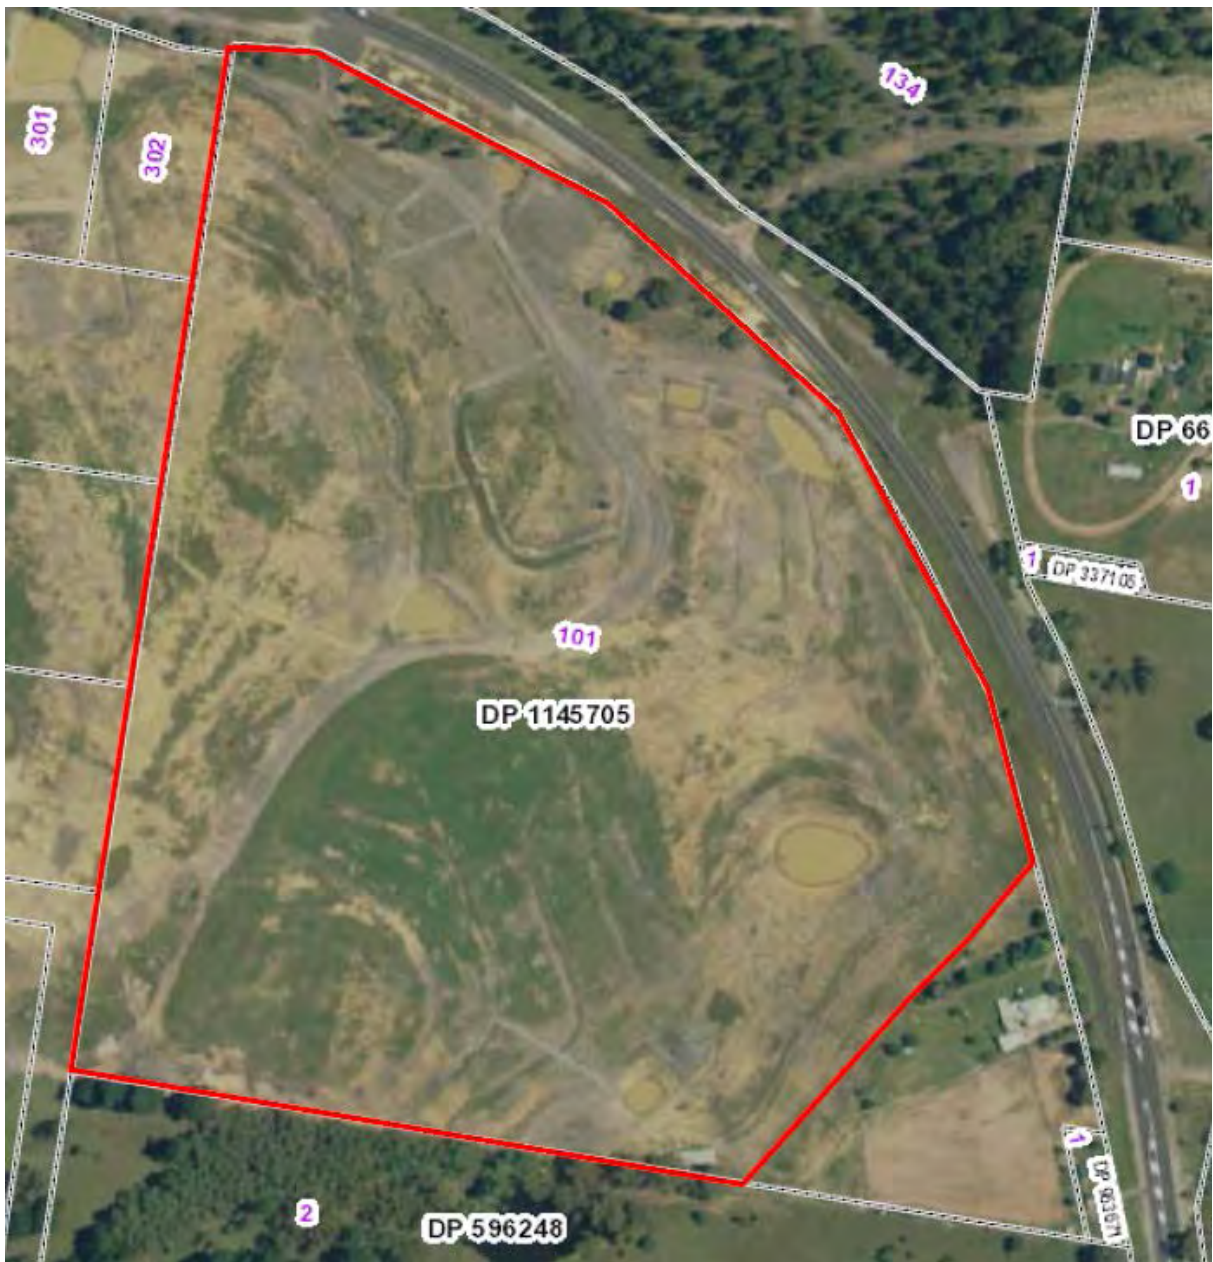
Figure 1 Rehabilitated pastures of the Morris Property

The Morris property is located on land formerly comprising Enhance Place Mine. The property is within Blackman's Flat on the southern side of Castlereagh Highway at Blackmans Flat, 15km north of Lithgow. The land to which this report relates is shown on Figure 1 and Figure 2 and covers an area of approximately 16.2 ha.
