# **Annual Environmental Management Report**

**2017**

**Enhance Place Mine**

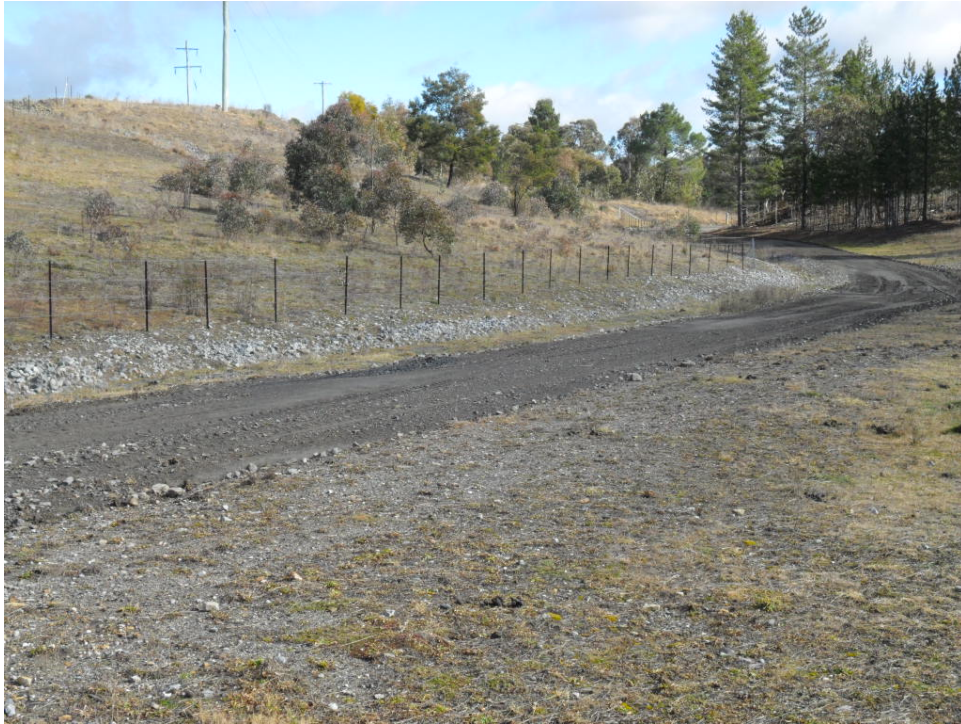
**Plate 1**      *Access track grading – August 2017*

Surface water pooling may also occur as a result of inappropriate or inadequate drainage structures. Sediment ponds and contour drains have previously been constructed where appropriate and there is no evidence of failure to date. Drainage structures were routinely examined during the 2017 reporting period with minor maintenance works undertaken, including re-grading of the access track to improve surface water drainage (**Plate 1 & 2**).

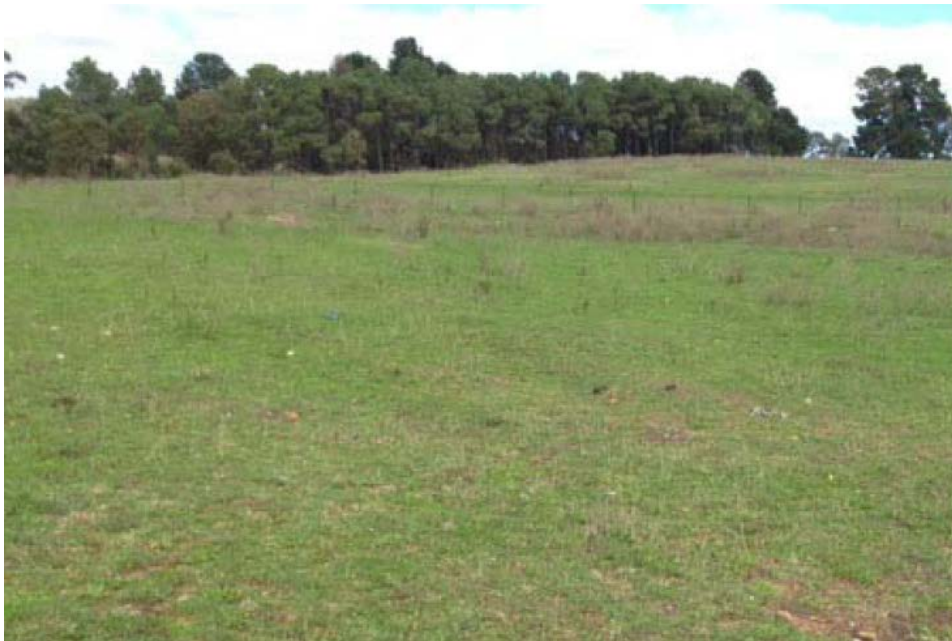
**Plate 3**     *Rehabilitated Pasture Areas – April 2017*

An inspection of the rehabilitated pasture areas by First Field Environmental consultants determined further application of fertilizer was not required during the 2017 reporting period. Satisfactory levels of groundcover was also observed to be present in all pasture areas (**Plate 3**) therefore re-sowing of summer pasture species was not required (*Monitoring and Evaluation Report into Rehabilitated Pasture*, First Field Environmental, 2017) [refer **Appendix B**].

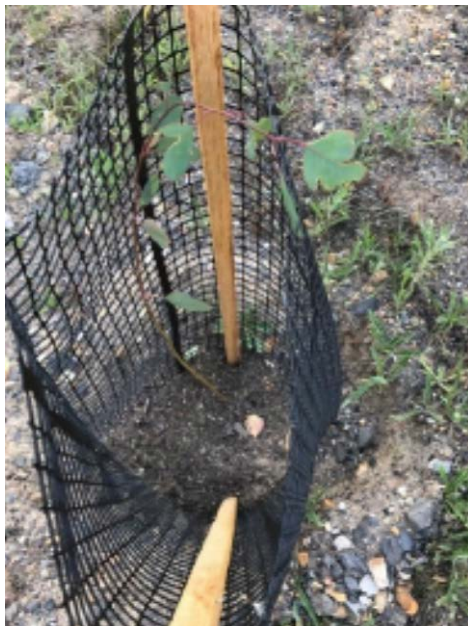
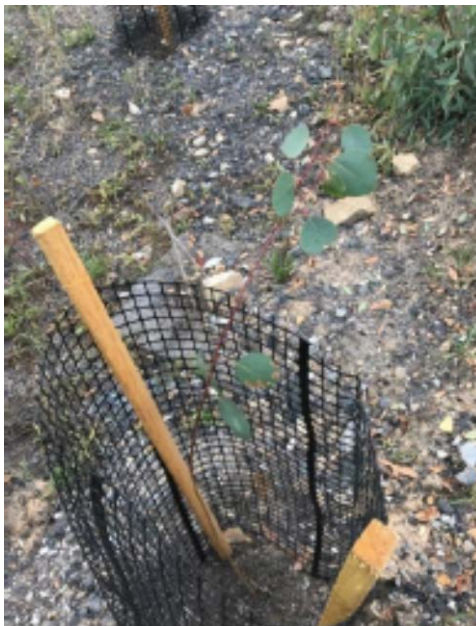
**Plate 5** *Replacement trees planted in Tree Rehabilitation Area – 2017*

During the 2017 reporting period twelve (12) long stem deep rooted native tree species were planted to replace species which had died. Trees were planted into an auger hole prepped with organic soil, fertilizer and water crystals, with hardwood stakes and mesh tree guards installed on each plant (**Plate 5**).

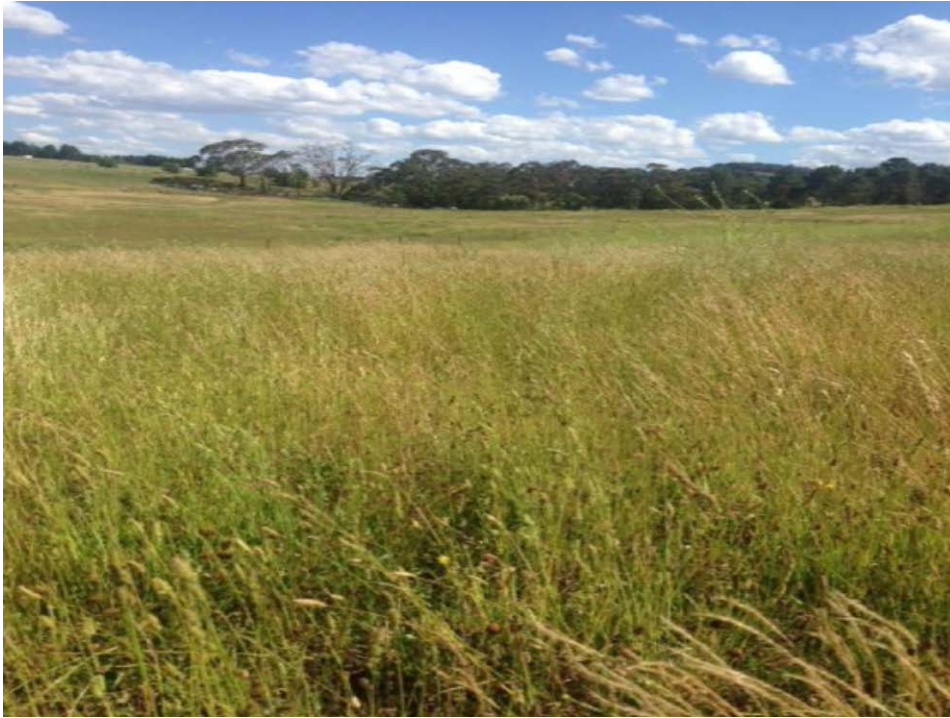
**Plate 7** *Regeneration of pasture in Paddock 1 during stock exclusion – January 2017*

(January, May & September 2017), were developed to evaluate the success of rehabilitation following the Stock Management Plan's implementation over two pasture-growing seasons. The findings of these reports indicated the stock exclusion was beneficial for the site's pasture rehabilitation, with the pasture in each paddock now consisting of a good mix of species which appears to withstand grazing pressure (**Plate 7**). The condition of each pasture paddock was found to satisfy the land management goals, with overall ground coverage greater than 70%.

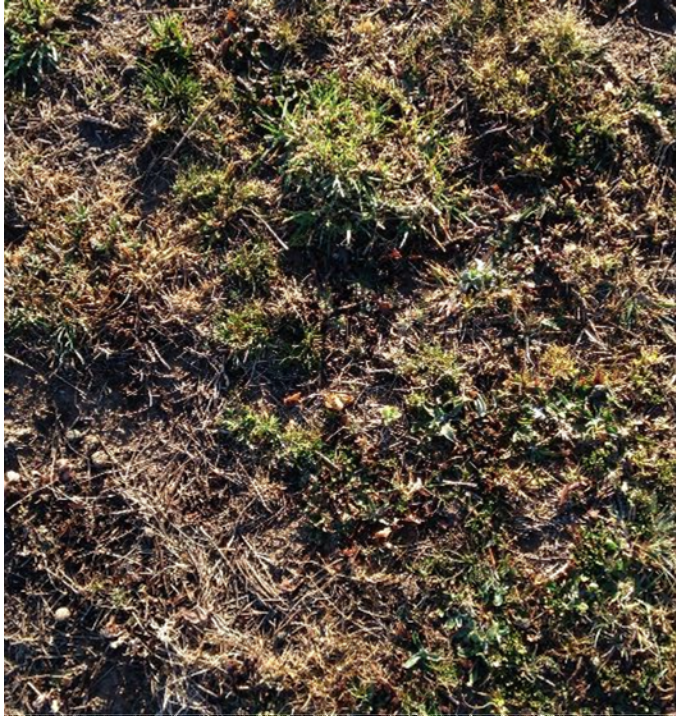
Figure 3 Pasture composition representative of rehabilitated pasture areas

**Species composition at pasture rehabilitation areas** – Pasture rehabilitation areas are established with a mix of 70% perennial grasses and 20% annual legumes and are representative of species composition at the analogue pasture site. An example of rehabilitated pasture is shown in Figure 3.

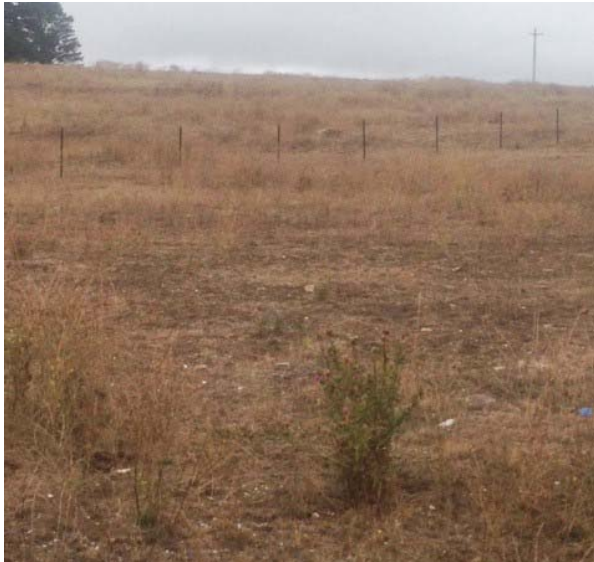
Figure 2 Groundcover in paddock 1

The rehabilitated paddocks were visually assessed and the overall percentage of groundcover in each paddock was found to be greater than 70%. Examples of groundcover typical to each paddock are provided in Figures 2, 3 and 4.

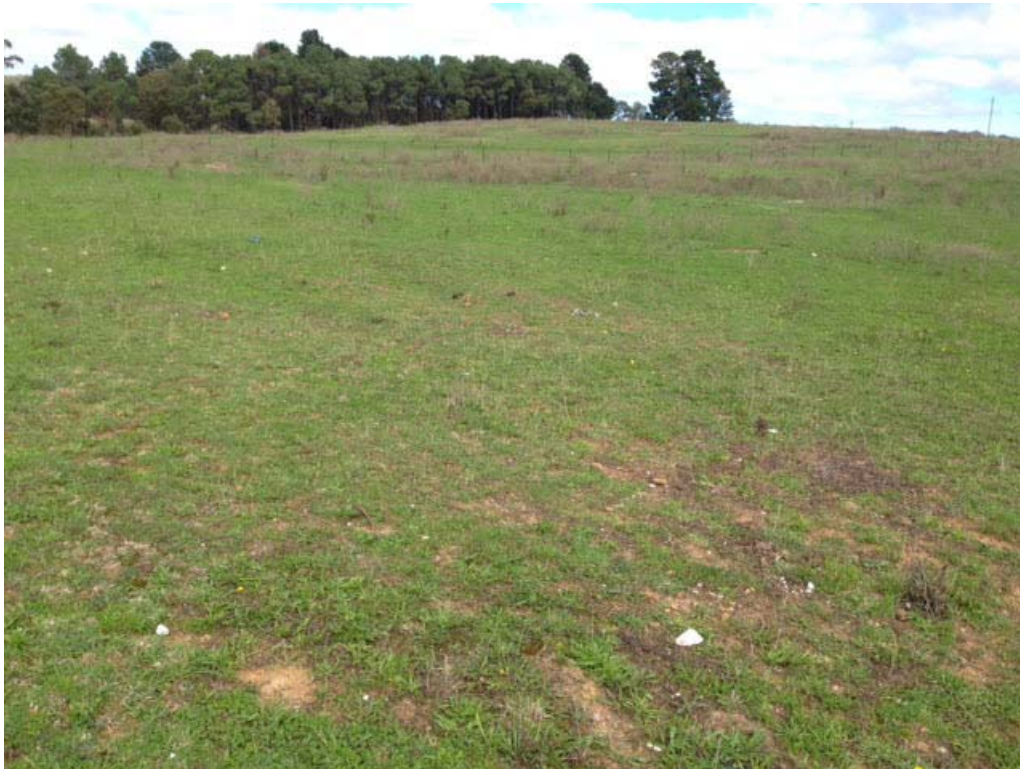
Figure 3 Looking south west across paddock 2.

The exclusion of stock from paddock 2 has had a positive effect on pasture growth during the study period. Growth of winter pasture species in paddock 2 has increased to >3cm height in many places, (Figure 5) with overall ground coverage continuing to remain above 70%.

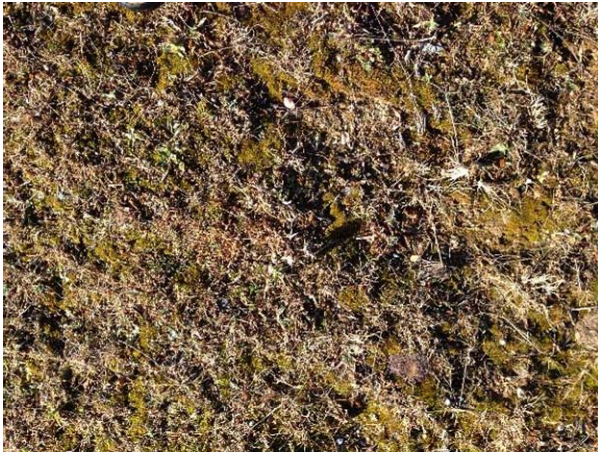
Figure 2 Groundcover in paddock 1

The rehabilitated paddocks were visually assessed and the overall percentage of groundcover in each paddock was found to be in excess of 70%. Examples of groundcover typical to each paddock are provided in Figures 2, 3 and 4.

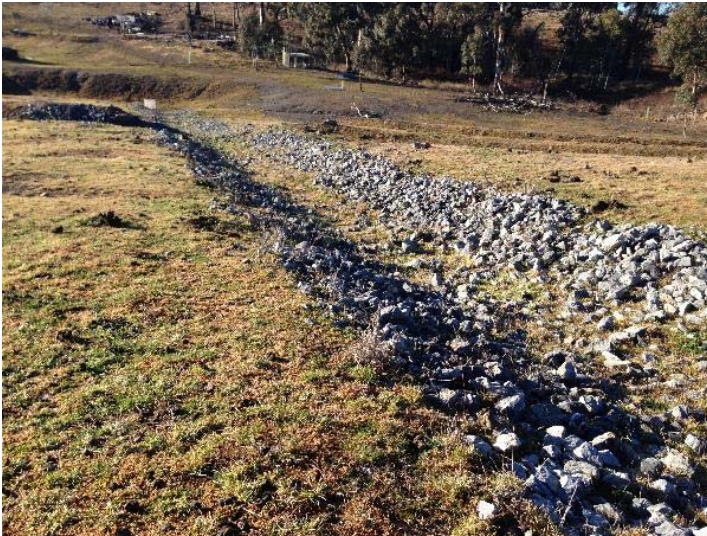
Figure 5 Drainage structure

No impediments were observed within drainage structures and there is no evidence of erosion or sedimentation associated with drainage structures (see Figure 5).

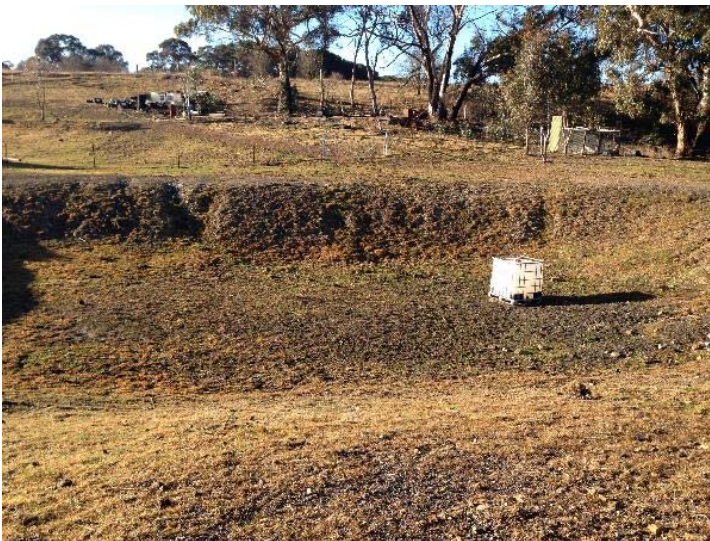
Figure 6 Sediment retention basin

No significant or active surface erosion was observed on the sides of the sediment retention basins (see Figure 6).
