Annual Environmental Management Report

2018

Enhance Place Mine

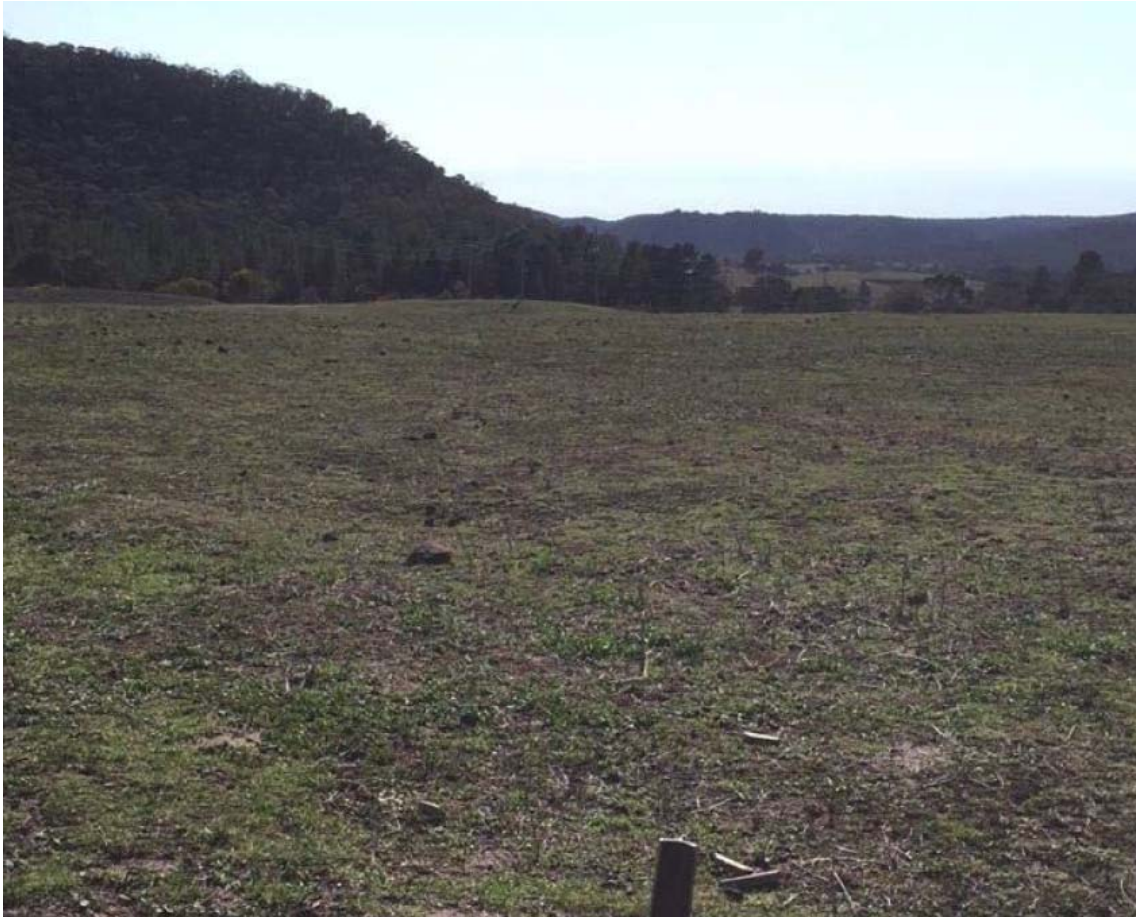
Plate 1 Pasture Area – Quadrat 1 September 2018

Monitoring of pasture conditions was undertaken September 2018 and detailed in the *Enhance Place Mine Rehabilitation Monitoring Report 2018 (First Field Environmental, 2018)*. Monitoring of pasture conditions is undertaken at four quadrats location; refer to Plan 3, **Appendix B**). Groundcover in quadrats 1, 2 and 4 has maintained 90% total living groundcover during the period 2015 – 2018. The groundcover in quadrat 3 has decreased from 90% in 2017 to 85% in 2018. Groundcover is considered to be satisfactory at all

As groundcover conditions were considered satisfactory, application of fertilizer was not required during the 2018 reporting period, as First Field Environmental (2017 & 2018).

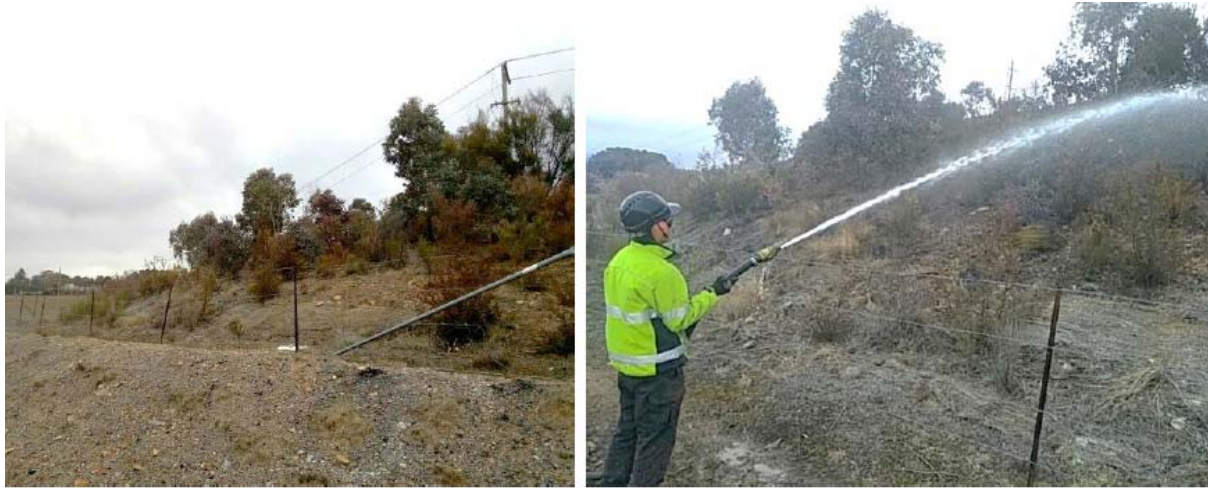
Plate 5 Treed Rehabilitation Area Watering – August 2018

Routine maintenance inspections of the treed rehabilitation area were undertaken to determine the soil moisture content and the requirement for watering; and for the manual removal of weeds from trees and surrounding tree guards.

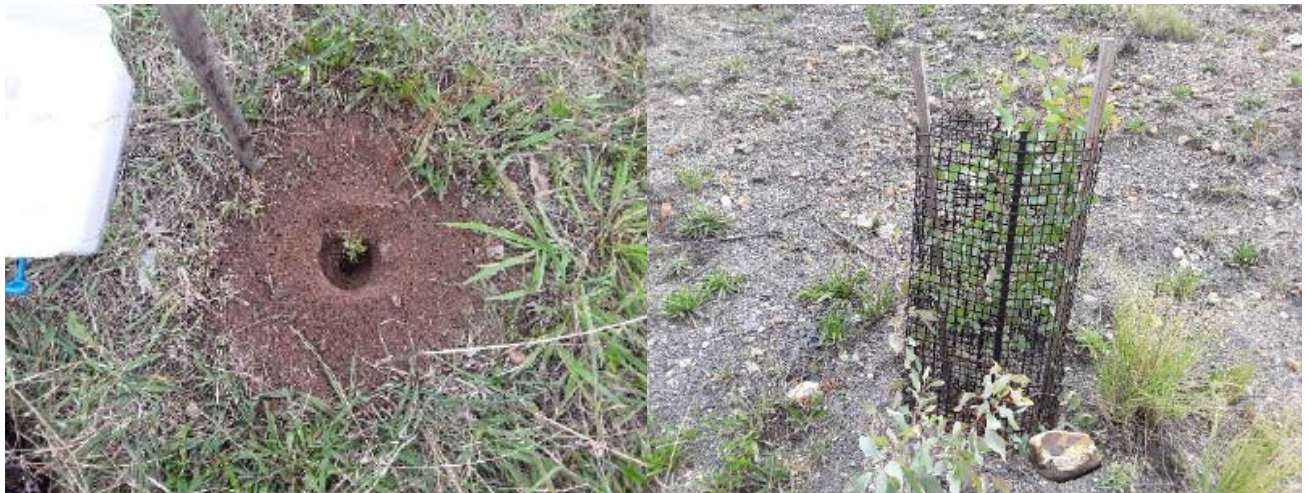
Plate 6 Replacement trees planted in Treed Rehabilitation Area – March 2018

During the 2018 reporting period twelve (14) long stem deep rooted native tree species were planted to replace species which had died. Trees were planted into an auger hole prepared with organic soil, fertilizer and water crystals, with hardwood stakes and mesh tree guards installed on each plant (**Plate 6**).

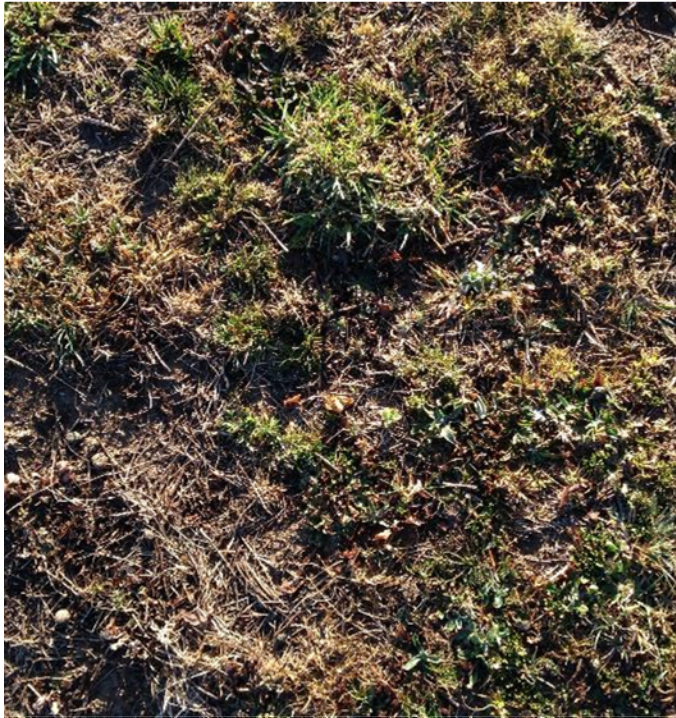
Figure 3 Pasture composition representative of rehabilitated pasture areas

Species composition at pasture rehabilitation areas – Pasture rehabilitation areas are established with a mix of 70% perennial grasses and 20% annual legumes and are representative of species composition at the analogue pasture site. An example of rehabilitated pasture is shown in Figure 3.

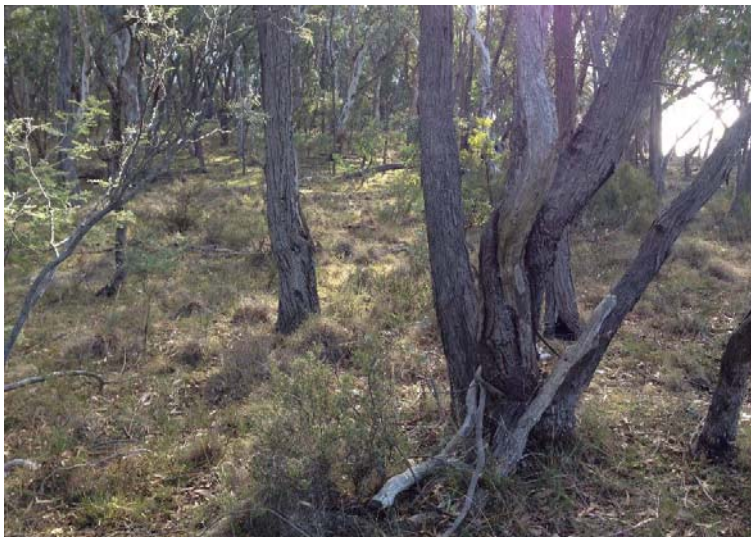
Figure 6 Vegetation structure of treed analogue site (Pine Dale Mine)

The treed analogue site is characterised by a canopy to 12m height with 40% canopy cover over a sparse shrubby mid-storey to 3m height and isolated shrubs to 1.5m height in the understorey. Groundcover consists of grasses and herbs with a cover of >90% (Figure 6).

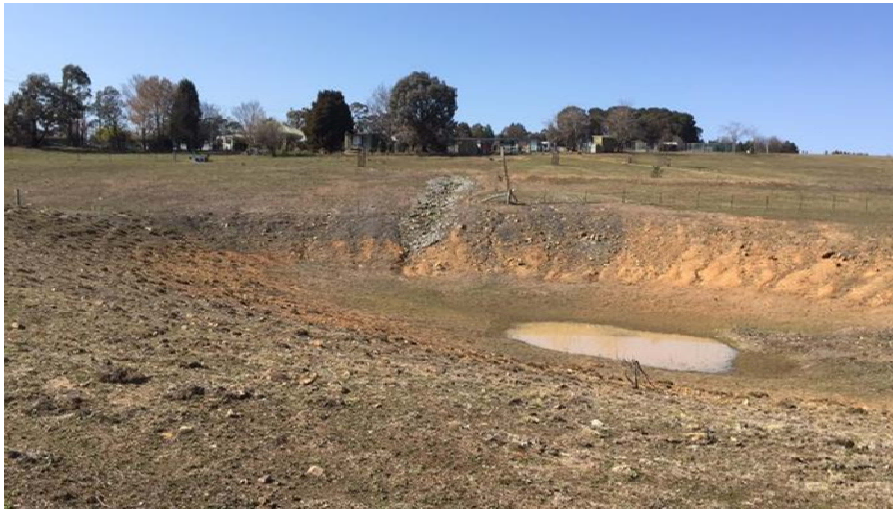
Figure 2 Indicative condition of sediment retention basins

Ponding of water – Sediment ponds and contour drains were established prior to 2013 and generally remain in good operational condition. Figure 2 shows the condition of sloping retention basin walls.

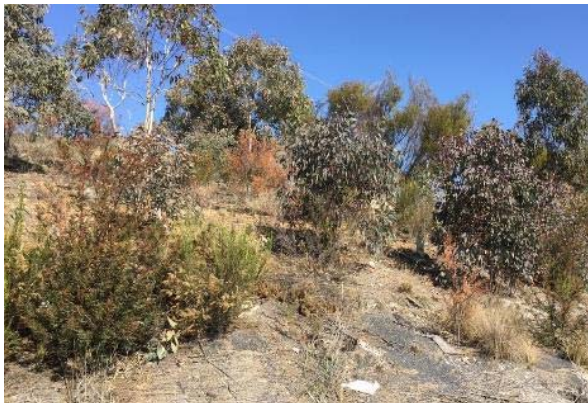
Figure 4 Vegetation structure and groundcover at transect 7

Groundcover at treed rehabilitation areas – Ground cover at transects 7 and 8 remain unchanged from 90% in previous years.

Canopy cover at treed rehabilitation areas - Canopy cover is developing in treed rehabilitation areas. A sparse mid-storey of isolated juvenile trees to 5m height and shrubs to 1.5m height exist over a sparse, low, shrubby understorey (seen in Figure 4 and Figure 5). Groundcover is a sparse mix of broadleaf herbs and grasses. Changes in vegetation structure over time (as shown in Appendix B) are not considered significant.

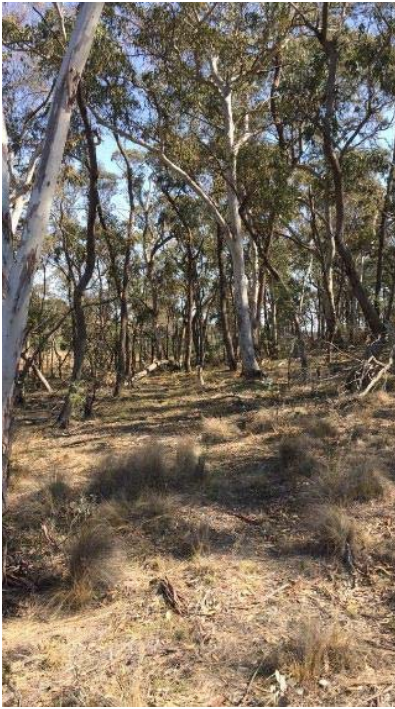
Figure 6 Vegetation structure of treed analogue site (Pine Dale Mine)

Treed analogue site - The treed analogue site is characterised by a canopy to 12m height with 20% canopy cover over a sparse shrubby mid-storey to 3m height and isolated shrubs to 1.5m height in the understorey. Groundcover consists of grasses and herbs with a cover of >95% (Figure 6).

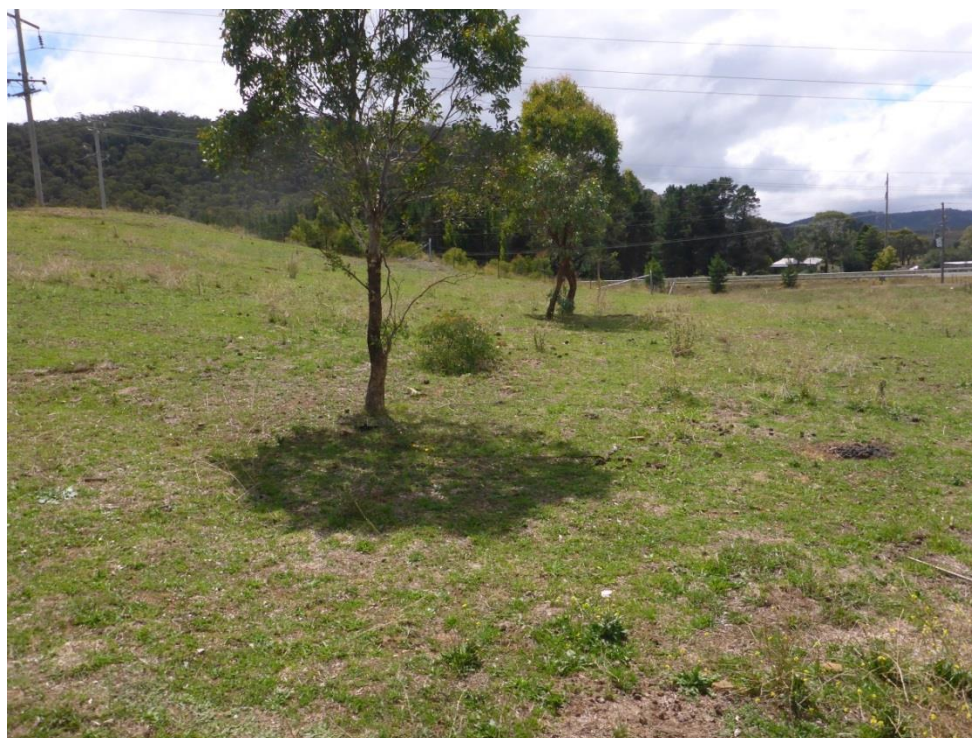
Photo 7 Rehabilitated Site EP5 March 2018

Photo 7 shows the general landscape setting for Site EP5 within the Morris Property at Enhance Place Mine during the 2018 inspections. Pasture at Site EP5 is dominated by perennial grasses fescue and phalaris, the herb plantain with some medic present in the sward, and greater than 90% groundcover.

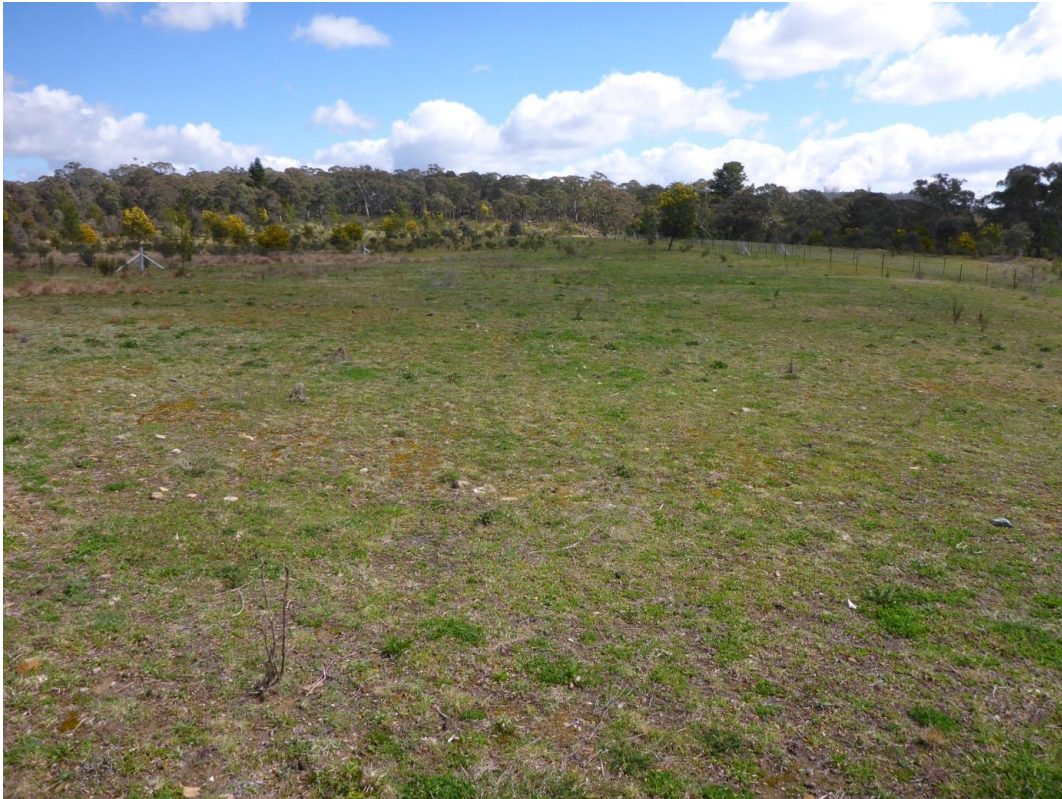
Photo 8 Rehabilitated Site EP2 September 2014

Photo 8 and **Photo 9** show the general landscape setting for Site EP2 within the Crown Land at Enhance Place Mine during the 2014 and 2018 inspections, with greater than 80% groundcover.

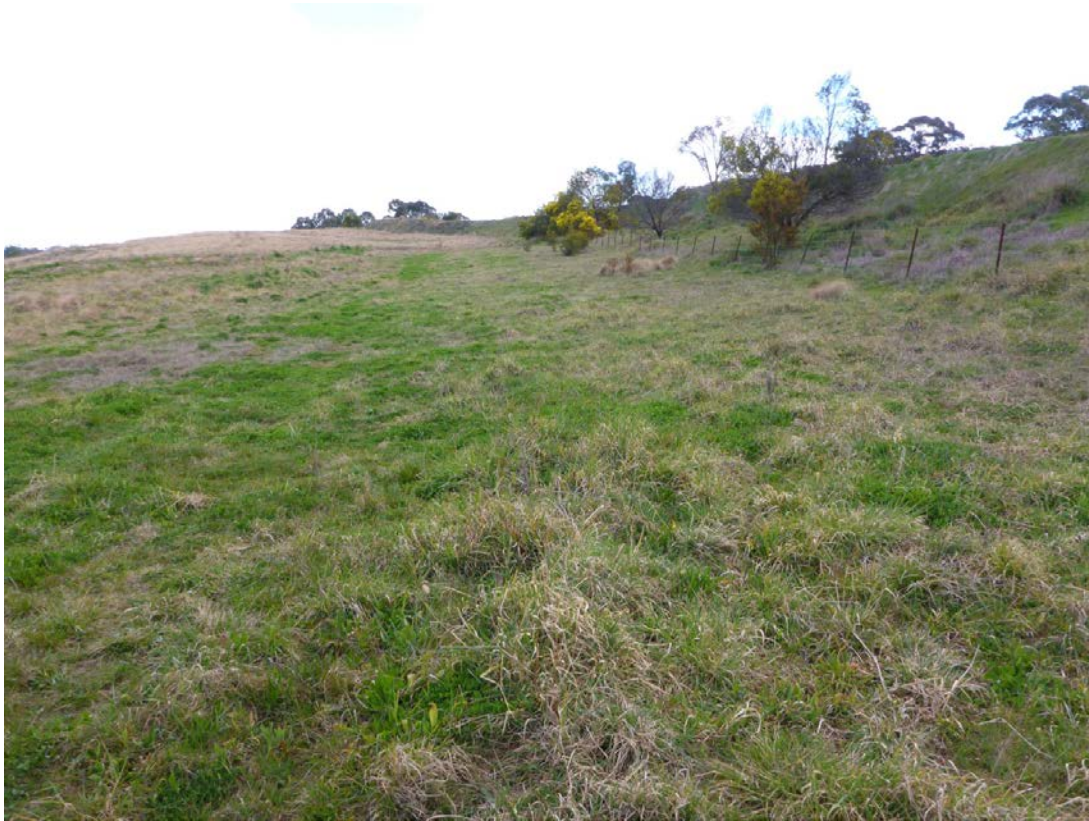
Plate 3: Analogue Site PD3 September 2014

Topsoil consists of a sandy clay loam over a medium clay subsoil. This area supports a perennial grass and clover pasture, including cocksfoot, tall fescue, phalaris, sub clover, with some annual ryegrass. These pasture species have a winter and spring growth habit, with the difference in pasture mass clearly evident between the 2014 (September) and 2018 (March) inspections.

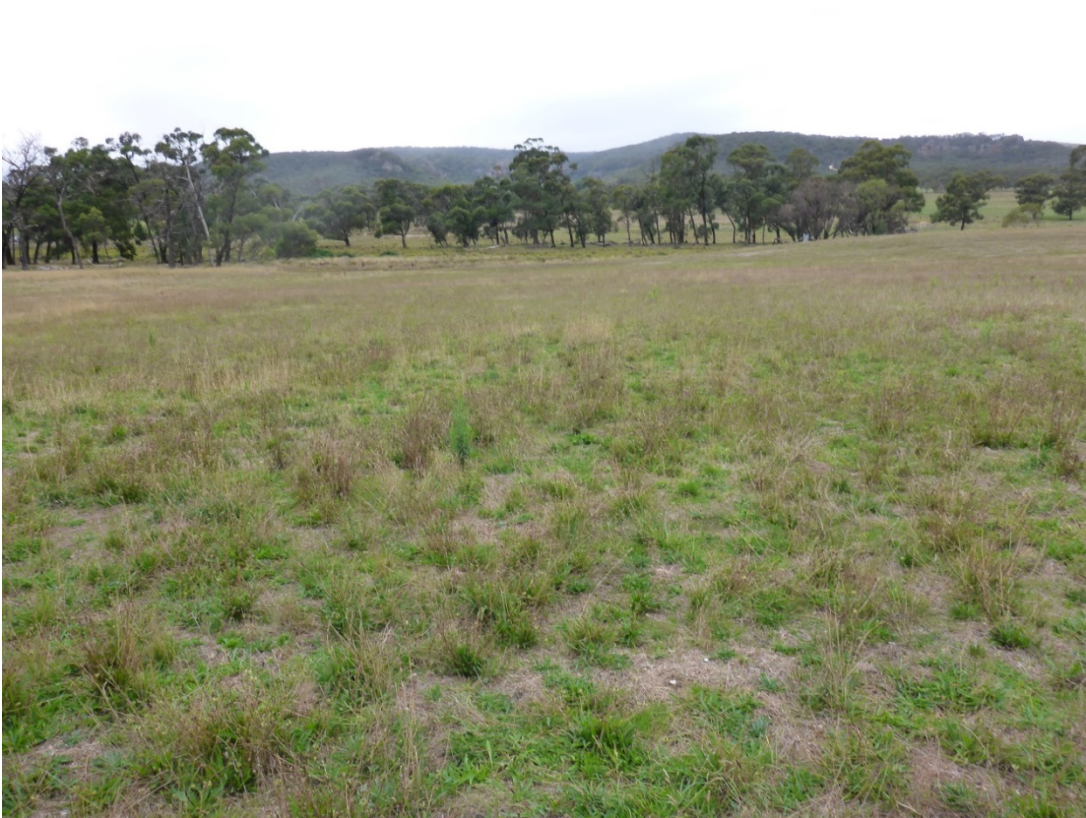
Plate 10: Rehabilitated Site PD7 March 2018

Plate 10 shows the general landscape setting for Site PD7 within Area C at Pine Dale Mine during the 2018 inspection. Pasture at Site PD6 is dominated by perennial grasses phalaris, fescue and paspalum along with the herb plantain and arrowleaf clover. There is greater than 90% groundcover with only isolated tussocks of African lovegrass, which comprises less than 5% of the pasture sward.

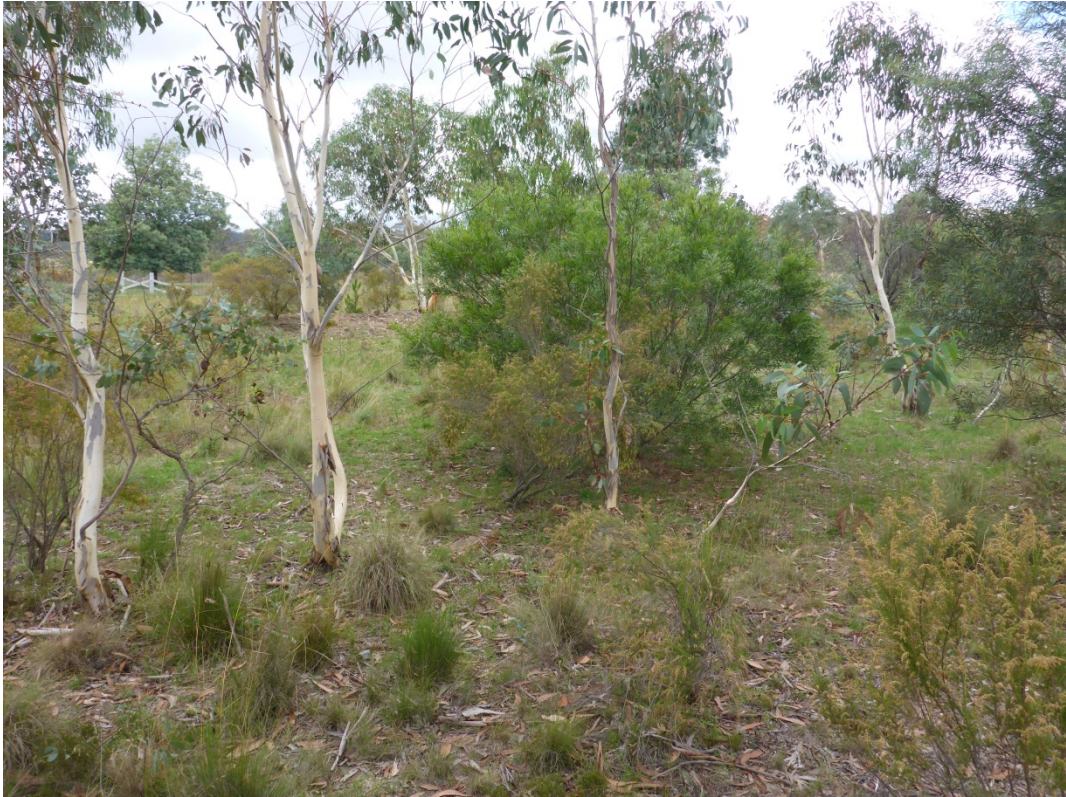
Plate 14: Analogue Site EP4 March 2018

Table 16 below shows soil nutrient levels at Site EP4 from the 2018 inspection. Site EP4 was chosen as an analogue site for the Morris Property as it is undisturbed by mining did not receive any of the Morris Property treatment, being located between eucalypt trees and not accessed by fertiliser spreading equipment. **Plate 14** shows the general landscape setting for analogue Site EP4

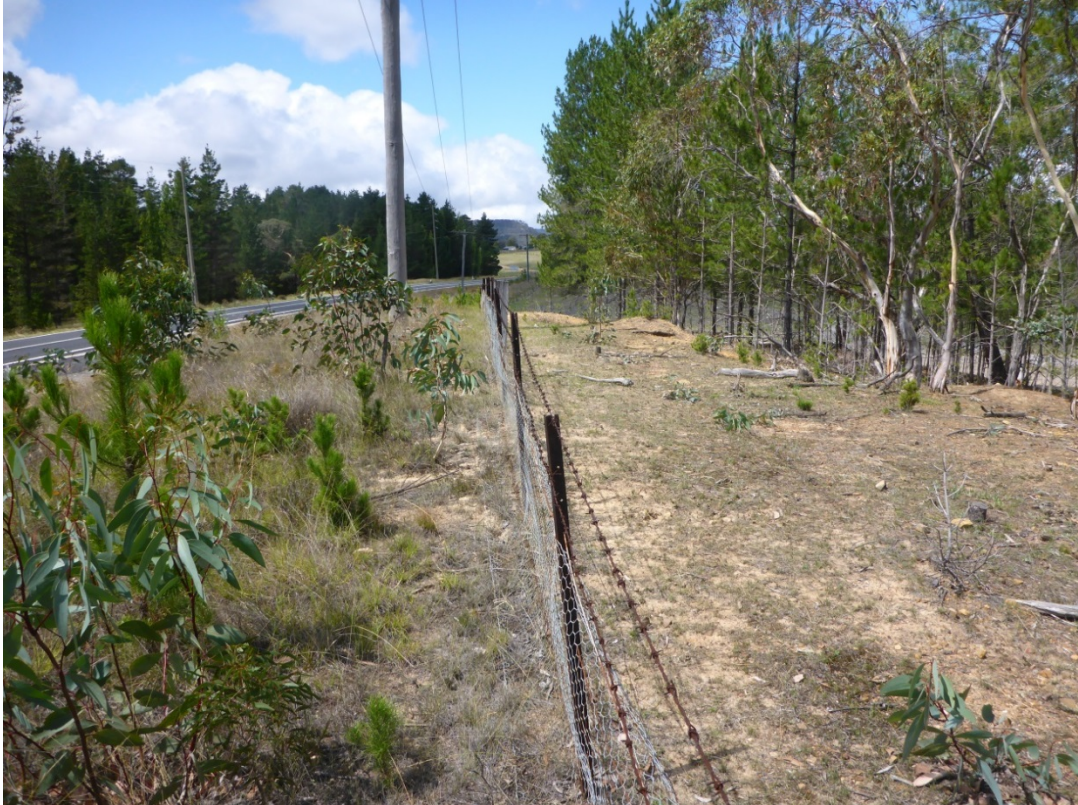
Plate 15: Analogue Site EP6 March 2018

Table 17 below shows soil nutrient levels at Site EP6 from the 2018 inspection. Site EP6 was chosen as an analogue site for the Morris Property as it is undisturbed by mining and also located in a roadside reserve and not accessed by fertiliser spreading equipment. **Plate 15** shows the general landscape setting for analogue Site EP6.

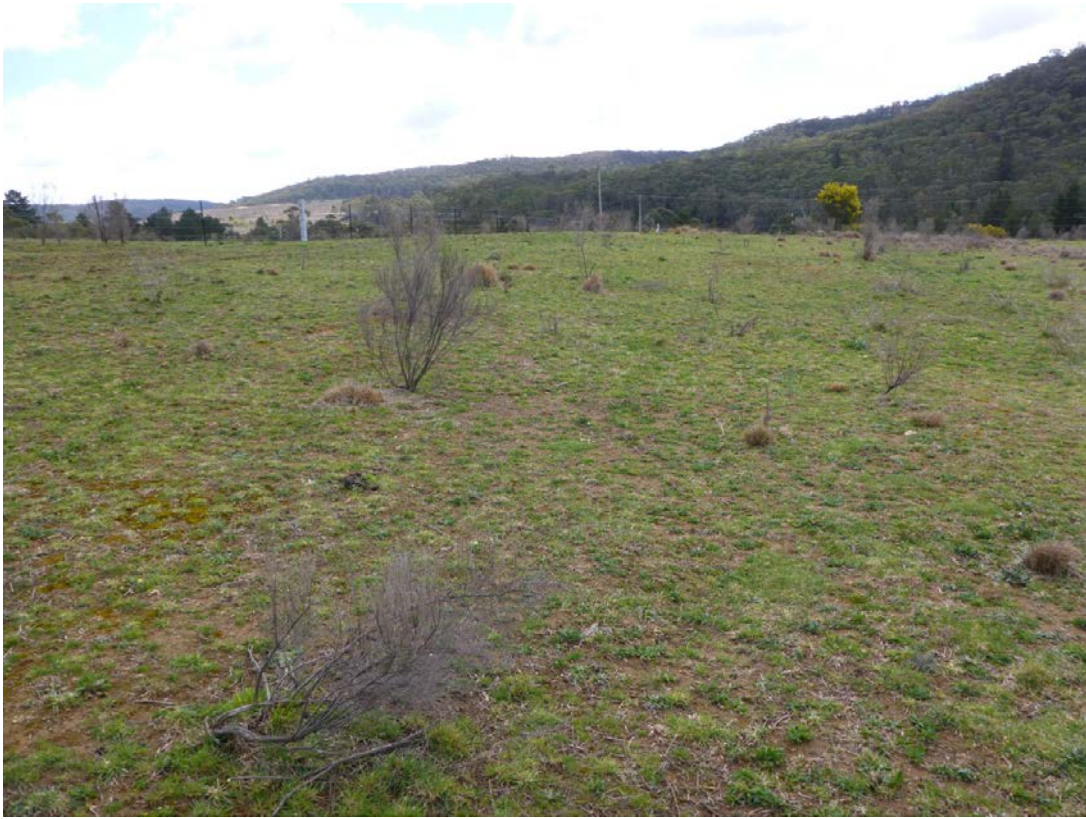
Plate 16: Rehabilitated Site EP1 September 2014

Plate 16 and **Plate 17** show the general landscape setting for Site EP1 within the Morris Property at Enhance Place Mine during the 2014 and 2018 inspections.

Overgrazing is still a major land management issue here, however increase in perennial grass pasture density have been achieved nonetheless.

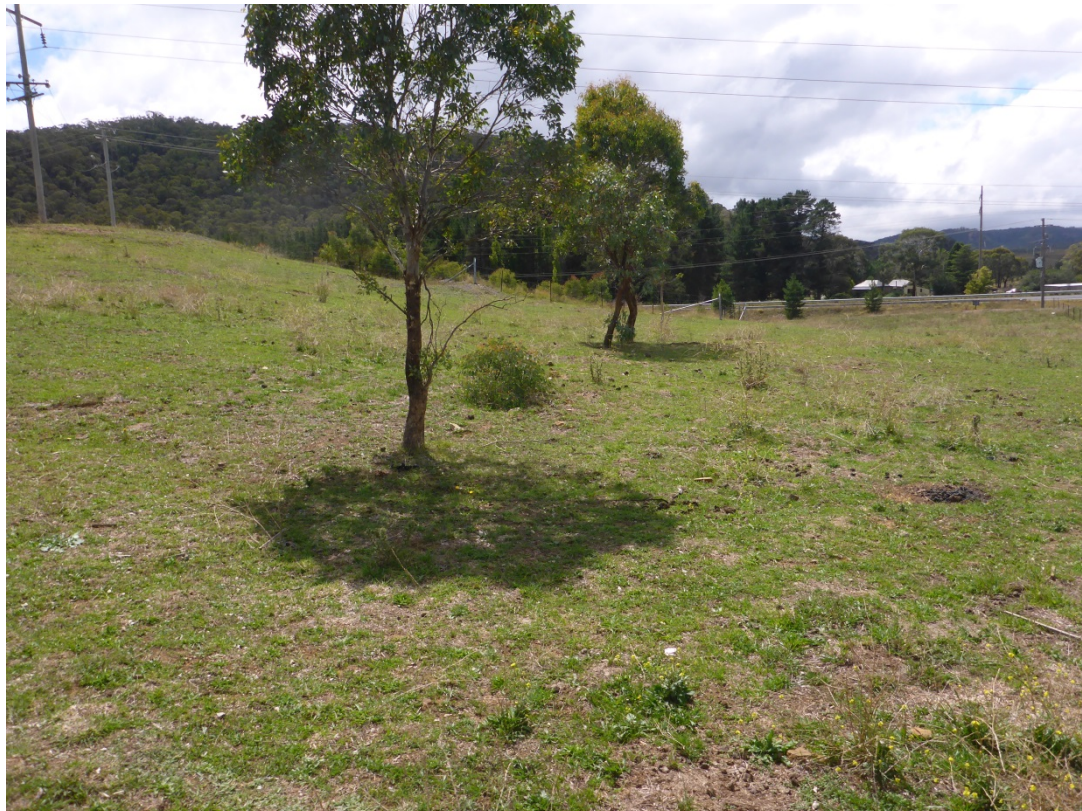
Plate 20: Rehabilitated Site EP5 March 2018

Plate 20 shows the general landscape setting for Site EP5 within the Morris Property at Enhance Place Mine during the 2018 inspections. Pasture at Site EP5 is dominated by perennial grasses fescue and phalaris, the herb plantain with some medic present in the sward, and greater than 90% groundcover.
