# PINE DALE MINE ANNUAL REVIEW 2021

**Prepared by Enhance Place Pty Ltd**

**18 February 2022**

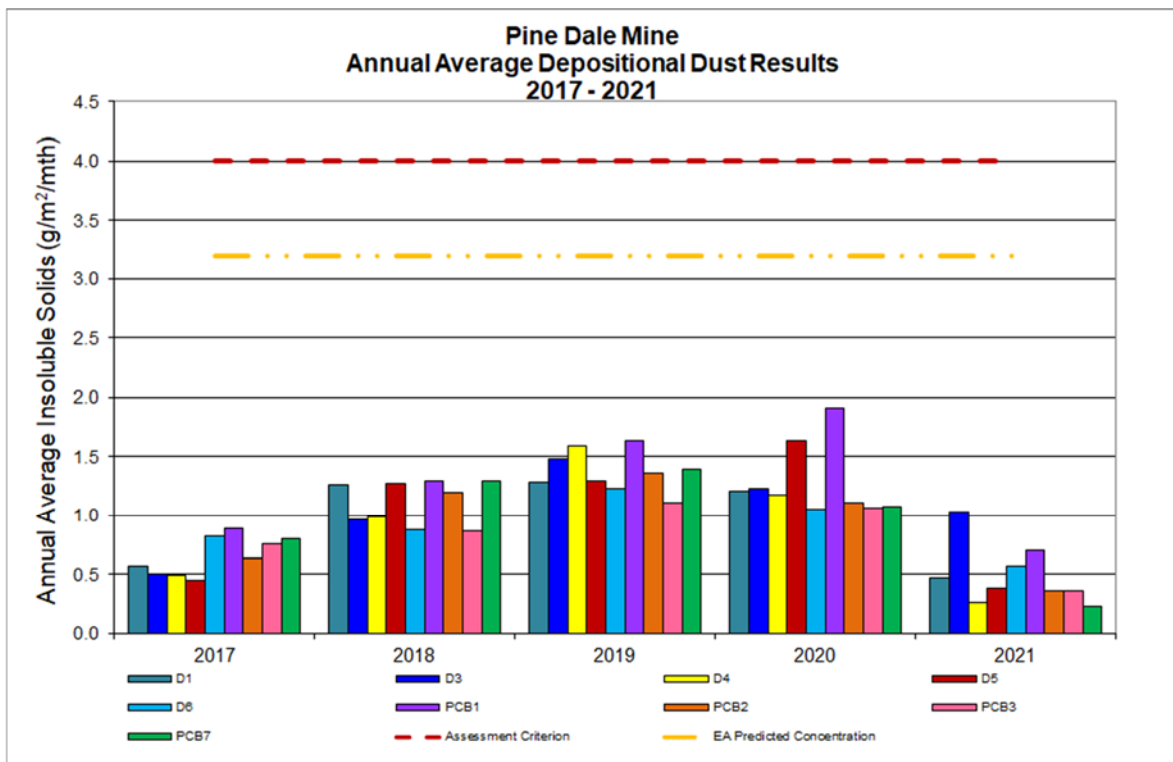
**Figure 5-1** Depositional dust data: 2017 – 2021

An examination of the historical data (refer **Table 5-3**) indicates most dust monitoring locations show a substantial decrease in the 2021 annual averages deposited dust concentrations when compared to the 2020 annual averages. Dust monitoring location D3 showed a slight decrease. Annual average deposited dust concentrations are shown to be generally consistent with the 2017 results (refer **Figure 5-1**) with the exception of D3. The decrease in concentrations is not considered to be due to a change in site activities at PDM as the mine has been in care and maintenance since 2014, rather it is considered to be influenced by the increased rainfall over the reporting period (refer **Section 5.3.1**) following prolonged dry conditions and associated correlation with dust storms (observed during 2018, 2019 and early 2020), and bushfires (observed during late 2019 and early 2020).

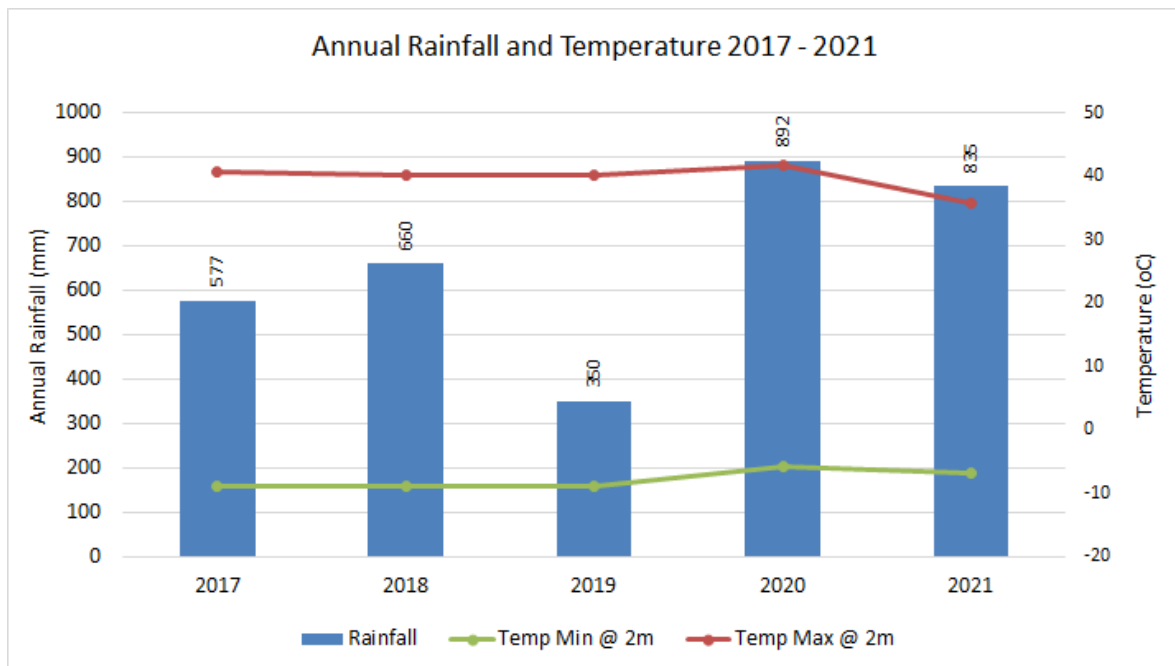
**Figure 5-2** Annual Temperature and Rainfall Summary: 2017 – 2021

The total annual rainfall and the minimum and maximum temperature at 2m is shown graphically in **Figure 5-2**.

Rainfall during this reporting period was observed to be greater than the annual rainfall recorded during 2019 (350mm), 2018 (660mm) and 2017 (577mm) and generally consistent with that recorded during 2020 (892mm).

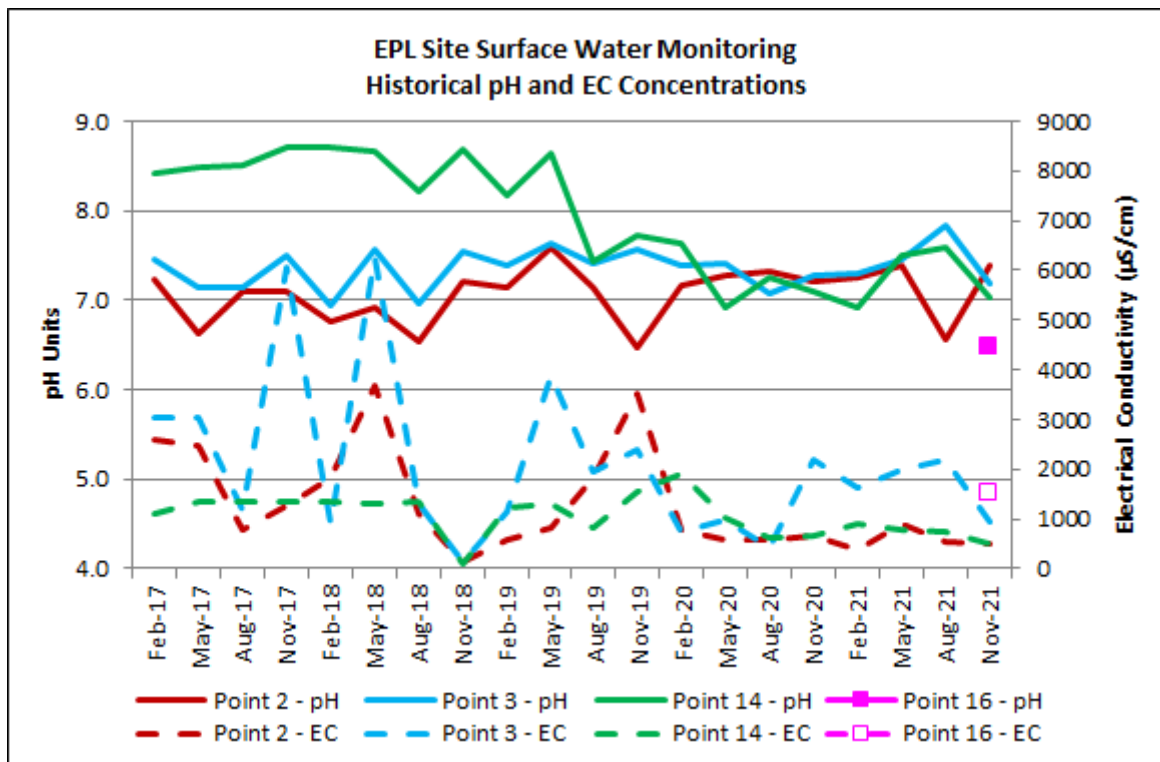
**Figure 6-1** Surface water at EPL monitoring points: pH and Electrical Conductivity

During the 2017 – 2021 monitoring period, pH has remained generally stable with a decreasing trend observable at EPL Point 14 during the period August 2019 – November 2020 which fluctuated upwards in May and August 2021 however had stabilised in November 2021.

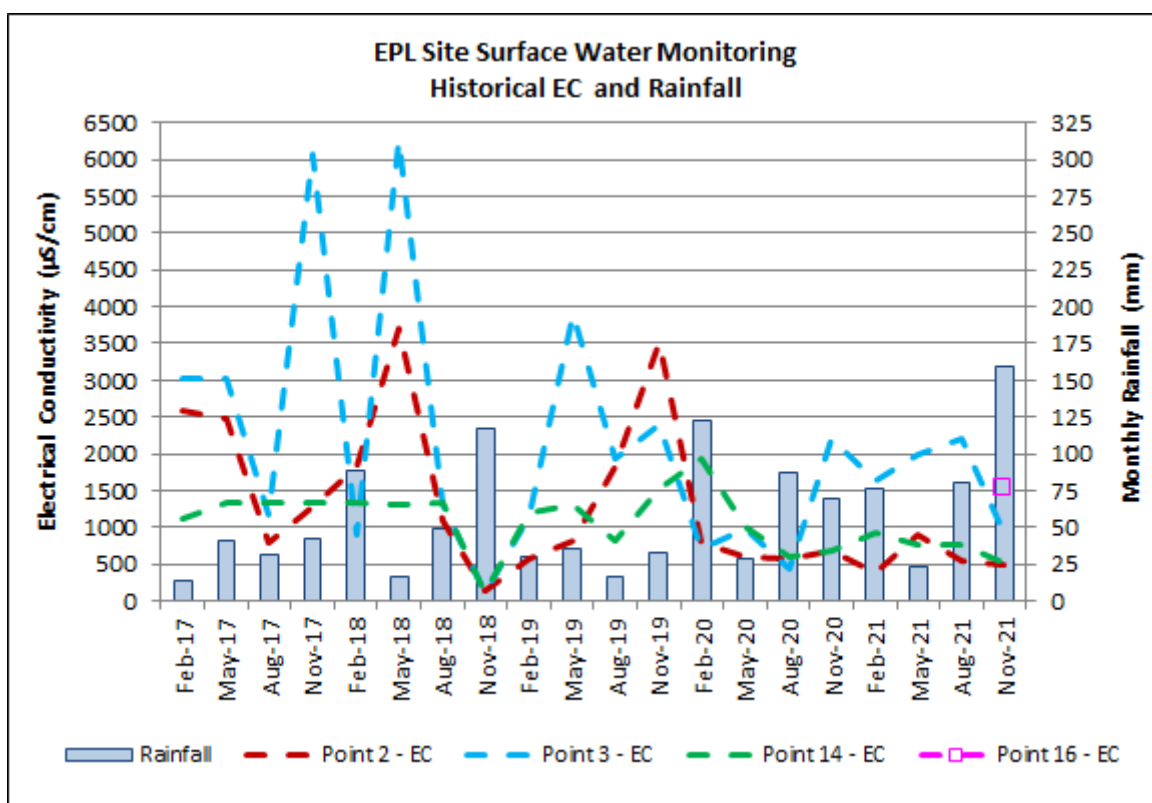
**Figure 6-3** Surface water at EPL monitoring points: Rainfall and Electrical Conductivity

Monthly rainfall totals greater than 50mm appear to influence lower electrical conductivity results at EPL Points 2 and 3 presumably through dilution from runoff. (refer **Figure 6-3**). The association between electrical conductivity and rainfall is not as apparent for EPL Point 14; the results decrease with some high rainfall quantities however also increase or are unchanged such that there is considered to be some other factor which influences the changes in electrical conductivity. There is insufficient data to comment on trends for EPL Point 16 with relation to rainfall.

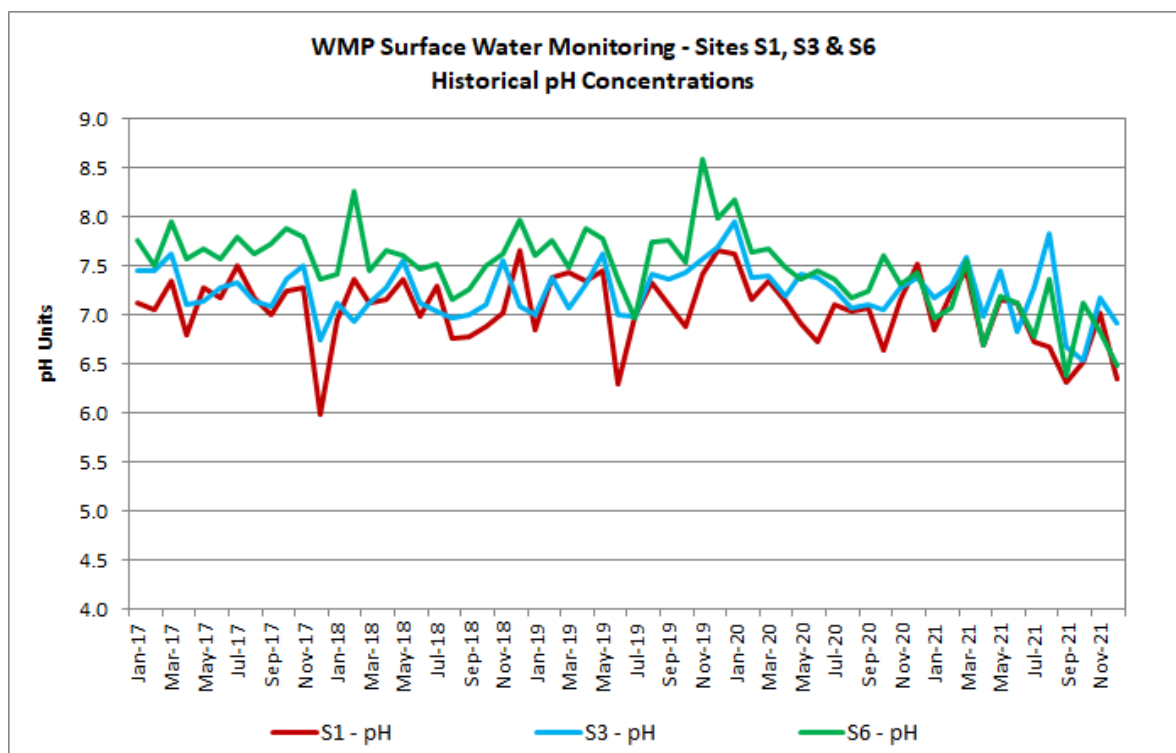
**Figure 6-4** S1, S3 and S6 Historical pH results

Generally, over the last five (5) years (refer to **Figure 6-4**) pH in Wangcol Creek is consistent between the upstream (S1) location and the downstream locations (S3 and S6). S1 is generally slightly more acidic in historical monitoring from 2017 -2021 and was similarly observed in January 2021 and July to October 2021. The pH of S1 and S6 were near identical between March to June 2021. Overall, the pH trend is stable (noting some large fluctuations) for S1 and a slight decrease for S3 and S6.

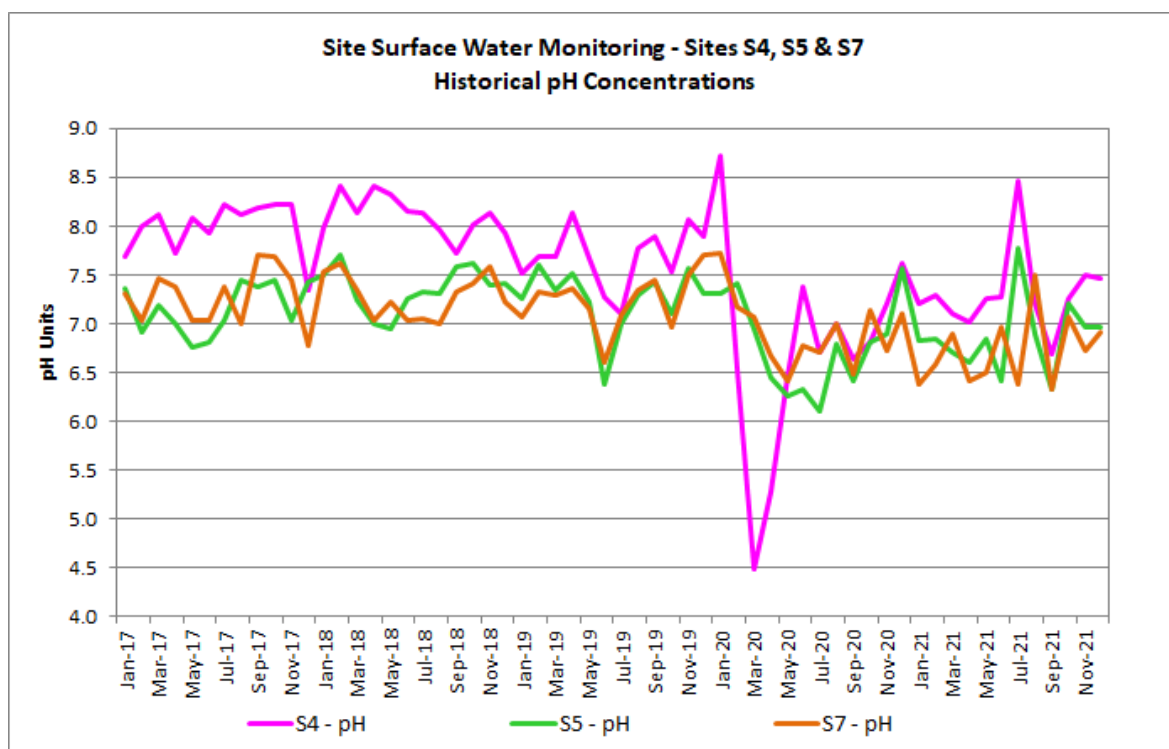
**Figure 6-5** S4, S5 & S6 Historical pH Results

Generally, over the last five (5) years (refer **Figure 6-5**) pH in Coxs River is higher (more alkaline) upstream of Blue Lake (and the confluence with Wangcol Creek) however the changes in pH indicate good correlation between the three (3) sampling locations along the River. Overall, the pH trend is a slight decrease for all locations.

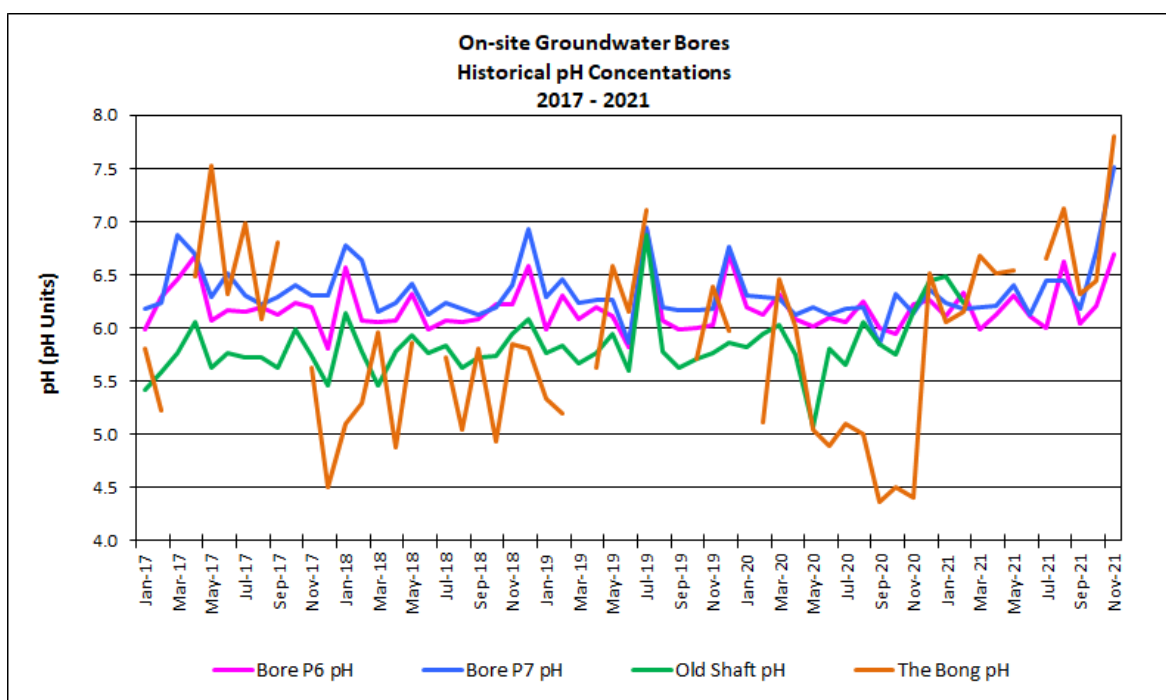
**Figure 6-11** Onsite Groundwater Bores pH: 2017 – 2021

The pH of the onsite groundwater monitoring bores for the period 2017 – 2021 is shown in **Figure 6-11**. Periods of no data (gaps in **Figure 6-11**) are due to The Bong (Water Cart Dam) being dry and therefore no sample being collected.

During the period 2017 – 2021 (refer **Figure 6-11**), fluctuations in pH are observable across all three (3) onsite groundwater sampling locations as well as The Bong. The pH at bores P6 and P7 are generally stable with fluctuations between 6 and 7 pH units until the November 2021 round during which the pH of P7 has increased to above 7pH units. The pH at Old Shaft was generally stable, with a spike in July 2019 which stabilised in August 2019, until a marked decrease during May 2020 at which time the pH increased to the completion of monitoring. The pH within The Bong, noting that it is considered to be representative of rainfall runoff for the period presented within **Figure 6-11**, indicated significant variations however overall does not indicate an increasing or decreasing trend.

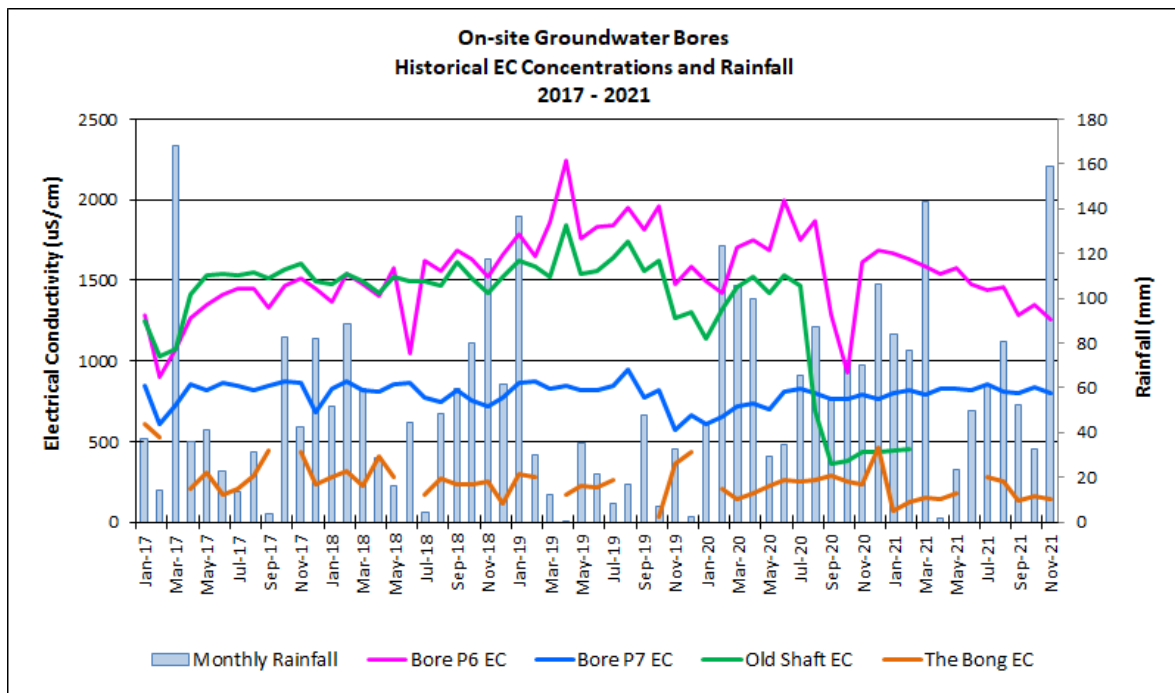
**Figure 6-12** Onsite Groundwater Bores Electrical Conductivity: 2017 – 2021

The electrical conductivity of the onsite groundwater monitoring bores for the period 2017 – 2021 is shown in **Figure 6-12**. Periods of no data (gaps in **Figure 6-12**) are due to The Bong being dry and therefore no sample being collected.

During the 2017 – 2021 period (refer **Figure 6-12**) the electrical conductivity within Bore P6 and Old Shaft follow a similar trend: increasing (with some fluctuations) during the period January 2016 – December 2019 and then decreasing through to November 2021 with a period between February / March 2020 – July / August 2020 in which concentration increased. The increases in electrical conductivity within bore P6 and Old Shaft generally correspond to periods of decreased rainfall, while the decreases correspond to increased rainfall up until January 2021; from that period the decrease in P6 does not appear to be affected by rainfall. There were no activities undertaken at PDM which extracted or discharged water into the Old Wallerawang underground workings, as such, the factors causing the increase or decrease of the electrical conductivity are considered outside the control of PDM.

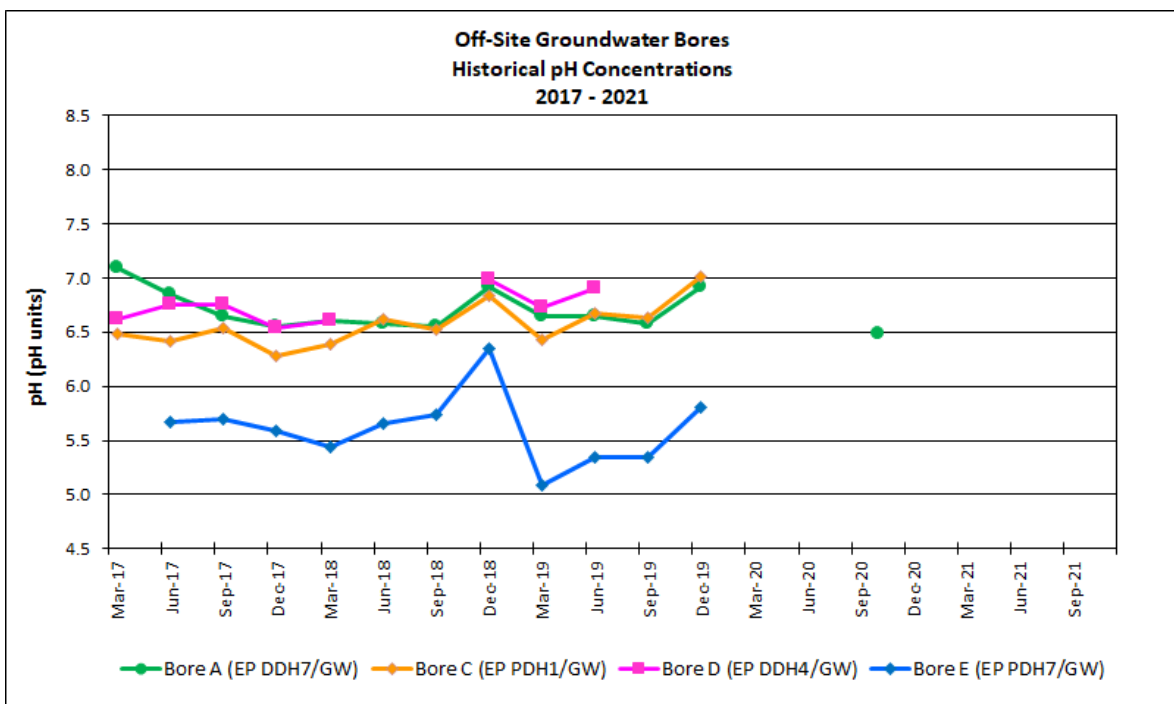
**Figure 6-14** Yarraboldy Groundwater Bores pH: 2017 – 2021

During the 2017 – 2021 monitoring period, the pH indicates a slight increasing trend in all bores except Bore E which overall is stable however with significant variation. It is noted that concentrations of sulphate and iron are generally low within Bores A, C and D and as such it is considered unlikely that pyrite oxidation and acid mine drainage are influencing pH, noting that an increasing pH would not be considered representative of the effect of acid mine drainage. There are some elevated levels of iron and low pH values within bore E during the 2019 monitoring period; however, this is unaccompanied by sulphate concentrations. As such, it remains unclear if the impacts of acid mine drainage from the Wallerawang underground workings are impacting the results from Bore E (Middle River seam).

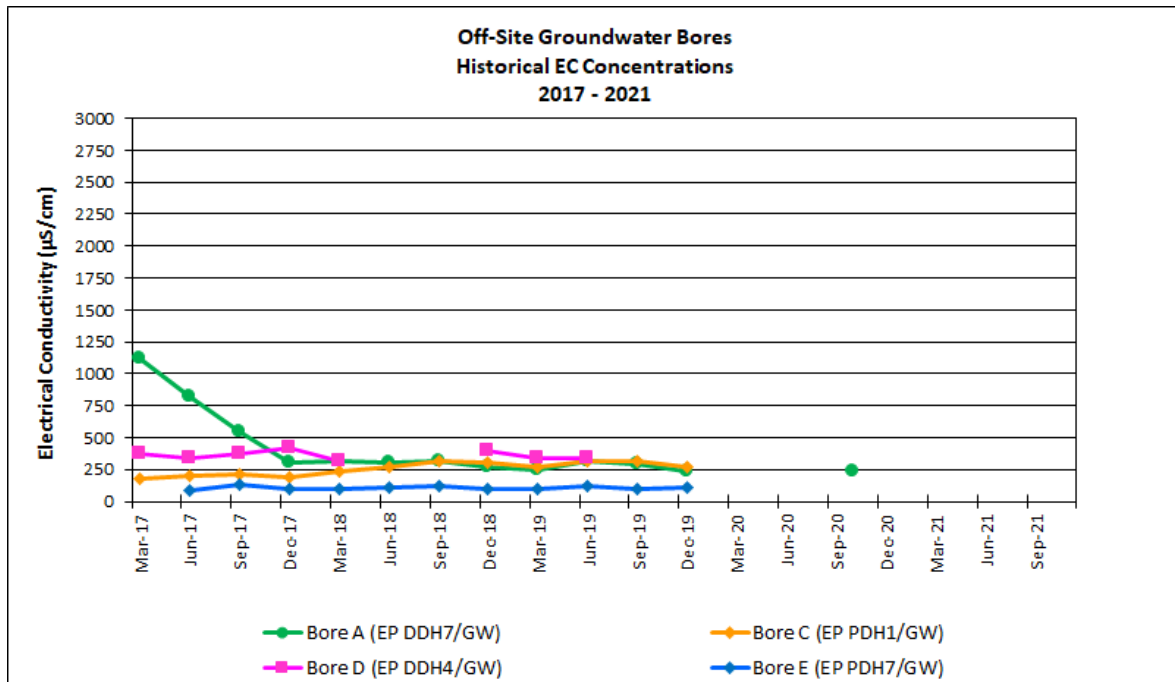
**Figure 6-15** Yarraboldy Groundwater Bores Electrical Conductivity: 2017 – 2021

During the 2017 – 2021 monitoring period, electrical conductivity is generally shown to be stable within bores A, C, D and E.

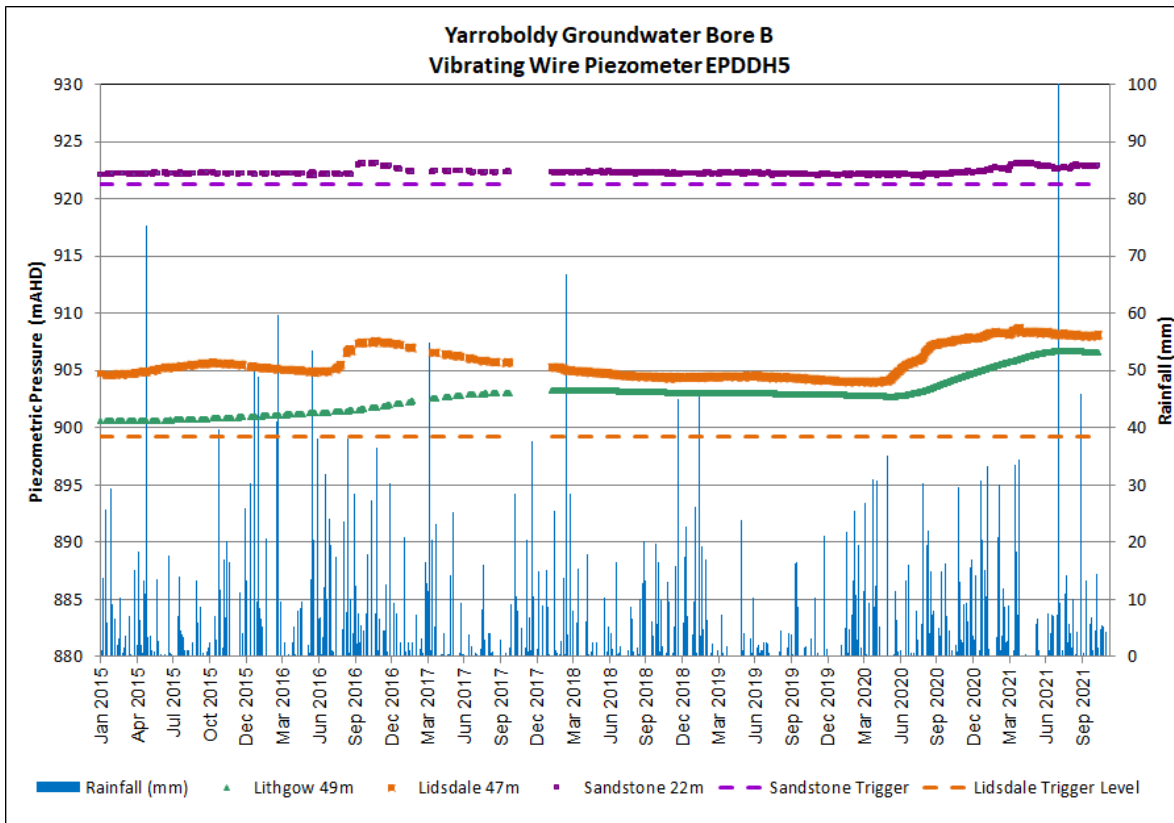
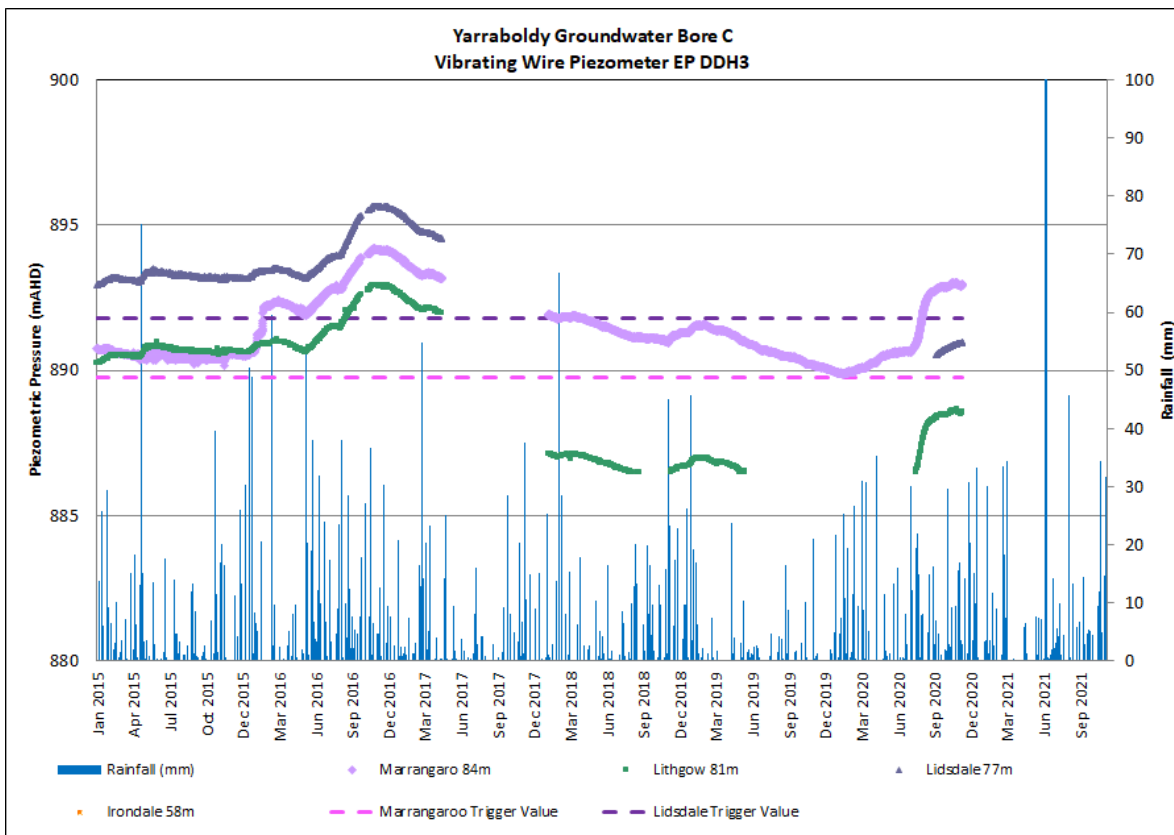
Groundwater level hydrographs for Bore B, Bore C and Bore E along with rainfall from 2015 are shown in **Figure 6-16** to **Figure 6-18**. There was no data available at Bore B for the period 19/10/2017 – 1/2/2018 and Bore C for the period 11/5/2017 – 1/2/2018 due to connectivity issues with the vibrating wire piezometer loggers. The loggers were removed from site and new loggers installed on 2/2/2018.

The groundwater levels at Bore B at the various aquifers have shown some variation in response to rainfall trends, however the response is generally minimal during the period January 2015 – March 2020. Following increased rainfall during the 2020 reporting period, the Lidsdale and Lithgow seam show an increase in water level and have stabilised in 2021. The water levels have not fallen below the groundwater trigger levels (refer **Figure 6-16**). There is no data available for the Irondale seam as the water level has fallen below the sensor height.

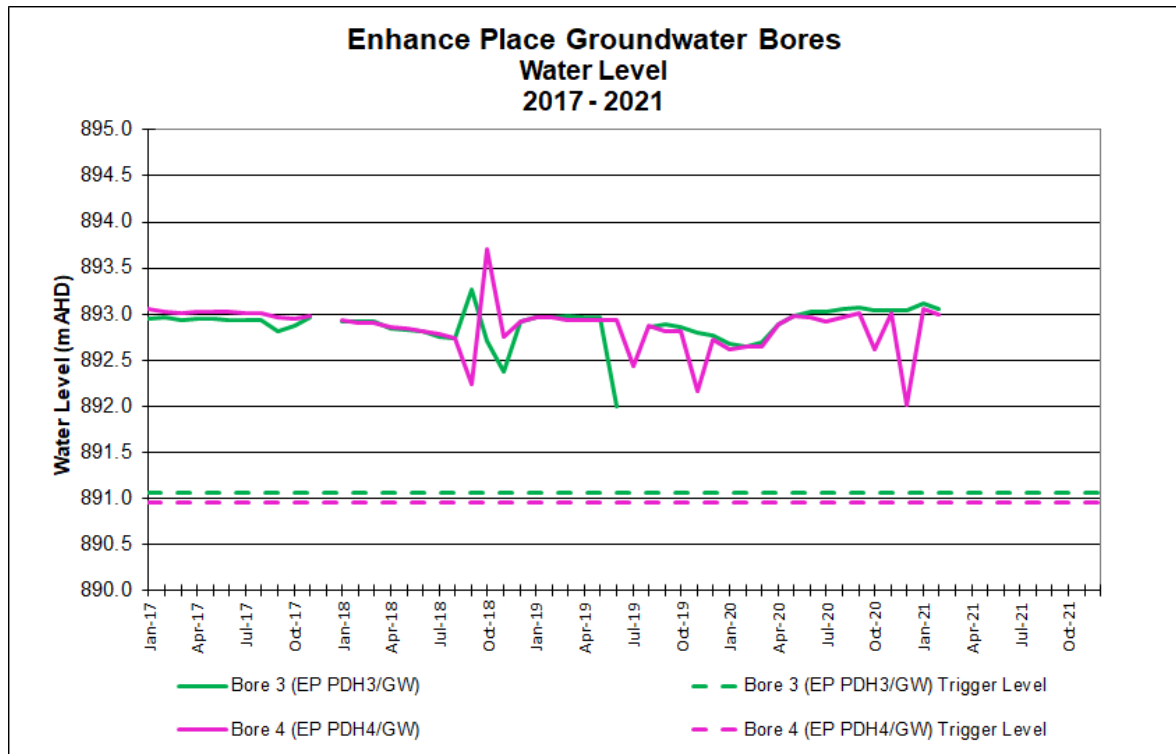
**Figure 6-19** Enhance Place Standing water levels 2017 – 2021

The standing water level for the period 2017 – 2021 is shown in **Figure 6-19**.

There are some fluctuations in water level observed at the Enhance Place bores during 2018, late 2019 and late 2020. Otherwise, water levels are generally consistent within only a slight decreasing trend until March 2020 upon which the water levels increase, with fluctuations, to the last monitoring undertaken in February 2021. The overall trends are considered to be associated with rainfall. The groundwater level at both bores has remained above the water level trigger values during the 2017 – 2021 monitoring periods.

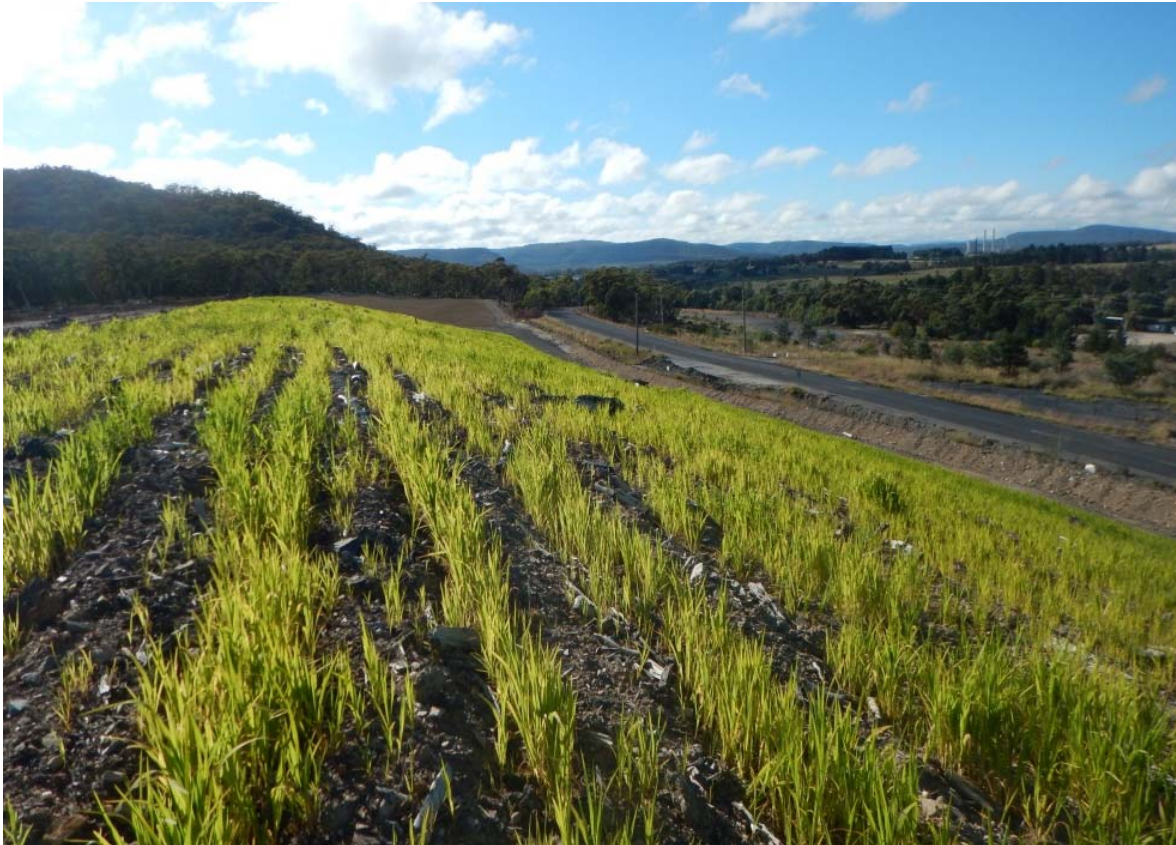
The amenity bund located along the southern boundary of the Yarraboldy Extension was re-profiled in 2014, with the southern batter having a gradient of 18° to minimise erosion and enhance establishment of seedlings. Following the application and tilling of topsoil, a native species grass and tree species seed mix was applied followed by mulch (refer **Photograph 7-1**).

**Photograph 7-1**     *Amenity Bund looking east following application of mulch and native mix 2015*

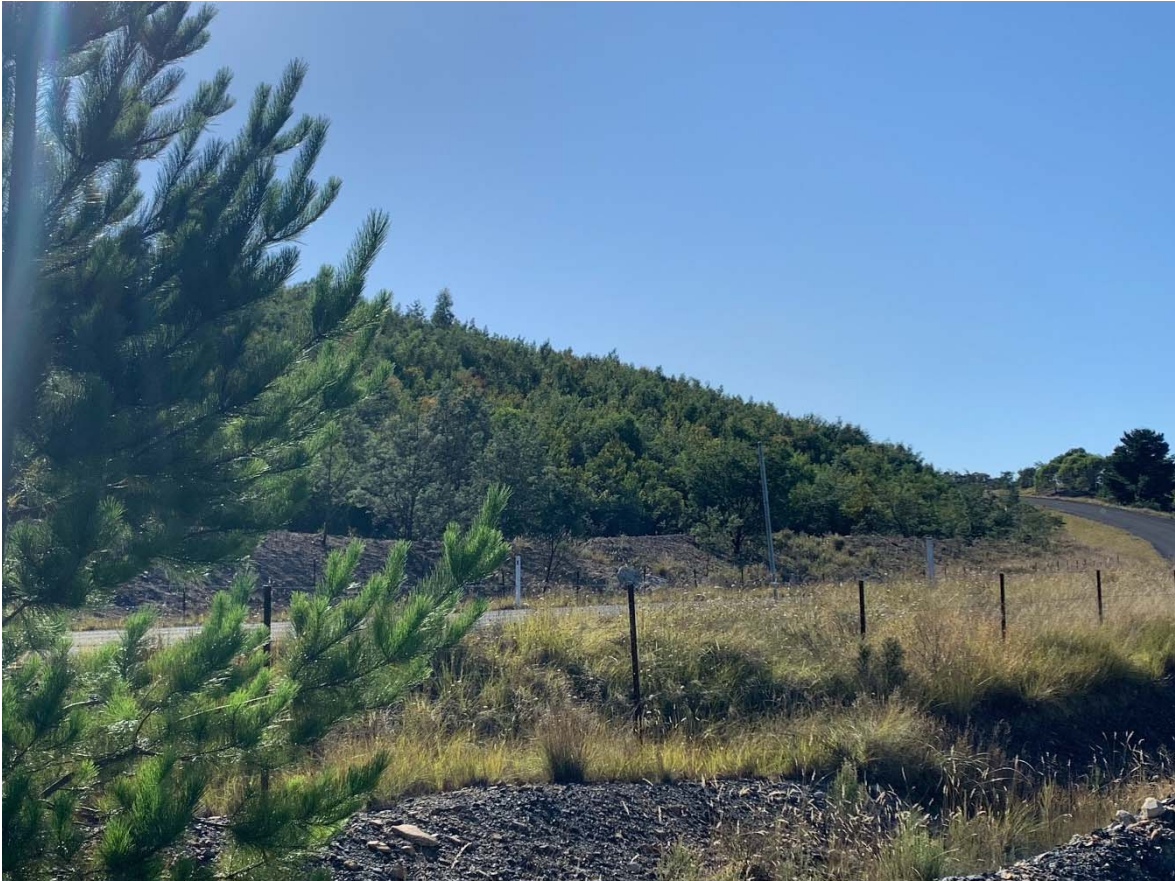
During the reporting period, maintenance works was not required to be undertaken in the Yarraboldy Extension. No rehabilitation maintenance activities were undertaken. Current vegetative cover on the bund (photo taken February 2022) is shown in **Photograph 7-2**.

**Photograph 7-2**      *Amenity Bund looking north east, February 2022*

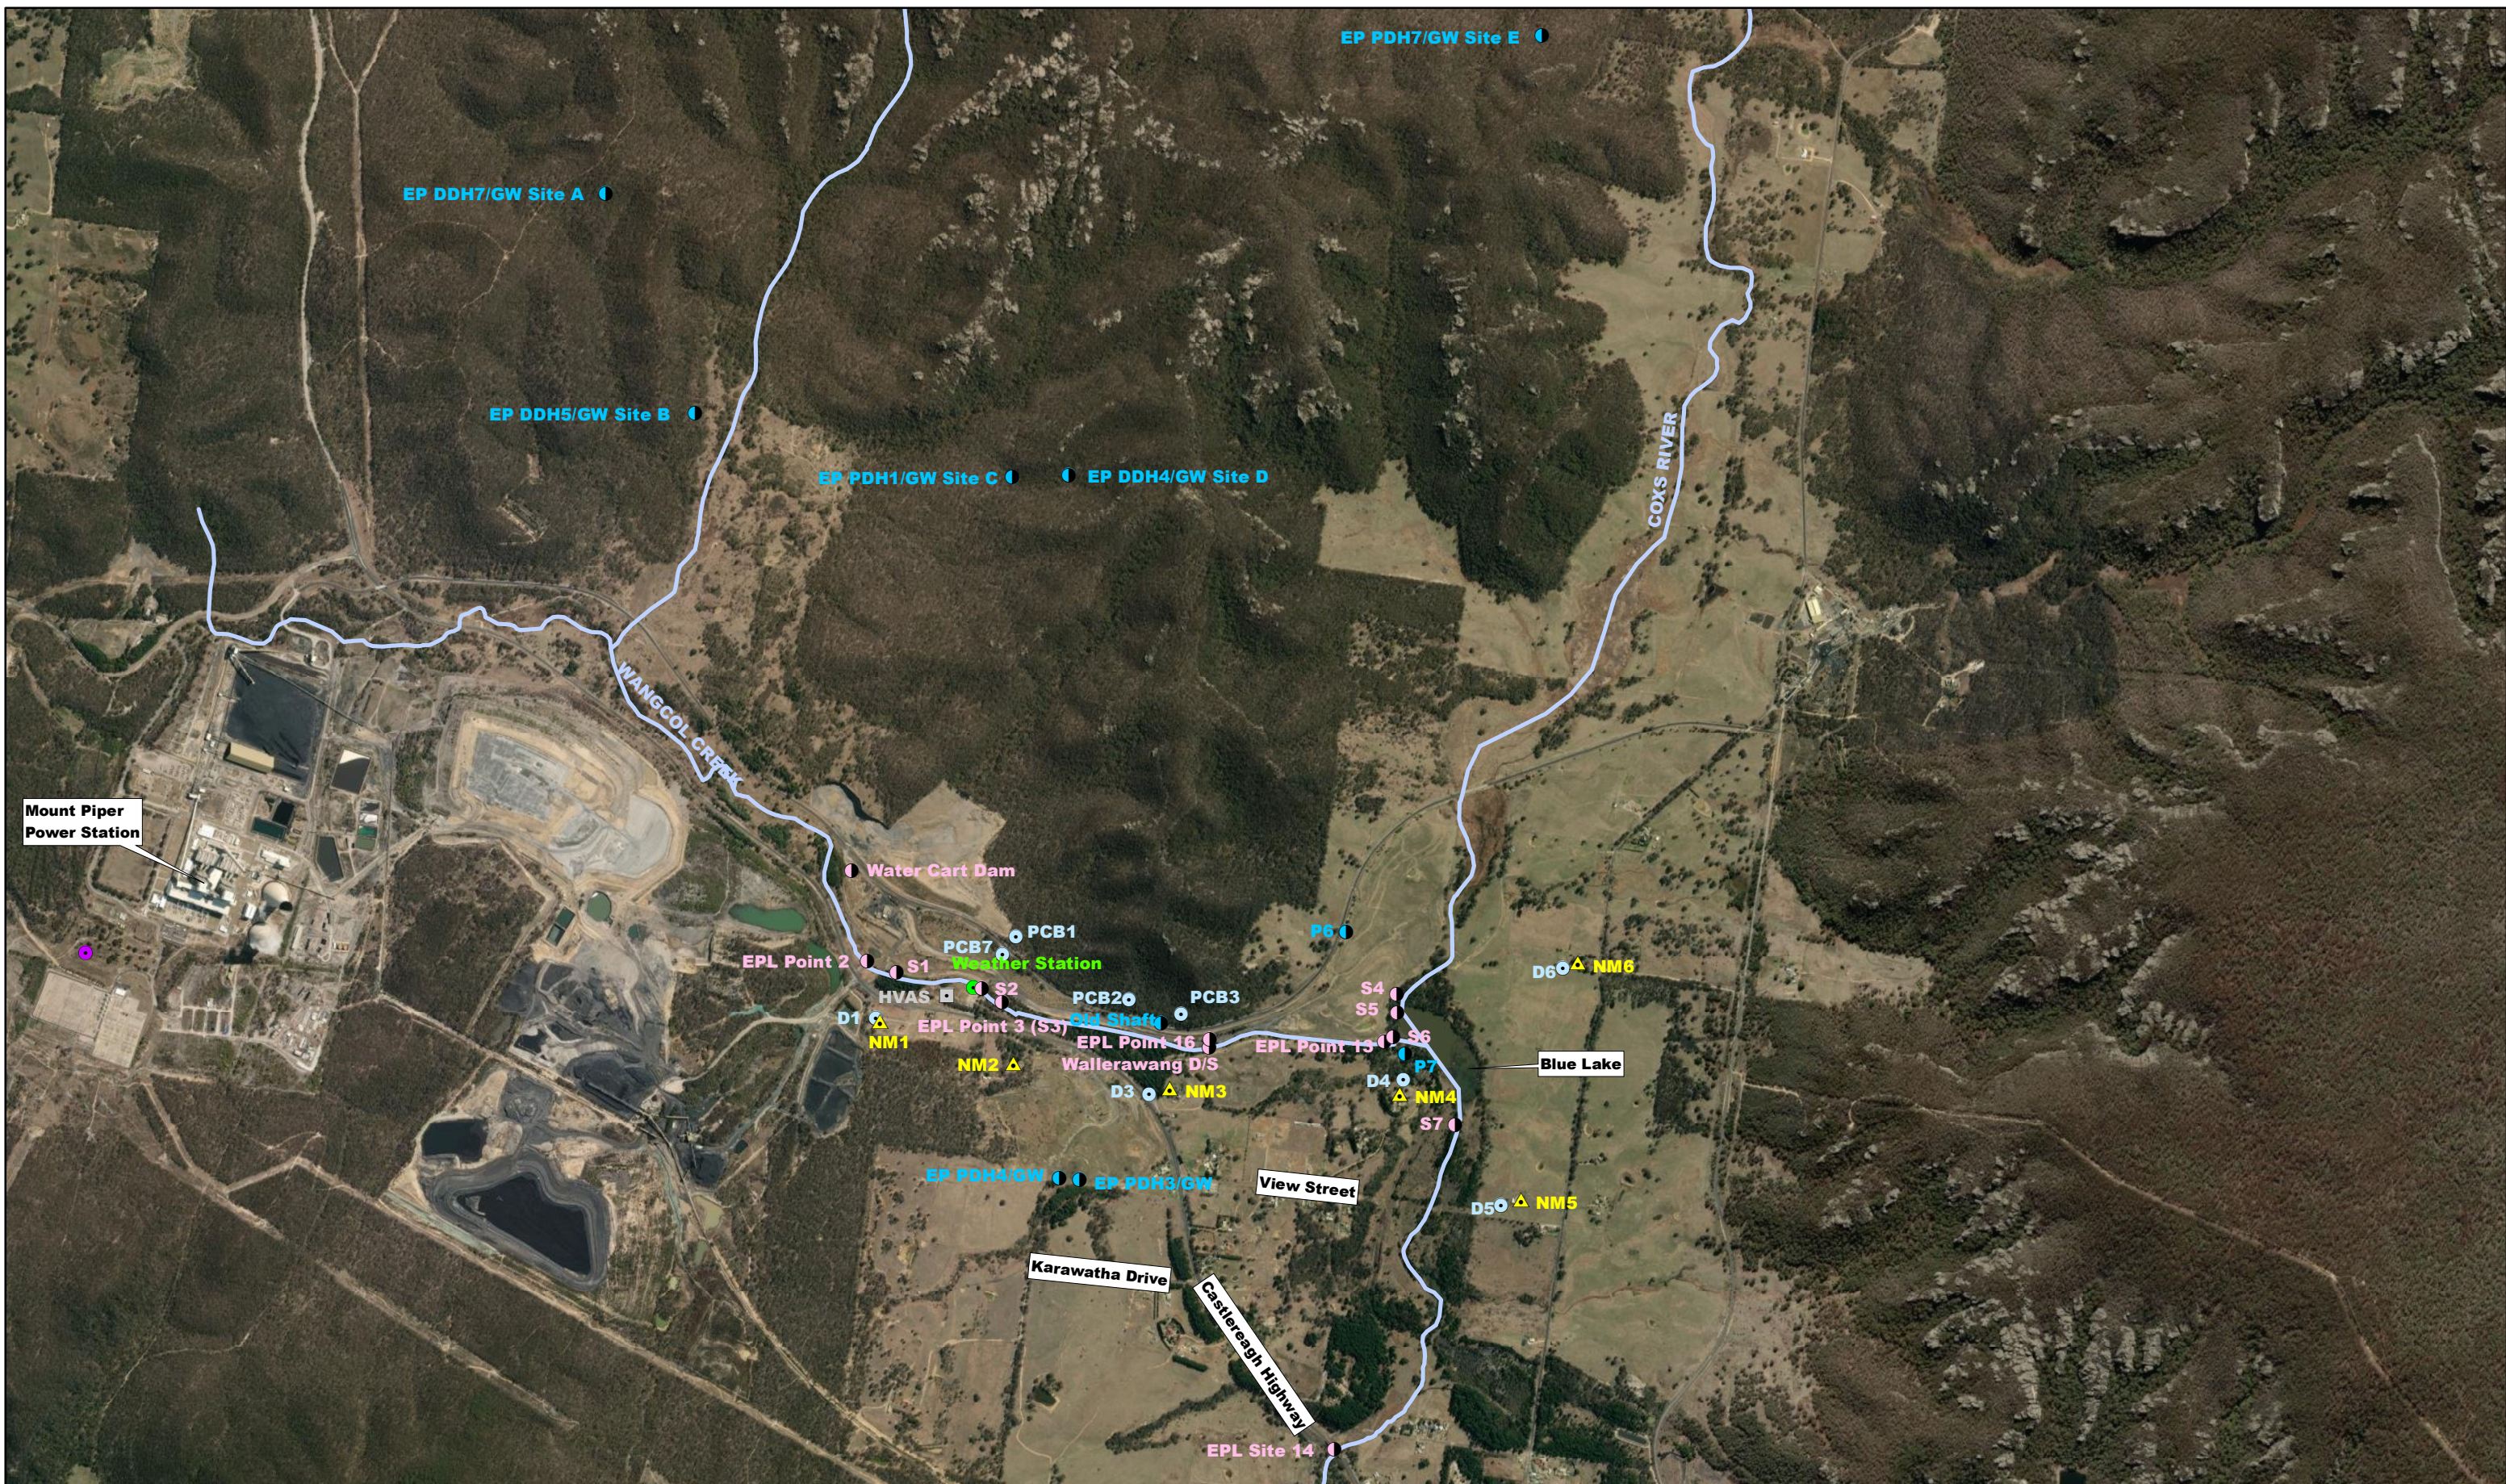
CDT-DWG-A3H-001/1

<b>LEGEND</b> Noise monitoring location Depositional dust monitoring location Groundwater monitoring location Surface water monitoring location Historic High Volume Air Sampling Location Meteorological monitoring location (up until 10 November 2021) Meteorological monitoring location (from 10 November 2021)		Note: Aerial taken from ArcGis Base Map, September 10 2018 Coordinate System MGA Zone 56		<b>PINE DALE MINE ENVIRONMENTAL MONITORING LOCATION PLAN</b>		PLAN: 3a
				DRAWN BY : F. Brooker	SCALE: 1:24,000 (A3)	DATE: 18/02/2022

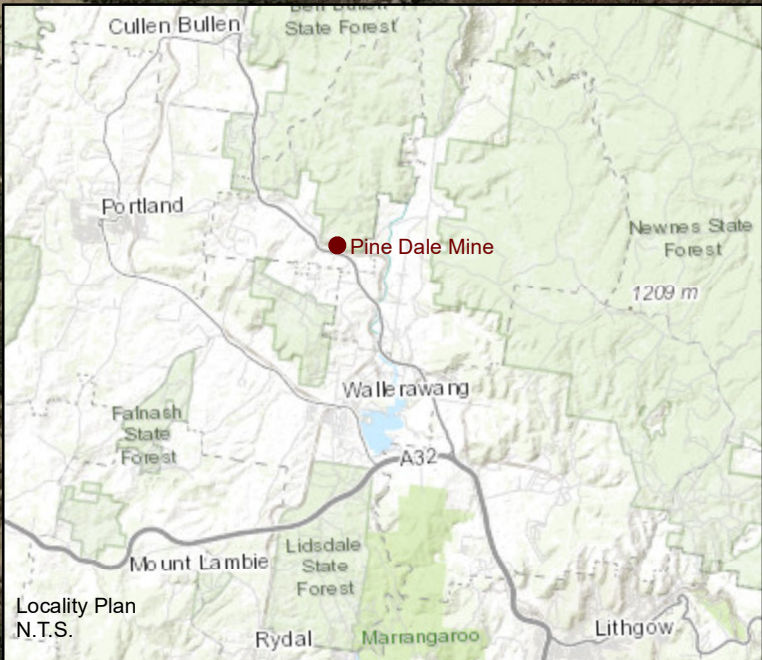
Drawing 1 - Environmental Monitoring Locations

- ▲ Noise monitoring location
- Depositional dust monitoring location
- Groundwater monitoring location
- Surface water monitoring location
- Historic High Volume Air Sampling Location
- Meteorological monitoring location (up until 10 November 2021)
- Meteorological monitoring location (from 10 November 2021)

**PINE DALE MINE ENVIRONMENTAL MONITORING LOCATION PLAN**

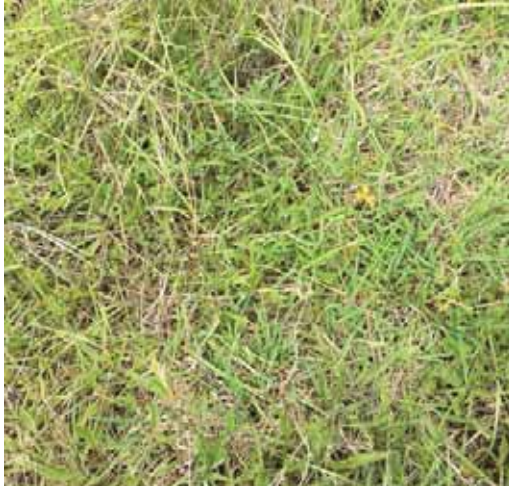
Figure 2 Pasture composition at the Pasture analogue site (2020)

**Species composition at pasture rehabilitation areas** – Pasture rehabilitation areas were established with a mix of ~70% perennial grasses and ~20% annual legumes consistent with species composition at the analogue pasture site. Examples of analogue pasture and Transect 2 pasture are shown in Figure 2 and Figure 3.

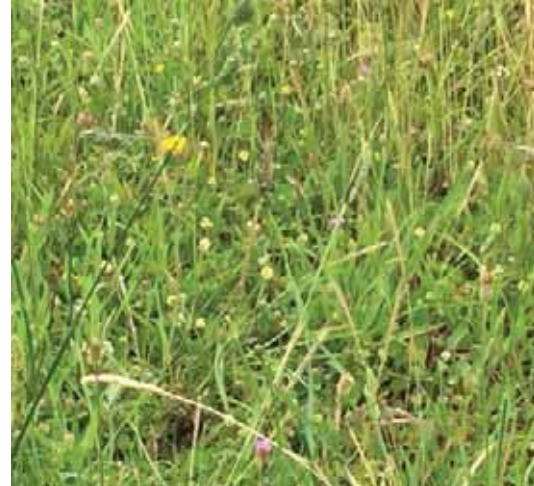
Figure 3 Typical pasture composition at Transect 2

**Groundcover at pasture rehabilitation areas** – Rehabilitated pasture surfaces in each of the transect areas support living groundcover of >90%.

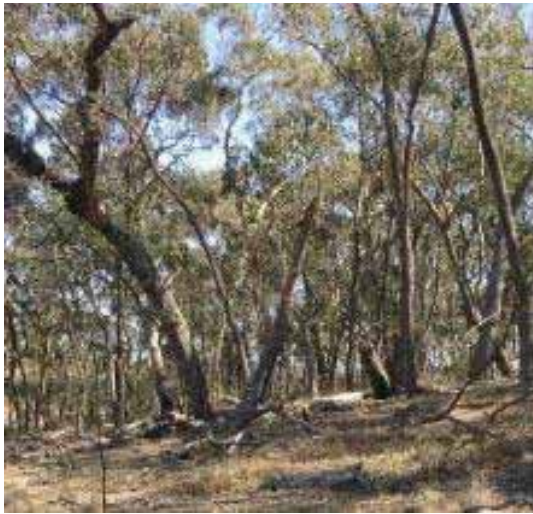
Figure 4 Vegetation structure of treed analogue site (Transect 7) in 2019

In 2019 the treed analogue site was characterised by a canopy to 14 m height with 20% canopy cover over a sparse shrubby mid-storey to 3 m height and isolated shrubs to 1.5 m height in the understorey. Groundcover consisted of grasses and herbs with a cover of >95% (Figure 4).

The treed analogue site was affected by fire in 2020 which resulted in the loss of groundcover, shrubby understorey and canopy.

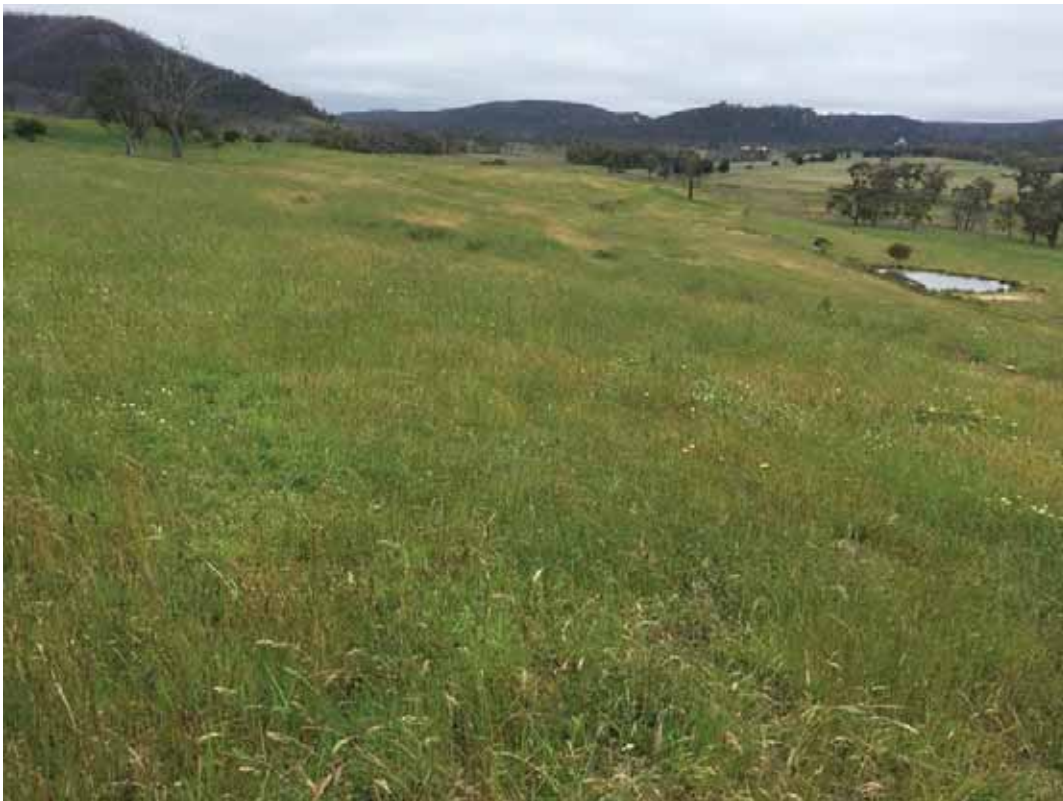
Transect 1 looking east 2021 note that the transect 1 photo-monitoring point was inaccessible to the presence of livestock
