PINE DALE MINE ANNUAL REVIEW 2022

Prepared by Enhance Place Pty Ltd

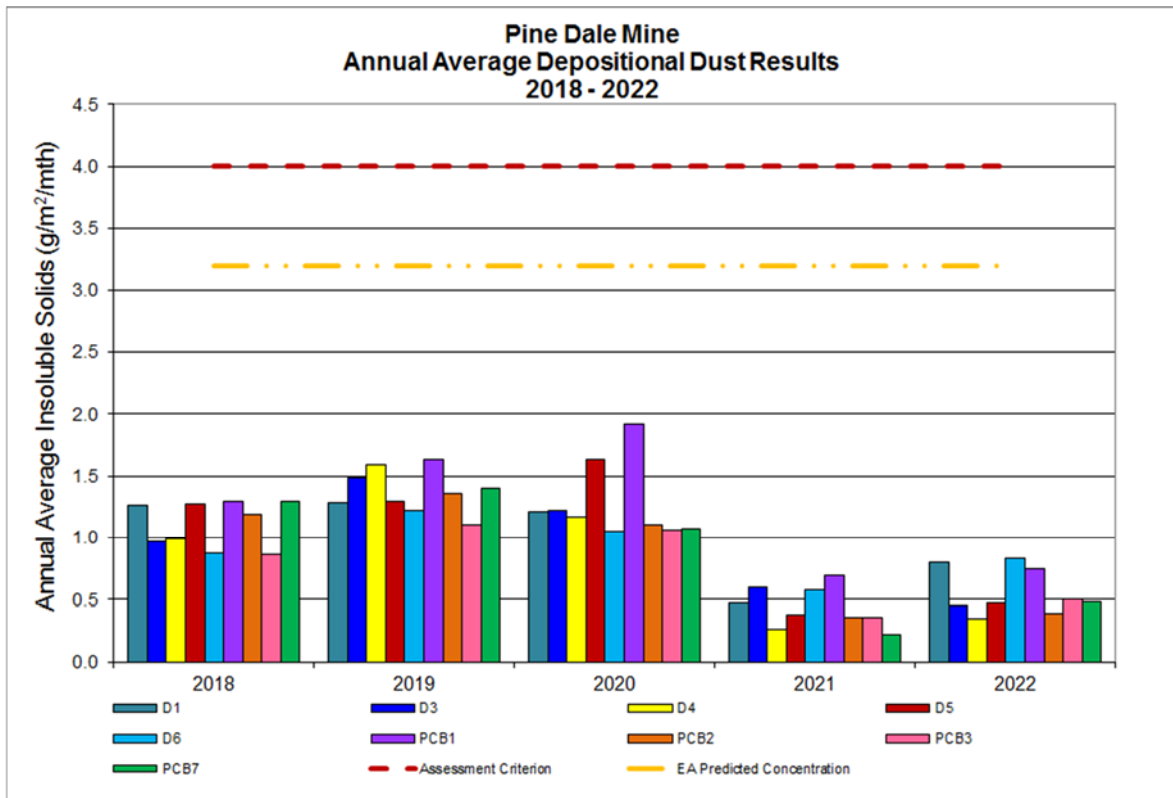
Figure 5-1 Depositional dust data: 2018 – 2022

An examination of the historical data (refer **Table 5-3**) indicates most dust monitoring locations show the 2022 annual averages broadly equivalent to those from 2021. The substantial decrease in the 2021 annual averages deposited dust concentrations when compared to the historical data is not considered to be due to a change in site activities at PDM as the mine has been in care and maintenance since 2014, rather it is considered to be influenced by the increased rainfall following prolonged dry conditions and associated correlation with dust storms (observed during 2018, 2019 and early 2020), and bushfires (observed during late 2019 and early 2020).

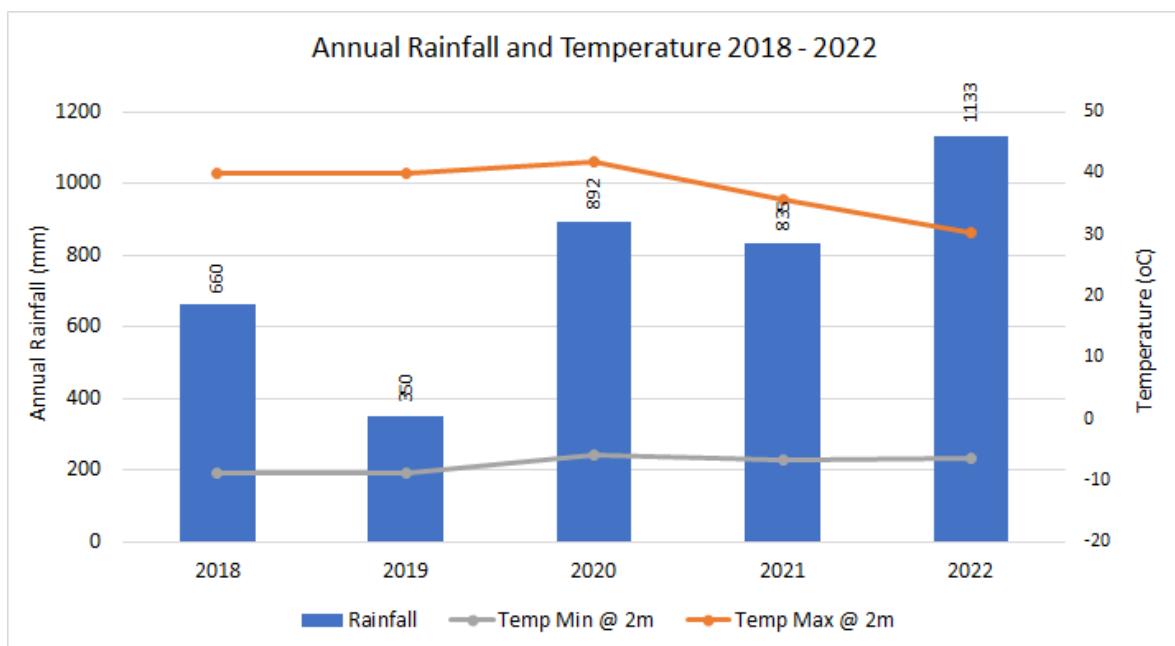
Figure 5-2 Annual Temperature and Rainfall Summary: 2018 – 2022

The total annual rainfall and the minimum and maximum temperature at 2m is shown graphically in **Figure 5-2**.

Rainfall during this reporting period was observed to be greater than the annual rainfall recorded during the previous four (4) years.

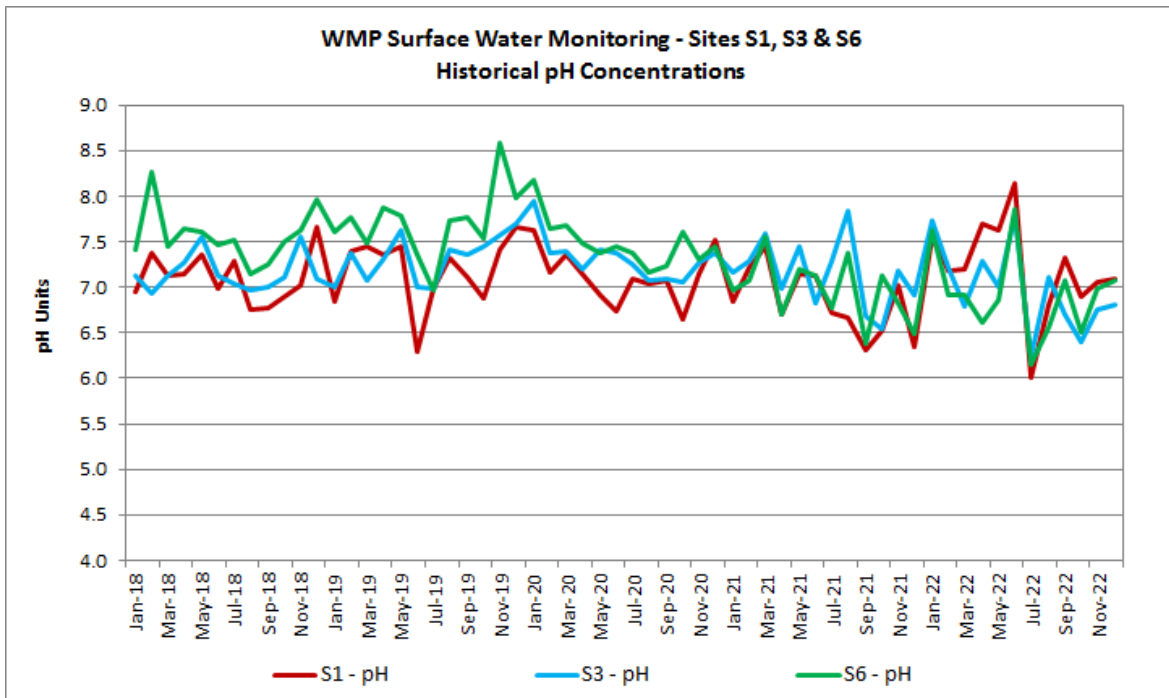
Figure 6-7 S1, S3 and S6 Historical pH results

Generally, over the last five (5) years (refer to **Figure 6-7**) pH in Wangcol Creek is consistent between the upstream (S1) location and the downstream locations (S3 and S6). S1 is generally slightly more acidic in historical monitoring however has been more alkaline throughout much of the 2022 monitoring period. Overall, the pH trend is stable (noting some large fluctuations).

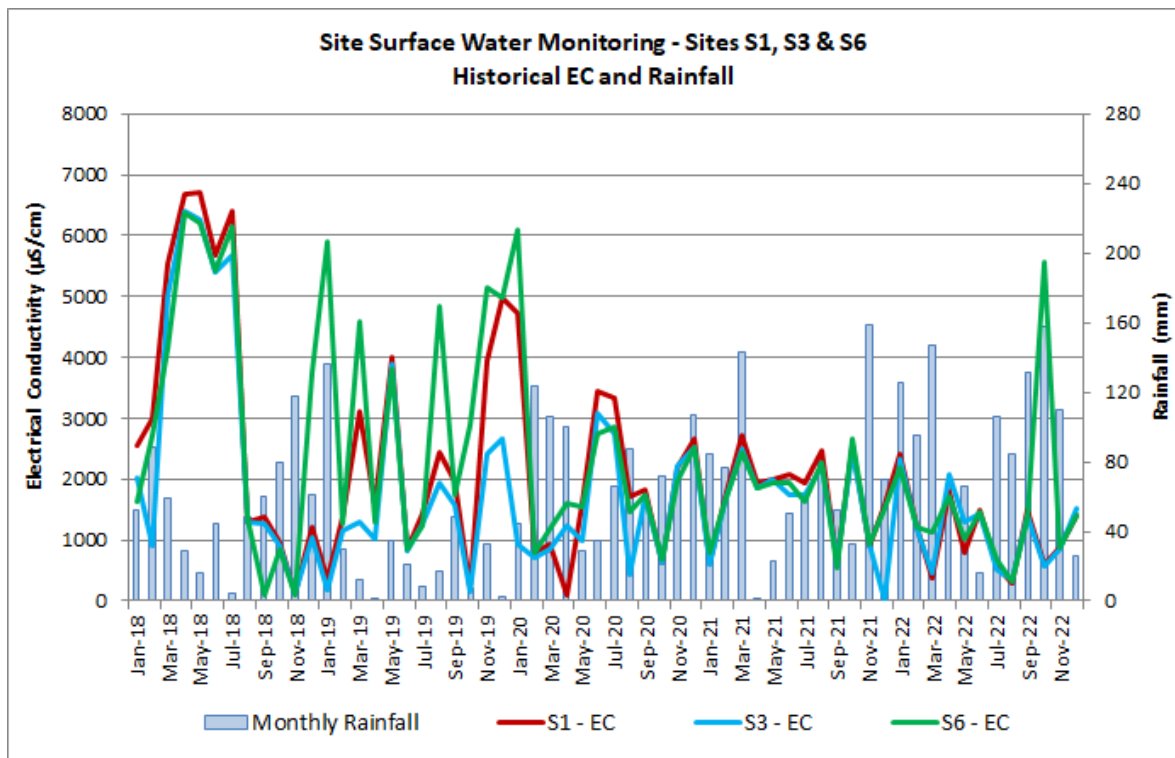
Figure 6-10 S1, S3 & S6 Historical EC Results & Rainfall

Generally, over the last five (5) years (refer to **Figure 6-10**) electrical conductivity in Wangcol Creek is consistent between the upstream (S1) location and the downstream locations (S3 and S6). Increases are generally observable during periods of low rainfall however, there are months of high rainfall in which electrical conductivity concentrations are also high, indicating that there are other contributions to the salinity of the water. Wangcol Creek (S1, S3 and S6) is considered to be impacted by saline discharges at a licence discharge point upstream of PDM. Another potential contributor to salinity during high rainfall months is sediment from the catchment.

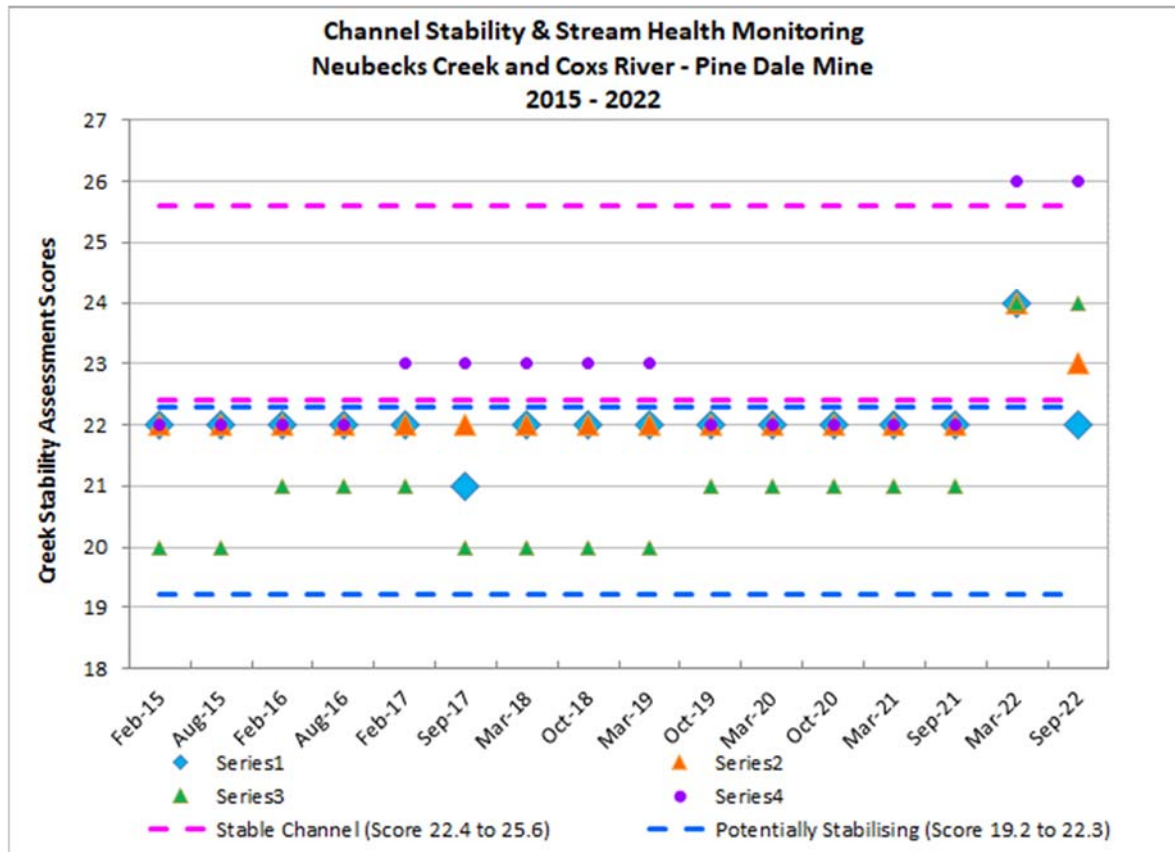
Figure 6-13 Channel Stability and Stream Health Scores

Follow-up (six-monthly) assessments have been conducted at the same monitoring locations; results are presented **Figure 6-13**. Generally, the stability of the locations have remained consistent or increased with the exception of decrease in classification based on a loss of vegetation in October 2019 presumed to be due to below average rainfall (drought conditions).

The March 2022 assessment could not be completed at SH1 and SH3 due to recent heavy rainfall making it unsafe to enter the waterway; these were undertaken in June 2022. The September 2022 assessments were undertaken in full. All locations were considered 'stable' or very stable, noting that the stability at SH3A is based on the presence of spray-concrete lining.

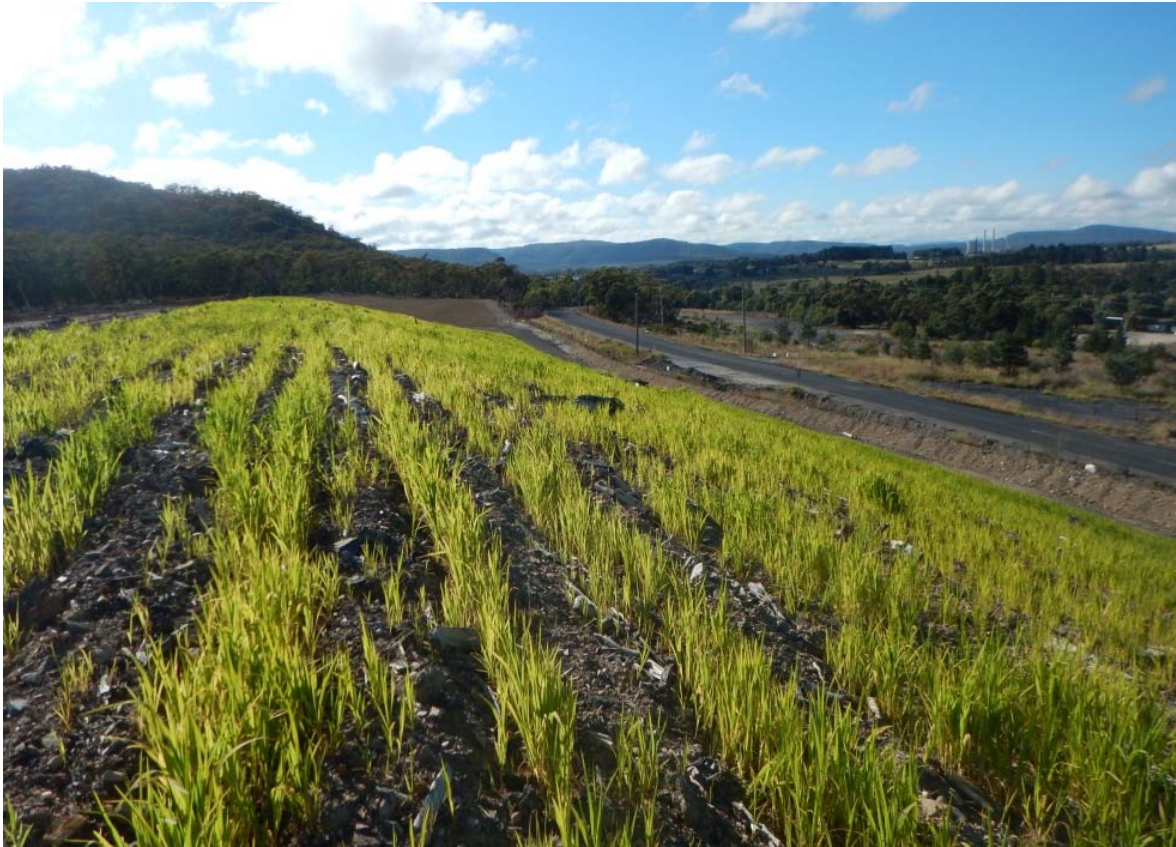
Photograph 7-1 *Amenity Bund looking east following application of mulch and native mix 2015.*

The amenity bund located along the southern boundary of the Yarraboldy Extension was re-profiled in 2014, with the southern batter having a gradient of 18° to minimise erosion and enhance establishment of seedlings. Following the application and tilling of topsoil, a native species grass and tree species seed mix was applied followed by mulch (refer **Photograph 7-1**).

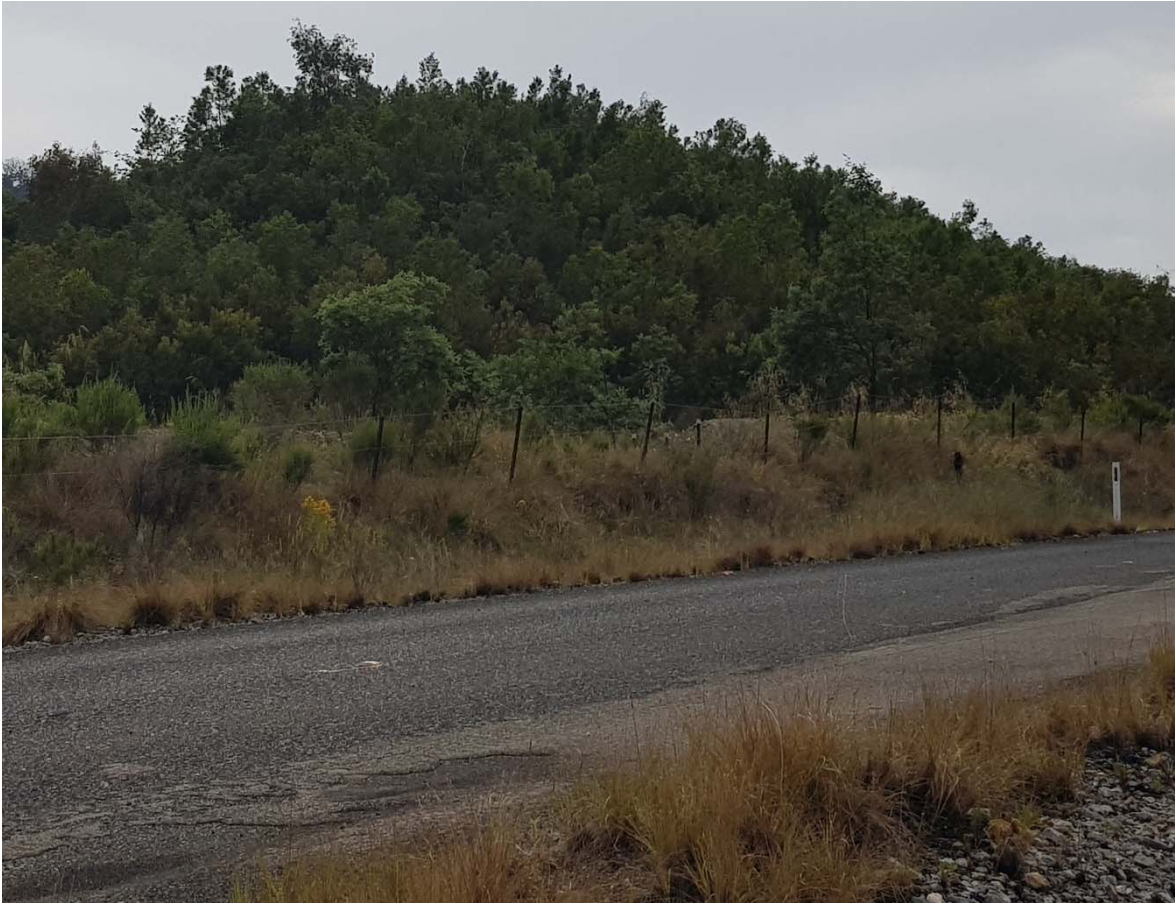
Photograph 7-2 *Amenity Bund looking northeast, December 2022*

During the reporting period, maintenance works was not required to be undertaken in the Yarraboldy Extension. No rehabilitation maintenance activities were undertaken. Current vegetative cover on the bund (photo taken December 2022) is shown in **Photograph 7-2**.

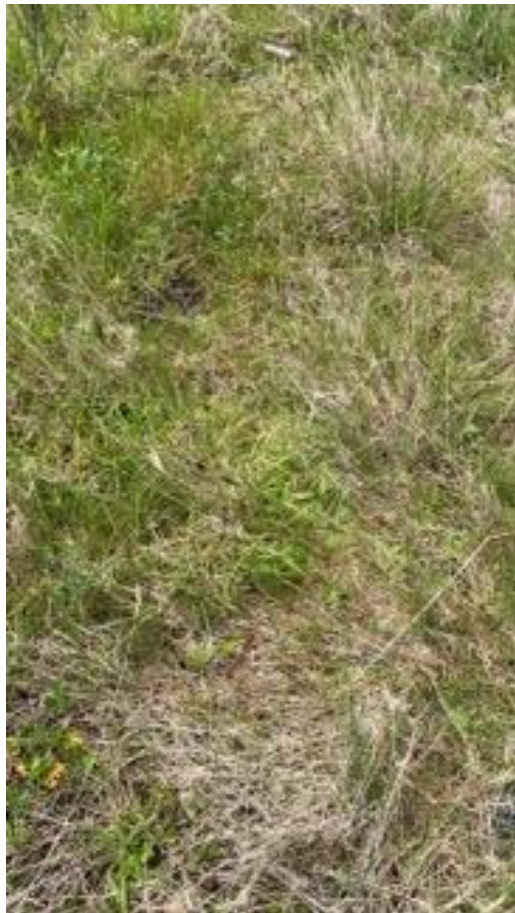
Figure 2 Pasture composition at the Pasture analogue site

Species composition at pasture rehabilitation areas – Pasture rehabilitation areas were established with a mix of ~70% perennial grasses and ~20% annual legumes consistent with species composition at the analogue pasture site. Examples of analogue pasture and rehabilitated pasture at Area C are shown in Figure 2 and Figure 3.

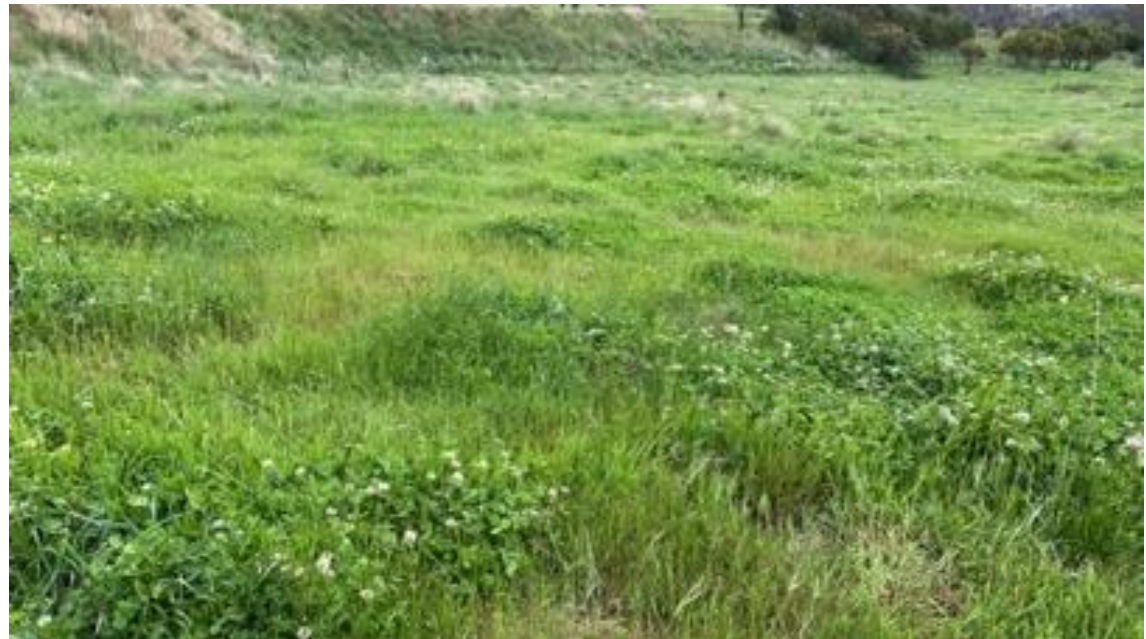
Figure 3 Typical pasture composition at Area C

Groundcover at pasture rehabilitation areas – Rehabilitated pasture surfaces in each of the transect areas support living groundcover of >90%.

Areas currently exist within each pasture rehabilitation area where groundcover is sparse or absent. It is estimated that these areas account for less than 10% of each pasture area.

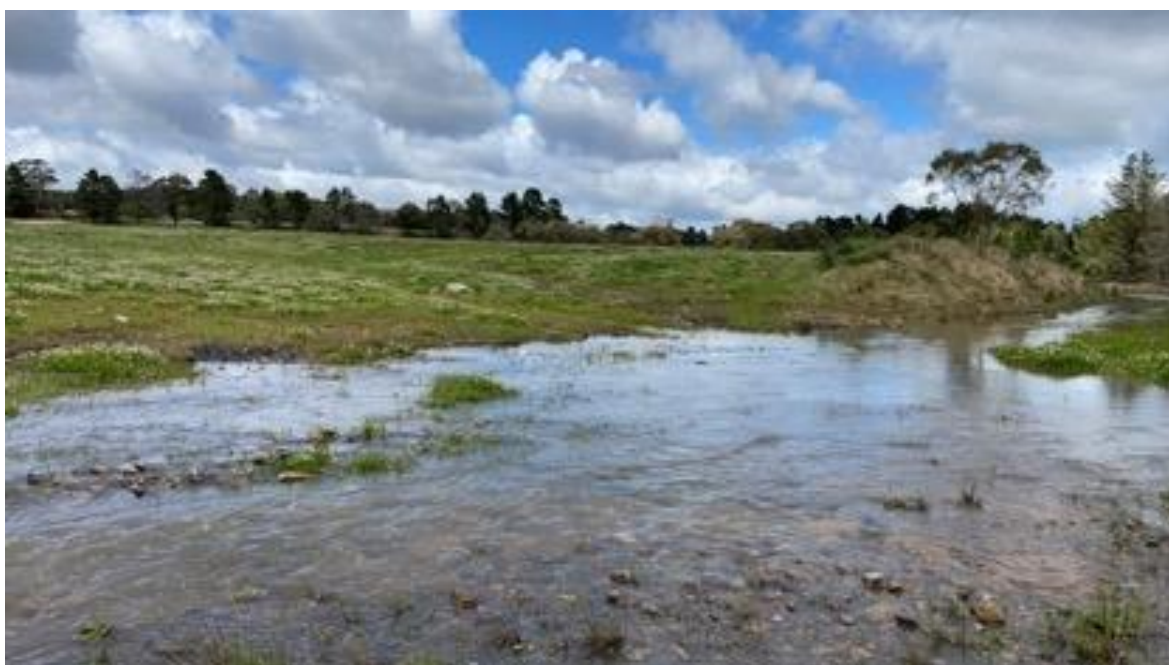
Figure 4 Localised flooding adjacent to Transect 4

Transect 4 was not surveyed in 2022 due to localised flooding (Figure 4).

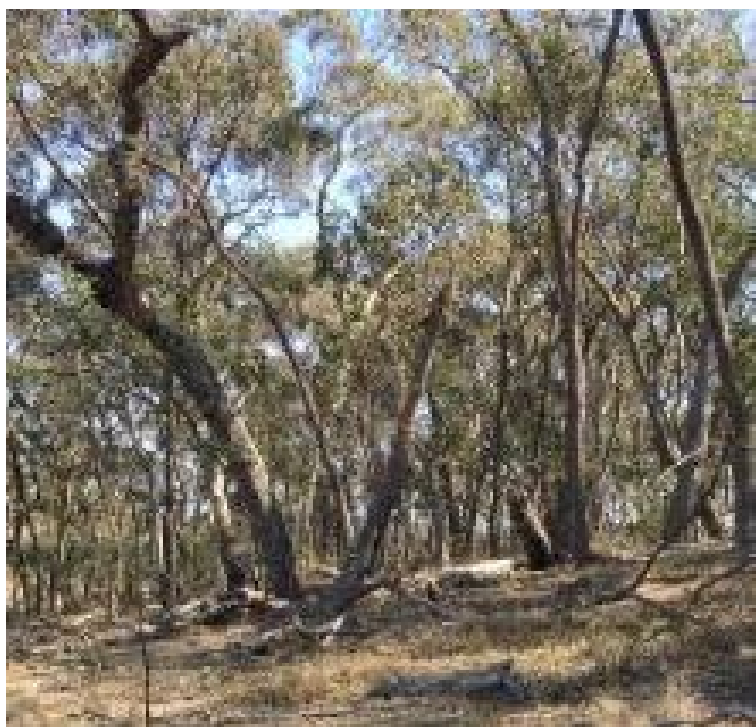
Figure 5 Vegetation structure of treed analogue site (Transect 7) in 2019

In 2019 the treed analogue site was characterised by a canopy to 14 m height with 20% canopy cover over a sparse shrubby mid-storey to 3 m height and isolated shrubs to 1.5 m height in the understorey. Groundcover consisted of grasses and herbs with a cover of >95% (Figure 5).

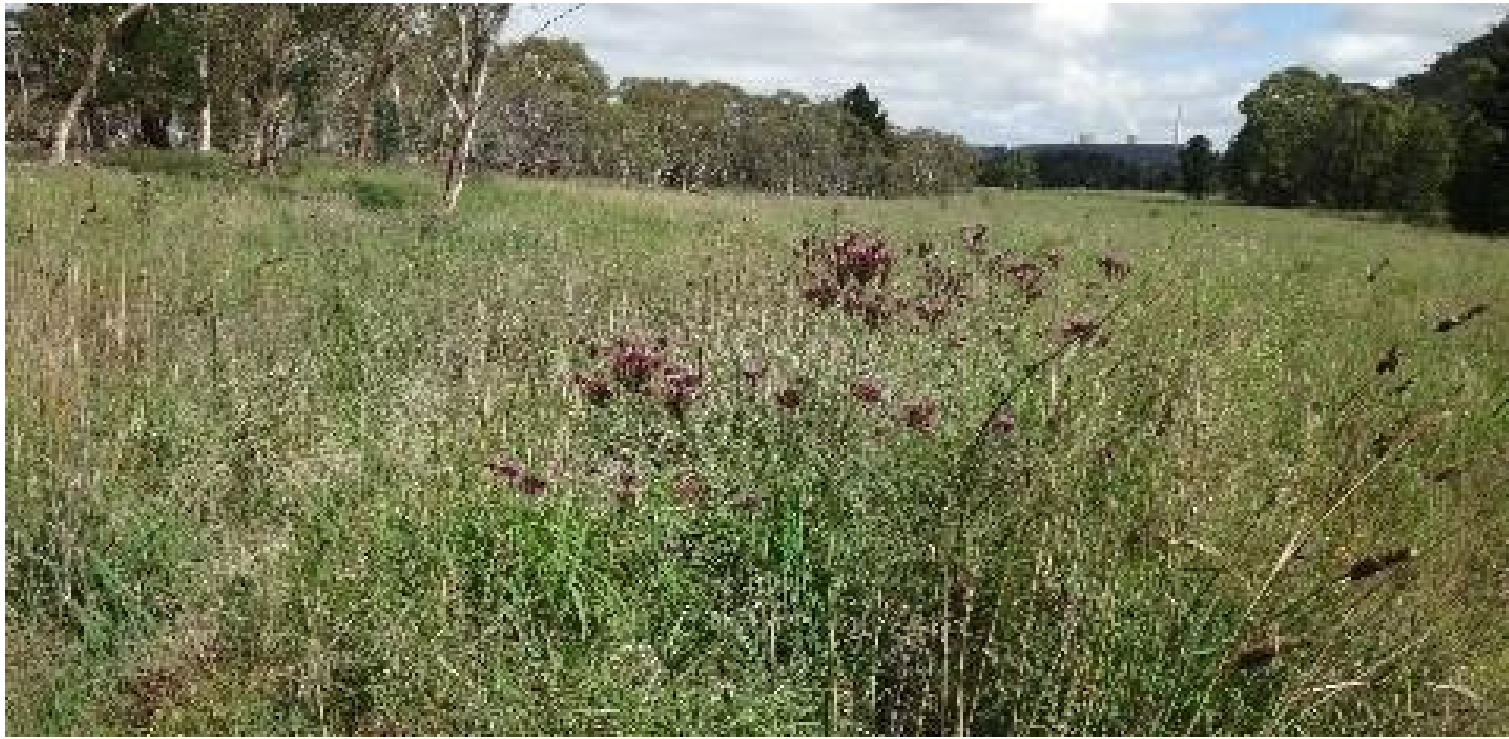
Transect 3 looking south 2022

Transect 3 Pasture rehabilitation area 2022									
Easting			Northing						
228267			6304532						
228306			6304560						
Landform and soils									
Slope		Transect located along a contour. 10 - <20% slope declining to the northwest.							
Erosion		Minor wind erosion observed on exposed soils.							
Cracking soils		Not observed.							
Surface drainage impediments		No significant drainage impediments.							
Vegetation									
Vegetation structure		Groundcover of mixed native and exotic grasses and broadleaf herbs.							
Species richness		>45 herbs and grasses recorded, dominated by exotic species.							
Cover classification		% cover at each observation							
		September 2015	September 2016	September 2017	September 2018	September 2019	September 2020	November 2021	November 2022
Total living cover		80%	90%	90%	90%	90%	90%	>90%	>90%
Annual living cover		40%	46%	40%	40%	40%	20%	20%	20%
Perennial living cover		50%	44%	50%	50%	50%	70%	70%	70%

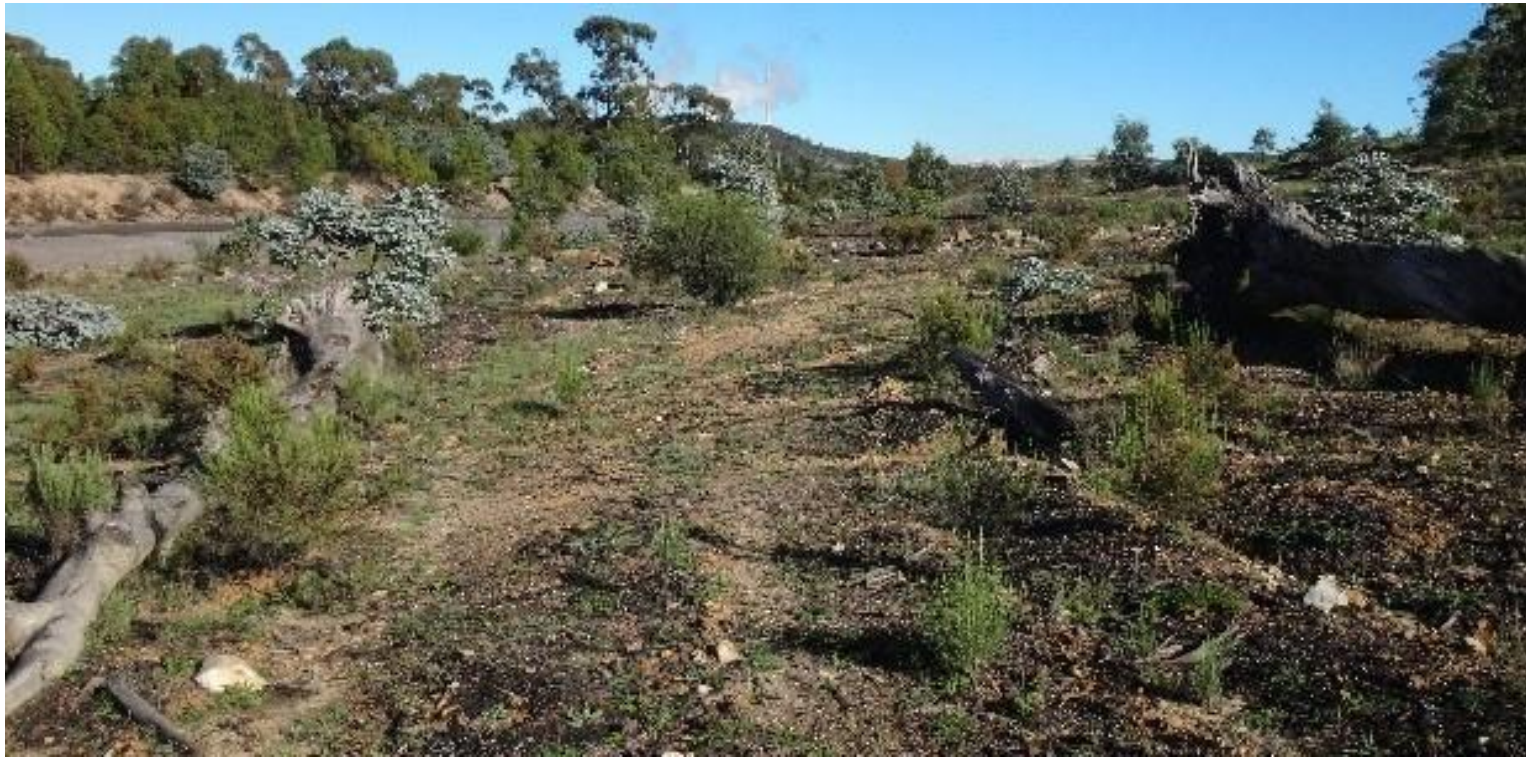
Adjacent to Transect 4 looking south-west 2022

Transect 4 Pasture rehabilitation area 2022									
Easting			Northing						
228318			6304224						
228249			6304227						
Landform and soils									
Slope		Transect located along a contour. 1 - <3% slope declining to the west.							
Erosion		Not assessed due to inaccessibility							
Cracking soils									
Surface drainage impediments									
Vegetation									
Vegetation structure		Not assessed due to inaccessibility							
Species richness									
Cover classification		% cover at each observation							
		September 2015	September 2016	September 2017	September 2018	September 2019	September 2020	November 2021	November 2022
Total living cover		80%	90%	90%	90%	90%	>90%	>90%	Not assessed due to inaccessibility
Annual living cover		40%	42%	30%	30%	40%	20%	20%	
Perennial living cover		50%	48%	60%	60%	50%	70%	70%	
Litter cover		-	-	<10%	10%	-	-	-	
Bare surface		20%	10%	<10%	10%	10%	10%	<10%	
Target weed presence

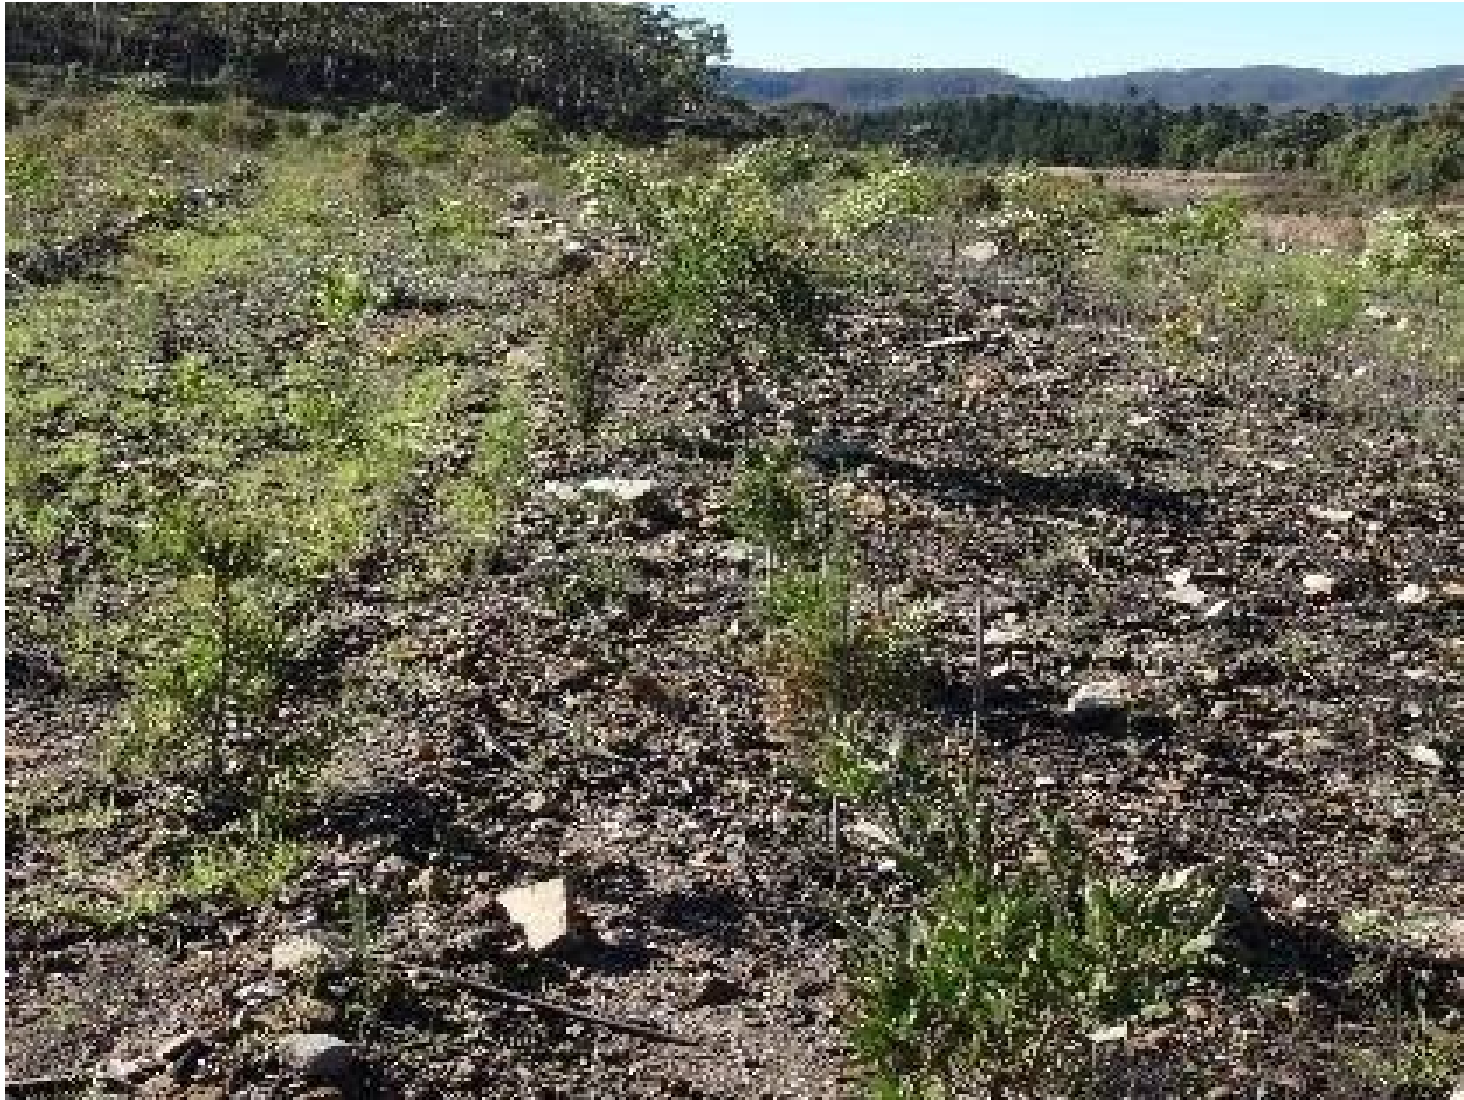
Transect 5 looking west 2022

Transect 5 Treed rehabilitation area 2022								
Easting		Northing						
227846		6304272						
227787		6304251						
Landform and soils								
Slope		Transect located along contour of mid slope inclining 10-20% to the north.						
Erosion		Minor wind and rill erosion observed on exposed soils.						
Cracking soils		Not observed.						
Surface drainage impediments		No significant drainage impediments.						
Vegetation								
Vegetation structure		Sparse tree layer to 3 m height with isolated juvenile trees and sparse mixed native shrub species. Moderately dense groundcover dominated by native and exotic grasses with scattered mixed native and exotic herbs.						
Species richness		Shrub layer consists of native species and juvenile trees. Groundcover dominated by exotic grasses. >30 species recorded.						
Cover classification	% cover at each observation							
	September 2015	September 2016	September 2017	September 2018	September 2019	September 2020	November 2021	November 2022

Total living cover	50%	75%	70%	70%	70%	80%	80%	80%
Annual living cover	20%	12%	10%	10%	10%	10%	20%	10%
Perennial living cover	30%	63%	60%	60%	60%	60%	60%	70%
Litter cover	10%	10%	10%	10%	15%	10%	-	10%
Bare surface	40%	15%	20%	20%	15%	10%	20%	10%
Target weed presence								
None observed.

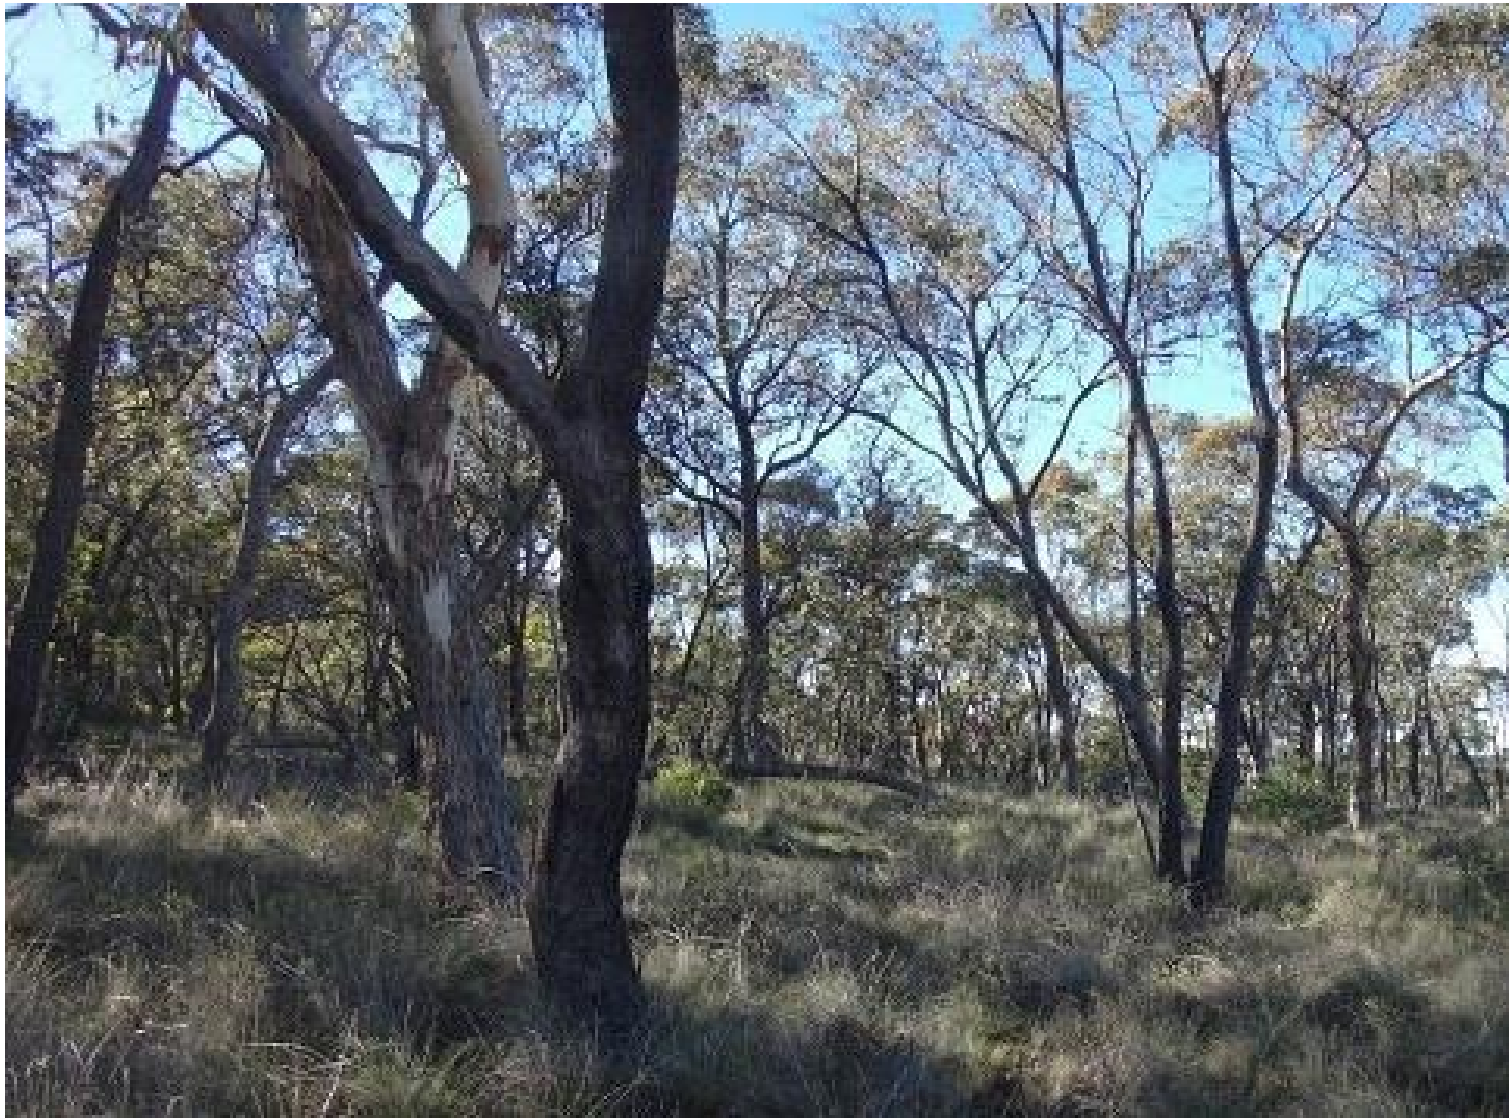
Transect 6 looking east 2022

Transect 6 Treed rehabilitation area 2022									
Easting			Northing						
226604			6304724						
226647			6304706						
Landform and soils									
Slope		Transect located along contour of mid slope inclining 10-20% to the northeast.							
Erosion		Minor wind and rill erosion observed on exposed soils.							
Cracking soils		Not observed.							
Surface drainage impediments		No significant drainage impediments.							
Vegetation									
Vegetation structure		Sparse tree layer to 5 m height with isolated juvenile trees and sparse mixed native shrub species. Moderately dense groundcover dominated by native and exotic grasses with scattered mixed native and exotic herbs.							
Species richness		Shrub layer consists of native species and juvenile trees. Groundcover dominated by exotic grasses. >35 species recorded.							
Cover classification		% cover at each observation							
		September 2015	September 2016	September 2017	September 2018	September 2019	September 2020	November 2021	November 2022

Total living cover		70%	80%	80%	70%	70%	80%	>90%	80%
Annual living cover		10%	12%	10%	10%	10%	10%	20%	20%
Perennial living cover		60%	68%	70%	60%	60%	70%	70%	60%
Litter cover		10%	10%	10%	10%	15%	10%	-	10%
Bare surface		20%	10%	10%	20%	15%	10%	<10%	10%
Target weed presence									
None observed.

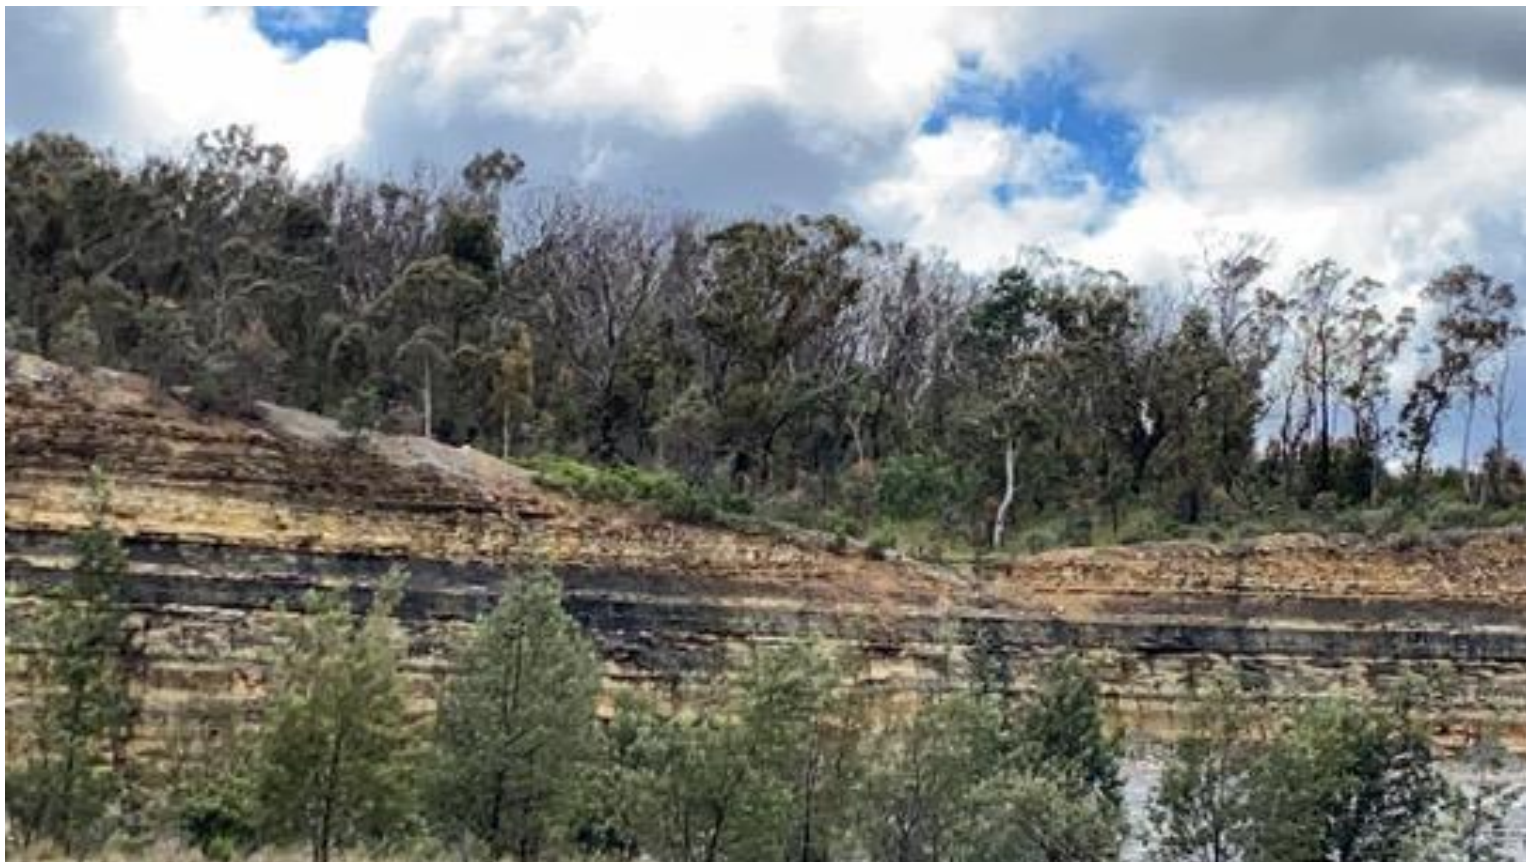
Looking towards Transect 7 2022

Treed analogue site (transect 7) 2022	
Easting	Northing
226801	6305097
226838	6305039
Landform and soils	
Slope	Transect located along contour of mid slope gently inclining to the north.
Erosion	Not assessed due to inaccessibility
Cracking soils	
Surface drainage impediments	
Vegetation	
Vegetation structure	Not assessed due to inaccessibility
Species richness	
Cover classification	
Total living cover	Not assessed due to inaccessibility
Annual living cover	
Perennial living cover	
Litter cover	
Bare surface	
Target weed presence	
Not assessed due to inaccessibility

Note that Transect 7 was inaccessible in 2021 and 2022
