PINE DALE MINE

ANNUAL ENVIRONMENTAL MANAGEMENT REPORT 2015

Prepared by: Enhance Place Pty Ltd
February 2016

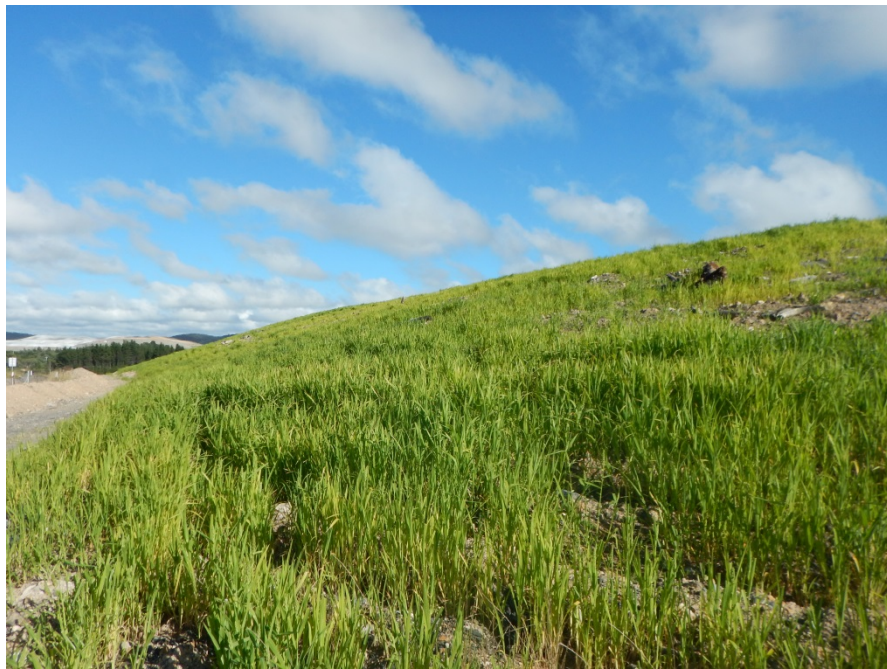
Plate 1 Amenity bund

The amenity bund located along the southern boundary of the Yarraboldy Extension has been re-profiled with the southern batter having a gradient of 18° to minimise erosion and enhance establishment of seedlings. Following the application and tilling of topsoil, a native species grass and tree species seed mix has been applied followed by mulch.

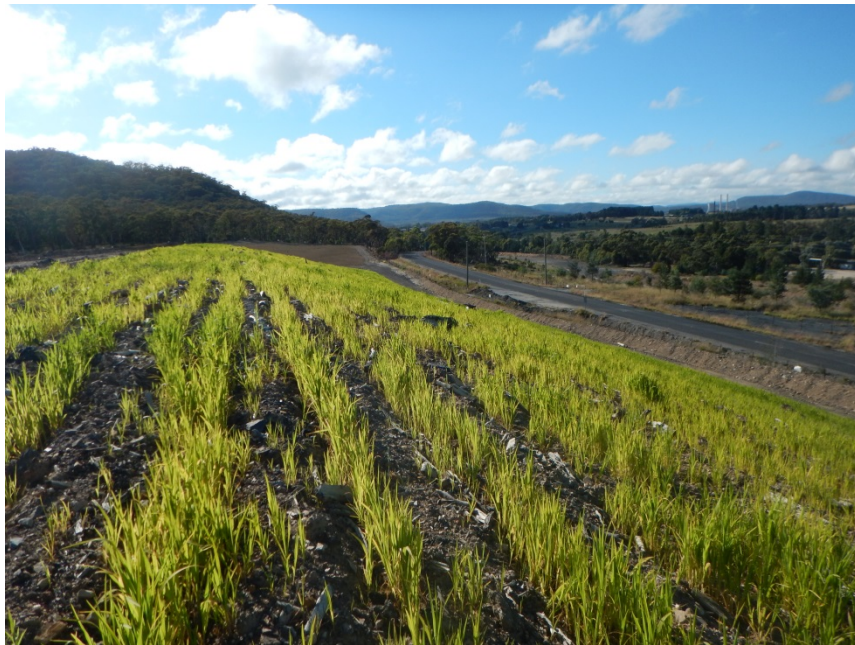
Plate 2 Amenity bund - application of mulch, grass and native species seed mix.

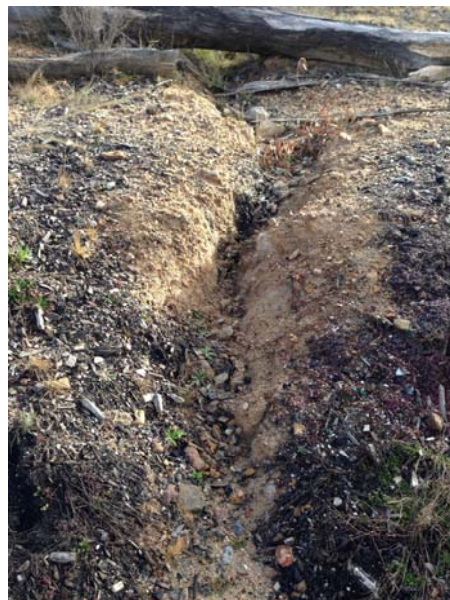
Severe rill erosion to an approximate depth of 20cm is occurring across exposed slopes of the treed rehabilitation areas (see Figure 3).

Figure 3 Rill erosion at transect 5

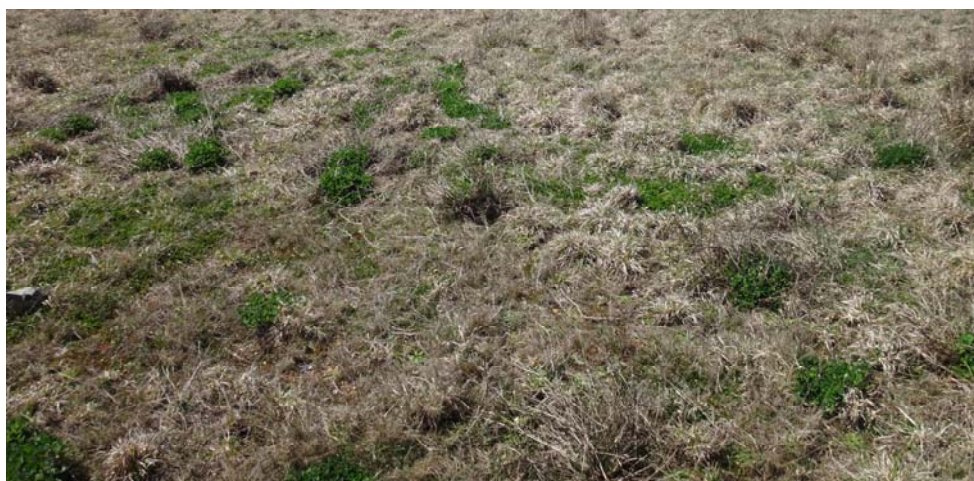
Species composition at pasture rehabilitation areas – Pasture rehabilitation areas are established with a mix of 70% perennial grasses and 20% annual legumes and are representative of species composition at the analogue pasture site. An example of transect 1, 2 and 3 pasture is shown in Figure 4.

Figure 4 Pasture composition representative of transects 1, 2 and 3

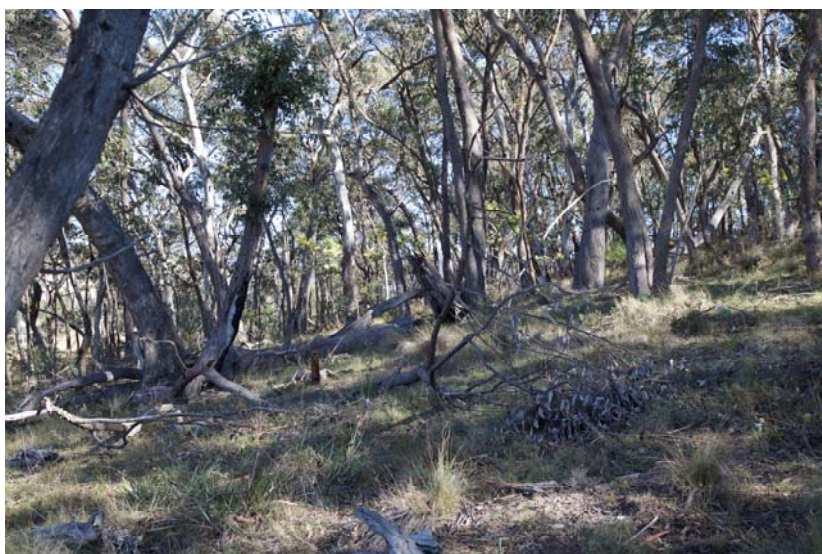
Figure 5 Vegetation structure of treed analogue site (transect 7)

The treed analogue site is characterised by a canopy to 12m height with 40% canopy cover over a sparse shrubby mid-storey to 3m height and isolated shrubs to 1.5m height in the understorey. Groundcover consists of grasses and herbs with a cover of 70% Figure 6.

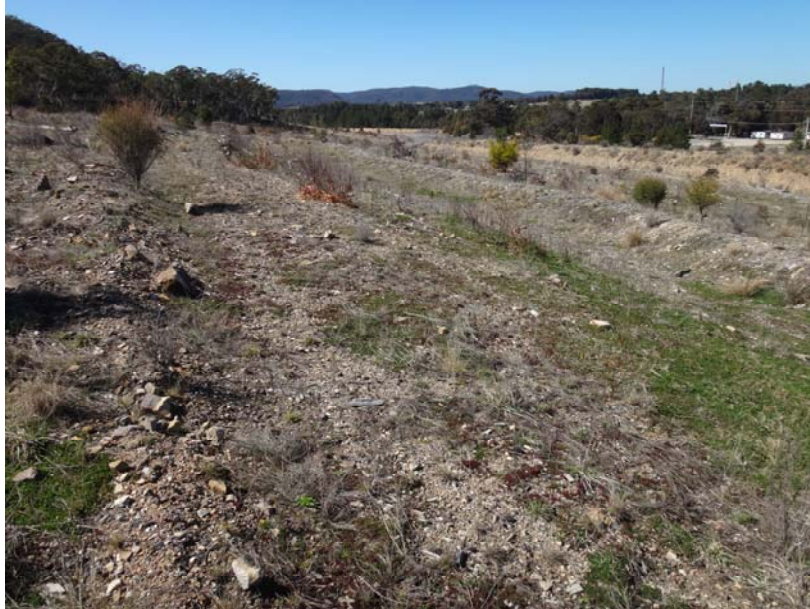
Figure 6 Transect 6 vegetation structure

Canopy cover is absent in treed rehabilitation areas. A sparse mid-storey of isolated juvenile trees and shrubs exists over a sparse, low, shrubby understorey (seen in Figure 6). Groundcover is a sparse mix of broadleaf herbs and grasses. Changes in vegetation structure over time (as shown in Appendix B) are not considered significant.

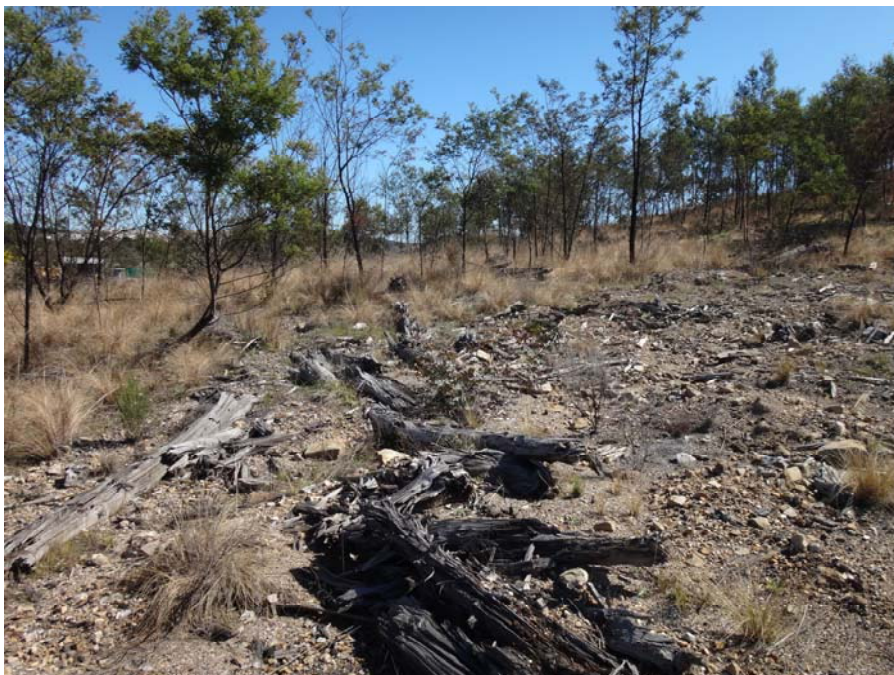
Habitat features – Crushed timber piles and rock pile clusters were observed within the treed rehabilitation areas of transects 5 and 6 (Figure 7). Habitat features at the treed analogue site include fallen trees and scattered piles of fallen vegetation (visible in Figure 5).

Figure 7 Crushed timber placed as habitat at transect 6

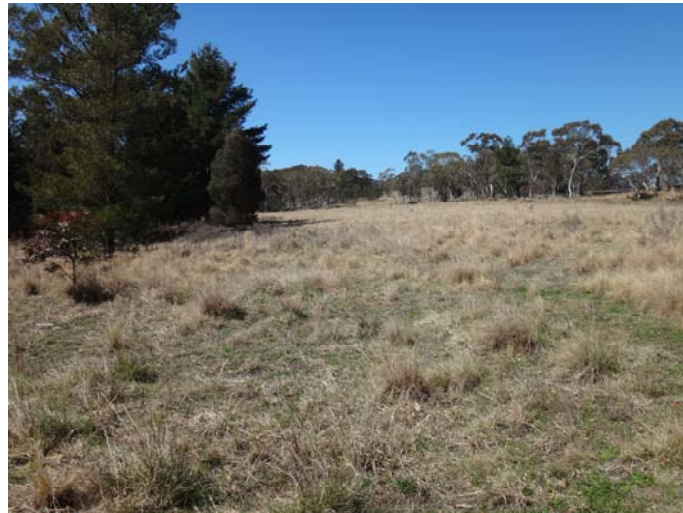
Noxious and targeted weed species - No noxious weeds were observed at any of the monitoring locations during this survey. The presence of African Lovegrass was noted at transects 1, 2 and 4 and occurred across less than 10% of the pasture area. These outbreaks have been subjected to ongoing chemical control and were not observed to be growing or producing seed. Recently sprayed African lovegrass can be seen in Figure 8.

Figure 8 Recently sprayed African lovegrass at transect 4
