PINE DALE MINE

ANNUAL REVIEW

2017

Prepared by: Enhance Place Pty Ltd
February 2018

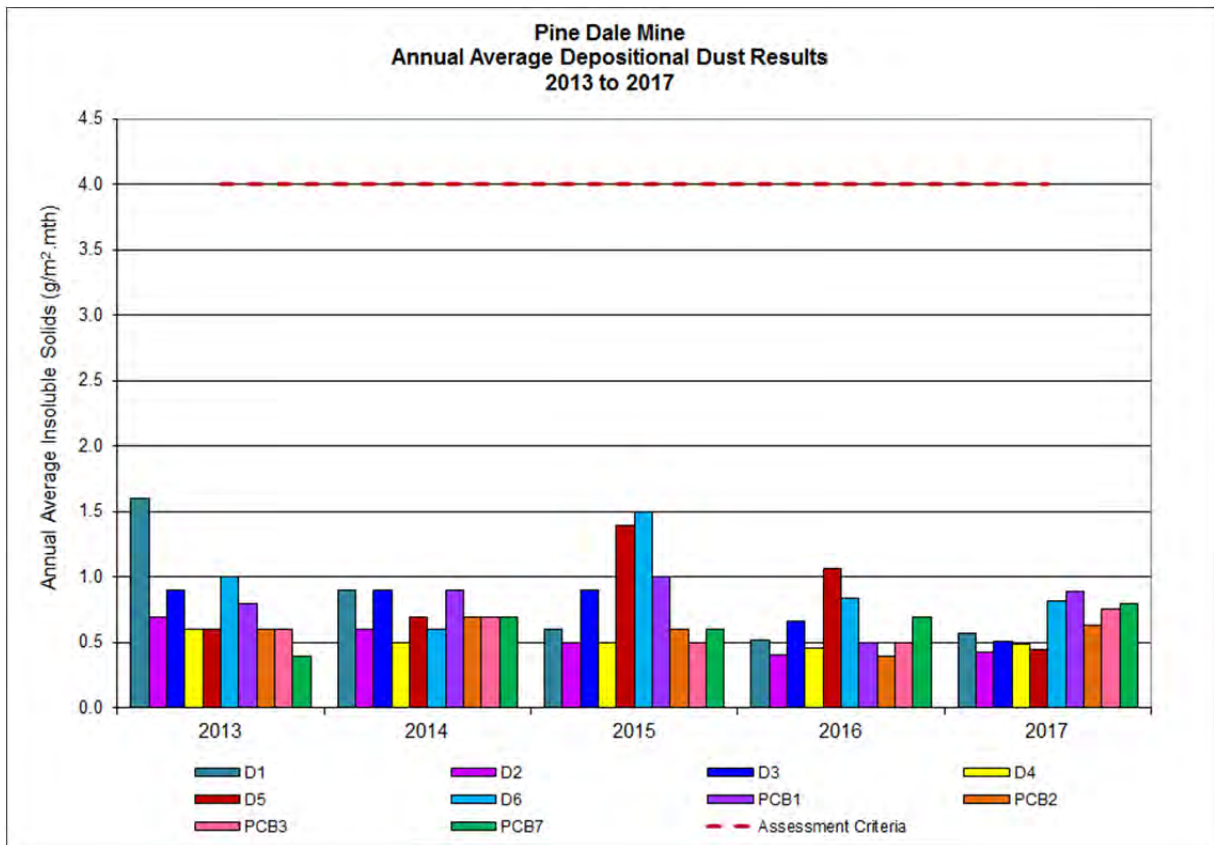
Figure 1
Historical Depositional Dust Data

An examination of the historical data indicates a slight decrease in the depositional dust concentrations at the site during the period 2013 to 2017. Operations at the mine ceased during April 2014, with a reduction in depositional dust concentrations reflected during the Care and Maintenance phase (2015 to 2017). All depositional dust results are shown to be lower than the concentrations predicted in the site Environmental Assessment (predicted annual average of 3.2g/m²/month deposited dust).

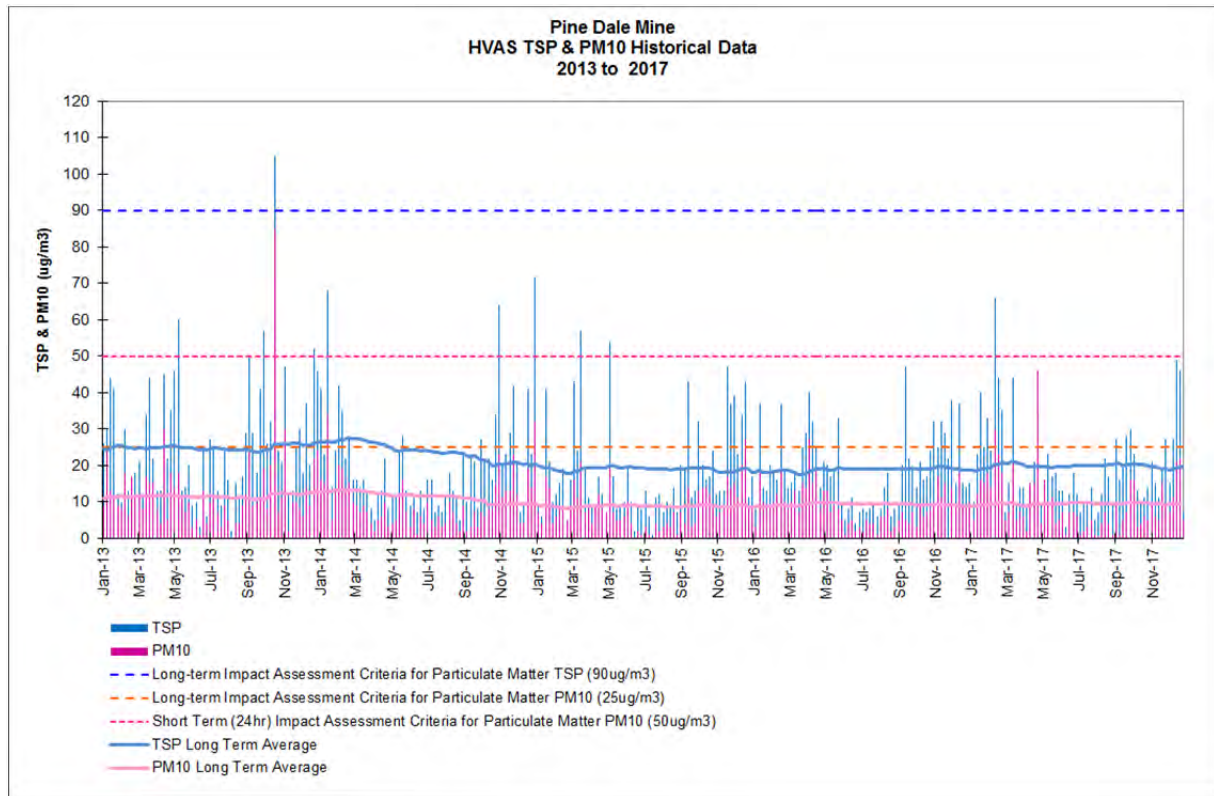
Figure 2
Historical HVAS Data

Results also demonstrate consistent PM₁₀ and TSP levels were recorded at the site throughout the 2013 to 2017 monitoring period (see **Table 10** and **Figure 2**). The PM₁₀ and TSP particulate concentrations observed in 2013 are slightly higher than those recorded during 2014 to 2017. This is most likely attributed to the commencement of mining in 2012, bushfires and the low rainfall received at the site during the 2013 monitoring period. There has been a notable decrease in concentrations throughout 2014 to 2016; this is likely due to the higher rainfall recorded during 2015 and 2016, and the cessation of mining activities in April 2014. The PM₁₀ and TSP particulate concentrations recorded during 2017 are slightly higher than the previous year, however, the rainfall recorded during 2017 was the lowest recorded at the site since 2007 (refer Section 6.3.1).

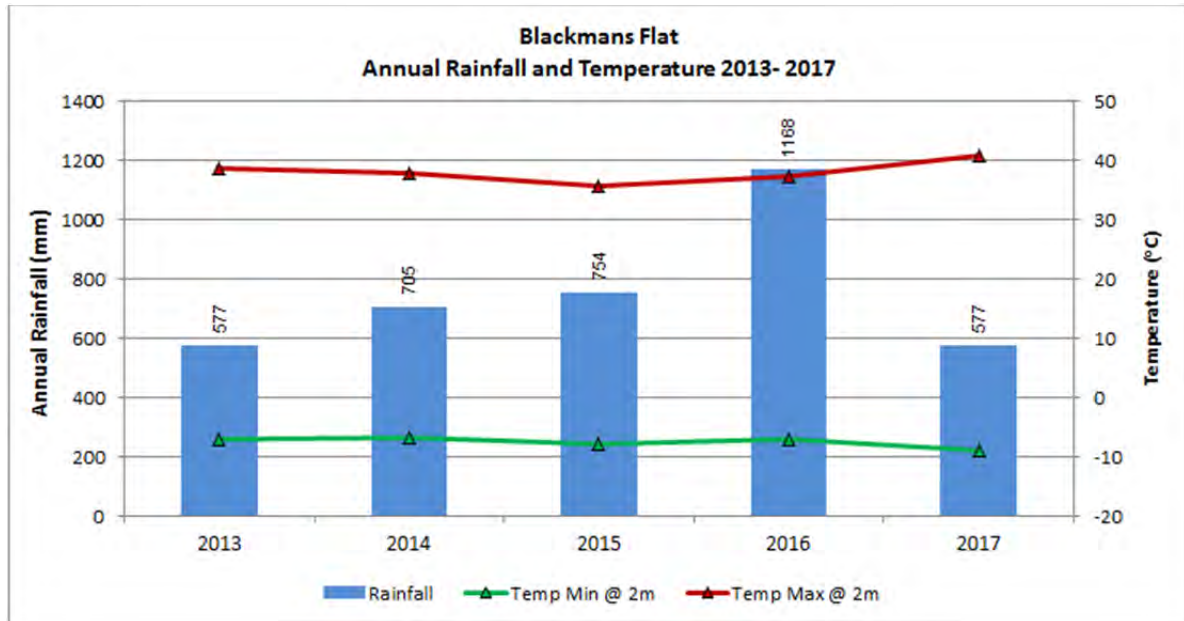
Figure 3
Annual Temperature & Rainfall Summary

Pine Dale Mine received 577 mm of rainfall and experienced 130 rainfall days during the 2017 reporting period. Rainfall during this reporting period was observed to be considerably lower than rainfall recorded in 2016 (1167.6 mm and 147 rainfall days) and 2015 (756.2 mm and 144 rainfall days). The monthly rainfall data for 2017 is summarised in **Table 11**. A graphical presentation of annual rainfall during the previous 5 years is presented in **Figure 3**.

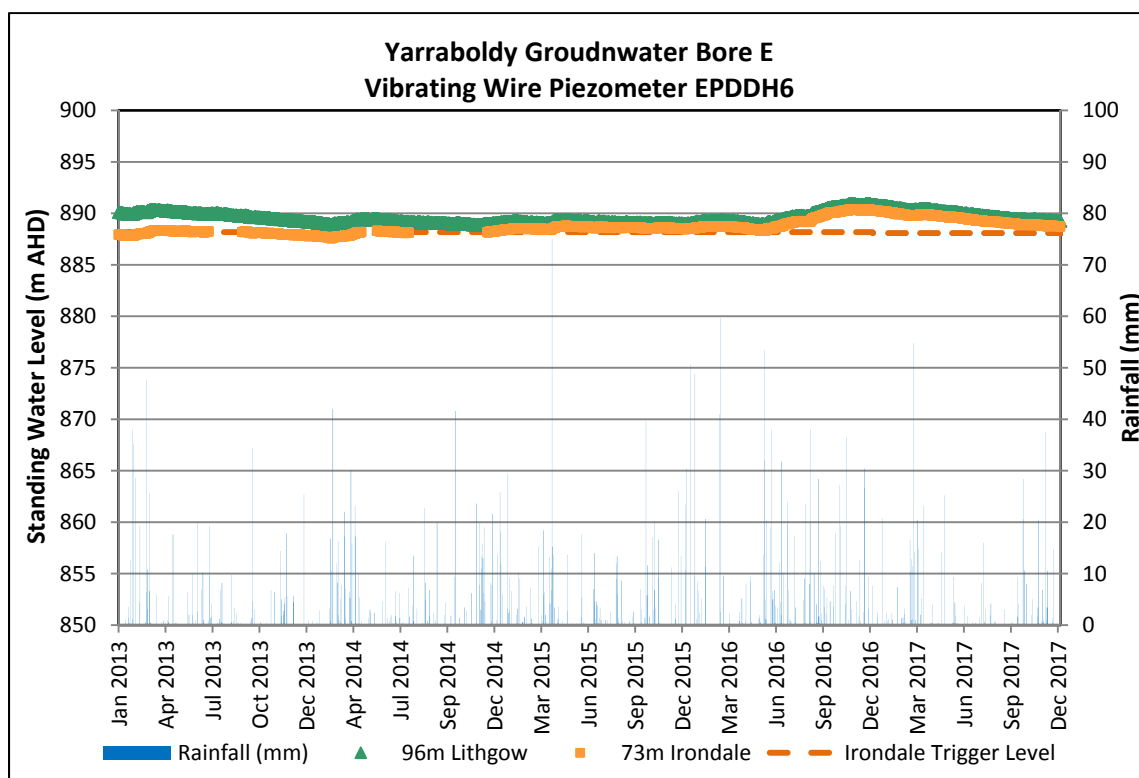
Figure 19
Off-Site Bore E-VWP Historical SWL & Rainfall

Note: Bore E was inaccessible during the period April to December 2016 due to an access bridge closure in the State Forest.

Request b)	Response requested by 31 March 2017 – <i>is there a timeframe by which the bridge allowing access to Bore E is to be repaired? It is noted that Bore E has been inaccessible since March 2016 and failure to monitor at this location is a non-compliance with the management plan.</i>	DPE	A letter response was provided to the Department on 24 March 2017 detailing the actions taken regarding access to Bore E. Sampling and data downloads at the Bore E site were resumed on a monthly basis from March 2017.	Appendix D

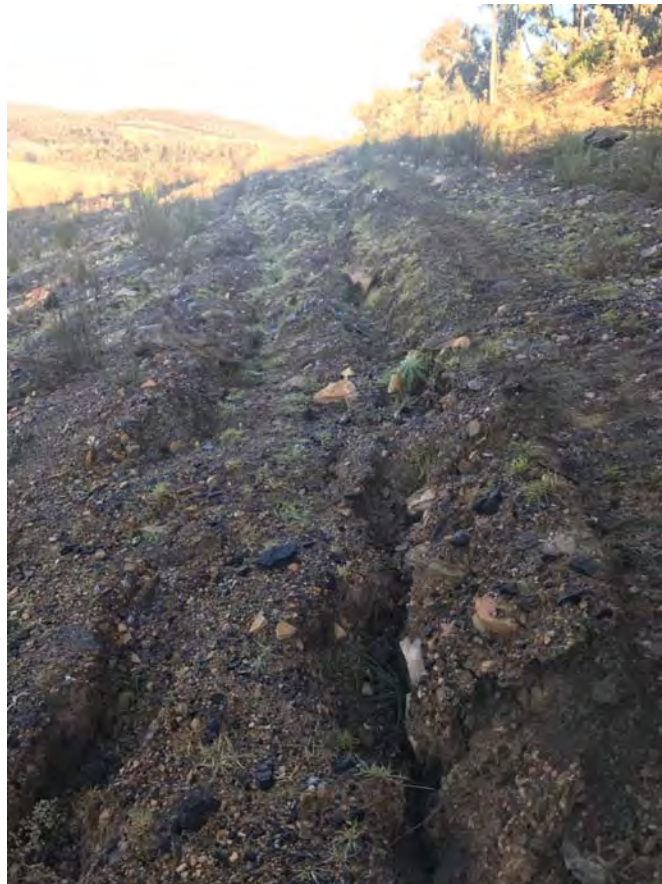
Plate 2 Surface cracking on slope in Yarraboldy Extension area, May 2017.

- The inspection and maintenance of windrows and silt fencing to prevent potential surface water impacts and sediment entering Neubeck's Creek;
- Repair of surface cracking from soil settling in the Yarraboldy extension area (May 2017);
- Repair of drainage lines and erosion control structures in Area A from runoff during storm event (June 2017);

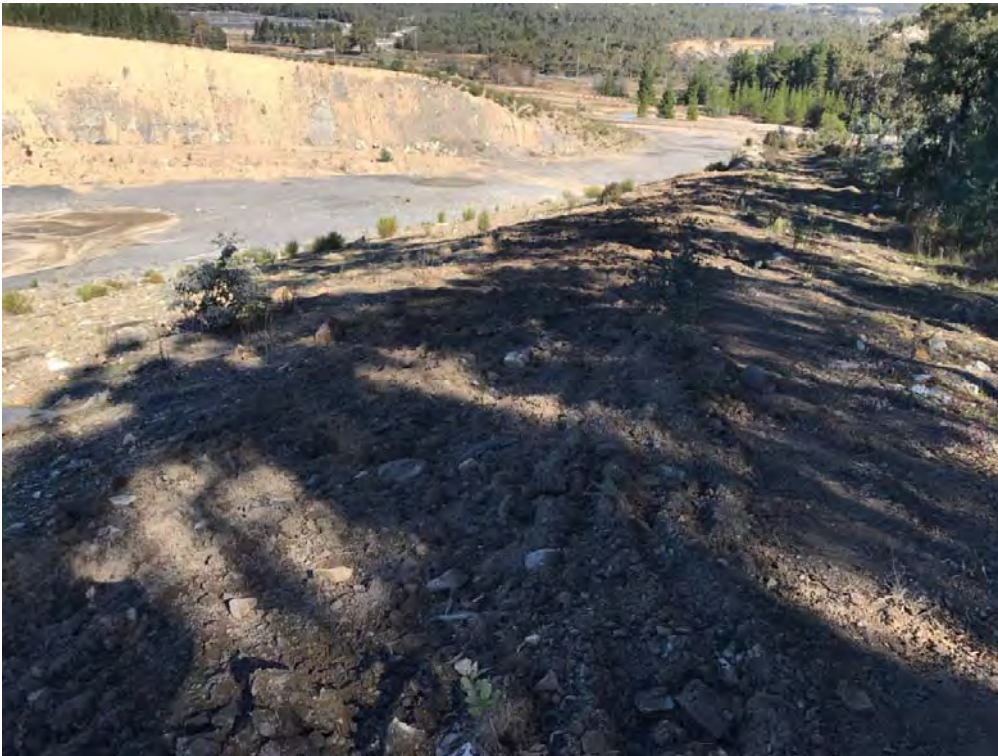
Plate 3 Repair of surface cracking in Yarraboldy Extension area, May 2017.

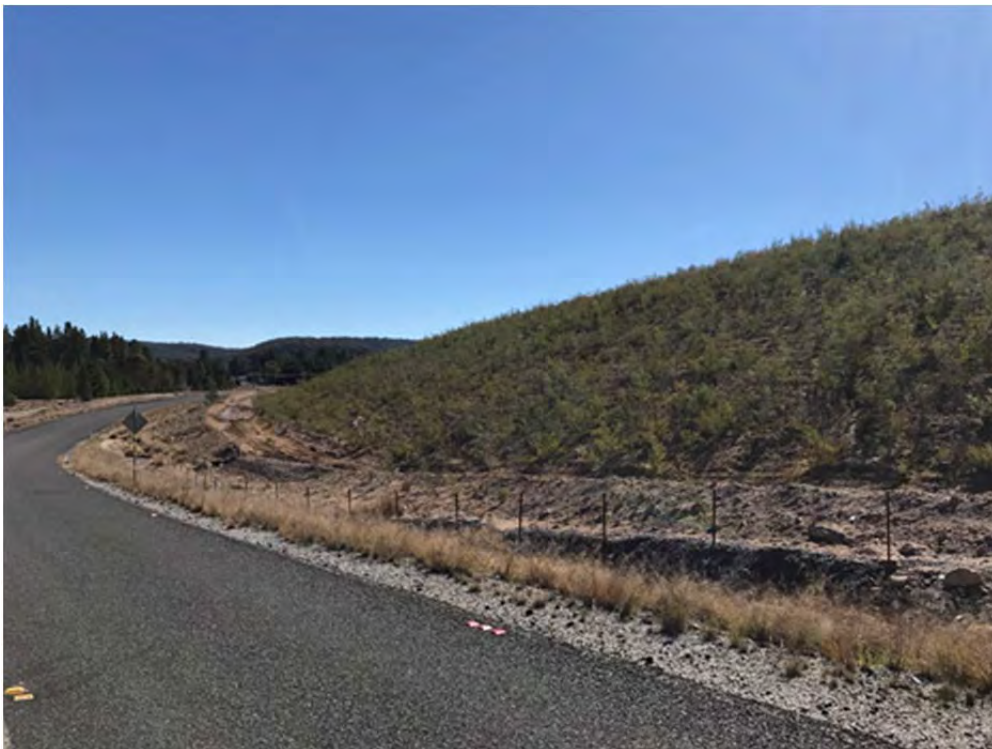
Plate 4 Repair of drainage line in Yarraboldy Extension area, June 2017.

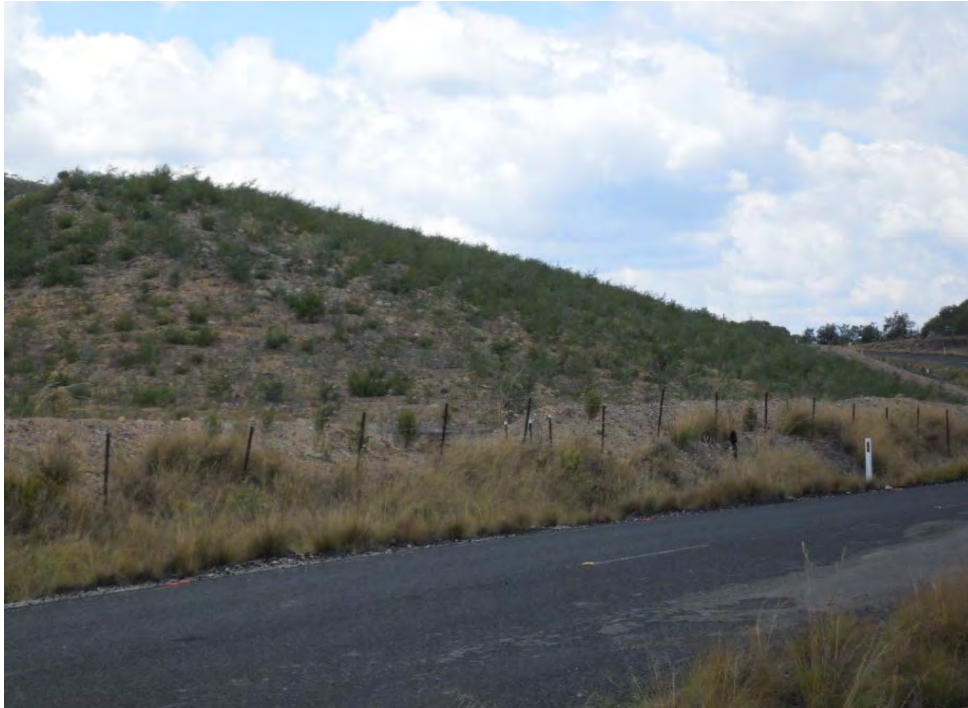
Plate 5 Amenity Bund - Yarraboldy Extension area, December 2017.

Growth of vegetation on the bund during the 2017 reporting period is shown in **Plate 5 & 6**.

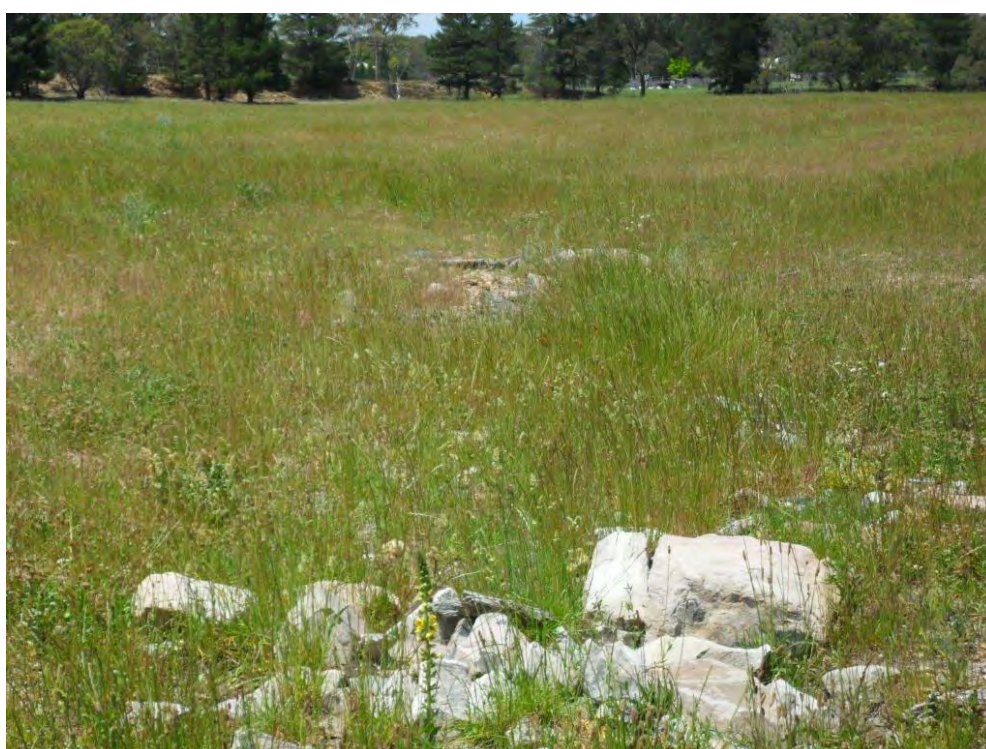
The 2017 Rehabilitation Monitoring Report (refer **Appendix C**) indicated Transect 4, in the eastern portion of Area 8 had 90% groundcover, which is consistent with the previous reporting period (2016). African Lovegrass was reported as comprising <10% of the pasture sward (refer **Plate 11**).

Plate 11 Area 8 – Pasture growth / ground coverage, January 2017

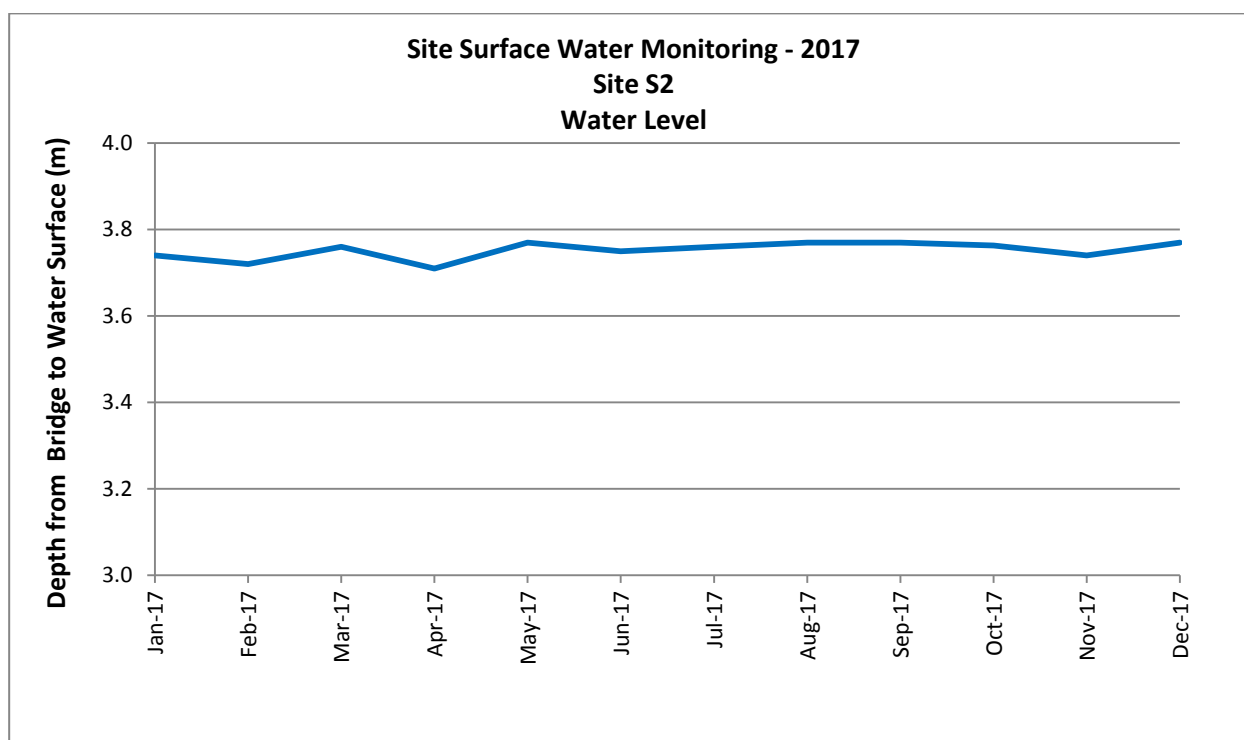
Figure 11 Site Surface Water S2 - Water Level 2017

The water level at surface water site S2 remained relatively stable throughout the 2017 monitoring period.
