## **PINE DALE MINE**

# **ANNUAL REVIEW 2018**

Prepared by: Enhance Place Pty Ltd  
February 2019

Revision 1.0 – 25 February 2019

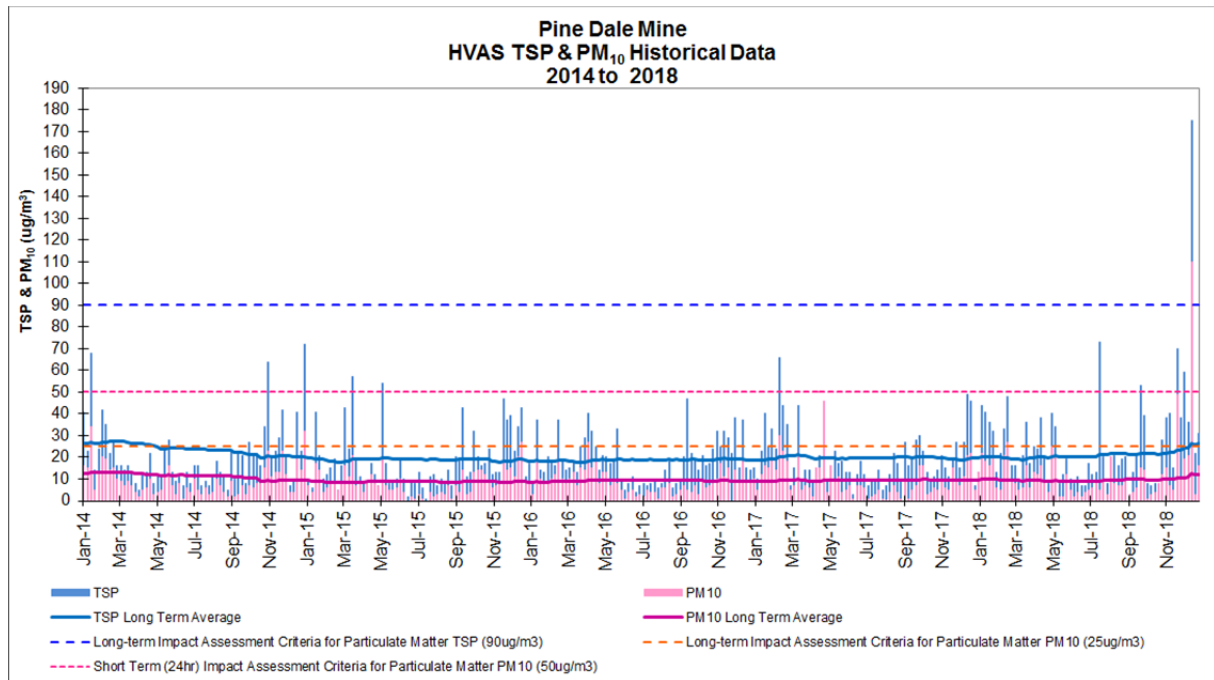
**Figure 2 Historical HVAS Data**

Results also demonstrate consistent PM<sub>10</sub> and TSP levels were recorded at the site throughout the 2014 to 2018 monitoring period (see **Table 9** and **Figure 2**). The annual average PM<sub>10</sub> and TSP particulate concentrations observed in 2018 are slightly higher than those recorded between 2014 and 2017 during which PDM has been under care and maintenance. It is considered that the slight increase in the concentrations in 2018 could be due to prolonged below average rainfall observed at the site, which is discussed in further detail in Section 6.3.1.

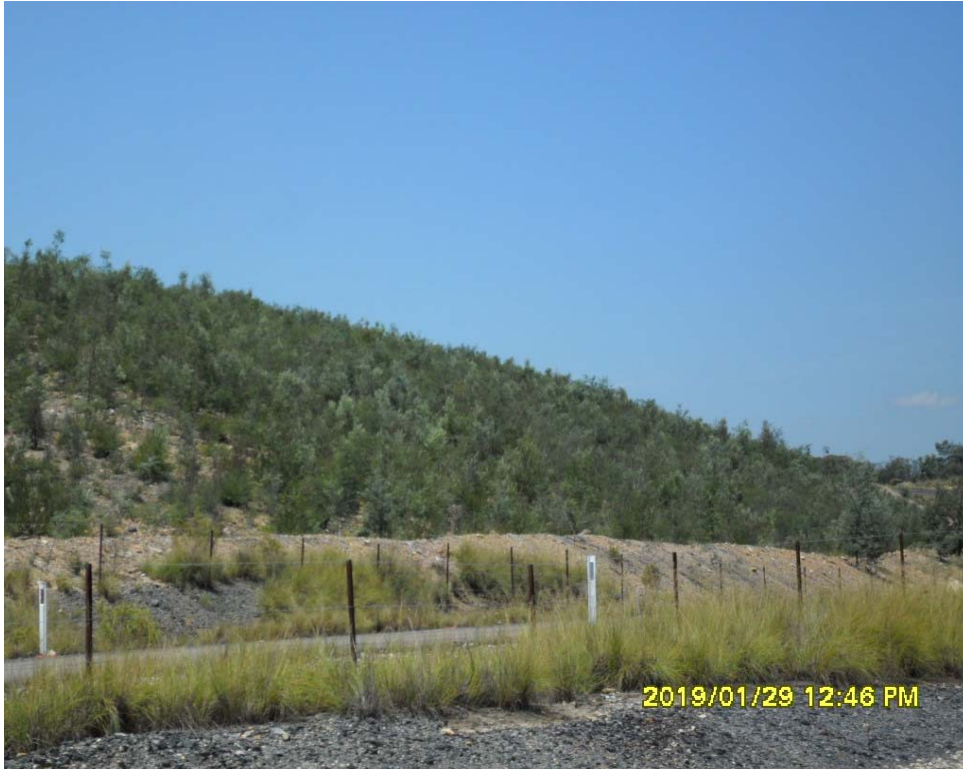
**Plate 2 Amenity Bund – Yarraboldy Extension Area, January 2019**

drought conditions. Growth of vegetation on the bund (photo taken January 2019), which is representative of growth during the 2018 reporting period is shown in **Plate 2**. Growth during the 2017 reporting period is shown for comparison in **Plate 3**.

During the reporting period, rehabilitation maintenance works were undertaken in the Yarraboldy Extension. These works were limited to drainage line repairs as hay bales were unable to be installed to reduce flow velocities due to the limited availability of hay during

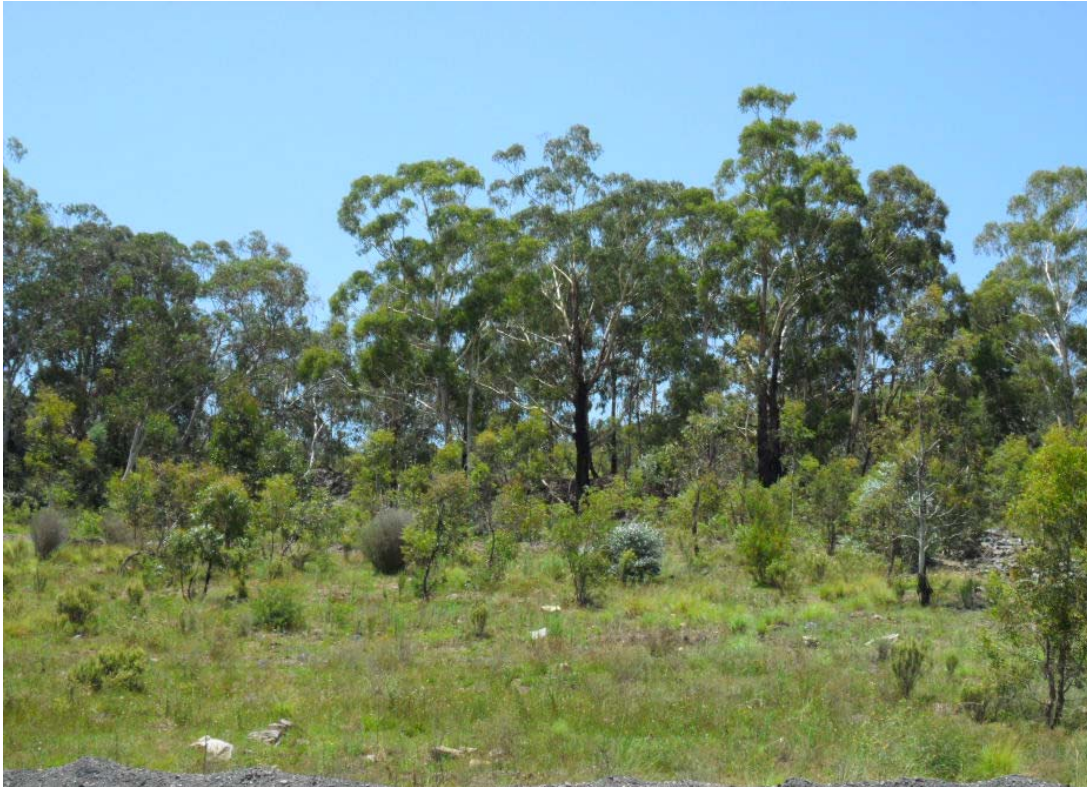
**Plate 4 Area A – Vegetation cover, January 2019**

The total vegetation cover of Area A in January 2019 is shown in **Plate 4**. Vegetation cover of Area A in January 2019 is considered to be similar to vegetation cover during December 2018.

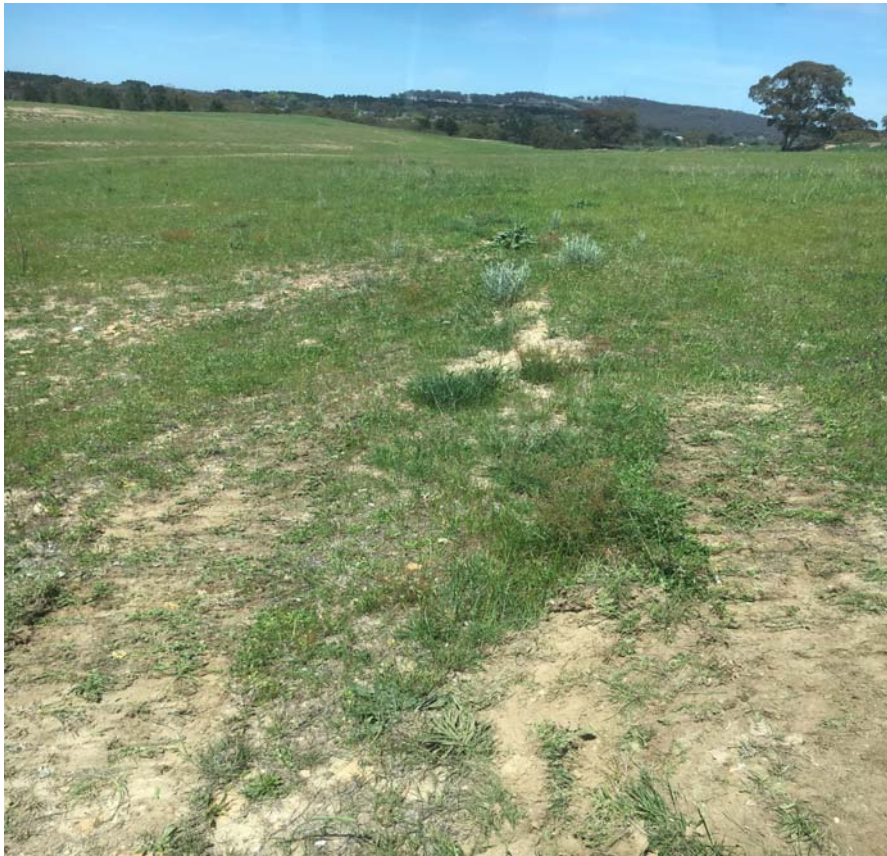
**Plate 5 Repair of cracking at Area B**

During the reporting period, rehabilitation maintenance works were undertaken in Area B to repair the cracking identified at transect 3 (refer **Plate 5**).

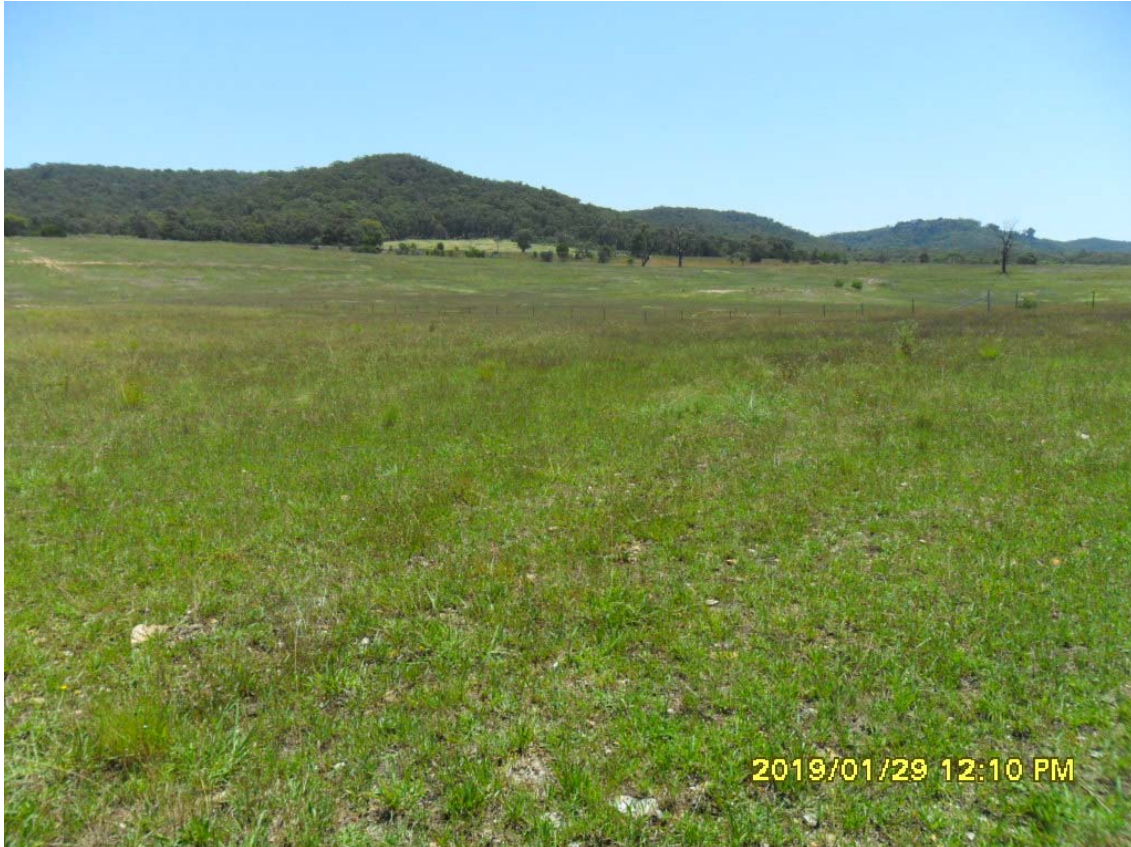
**Plate 6 Area B Pasture Growth – January 2019**

The SLR (2018) Rehabilitation and Completion Assessment report indicates that rehabilitation has been successfully completed in Area B and C. The SLR (2018) Rehabilitation and Completion Assessment Report is located in **Appendix D**.

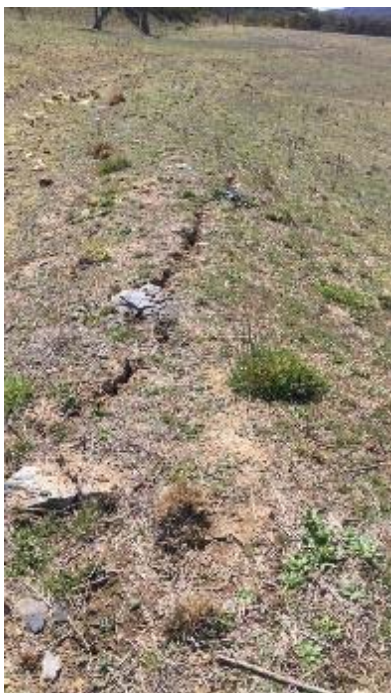
Figure 2 Extent of cracking along contour

**Pasture rehabilitation areas** - The pasture rehabilitation areas support evidence of minor wind erosion where groundcover is poorly established or absent. Isolated occurrences of soil cracking were observed along contours in Transect 3 (see Figures 2 and 3).

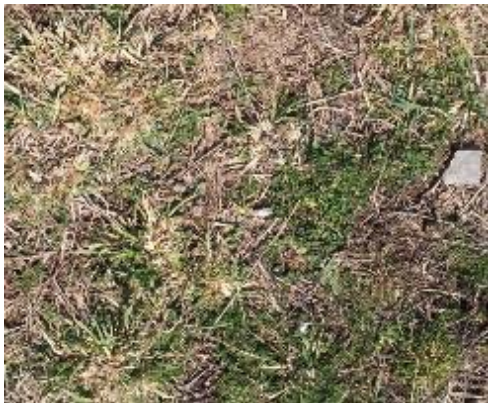
Figure 4 Typical pasture composition of transect 1

**Species composition at pasture rehabilitation areas** – Pasture rehabilitation areas are established with a mix of 70% perennial grasses and 20% annual legumes and are representative of species composition at the analogue pasture site. Examples of transect 1, 2 and 3 pasture are shown in Figure 4 and Figure 3.

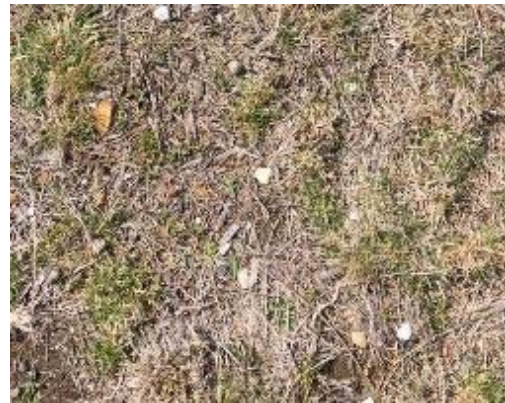
Figure 5 Pasture composition representative of transects 2 and 3

**Groundcover at pasture rehabilitation areas** – Rehabilitated pasture surfaces in each of the transect areas support living groundcover of approximately 90%.

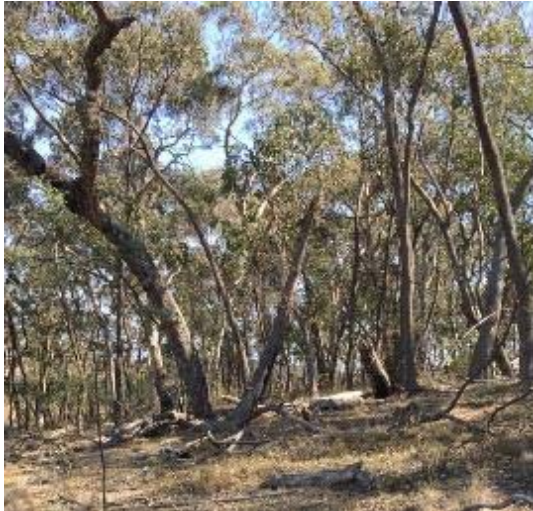
Figure 6 Vegetation structure of treed analogue site (transect 7)

The treed analogue site is characterised by a canopy to 14m height with 20% canopy cover over a sparse shrubby mid-storey to 3m height and isolated shrubs to 1.5m height in the understorey. Groundcover consists of grasses and herbs with a cover of >95% (Figure 6).

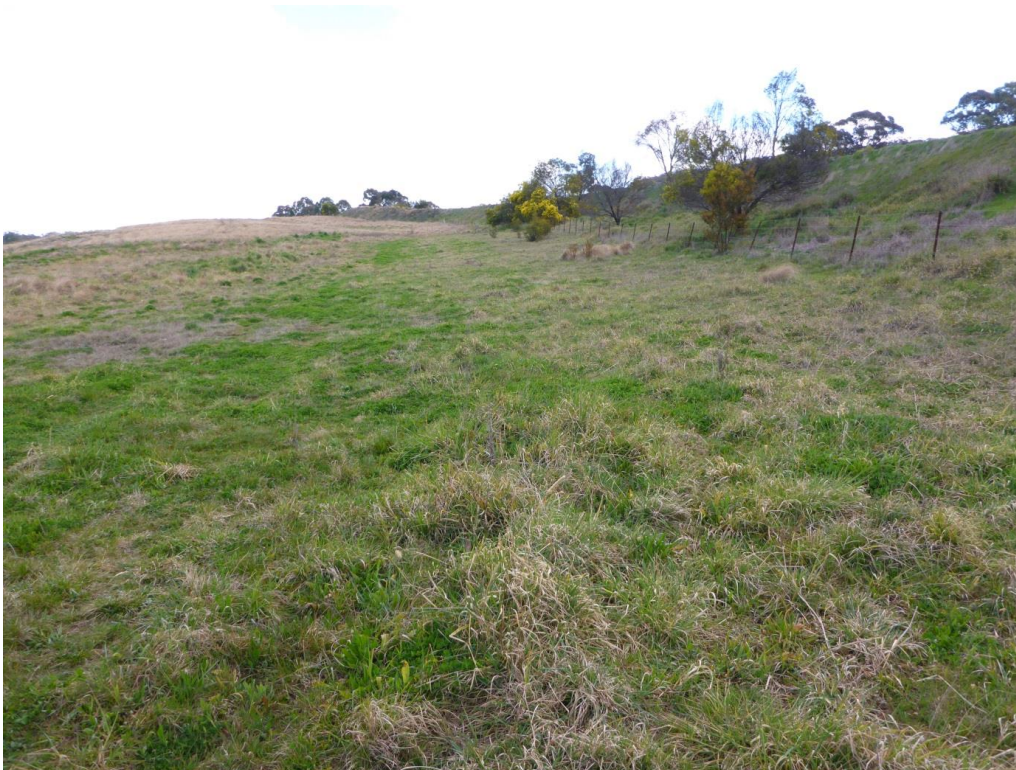
**Photo 1    Analogue Site PD3 – September 2014**

Topsoil consists of a sandy clay loam over a medium clay subsoil. This area supports a perennial grass and clover pasture, including cocksfoot, tall fescue, phalaris, sub clover, with some annual ryegrass. These pasture species have a winter and spring growth habit, with the difference in pasture mass clearly evident between the 2014 (September) and 2018 (March) inspections.

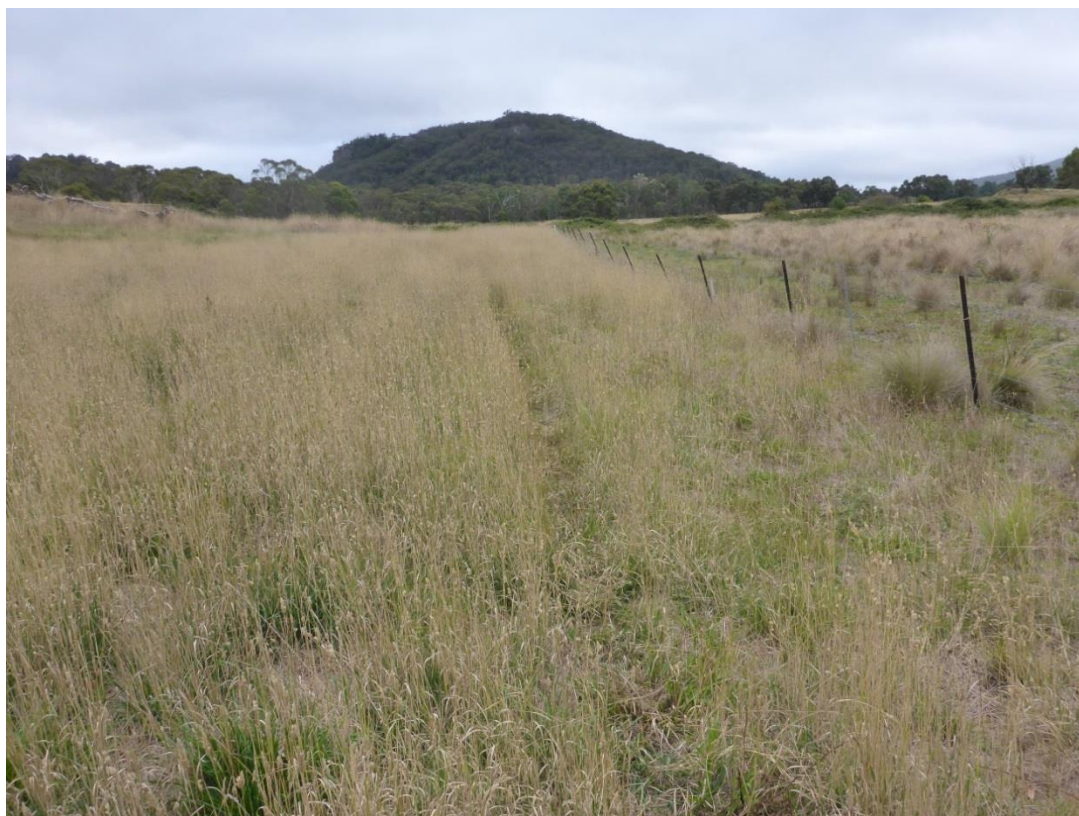
**Photo 3 Analogue Site PD6 March 2018**

**Photo 3** shows the general landscape setting for Site PD6 within Area C at Pine Dale Mine during the 2018 inspection. Pasture at Site PD6 is dominated by the perennial grasses phalaris and fescue.

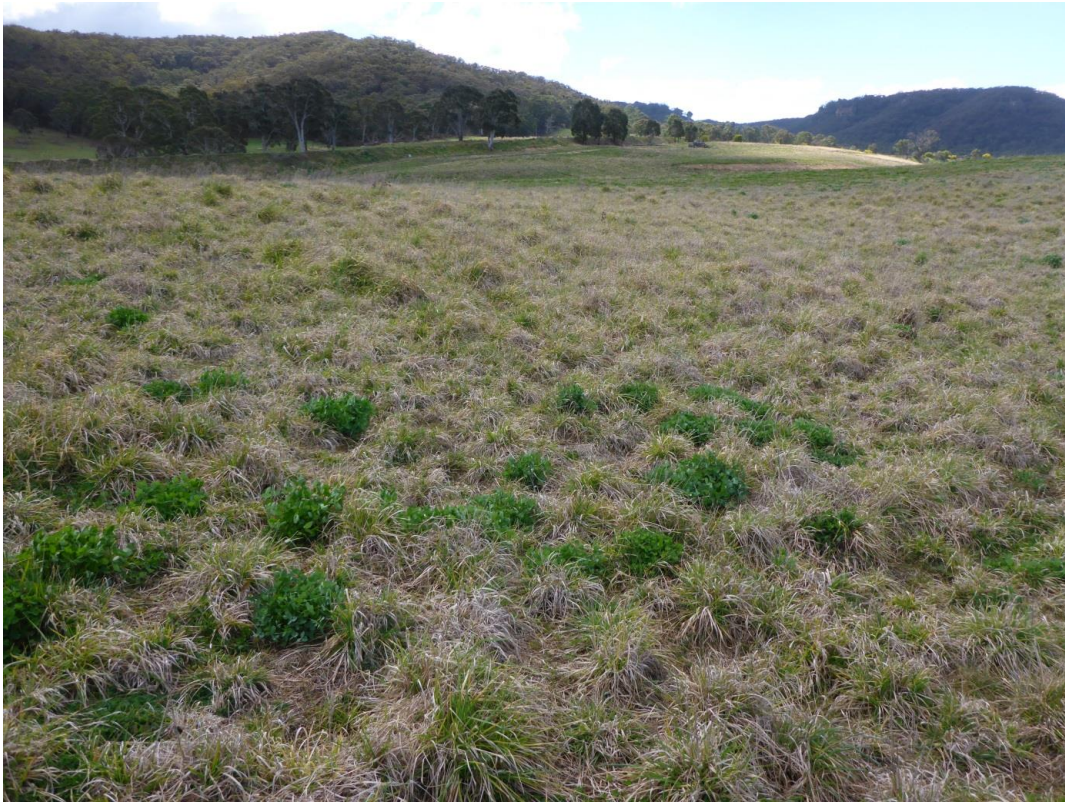
**Photo 4    Rehabilitated Site PD1 September 2014**

Pasture at Site PD1 is dominated by perennial cocksfoot and paspalum grass pasture with some sub clover and arrowleaf clover present in the sward, with greater than 90% groundcover. There is no African lovegrass present. The difference in pasture growth between autumn and spring can clearly be seen.

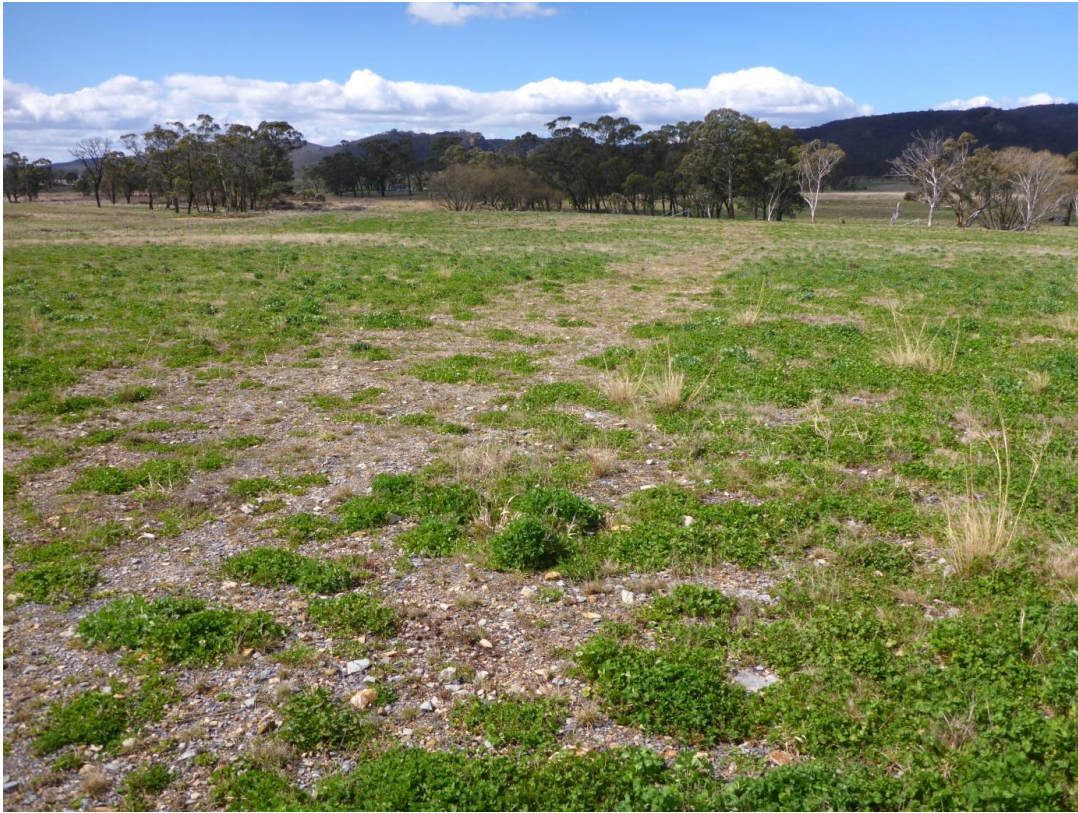
**Photo 6    Rehabilitated Site PD2 September 2014**

Pasture at Site PD2 is dominated by perennial cocksfoot and paspalum grass pasture with the herb plantain and some arrowleaf clover present in the sward, with greater than 80% groundcover. There are isolated African lovegrass tussocks present which comprise less than 5% of the pasture sward. Significant increase in perennial grass groundcover can be seen between the two inspection periods.

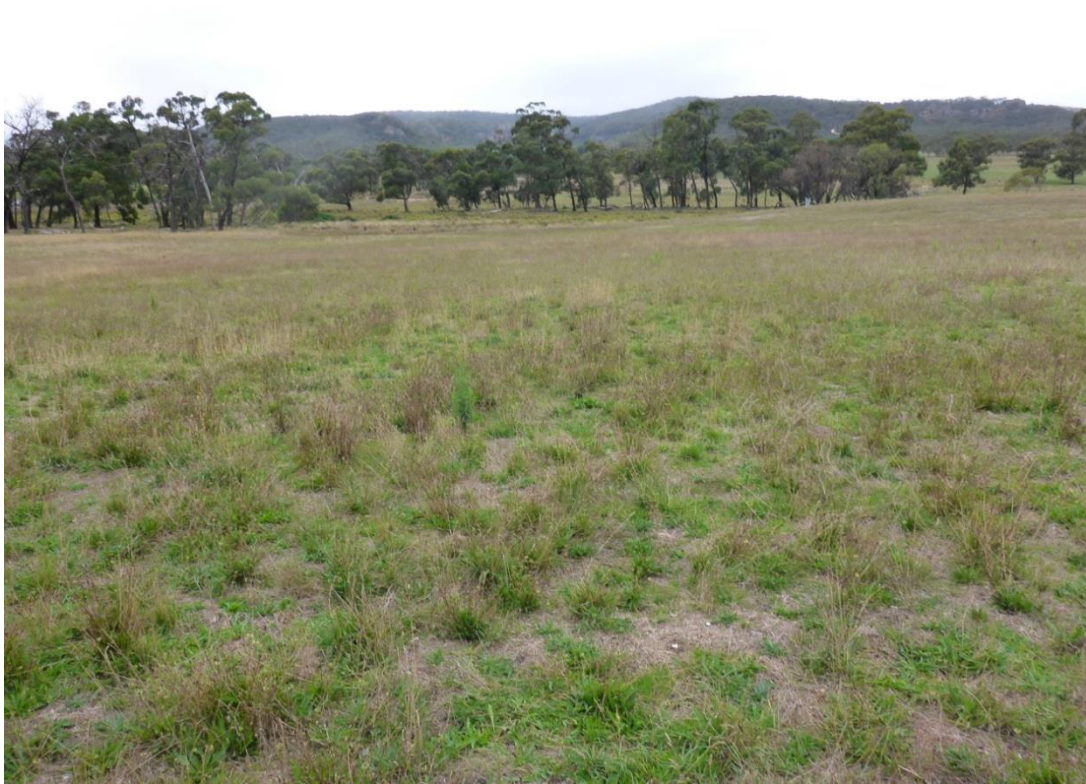
**Photo 8    Rehabilitated Site PD7 March 2018**

**Photo 8** shows the general landscape setting for Site PD7 within Area C at Pine Dale Mine during the 2018 inspection. Pasture at Site PD6 is dominated by perennial grasses phalaris, fescue and paspalum along with the herb plantain and arrowleaf clover. There is greater than 90% groundcover with only isolated tussocks of African lovegrass, which comprises less than 5% of the pasture sward.

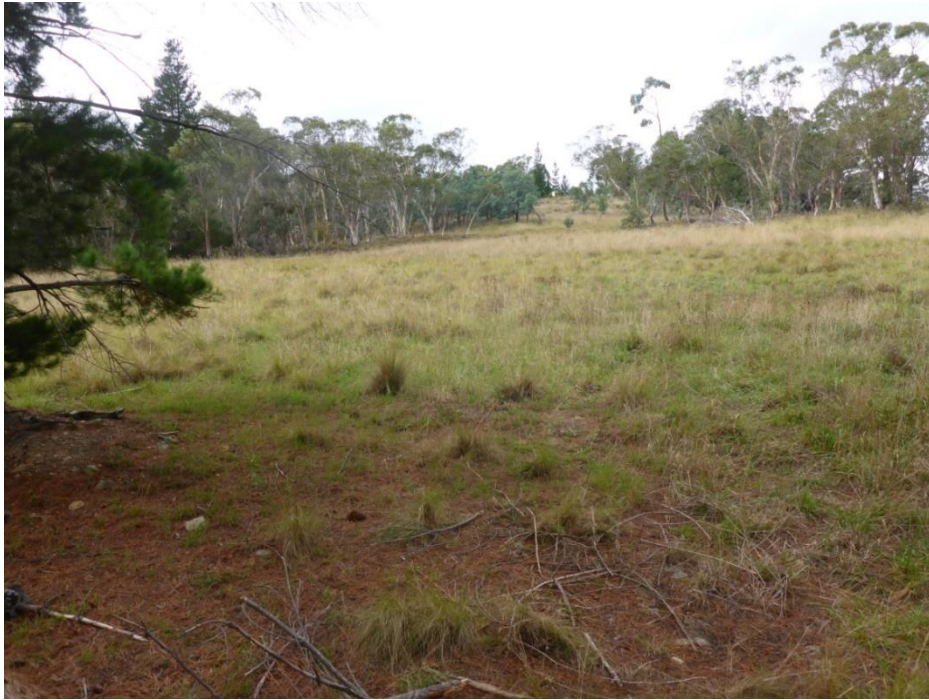
**Photo 9    Analogue Site PD8 March 2018**

**Photo 9** shows the general landscape setting for Site PD8 within Area 8 at Pine Dale Mine during the 2018 inspection. Pasture at Site PD8 is dominated by perennial phalaris and fescue with some arrowleaf clover present in the sward, with greater than 90% groundcover. There are isolated African lovegrass tussocks present which comprise less than 5% of the pasture sward.

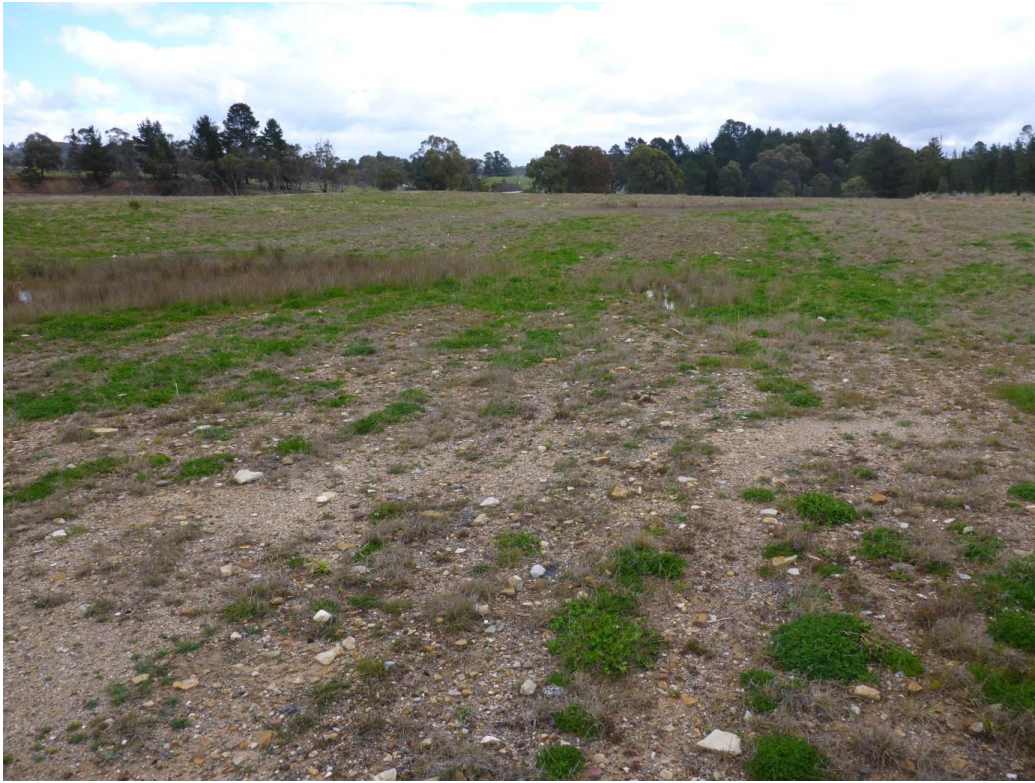
**Photo 10 Rehabilitated Site PD4 September 2014**

**Photo 10** and **Photo 11** show the general landscape setting for Site PD4 within Area 8 at Pine Dale Mine during the 2014 and 2018 inspections.

Pasture at Site PD4 is dominated by perennial grasses cocksfoot, fescue and paspalum with some arrowleaf clover present in the sward, and greater than 90% groundcover. There are isolated African lovegrass tussocks present which comprise less than 5% of the pasture sward. Significant increase in perennial grass groundcover can be seen between the two inspection periods.

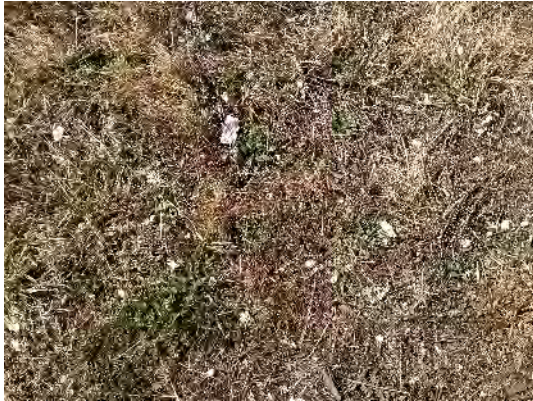
Figure 2 Typical pasture composition of transects 1, 2 and 3

**Species composition at pasture rehabilitation areas** – Pasture rehabilitation areas are established with a mix of 70% perennial grasses and 20% annual legumes and are representative of species composition at the analogue pasture site. An example of transect 1, 2 and 3 pasture is shown in Figure 2 and Figure 3.

**Groundcover at pasture rehabilitation areas** – Rehabilitated pasture surfaces in each of the transect areas support living groundcover of approximately 90%.

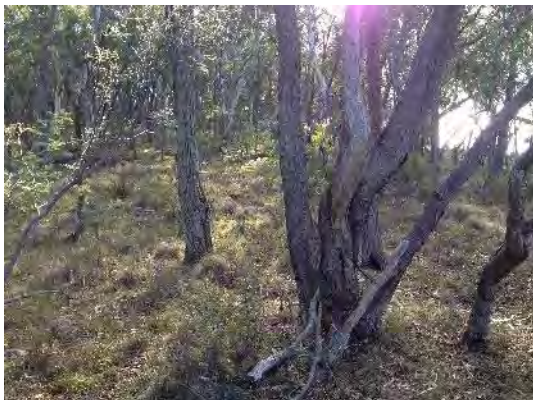
Figure 4 Vegetation structure of treed analogue site (transect 7)

The treed analogue site is characterised by a canopy to 12m height with 40% canopy cover over a sparse shrubby mid-storey to 3m height and isolated shrubs to 1.5m height in the understorey. Groundcover consists of grasses and herbs with a cover of >95% (Figure 4).

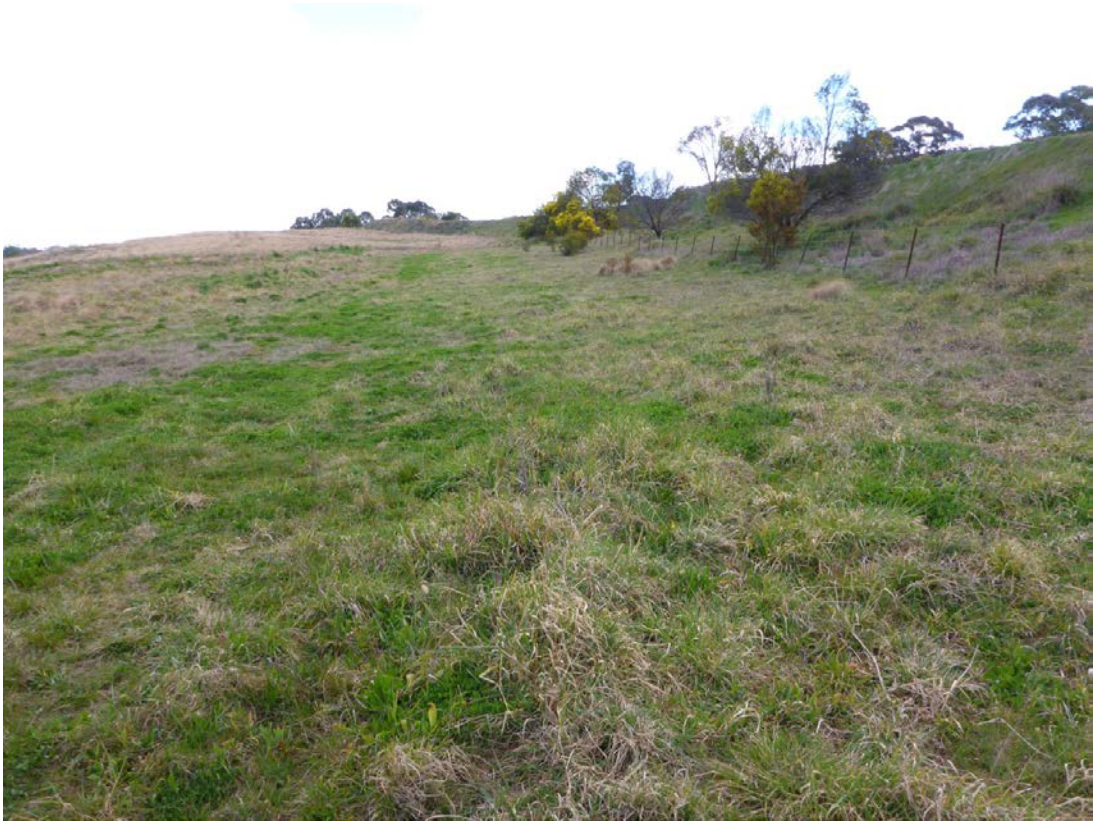
**Plate 4: Analogue Site PD3 March 2018**

Topsoil consists of a sandy clay loam over a medium clay subsoil. This area supports a perennial grass and clover pasture, including cocksfoot, tall fescue, phalaris, sub clover, with some annual ryegrass. These pasture species have a winter and spring growth habit, with the difference in pasture mass clearly evident between the 2014 (September) and 2018 (March) inspections.

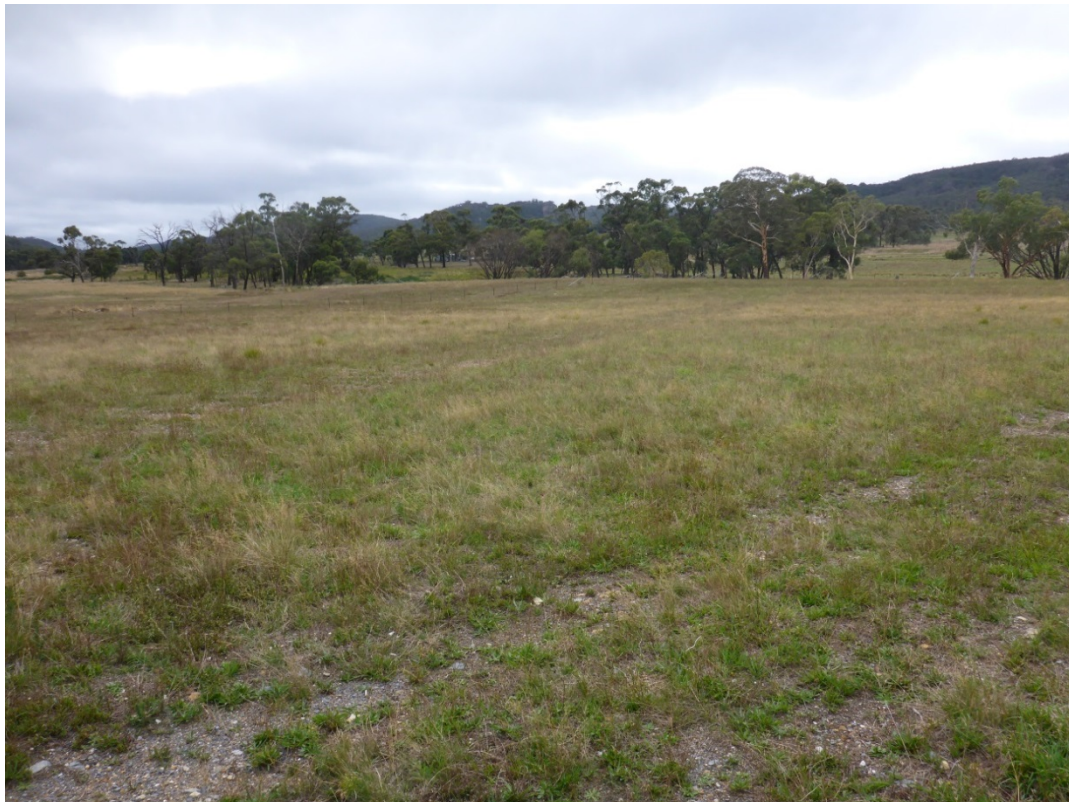
**Plate 9: Analogue Site PD6 March 2018**

**Plate 9** shows the general landscape setting for Site PD6 within Area C at Pine Dale Mine during the 2018 inspection. Pasture at Site PD6 is dominated by the perennial grasses phalaris and fescue

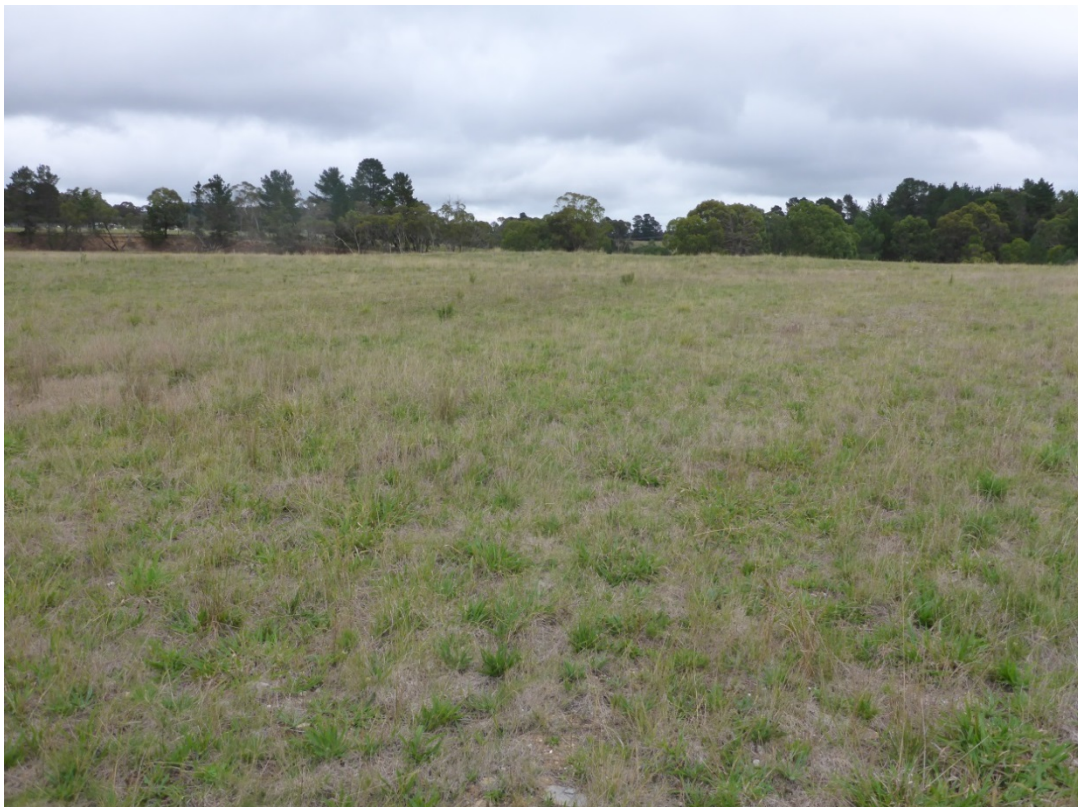
**Plate 12: Rehabilitated Site PD4 March 2018**

**Plate 11** and **Plate 12** show the general landscape setting for Site PD4 within Area 8 at Pine Dale Mine during the 2014 and 2018 inspections.

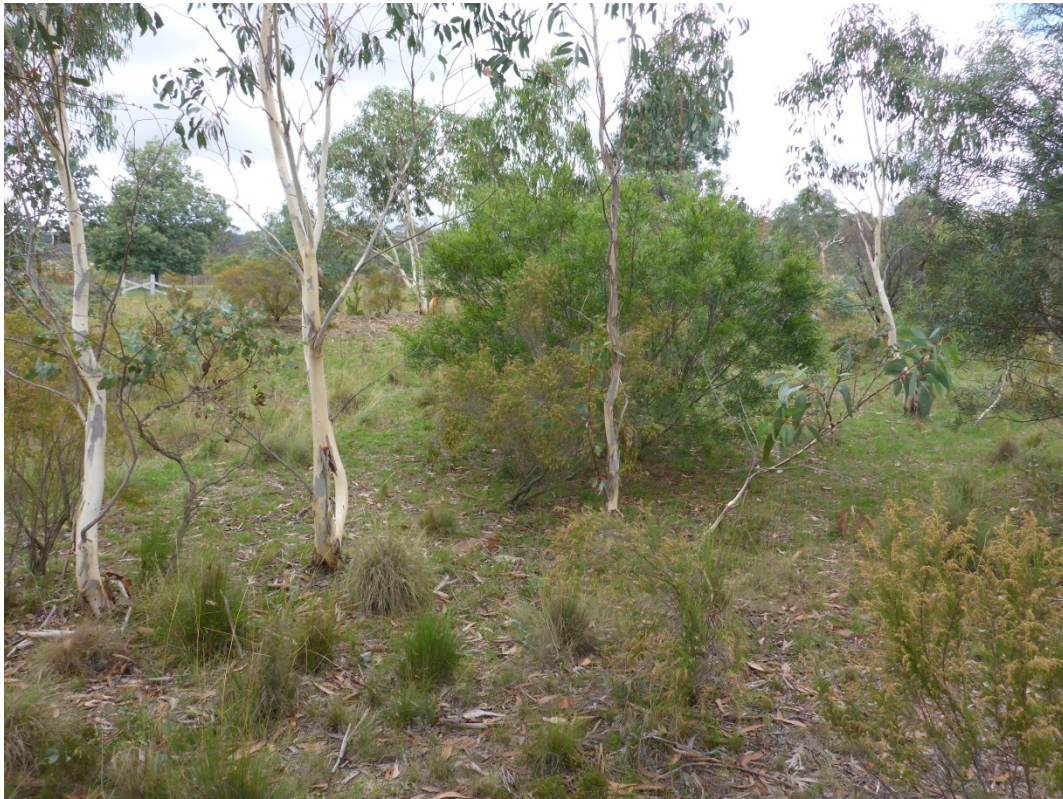
**Plate 14: Analogue Site EP4 March 2018**

**Table 16** below shows soil nutrient levels at Site EP4 from the 2018 inspection. Site EP4 was chosen as an analogue site for the Morris Property as it is undisturbed by mining did not receive any of the Morris Property treatment, being located between eucalypt trees and not accessed by fertiliser spreading equipment. **Plate 14** shows the general landscape setting for analogue Site EP4

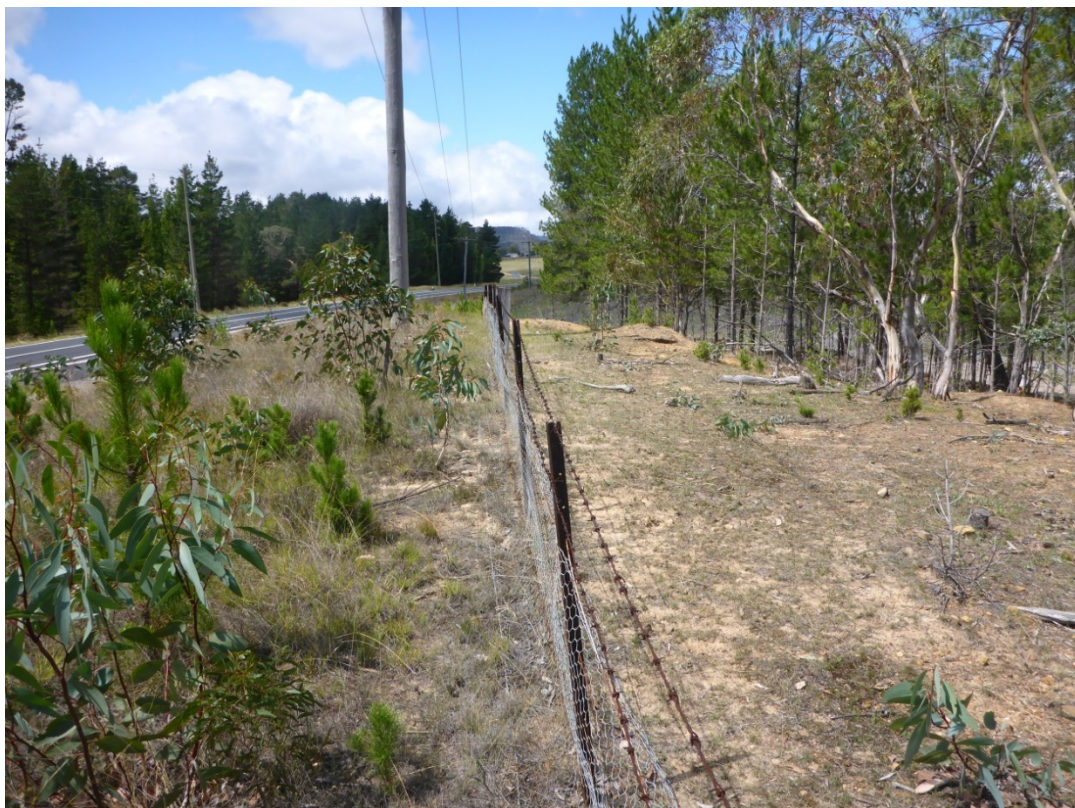
**Plate 15: Analogue Site EP6 March 2018**

**Table 17** below shows soil nutrient levels at Site EP6 from the 2018 inspection. Site EP6 was chosen as an analogue site for the Morris Property as it is undisturbed by mining and also located in a roadside reserve and not accessed by fertiliser spreading equipment. **Plate 15** shows the general landscape setting for analogue Site EP6.

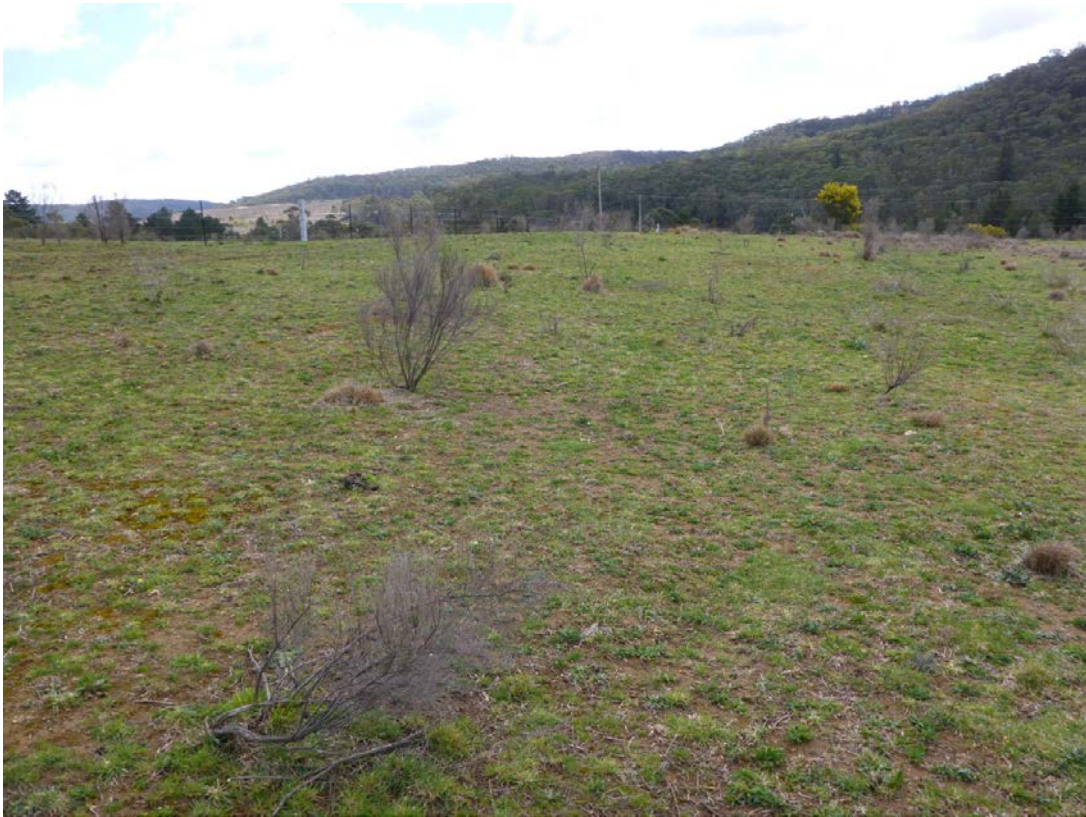
**Plate 16: Rehabilitated Site EP1 September 2014**

**Plate 16** and **Plate 17** show the general landscape setting for Site EP1 within the Morris Property at Enhance Place Mine during the 2014 and 2018 inspections.

Overgrazing is still a major land management issue here, however increase in perennial grass pasture density have been achieved nonetheless.

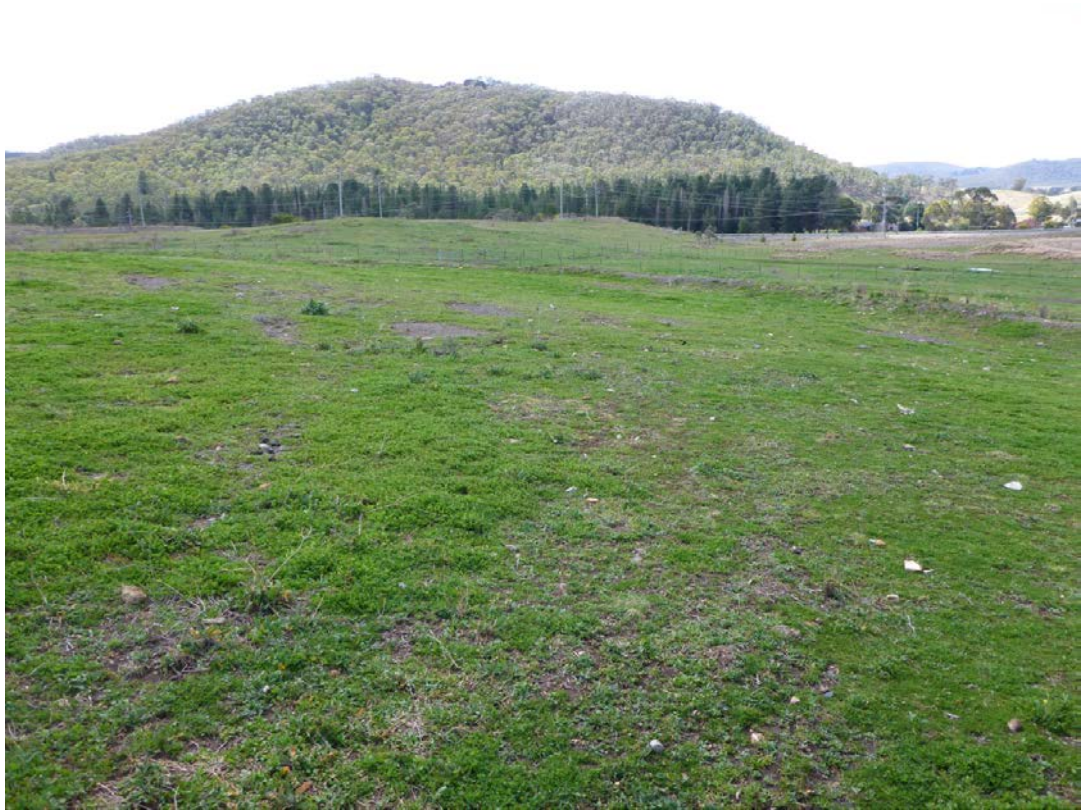
**Plate 18: Rehabilitated Site EP3 September 2014**

**Plate 18** and **Plate 19** show the general landscape setting for Site EP3 within the Morris Property at Enhance Place Mine during the 2014 and 2018 inspections.

Overgrazing is still a major land management issue here, however increase in perennial grass pasture density have been achieved nonetheless.

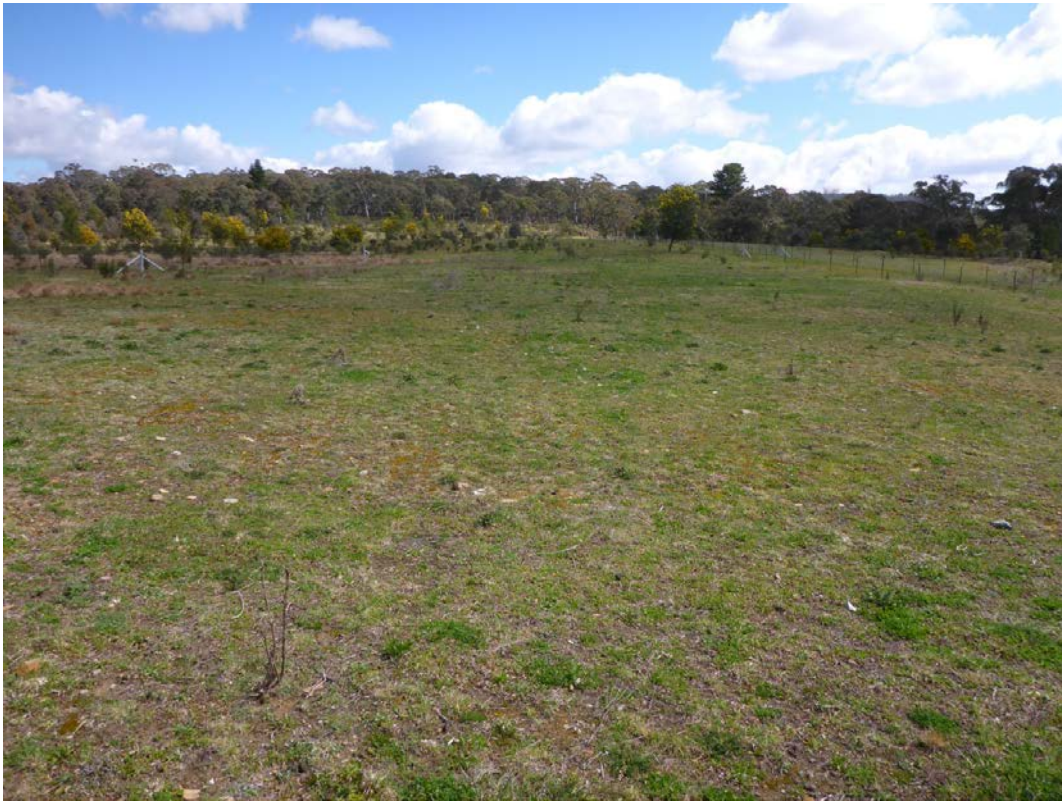
**Plate 21: Rehabilitated Site EP2 September 2014**

The Crown Land Block adjacent to the Morris property is grazed only by kangaroos with domestic stock being excluded. In 2014 EP2 had sufficient groundcover and a desirable pasture species composition with no further remediation work recommended.

**Plate 21** and **Plate 22** show the general landscape setting for Site EP2 within the Morris Property at Enhance Place Mine during the 2014 and 2018 inspections, with greater than 80% groundcover.
