PINE DALE MINE

ANNUAL REVIEW

2019

Prepared by: Enhance Place Pty Ltd
February 2020

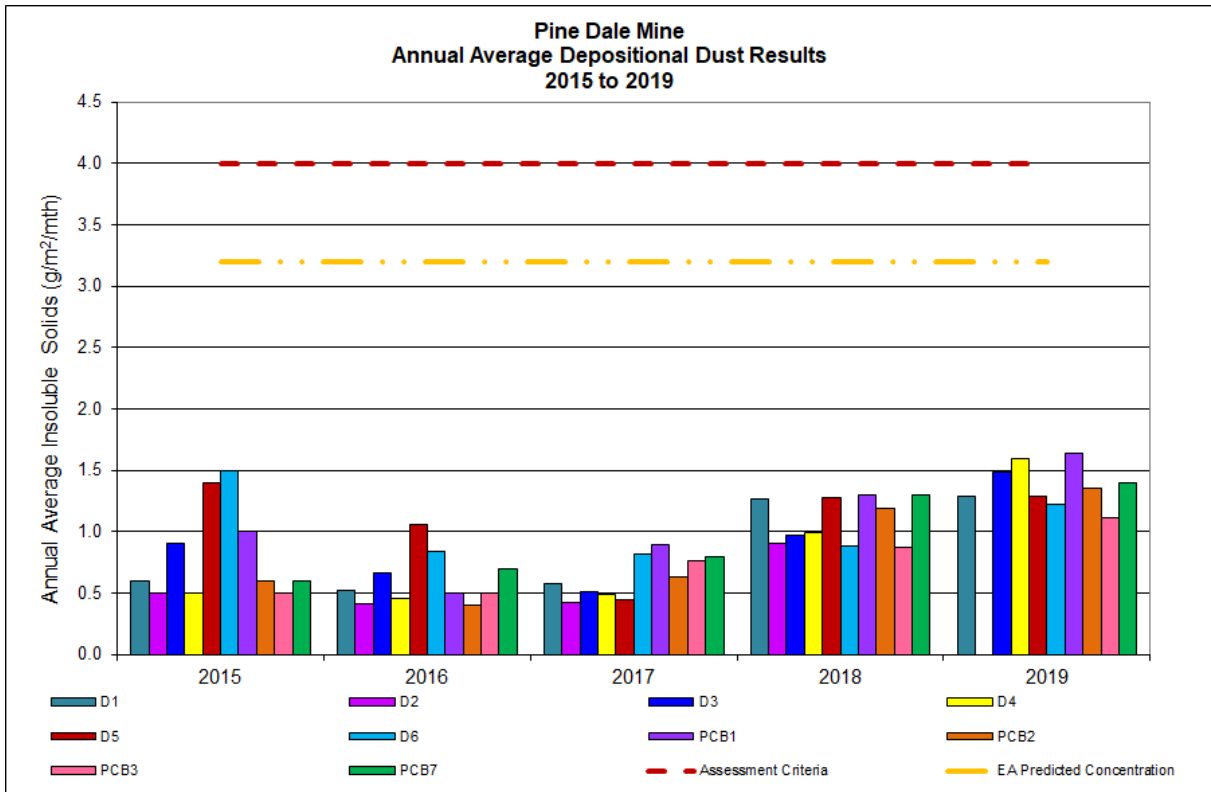
An examination of the historical data indicates a slight increase in the annual average depositional dust concentrations at the site during the period 2017 to 2019. Annual deposited dust concentrations shown in **Figure 1** reflect the operations that occurred within PDM in a care and maintenance state. Results observed in 2018 and 2019 have generally increased. These increases are considered to be due to below average rainfall (refer **Section 6.3** for rainfall totals) resulting in low soil moisture which makes the region more prone to dust storms, with dust storms observed during 2018 and 2019. All of the 2019 annual average depositional dust results are shown to be lower than the concentrations predicted in the site Environmental Assessment (predicted annual average of 3.2g/m²/month deposited dust) and the assessment criterion.

Figure 1 Historical Depositional Dust Data

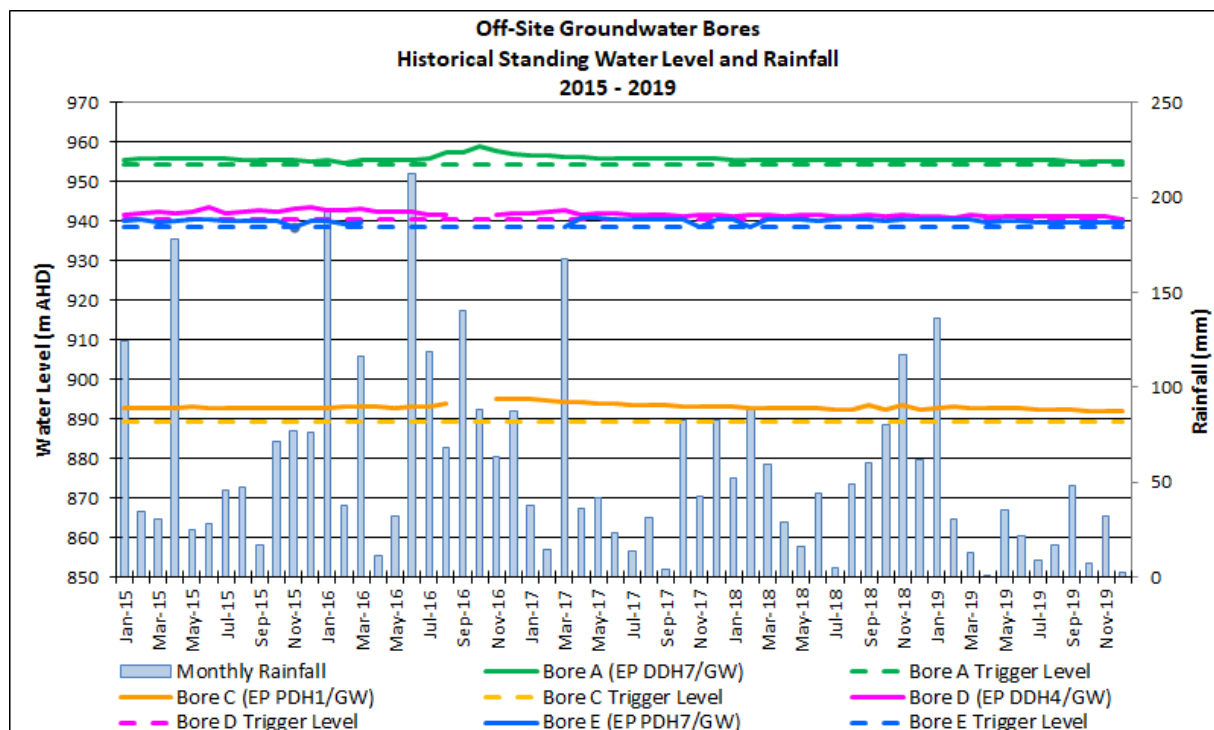
The monthly standing water level measurements compared with rainfall is shown in **Figure 14**. The quarterly pH and electrical conductivity measurements for the period 2015 - 2019 are shown in **Figure 15** and **Figure 16**. The results of quarterly water quality monitoring within the Yarraboldy (off-site) groundwater bores for pH, EC and standing water level are generally shown to be consistent throughout the 2019 monitoring period.

Figure 14 Off-Site Groundwater Bores Historical Standing Water Level

Note: Gaps in graph indicate no standing water level measurement was able to be taken.

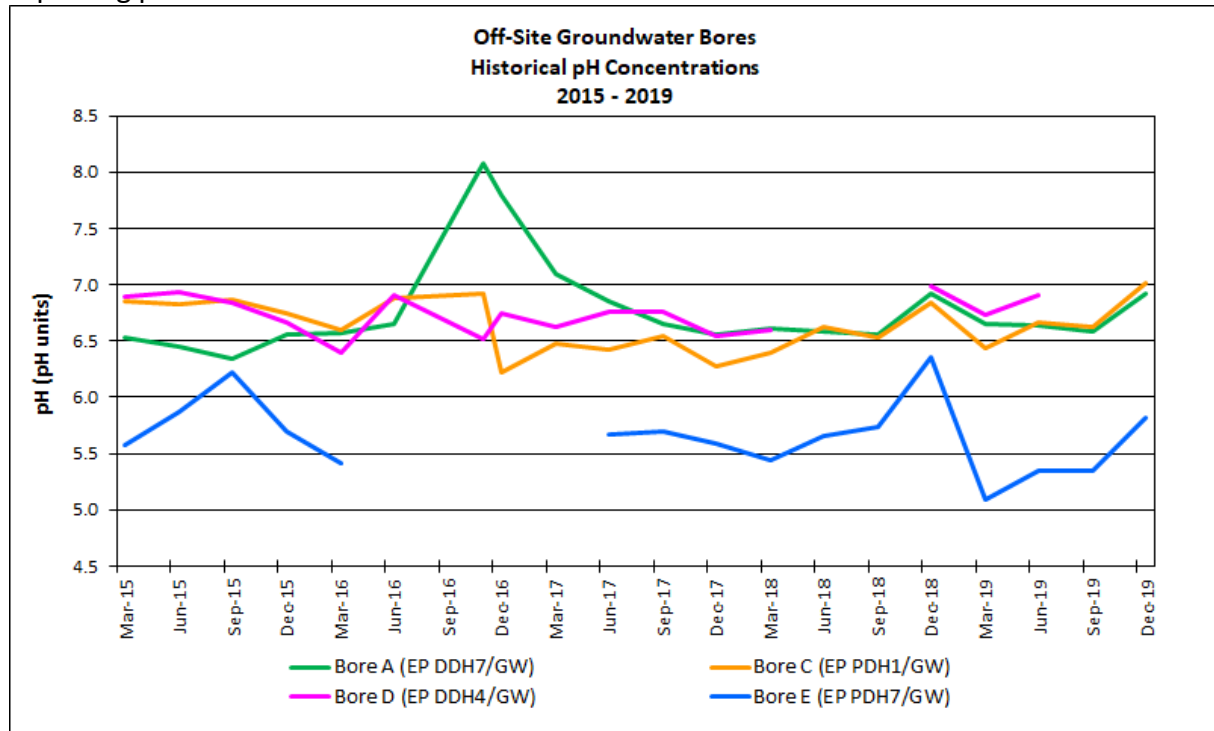
Figure 15 Off-Site Groundwater Bores Historical pH Results

Groundwater samples collected from off-site bores were shown to be within pH trigger value ranges with the exception of the following:

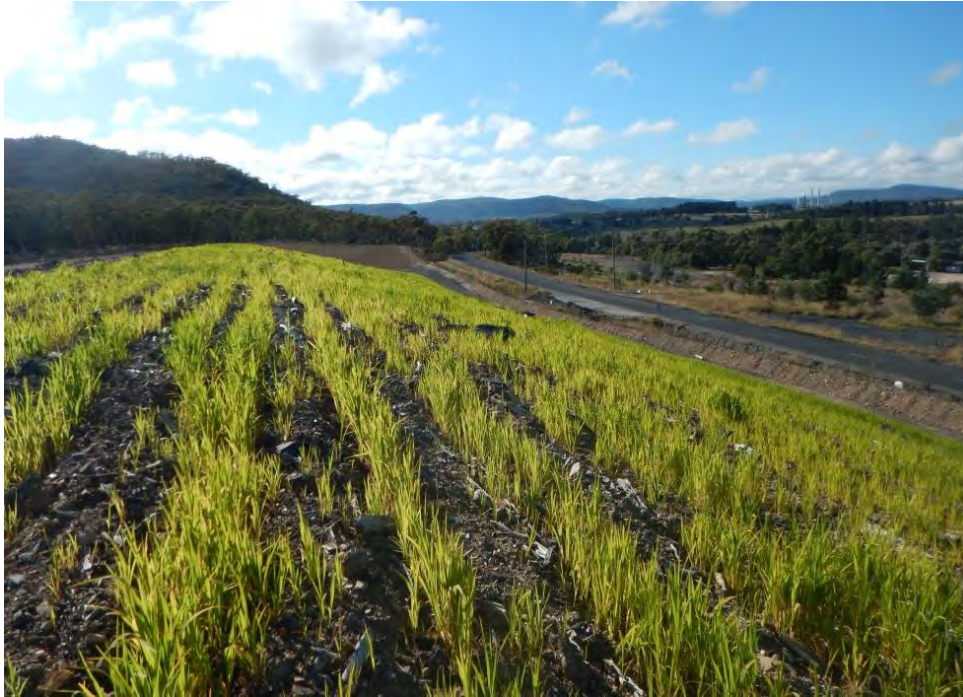
Plate 1 Amenity bund – application of mulch & native seed mix (2015)

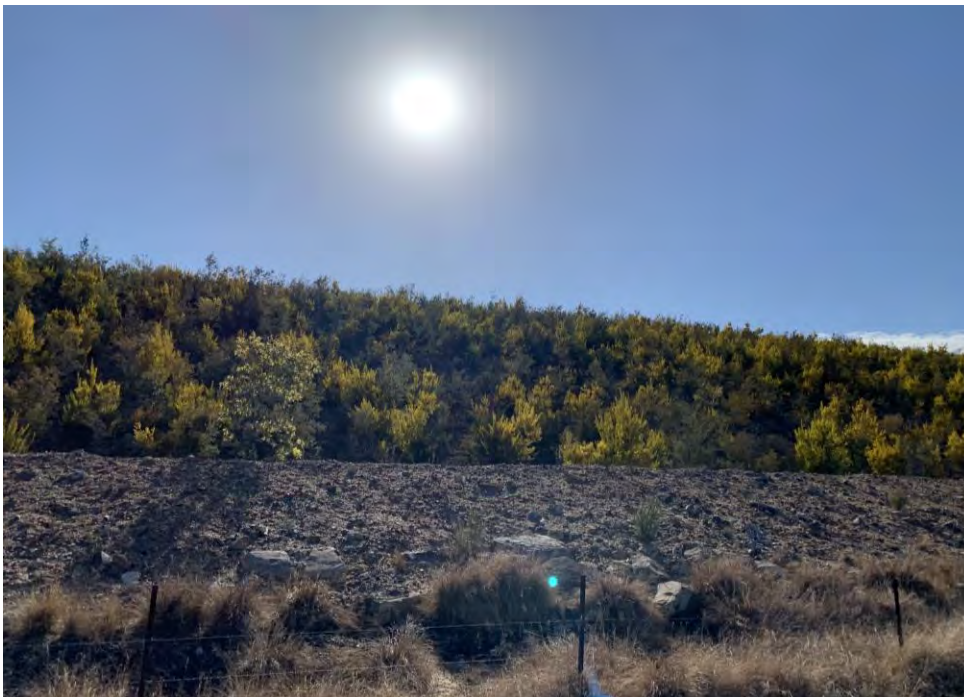
Plate 2 Amenity Bund – December 2019

During the reporting period, maintenance works was not required to be undertaken in the Yarraboldy Extension. Rehabilitation work was limited to application of fertiliser due to the persistent dry conditions. Growth of vegetation on the bund (photo taken December 2019), which is representative of growth during the 2019 reporting period is shown in **Plate 2**.

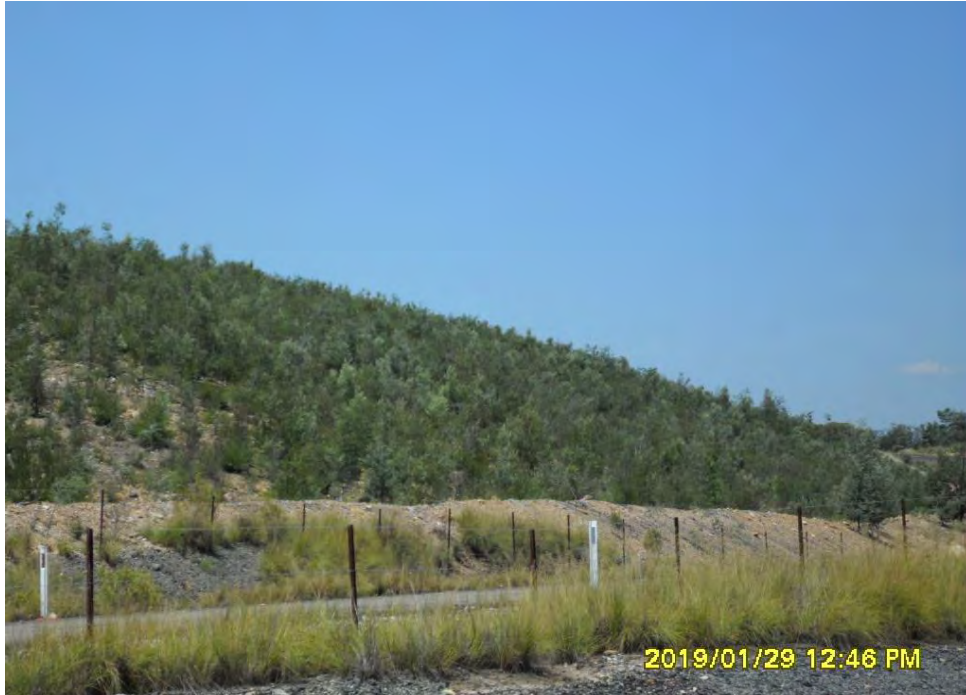
Plate 3 Amenity Bund – January 2019

Growth during the previous January 2019 and December 2017 are shown for comparison in **Plate 3** and **Plate 4**.

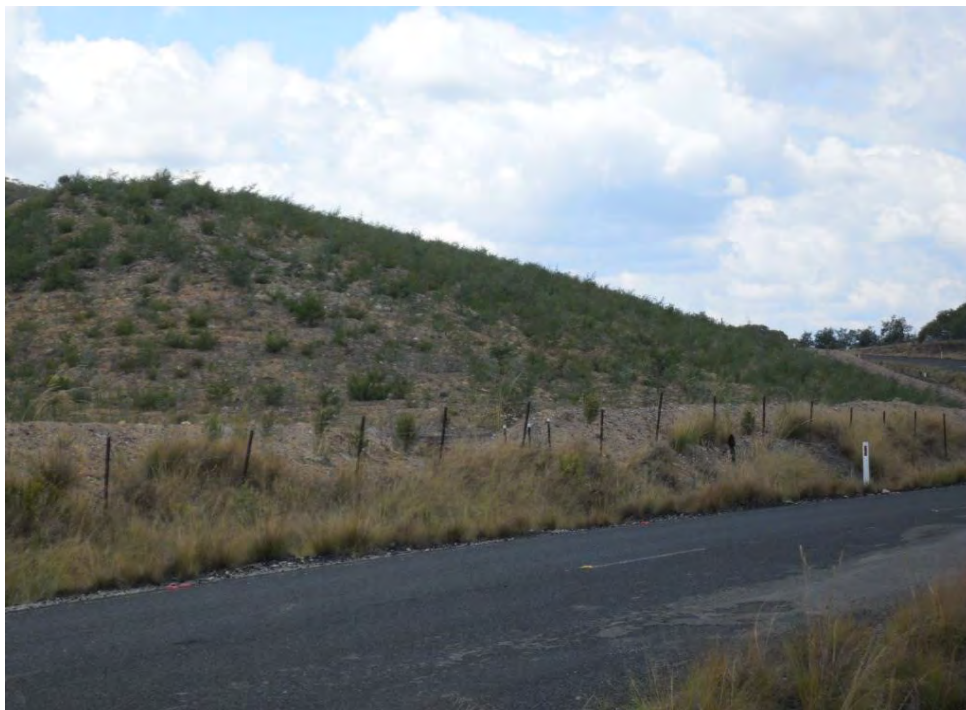
Plate 4 Amenity Bund – December 2017

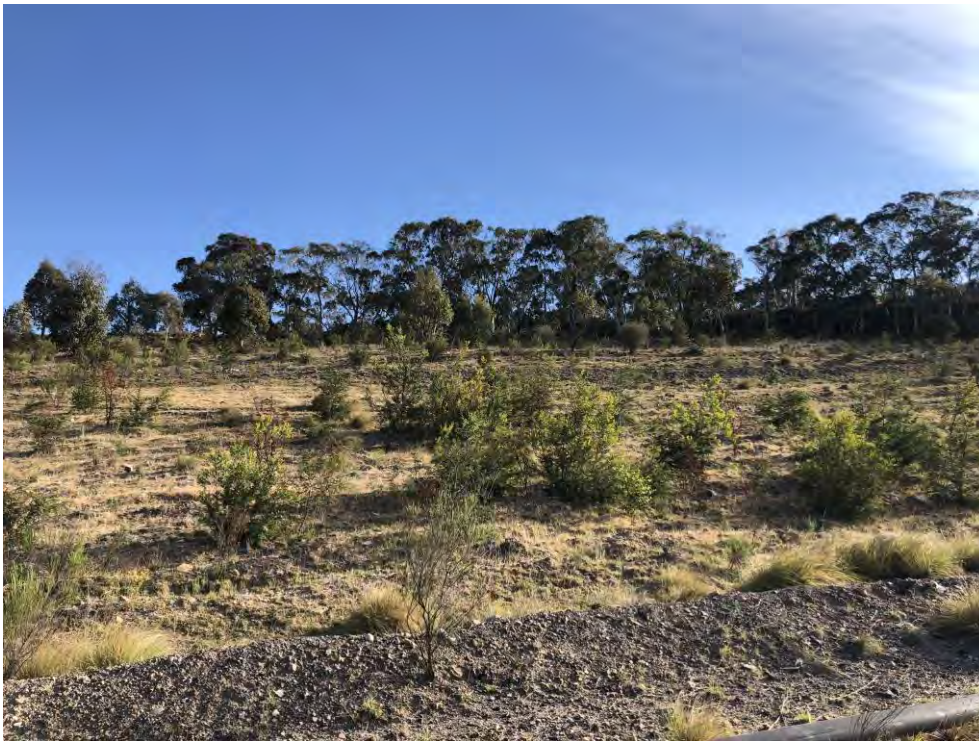
The total vegetation cover at Area A during December 2019 is shown in **Plate 5**.

Plate 5 Area A – Vegetation cover – December 2019

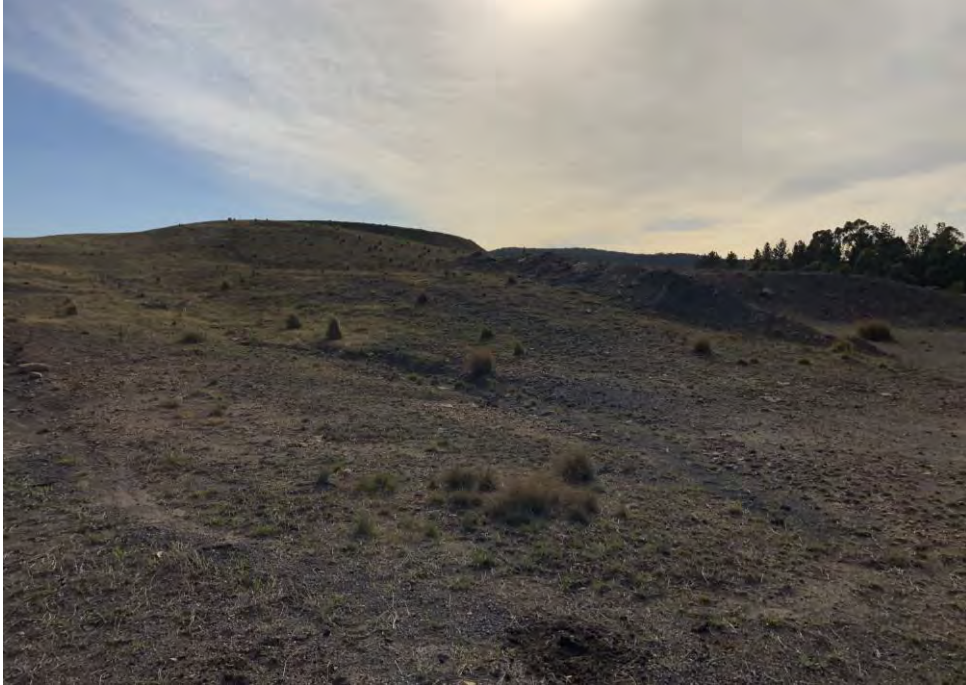
Plate 6 Area B – December 2019

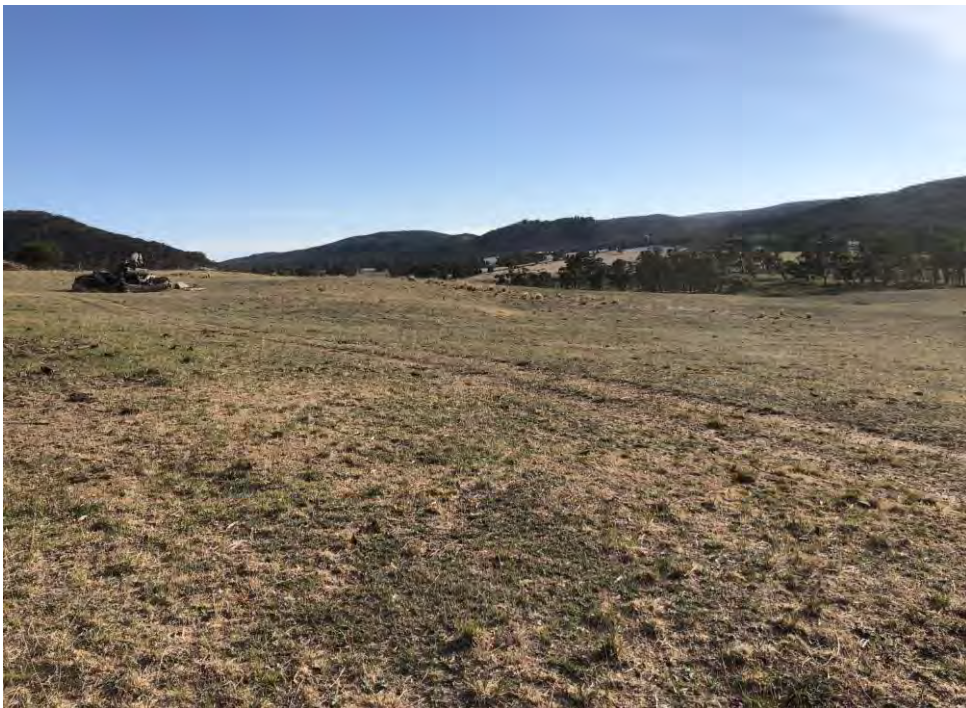
Plate 7 Area C Pasture Growth – December 2019

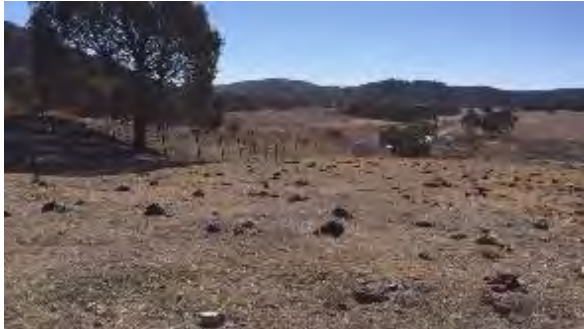
Figure 1 Pasture composition at the Pasture Analogue site

Species composition at pasture rehabilitation areas – Pasture rehabilitation areas are established with a mix of ~70% perennial grasses and ~20% annual legumes and are consistent with species composition at the analogue pasture site. Examples of analogue pasture and Transect 1 pasture are shown in Figure 2 and Figure 3.

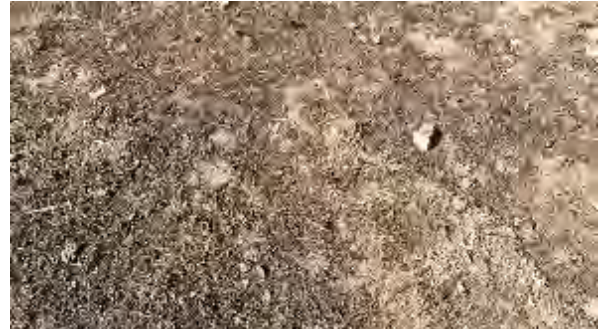
Figure 2 Typical pasture composition at Transect 1

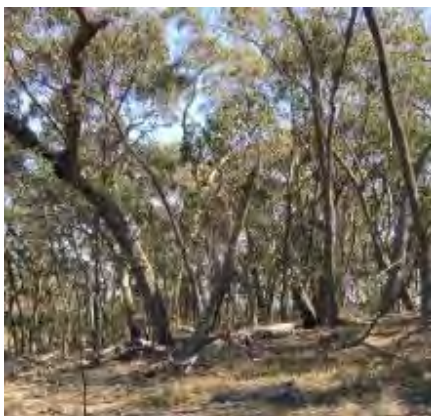
The treed analogue site is characterised by a canopy to 14m height with 20% canopy cover over a sparse shrubby mid-storey to 3m height and isolated shrubs to 1.5m height in the understorey. Groundcover consists of grasses and herbs with a cover of >95% (Figure 4).

Figure 3 Vegetation structure of Treed Analogue site (Transect 7)

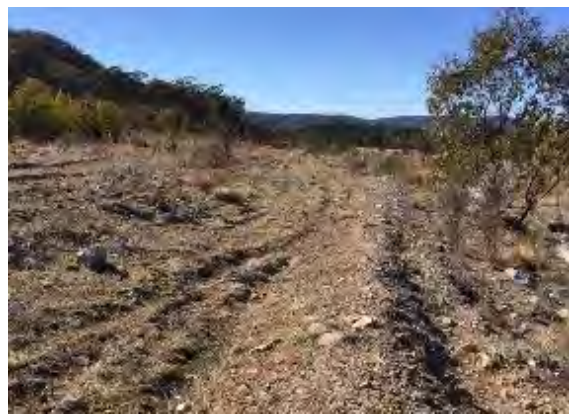
Figure 4 Transect 6 vegetation structure

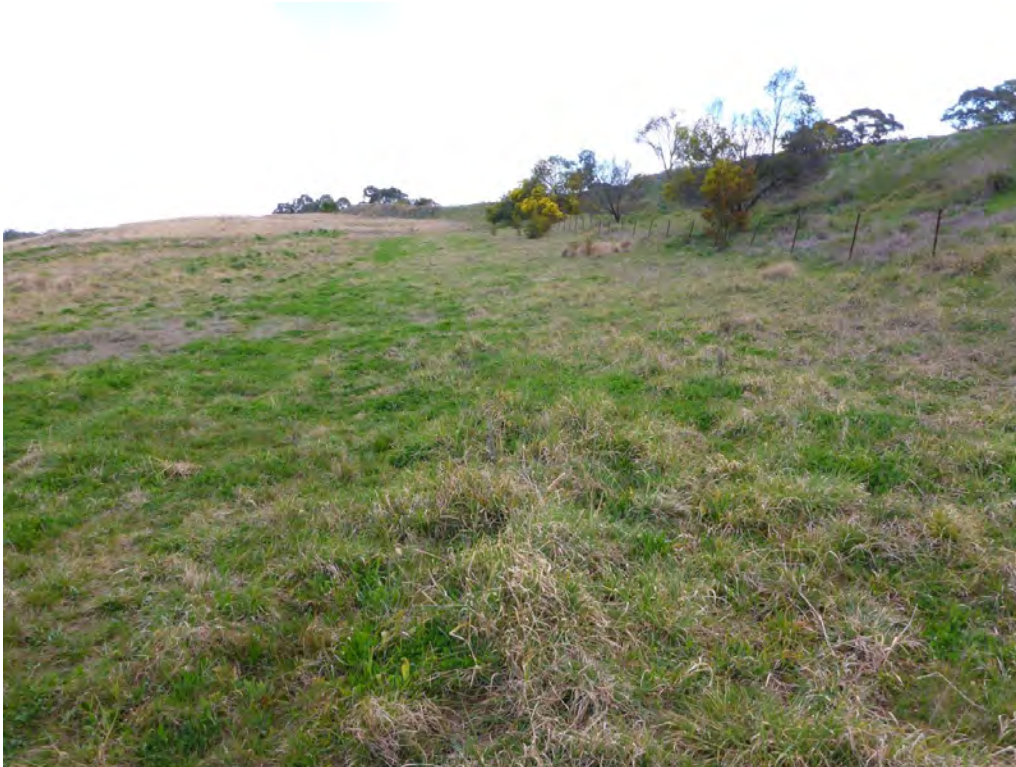
Photo 1 Analogue Site PD3 – September 2014

Topsoil consists of a sandy clay loam over a medium clay subsoil. This area supports a perennial grass and clover pasture, including cocksfoot, tall fescue, phalaris, sub clover, with some annual ryegrass. These pasture species have a winter and spring growth habit, with the difference in pasture mass clearly evident between the 2014 (September) and 2018 (March) inspections.

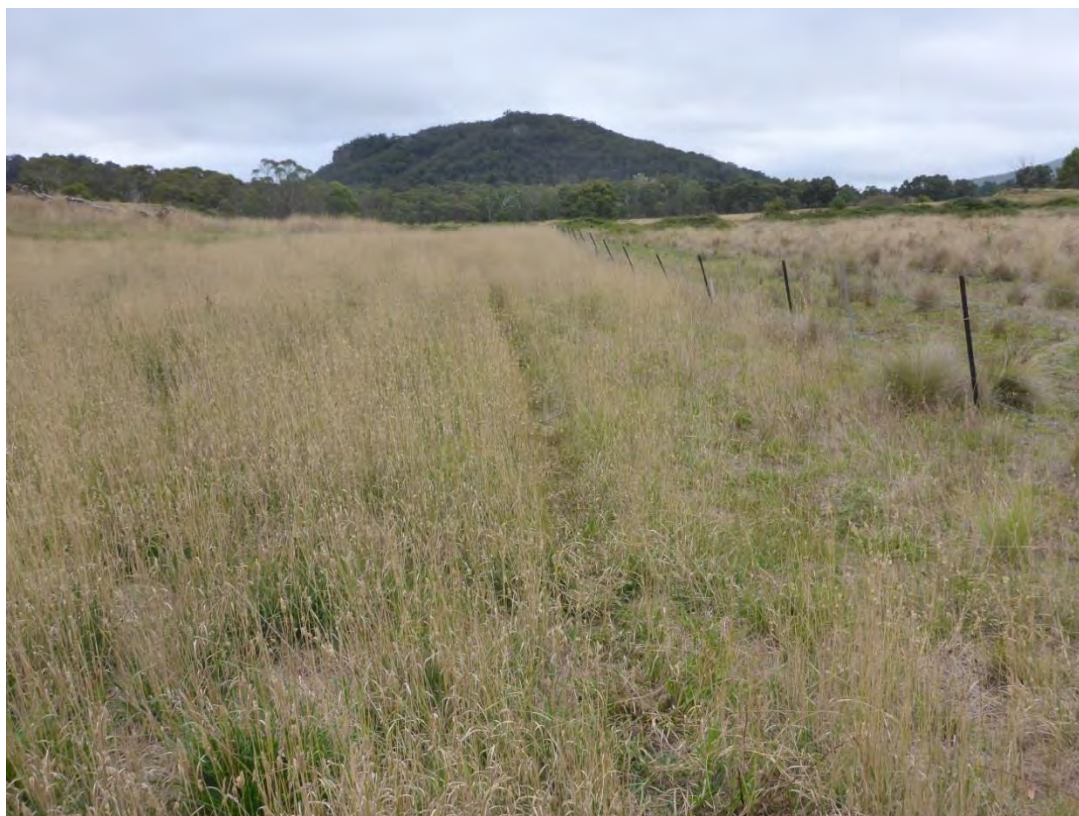
Photo 3 Analogue Site PD6 March 2018

Photo 3 shows the general landscape setting for Site PD6 within Area C at Pine Dale Mine during the 2018 inspection. Pasture at Site PD6 is dominated by the perennial grasses phalaris and fescue.

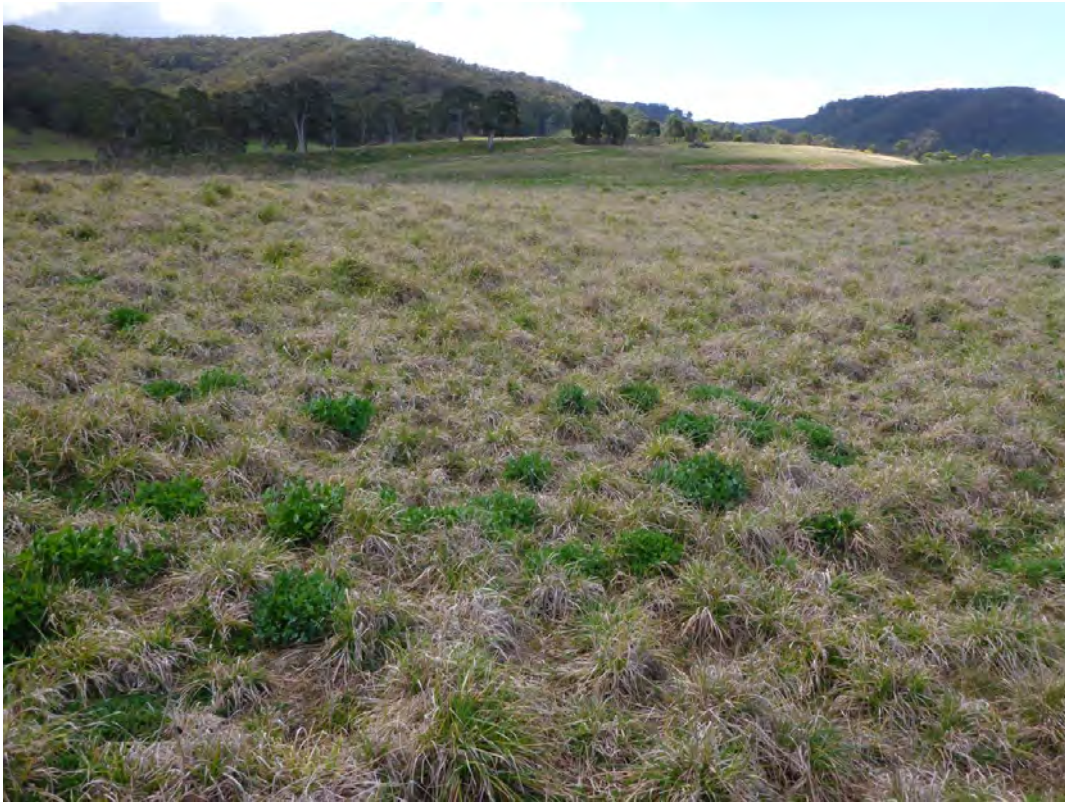
Photo 4 Rehabilitated Site PD1 September 2014

Pasture at Site PD1 is dominated by perennial cocksfoot and paspalum grass pasture with some sub clover and arrowleaf clover present in the sward, with greater than 90% groundcover. There is no African lovegrass present. The difference in pasture growth between autumn and spring can clearly be seen.

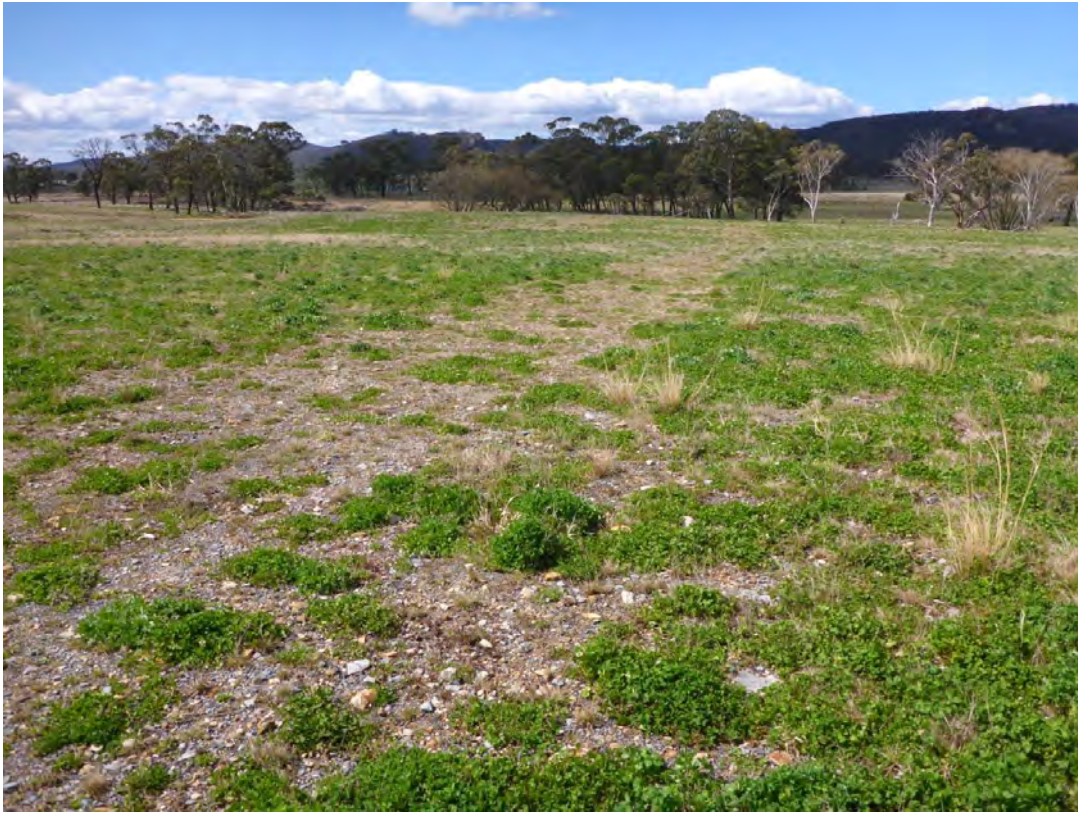
Photo 6 Rehabilitated Site PD2 September 2014

Pasture at Site PD2 is dominated by perennial cocksfoot and paspalum grass pasture with the herb plantain and some arrowleaf clover present in the sward, with greater than 80% groundcover. There are isolated African lovegrass tussocks present which comprise less than 5% of the pasture sward. Significant increase in perennial grass groundcover can be seen between the two inspection periods.

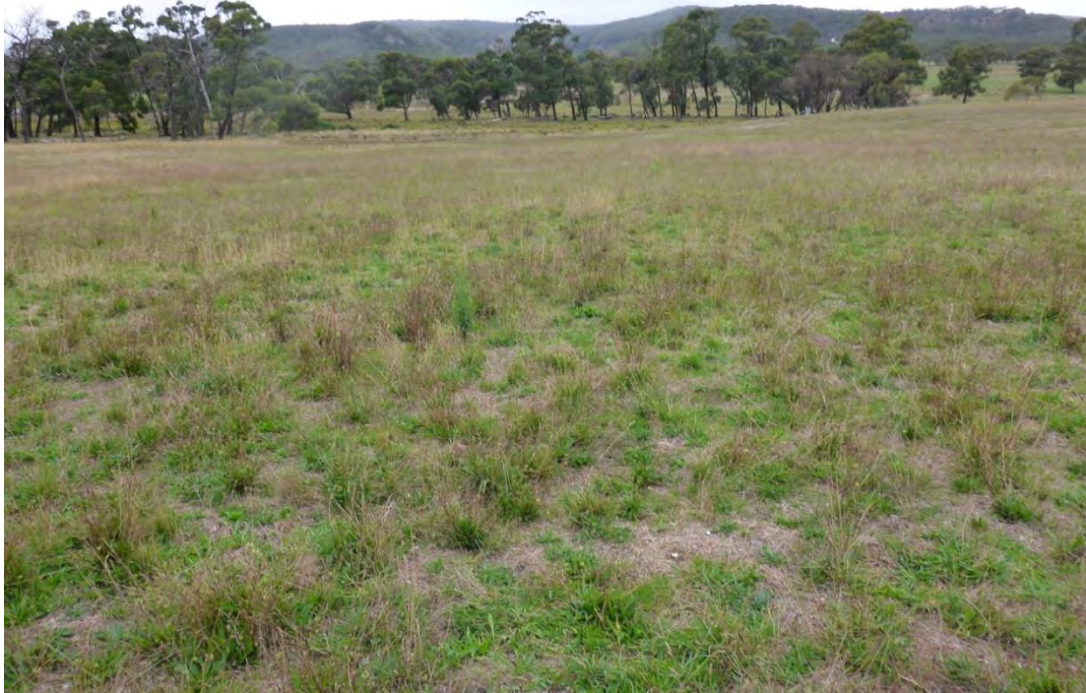
Photo 8 Rehabilitated Site PD7 March 2018

Photo 8 shows the general landscape setting for Site PD7 within Area C at Pine Dale Mine during the 2018 inspection. Pasture at Site PD6 is dominated by perennial grasses phalaris, fescue and paspalum along with the herb plantain and arrowleaf clover. There is greater than 90% groundcover with only isolated tussocks of African lovegrass, which comprises less than 5% of the pasture sward.

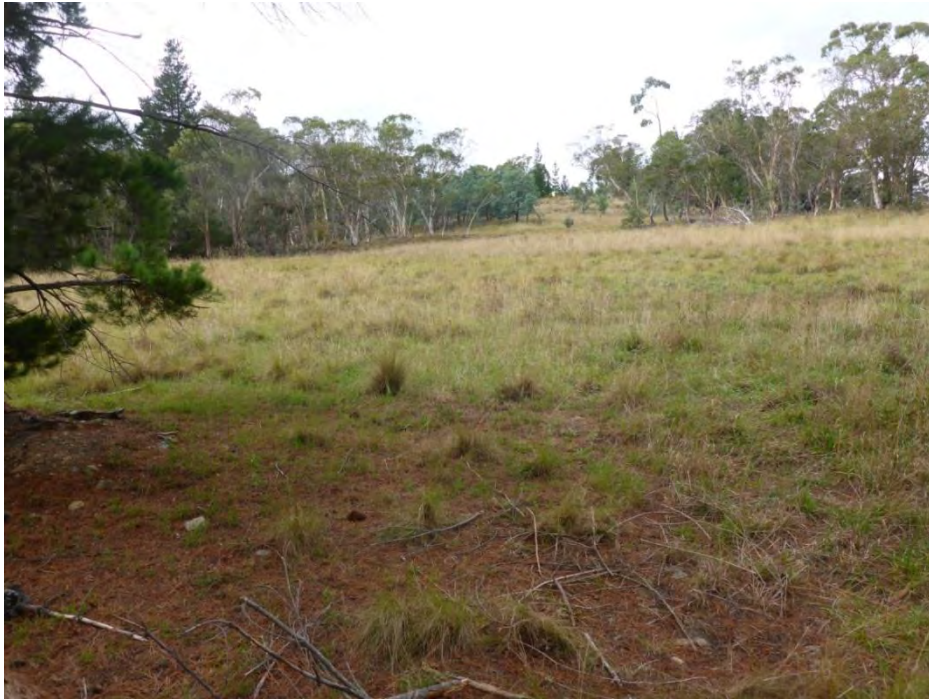
Photo 9 Analogue Site PD8 March 2018

Photo 9 shows the general landscape setting for Site PD8 within Area 8 at Pine Dale Mine during the 2018 inspection. Pasture at Site PD8 is dominated by perennial phalaris and fescue with some arrowleaf clover present in the sward, with greater than 90% groundcover. There are isolated African lovegrass tussocks present which comprise less than 5% of the pasture sward.

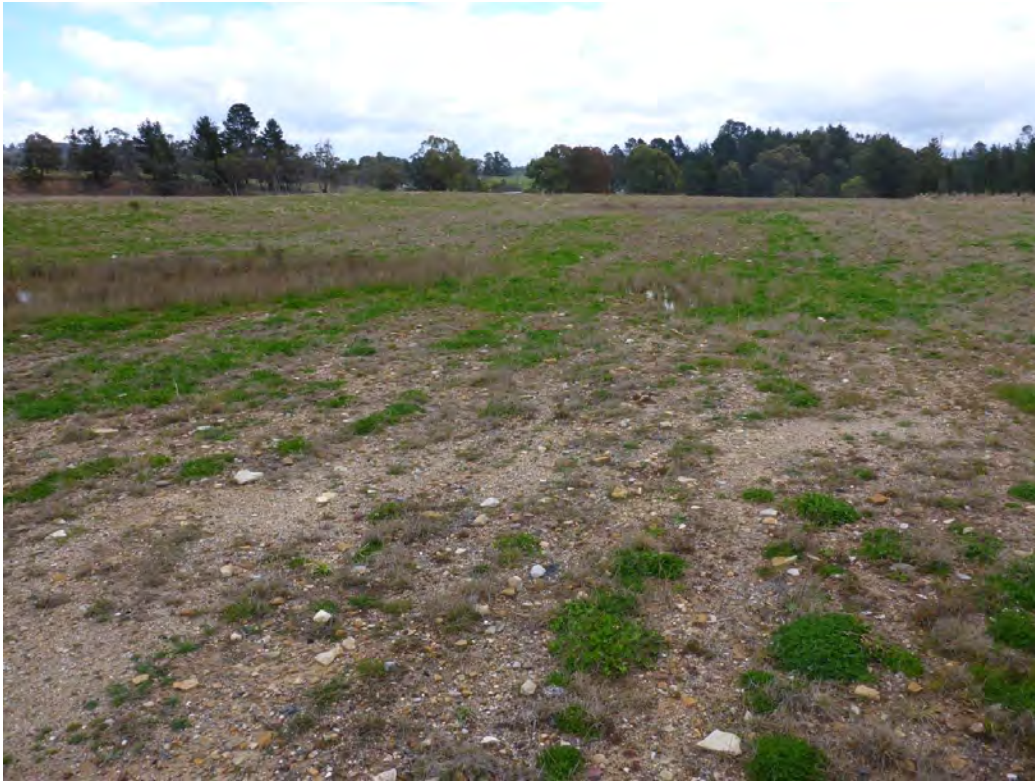
Photo 10 Rehabilitated Site PD4 September 2014

Photo 10 and **Photo 11** show the general landscape setting for Site PD4 within Area 8 at Pine Dale Mine during the 2014 and 2018 inspections.

Pasture at Site PD4 is dominated by perennial grasses cocksfoot, fescue and paspalum with some arrowleaf clover present in the sward, and greater than 90% groundcover. There are isolated African lovegrass tussocks present which comprise less than 5% of the pasture sward. Significant increase in perennial grass groundcover can be seen between the two inspection periods.

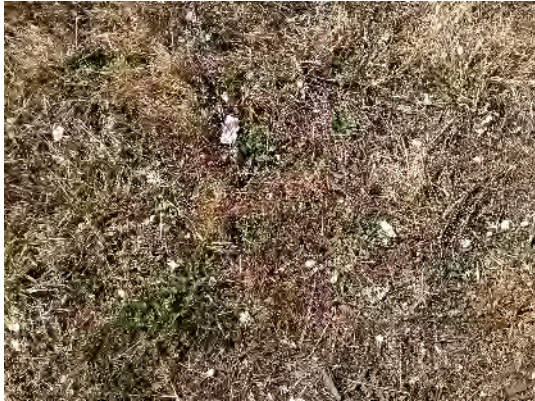
Figure 2 Typical pasture composition of transects 1, 2 and 3

Species composition at pasture rehabilitation areas – Pasture rehabilitation areas are established with a mix of 70% perennial grasses and 20% annual legumes and are representative of species composition at the analogue pasture site. An example of transect 1, 2 and 3 pasture is shown in Figure 2 and Figure 3.

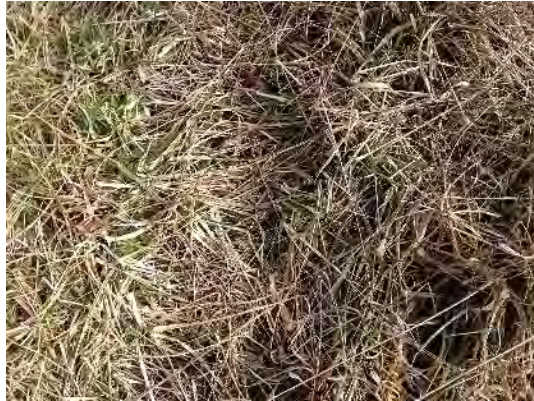
Figure 3 Pasture composition representative of transect 4

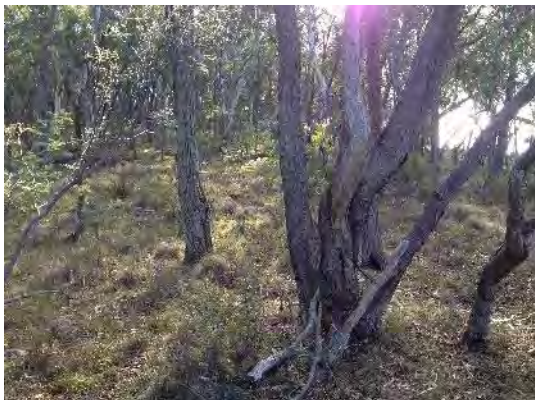
The treed analogue site is characterised by a canopy to 12m height with 40% canopy cover over a sparse shrubby mid-storey to 3m height and isolated shrubs to 1.5m height in the understorey. Groundcover consists of grasses and herbs with a cover of >95% (Figure 4).

Figure 4 Vegetation structure of treed analogue site (transect 7)

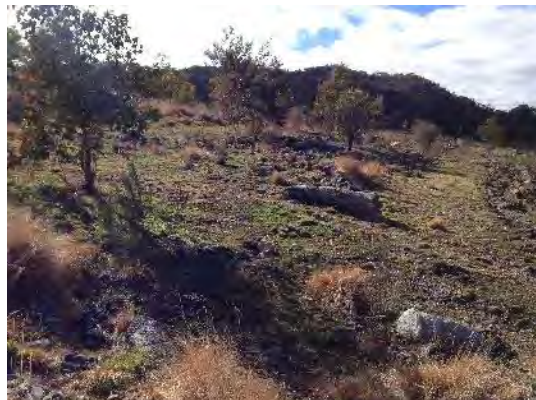
Figure 5 Transect 6 vegetation structure

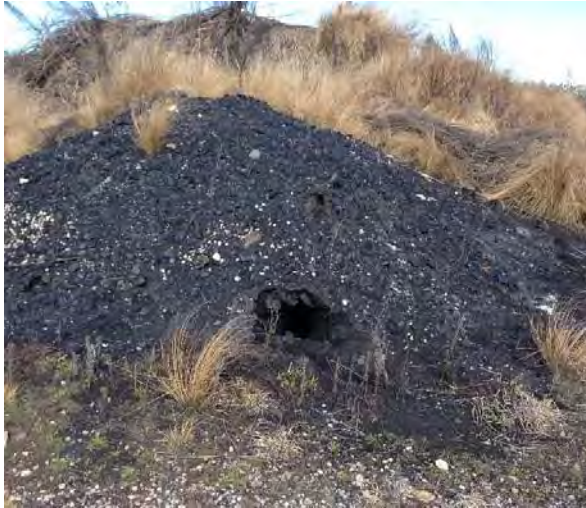
Figure 6 An active burrow in an equipment storage area

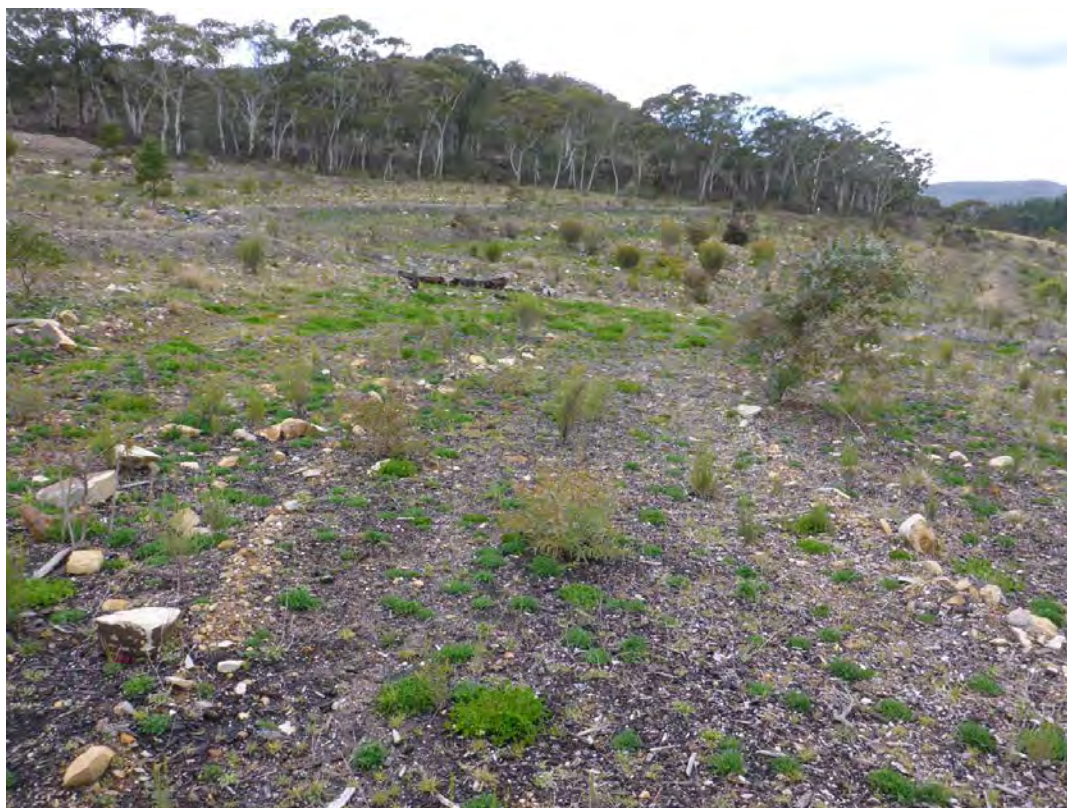
Plate 1: Rehabilitated Site PD5 September 2014

Increased growth of eucalypts can clearly be seen while groundcover consists of couch, phalaris and fescue perennial grasses with greater than 80% groundcover.

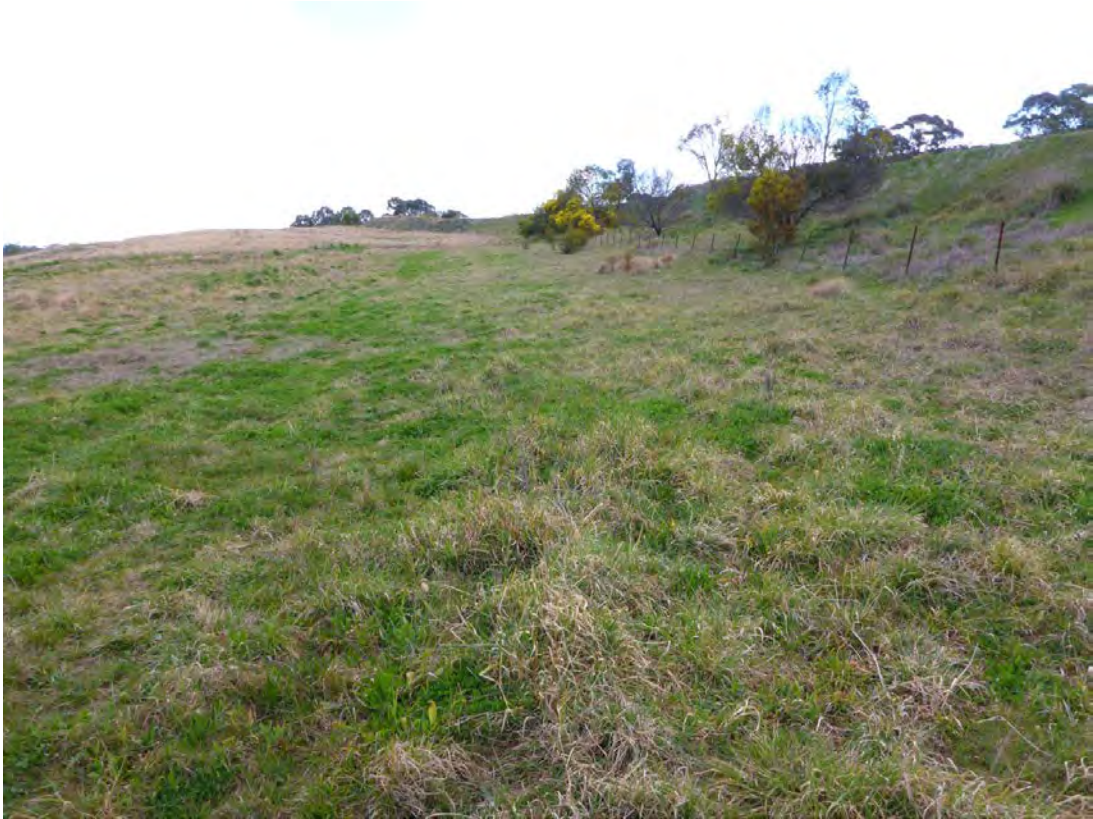
Plate 3: Analogue Site PD3 September 2014

Topsoil consists of a sandy clay loam over a medium clay subsoil. This area supports a perennial grass and clover pasture, including cocksfoot, tall fescue, phalaris, sub clover, with some annual ryegrass. These pasture species have a winter and spring growth habit, with the difference in pasture mass clearly evident between the 2014 (September) and 2018 (March) inspections.

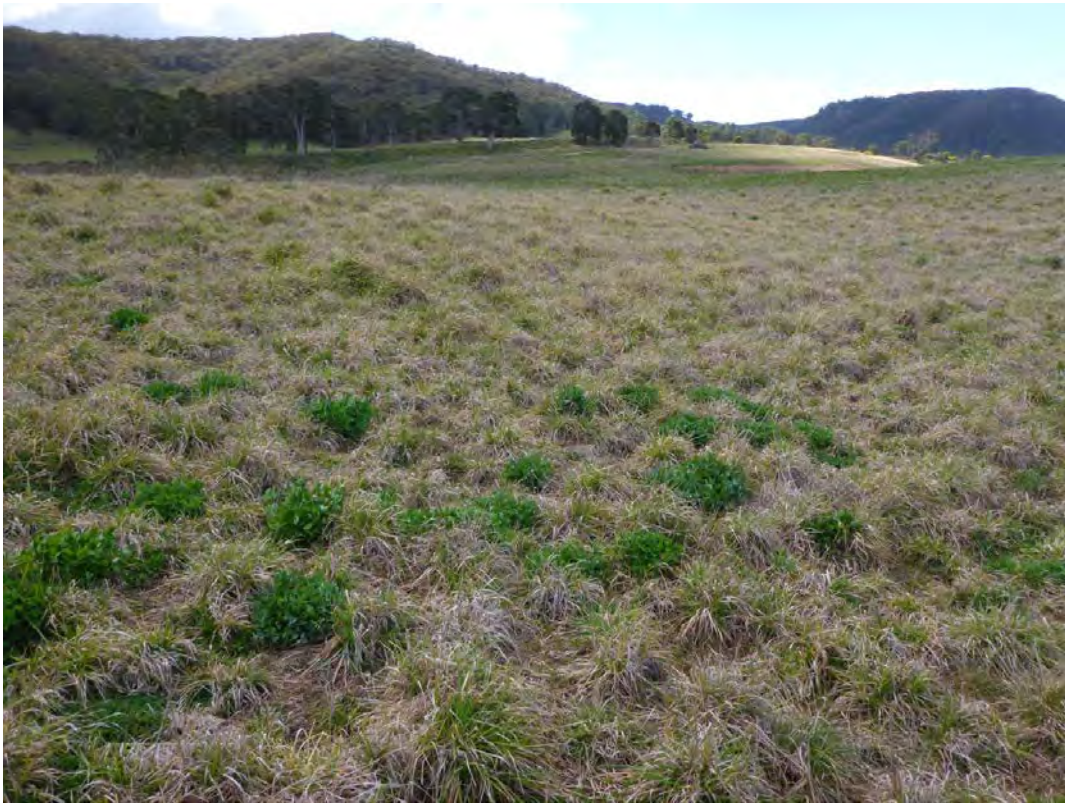
Plate 5: Rehabilitated Site PD1 September 2014

Pasture at Site PD1 is dominated by perennial cocksfoot and paspalum grass pasture with some sub clover and arrowleaf clover present in the sward, with greater than 90% groundcover. There is no African lovegrass present. Again the difference in pasture growth between autumn and spring can clearly be seen.

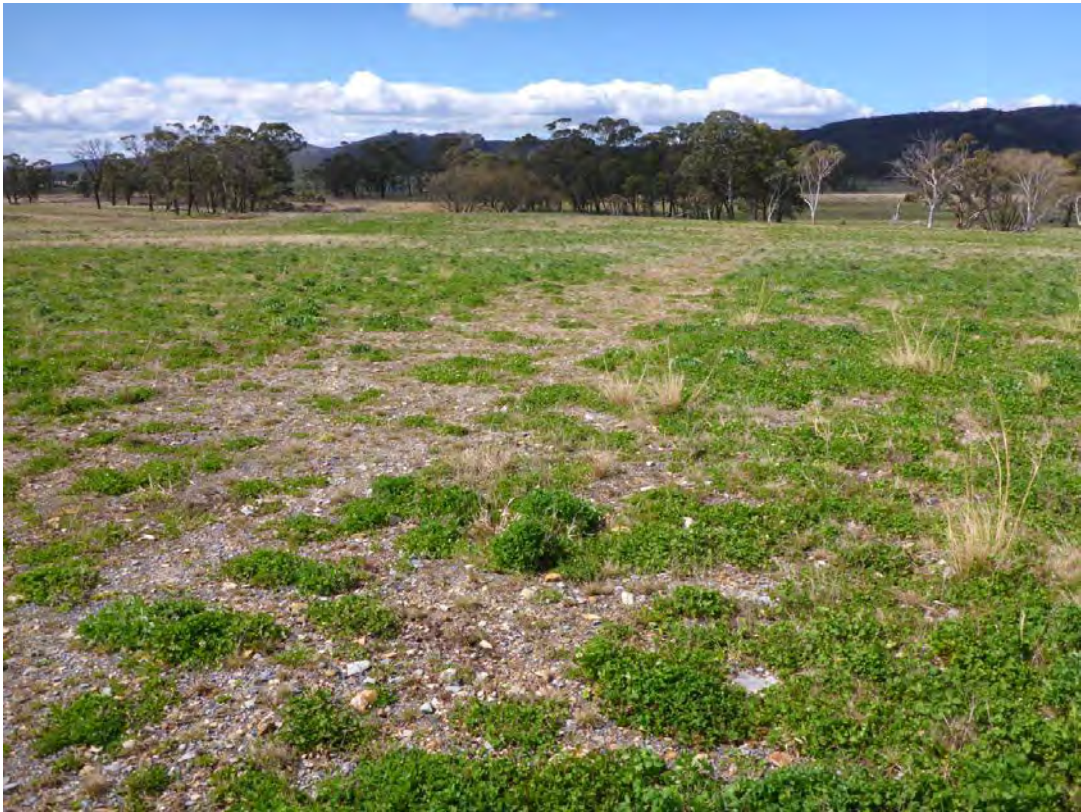
Plate 7: Rehabilitated Site PD2 September 2014

Plate 7 and **Plate 8** show the general landscape setting for Site PD2 within Area C at Pine Dale Mine during the 2014 and 2018 inspections.

Pasture at Site PD2 is dominated by perennial cocksfoot and paspalum grass pasture with the herb plantain and some arrowleaf clover present in the sward, with greater than 80% groundcover. There are isolated African lovegrass tussocks present which comprise less than 5% of the pasture sward. Significant increase in perennial grass groundcover can be seen between the two inspection periods.

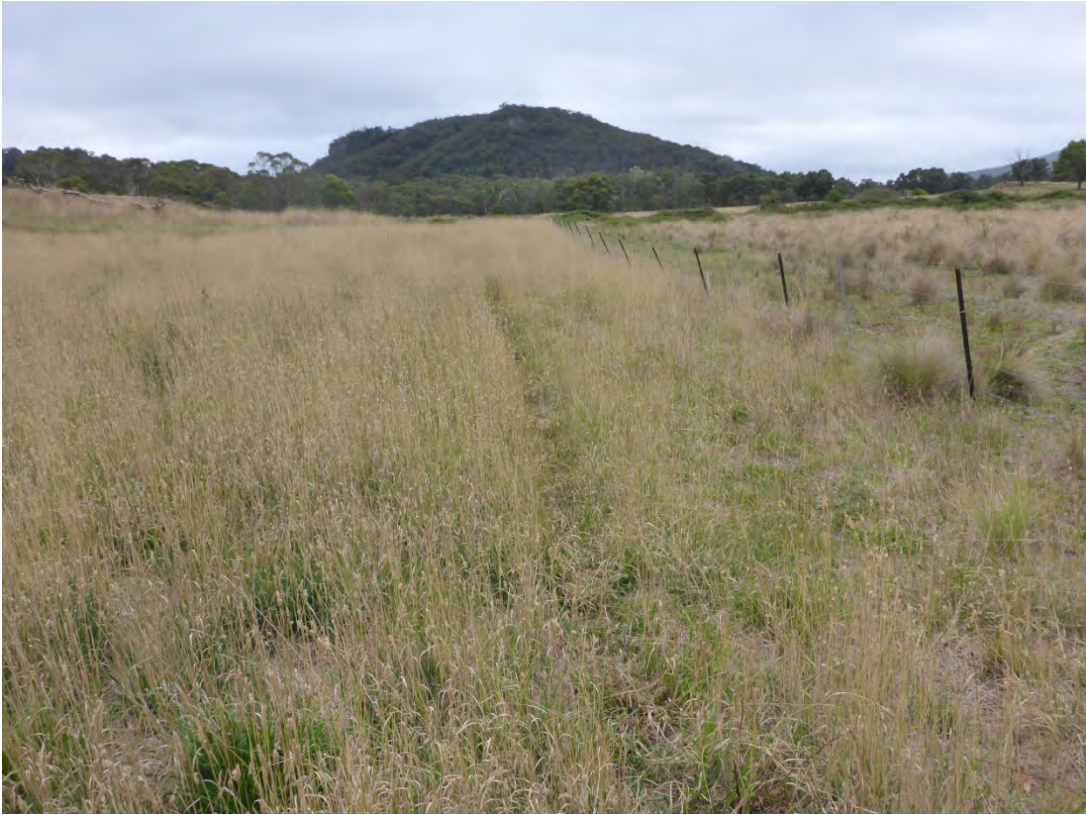
Plate 9: Analogue Site PD6 March 2018

Plate 9 shows the general landscape setting for Site PD6 within Area C at Pine Dale Mine during the 2018 inspection. Pasture at Site PD6 is dominated by the perennial grasses phalaris and fescue

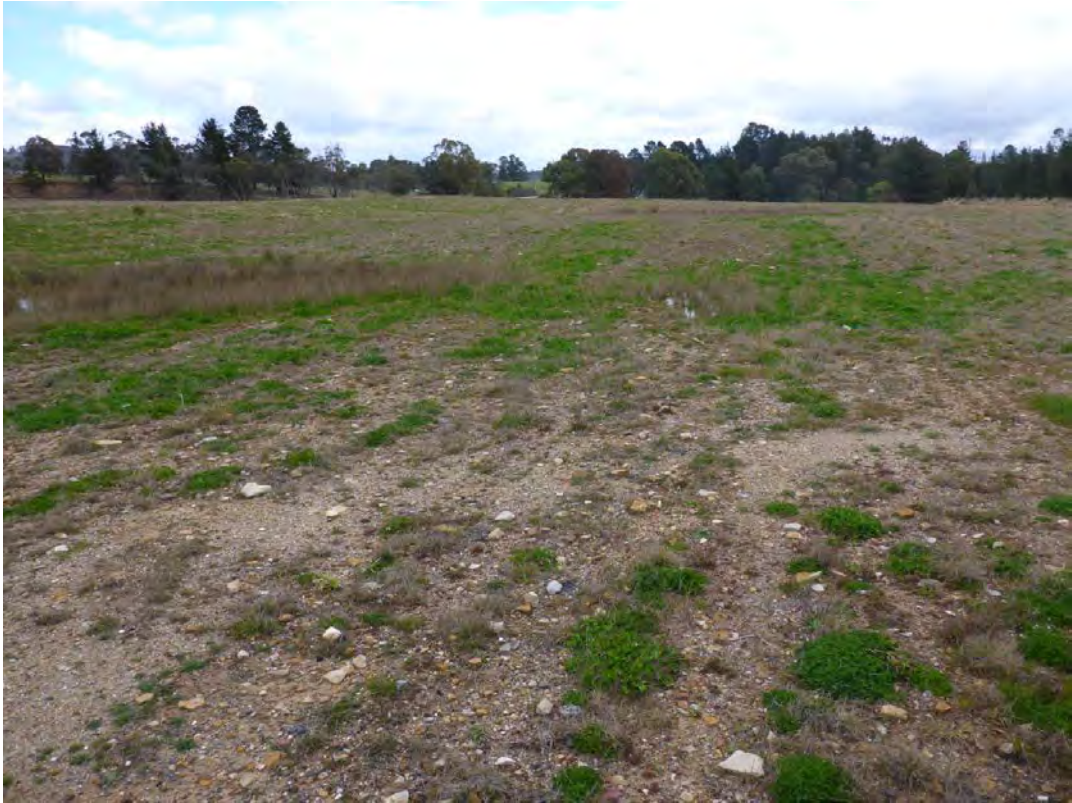
Plate 11: Rehabilitated Site PD4 September 2014

Plate 11 and **Plate 12** show the general landscape setting for Site PD4 within Area 8 at Pine Dale Mine during the 2014 and 2018 inspections.

Pasture at Site PD4 is dominated by perennial grasses cocksfoot, fescue and paspalum with some arrowleaf clover present in the sward, and greater than 90% groundcover. There are isolated African lovegrass tussocks present which comprise less than 5% of the pasture sward. Significant increase in perennial grass groundcover can be seen between the two inspection periods.
