PINE DALE MINE

ANNUAL REVIEW

2019

Prepared by: Enhance Place Pty Ltd
February 2020

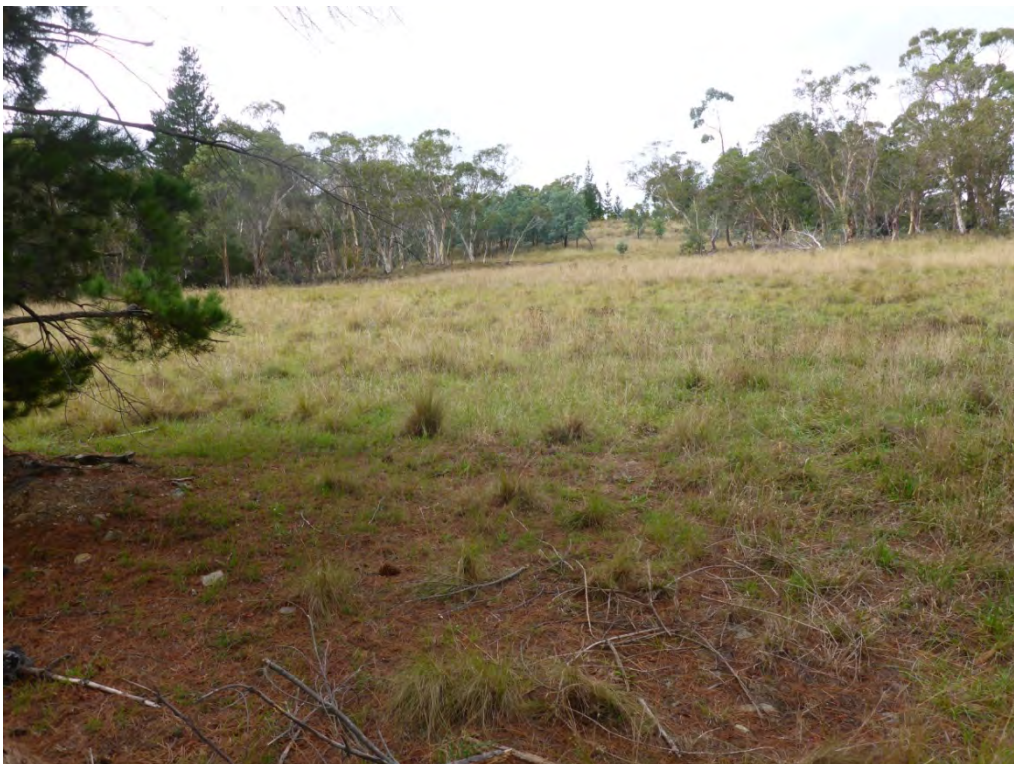
Plate 13: Analogue Site PD8 March 2018

Plate 13 shows the general landscape setting for Site PD8 within Area 8 at Pine Dale Mine during the 2018 inspection. Pasture at Site PD8 is dominated by perennial phalaris and fescue with some arrowleaf clover present in the sward, with greater than 90% groundcover. There are isolated African lovegrass tussocks present which comprise less than 5% of the pasture sward.

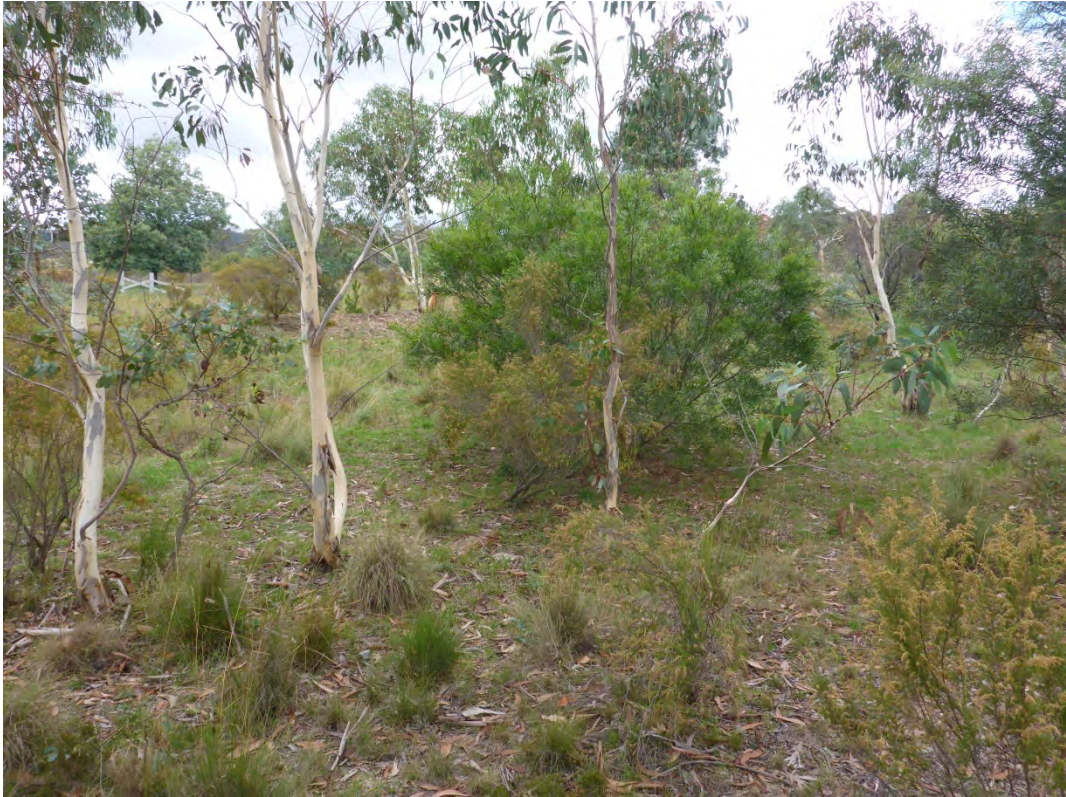
Plate 14: Analogue Site EP4 March 2018

Table 16 below shows soil nutrient levels at Site EP4 from the 2018 inspection. Site EP4 was chosen as an analogue site for the Morris Property as it is undisturbed by mining did not receive any of the Morris Property treatment, being located between eucalypt trees and not accessed by fertiliser spreading equipment. **Plate 14** shows the general landscape setting for analogue Site EP4

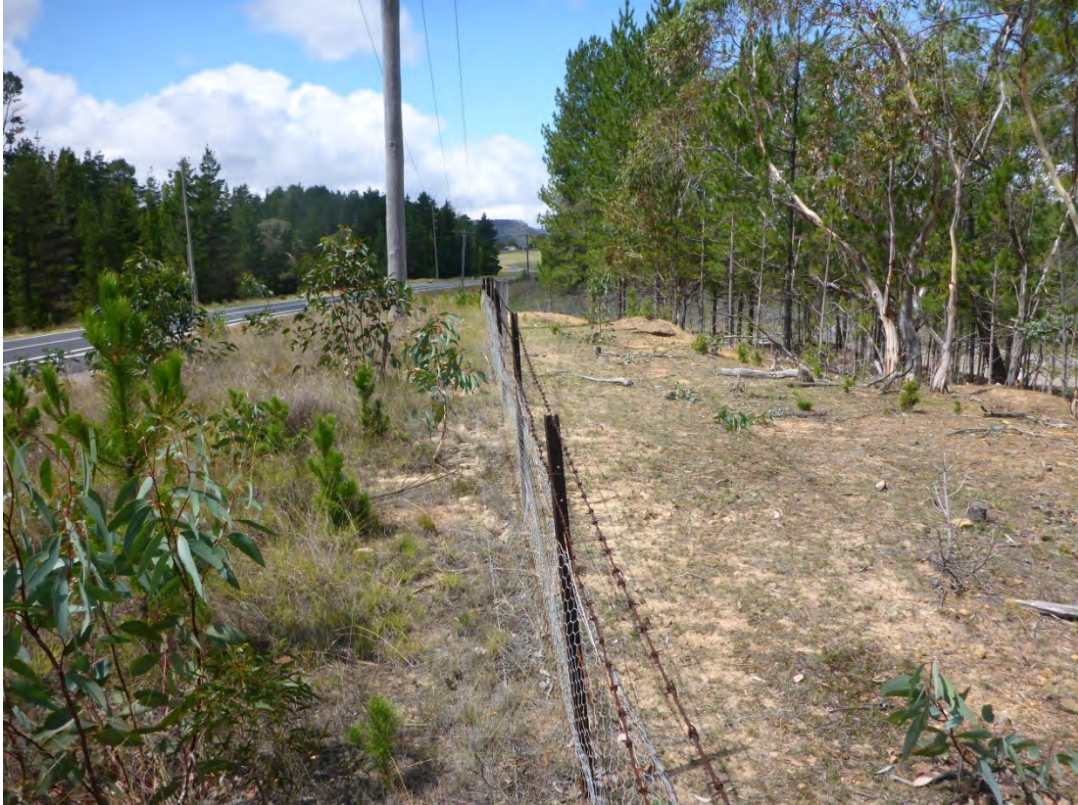
Plate 15: Analogue Site EP6 March 2018

Table 17 below shows soil nutrient levels at Site EP6 from the 2018 inspection. Site EP6 was chosen as an analogue site for the Morris Property as it is undisturbed by mining and also located in a roadside reserve and not accessed by fertiliser spreading equipment. **Plate 15** shows the general landscape setting for analogue Site EP6.

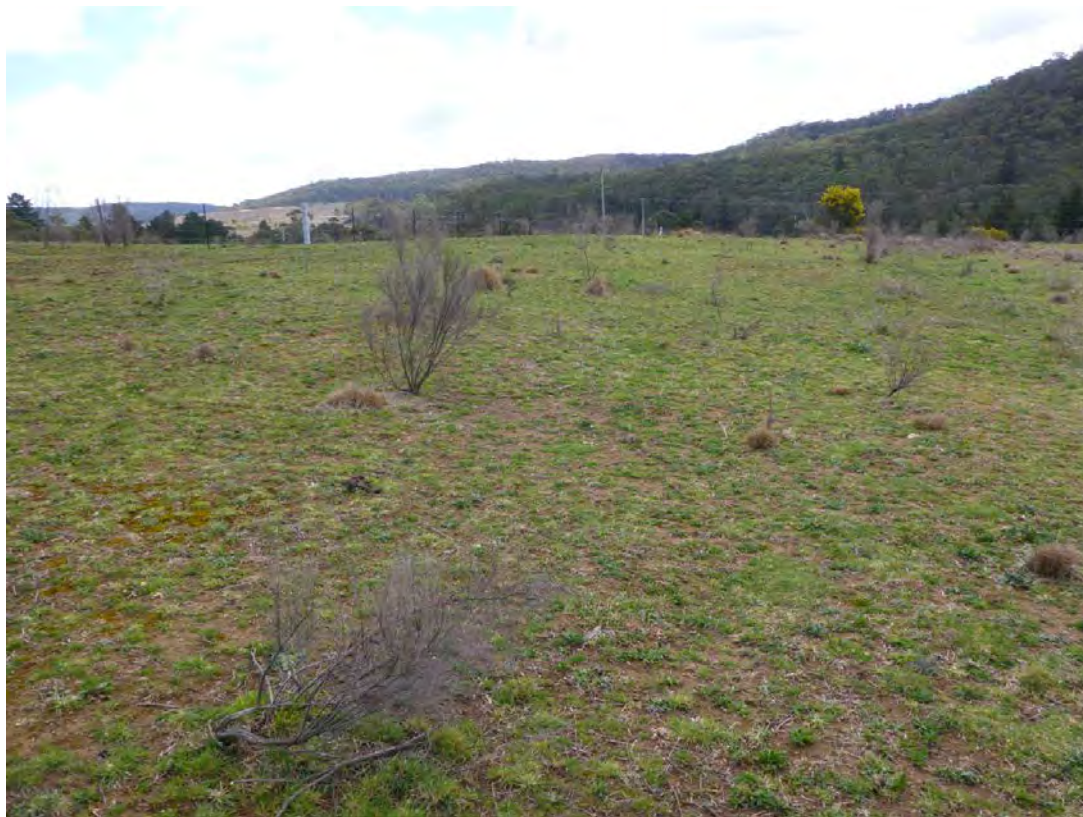
Plate 16: Rehabilitated Site EP1 September 2014

Plate 16 and **Plate 17** show the general landscape setting for Site EP1 within the Morris Property at Enhance Place Mine during the 2014 and 2018 inspections.

Overgrazing is still a major land management issue here, however increase in perennial grass pasture density have been achieved nonetheless.

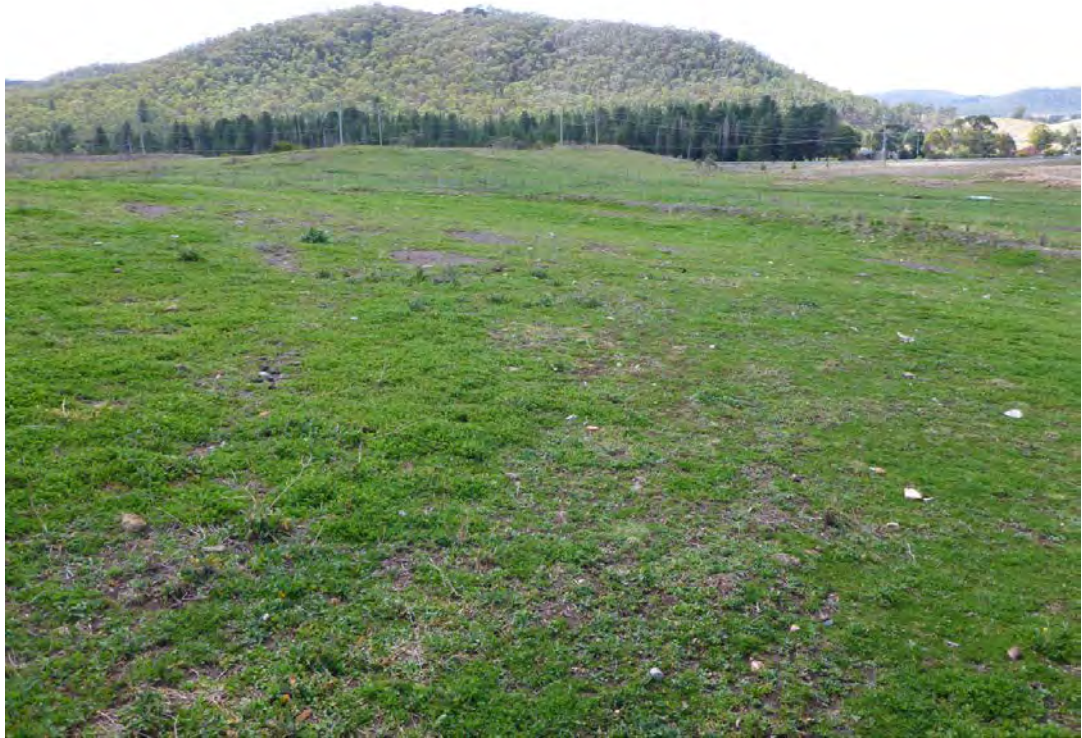
Plate 18: Rehabilitated Site EP3 September 2014

Plate 18 and **Plate 19** show the general landscape setting for Site EP3 within the Morris Property at Enhance Place Mine during the 2014 and 2018 inspections.

Overgrazing is still a major land management issue here, however increase in perennial grass pasture density have been achieved nonetheless.

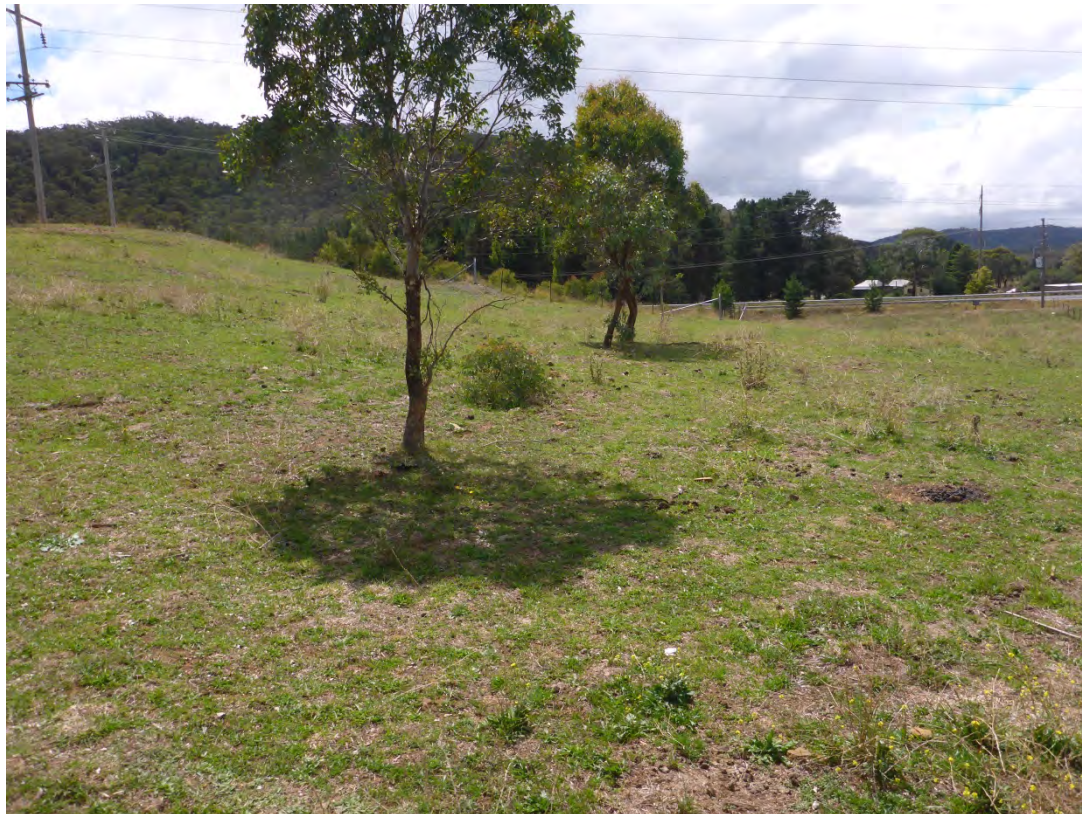
Plate 20: Rehabilitated Site EP5 March 2018

Plate 20 shows the general landscape setting for Site EP5 within the Morris Property at Enhance Place Mine during the 2018 inspections. Pasture at Site EP5 is dominated by perennial grasses fescue and phalaris, the herb plantain with some medic present in the sward, and greater than 90% groundcover.

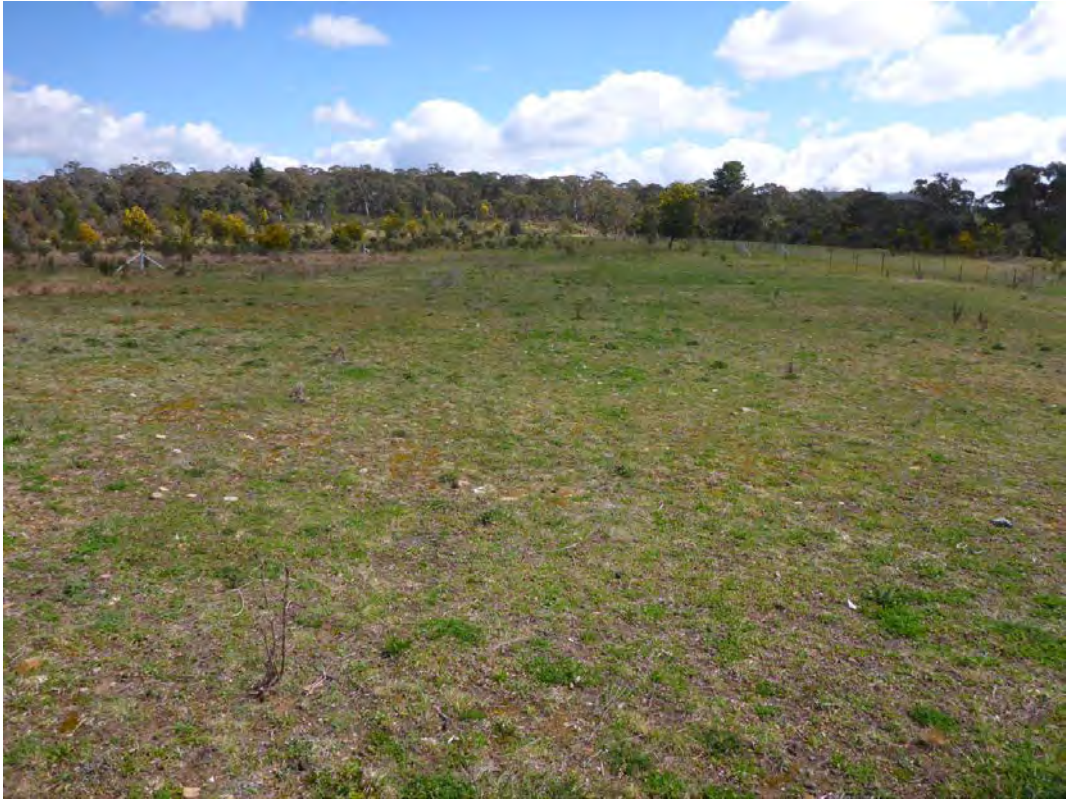
Plate 21: Rehabilitated Site EP2 September 2014

The Crown Land Block adjacent to the Morris property is grazed only by kangaroos with domestic stock being excluded. In 2014 EP2 had sufficient groundcover and a desirable pasture species composition with no further remediation work recommended.

Plate 21 and **Plate 22** show the general landscape setting for Site EP2 within the Morris Property at Enhance Place Mine during the 2014 and 2018 inspections, with greater than 80% groundcover.
