ENHANCE PLACE Pty Limited

**PINE DALE
OPEN CUT COAL MINE**

**ANNUAL
ENVIRONMENTAL
MANAGEMENT
REPORT
2011**

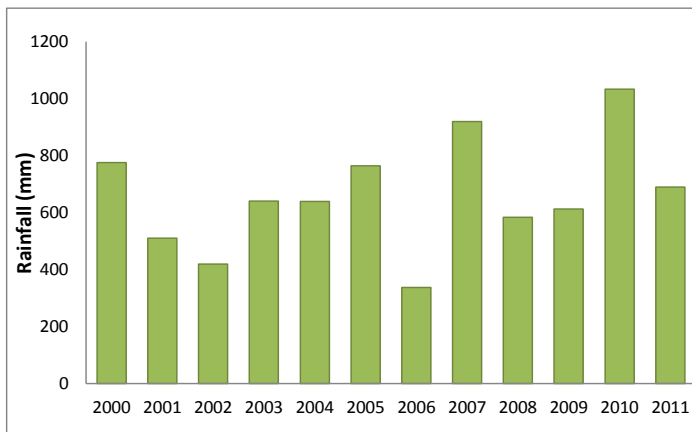
Figure 1 - Annual Rainfall Figures Since 2000

The average rainfall for the area is 860 mm. It can be seen from this Figure that 2007 is the first time rainfall has exceeded the average since recording began at Pine Dale Mine. Total rainfall recorded during the 2011 period was 690 mm. This is 170 mm below the average annual rainfall; however, this figure was reached with some significant single rain events rather than being evenly distributed throughout the 2011 period.

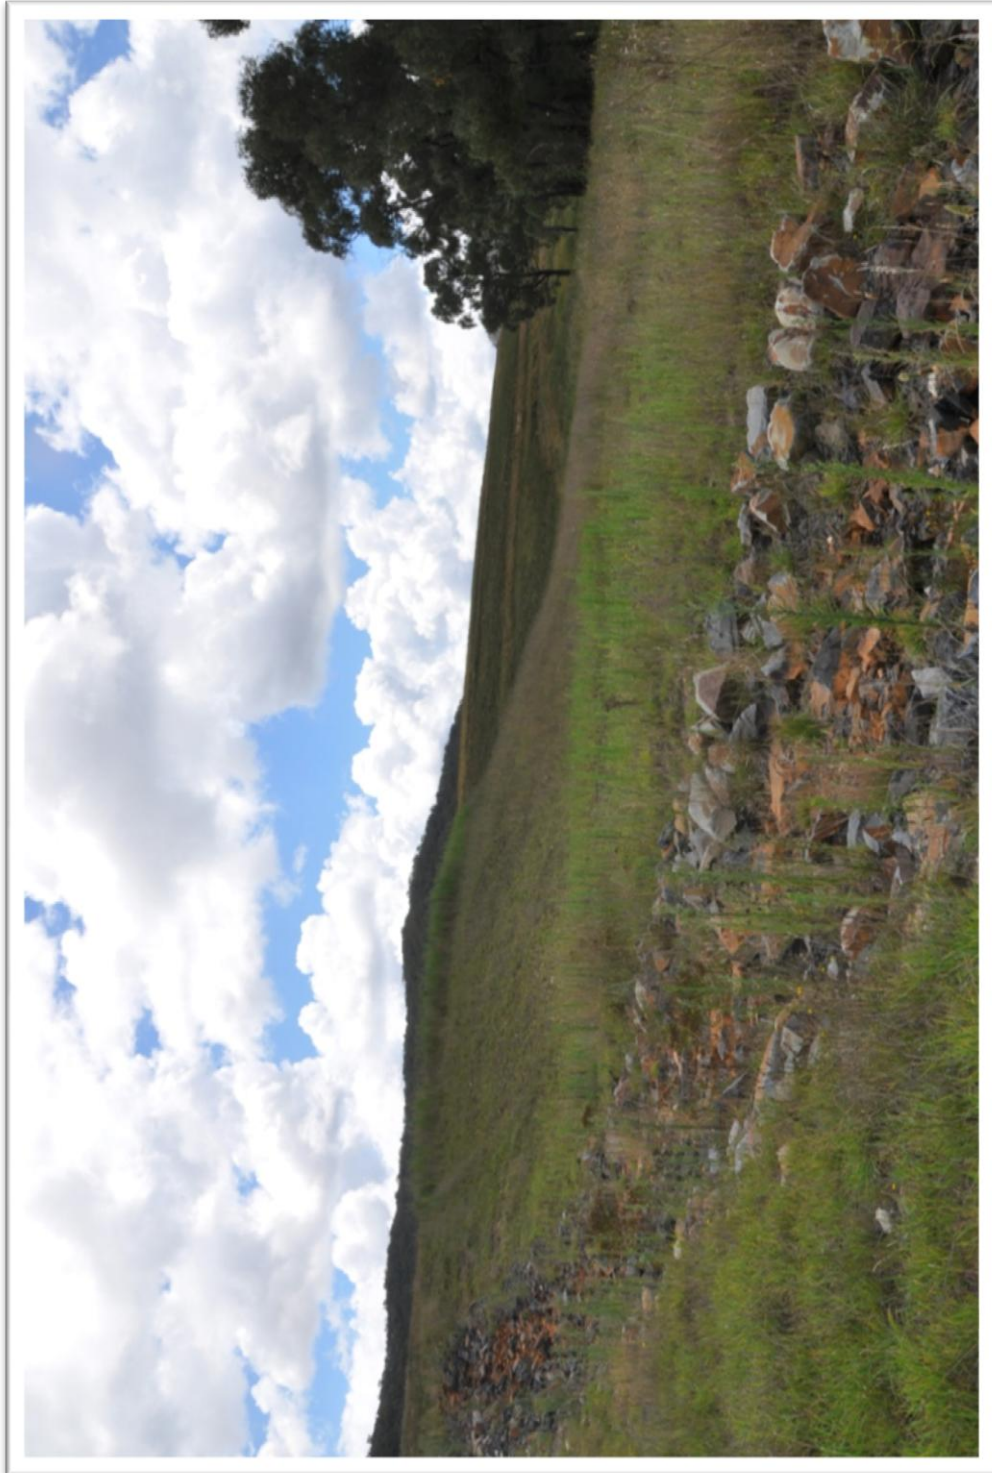
Photo 1 – Rehabilitation on Area C

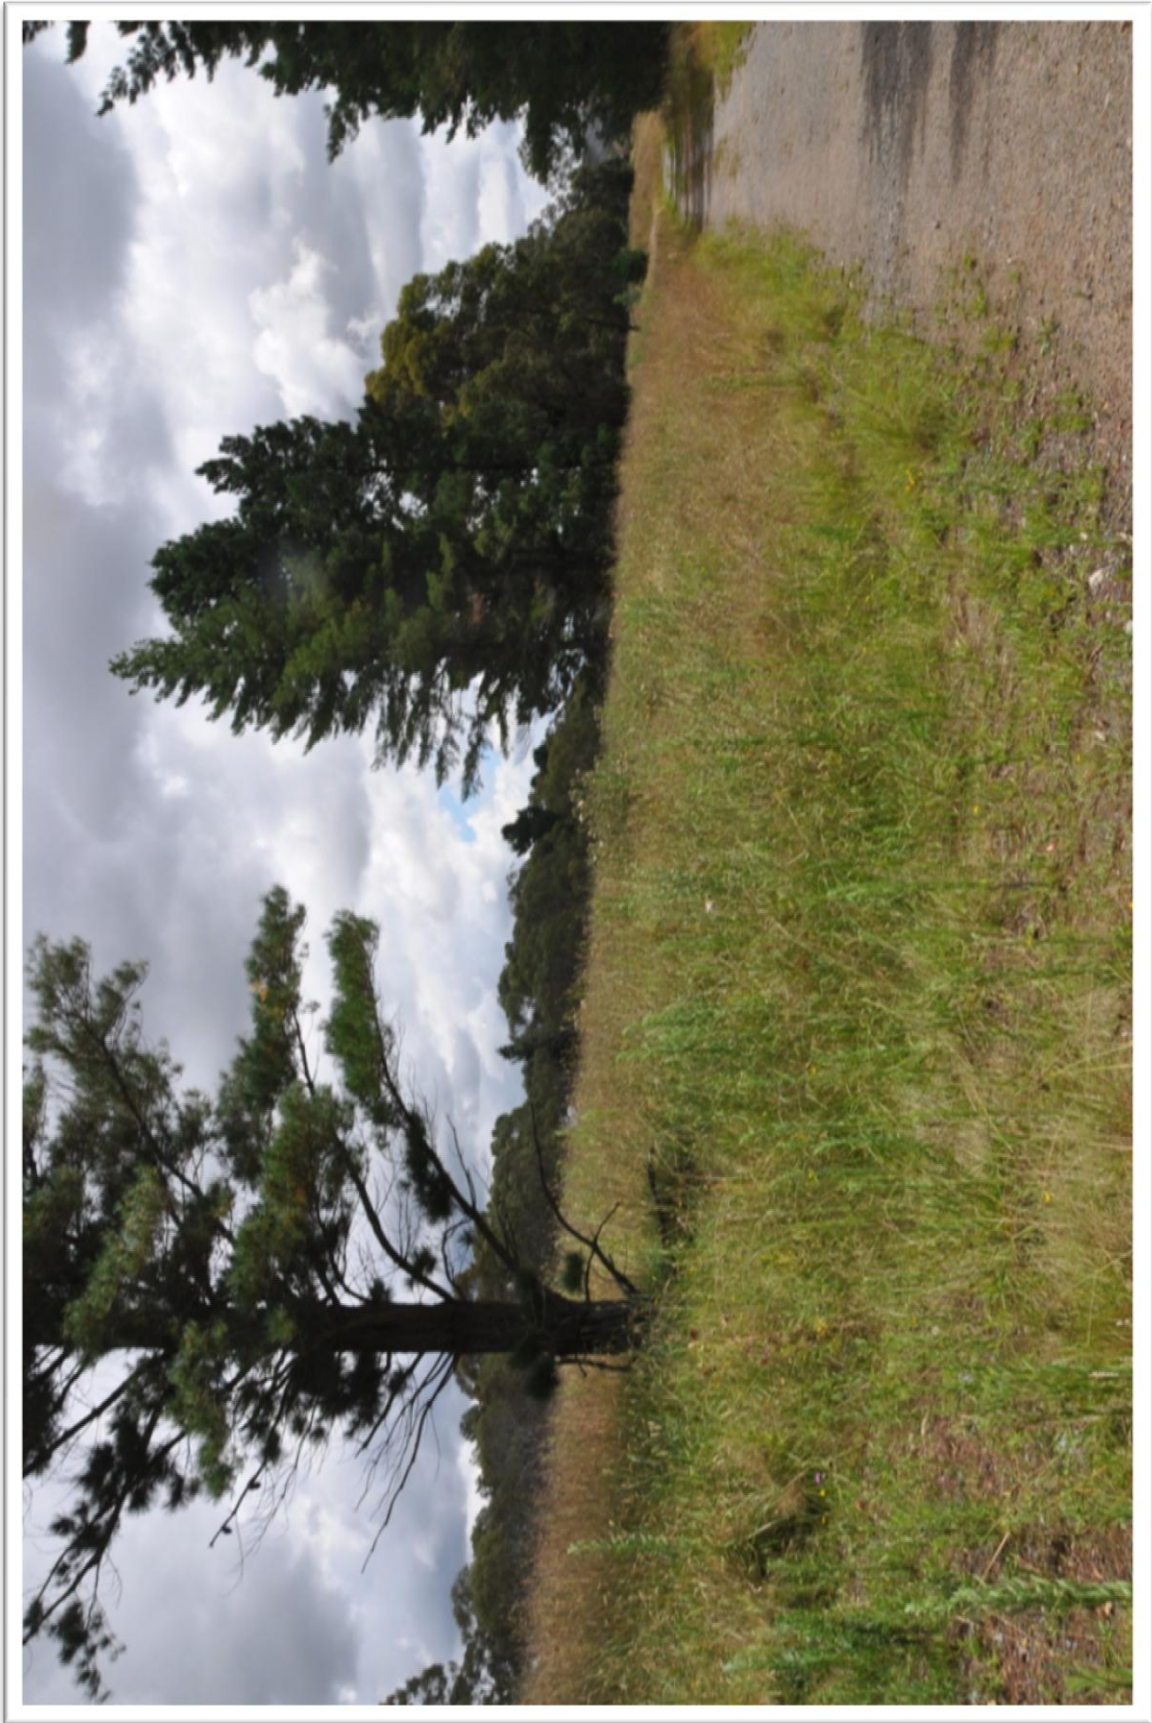
Photo 2 – Rehabilitation on Area A

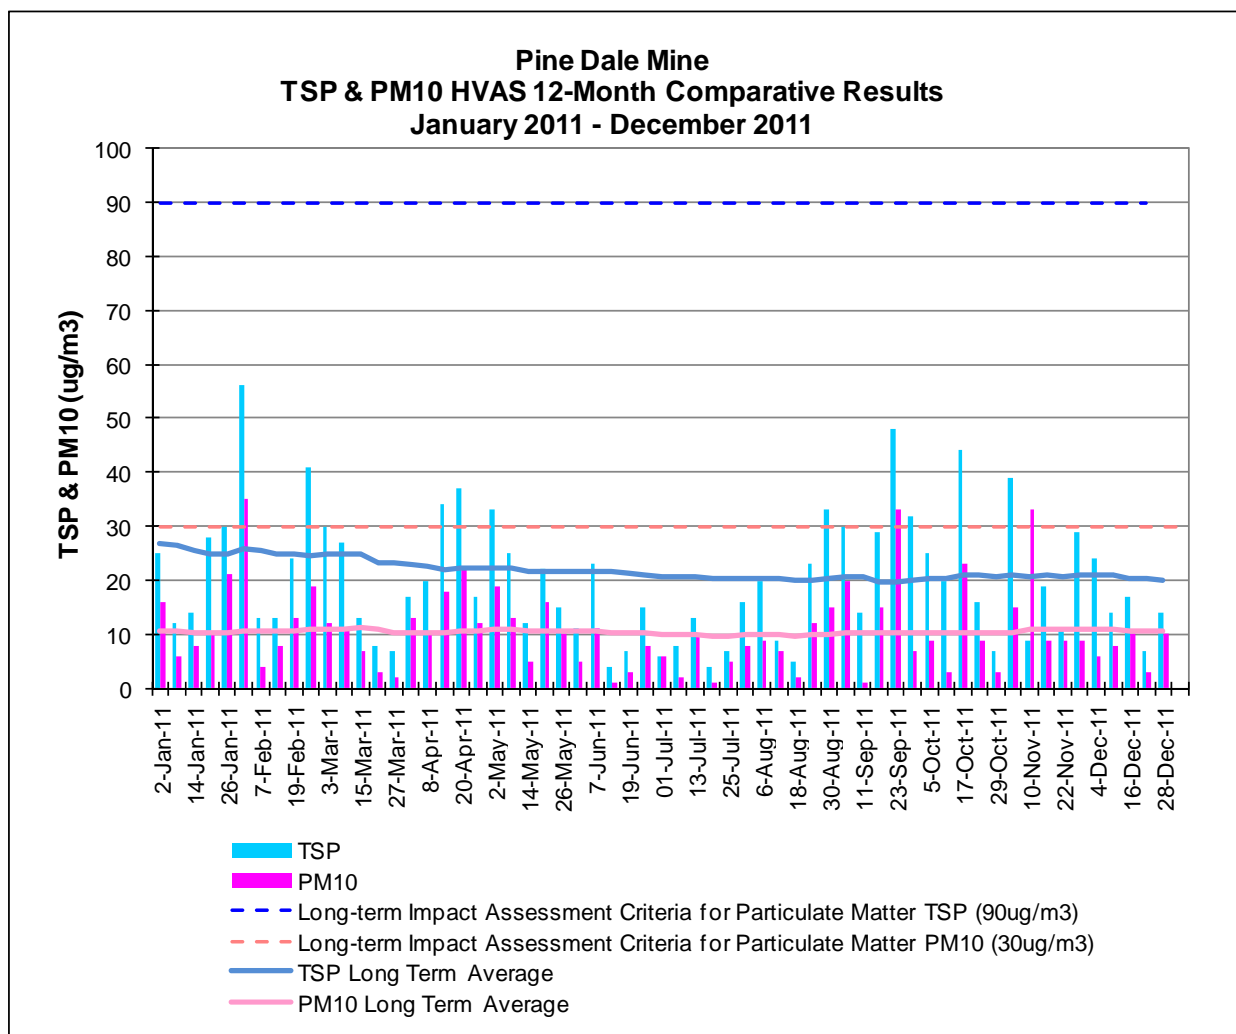
Figure 2 – TSP & PM10 Particulate Matter Summary Jan – Dec 2011

Run Date	HVAS TSP ($\mu\text{g}/\text{m}^3$)	HVAS PM10 ($\mu\text{g}/\text{m}^3$)
6-Aug-11	20	9
12-Aug-11	9	7
18-Aug-11	5	2
24-Aug-11	23	12
30-Aug-11	33	15
5-Sep-11	30	20
11-Sep-11	14	1
17-Sep-11	29	15
23-Sep-11	48	33
29-Sep-11	32	7
5-Oct-11	25	9
11-Oct-11	20	3
17-Oct-11	44	23
23-Oct-11	16	9
29-Oct-11	7	3
4-Nov-11	39	15
10-Nov-11	9	33
16-Nov-11	19	9
22-Nov-11	11	9
28-Nov-11	29	9
4-Dec-11	24	6
10-Dec-11	14	8
16-Dec-11	17	10
22-Dec-11	7	3
28-Dec-11	14	10
Annual Average	20	11

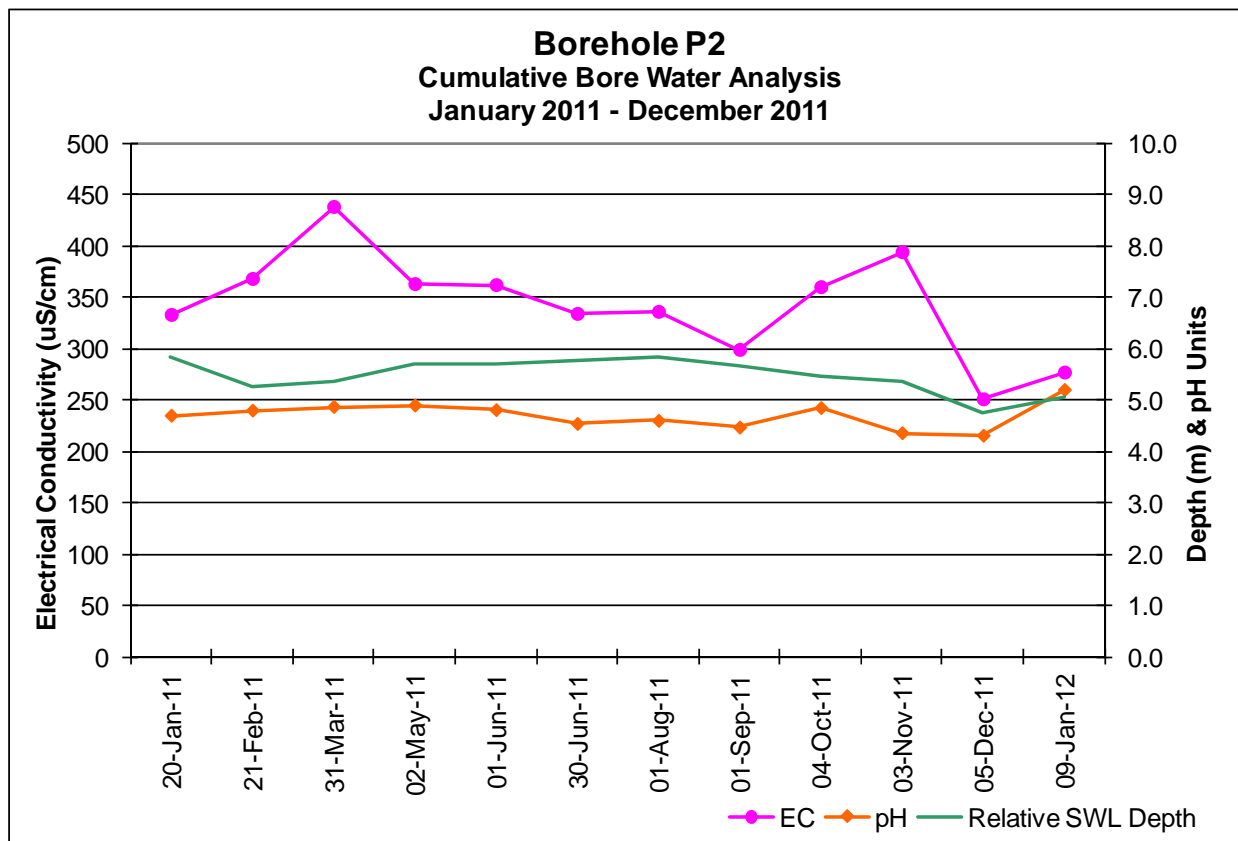
Figure 3 – Groundwater Monitoring Bore P2 Results Jan – Dec 2011

bores P2, P3 and P6 which showed variations in the relative Standing Water Levels throughout the year. Bores P2 and P6 exhibited standing water levels which were outside of the Action Trigger Levels during every monitoring event during 2011. These two bores were found to have higher water levels (contain more water) than the depths listed in their respective Action Thresholds. Bore P3 was found to have higher water levels greater than the Action Threshold during every monitoring event excluding August 2011.

The increase in water within bore holes P2 and P3 December 2011 is shown to correlate with total monthly rainfall received during November and December 2011. Rainfall in these months is shown to be considerably higher than the remainder of the year. The decrease then subsequent increase in water levels within bore P7 is shown to correlate with the decreasing then increasing rainfall levels throughout 2011. Similarly the increase in water levels within bore P7a from September to December 2011 correlates with the increase in rainfall experienced in during these months.

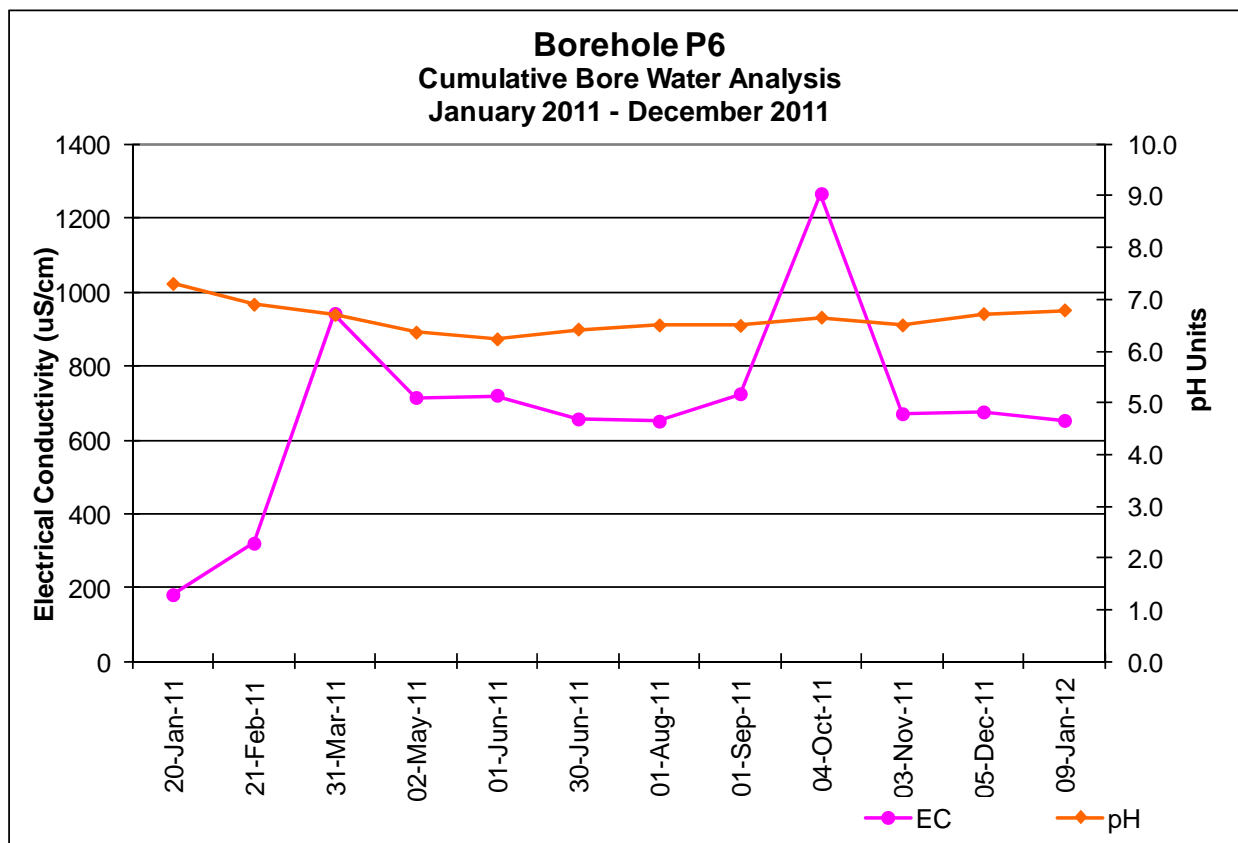
Figure 6 – Groundwater Monitoring Bore P6 – pH & EC Results Jan – Dec 2011

When the pH and Electrical Conductivity of the groundwater bores is examined, all sites are shown to fall within the required action threshold limits.
