**PINE DALE
MINE**

ANNUAL
ENVIRONMENTAL
MANAGEMENT
REPORT
2012

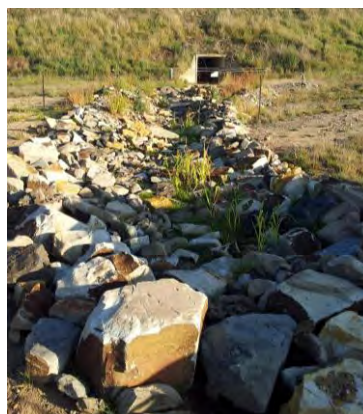
Plate 2
Rock lined drainage line in rehabilitated area C

The effectiveness of the erosion and sediment control structures at Pine Dale Mine was demonstrated by their performance against a number of high rainfall events throughout the reporting period (February 234.2mm and March 122.0mm).

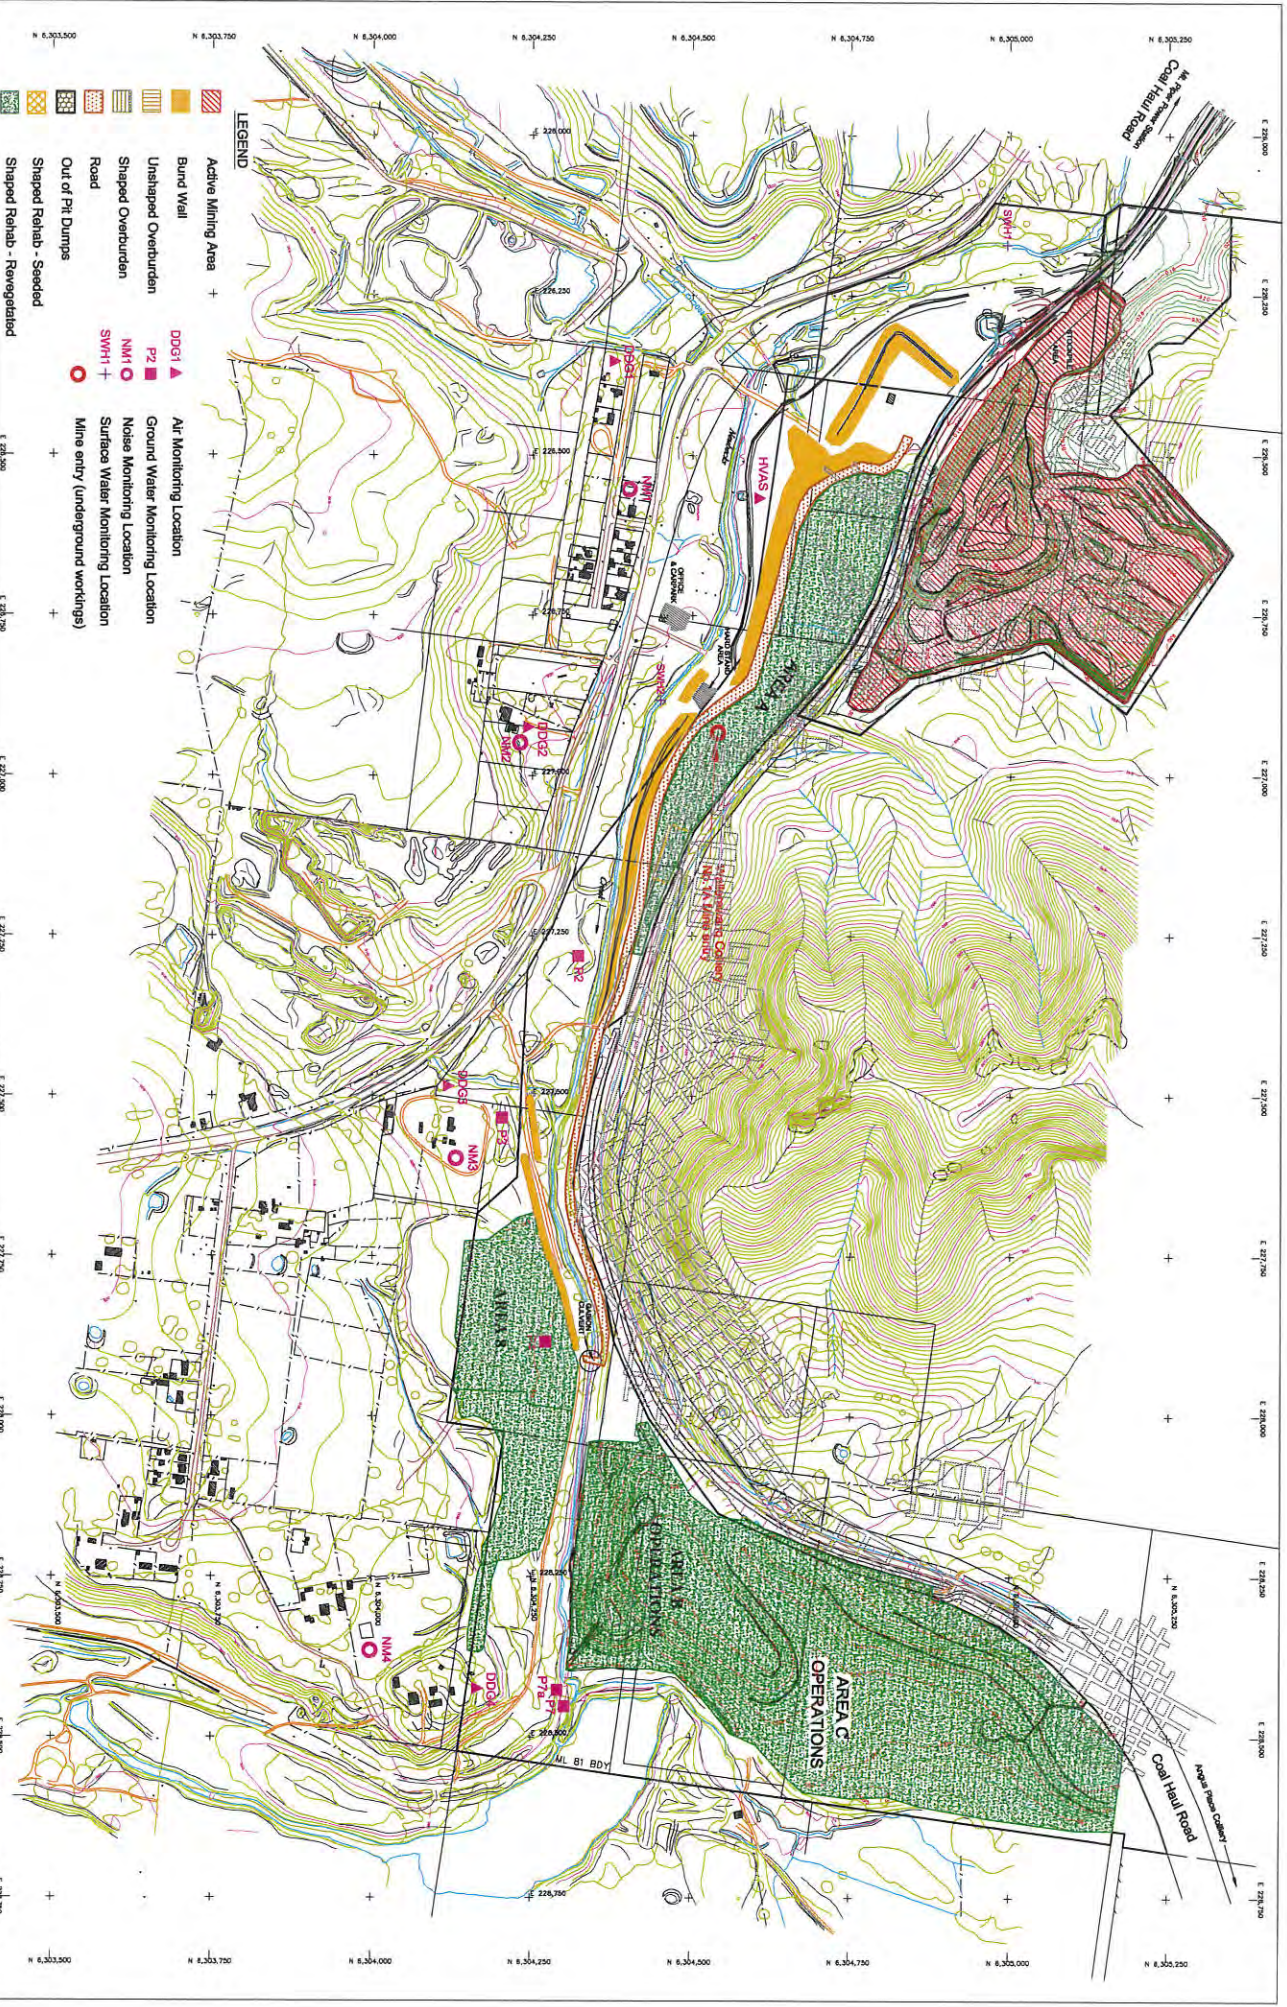
SITE PLANS 2012

- Active Mining Area
- Bund Wall
- Unshaped Overburden
- Shaped Overburden
- Road
- Out of Pit Dumps
- Shaped Rehab - Seeded
- Shaped Rehab - Revegetated

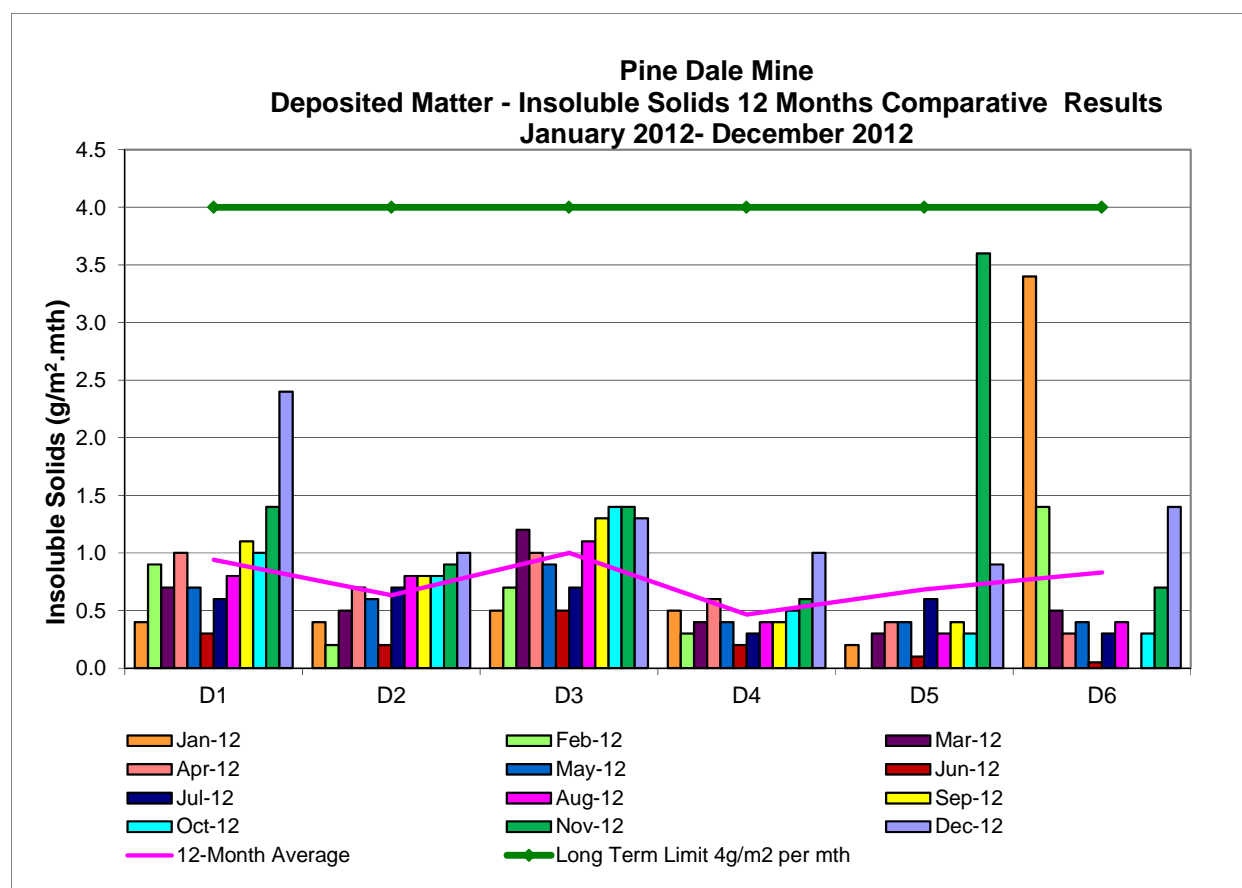
**Figure 1** Depositional Dust Results Graph

During the 2012 monitoring period, there was one instance where a dust gauge (D5) exceeded the maximum increase of 2g/m² per month in deposited matter, as stipulated in the site's *Air Quality Monitoring Program*. However, the field sheets completed during the November 2012 period noted bird droppings were present in the sample. The increase of 3.3g/m².month observed between the October and November 2012 sampling periods may be attributed to the contamination of the gauge by bird droppings.

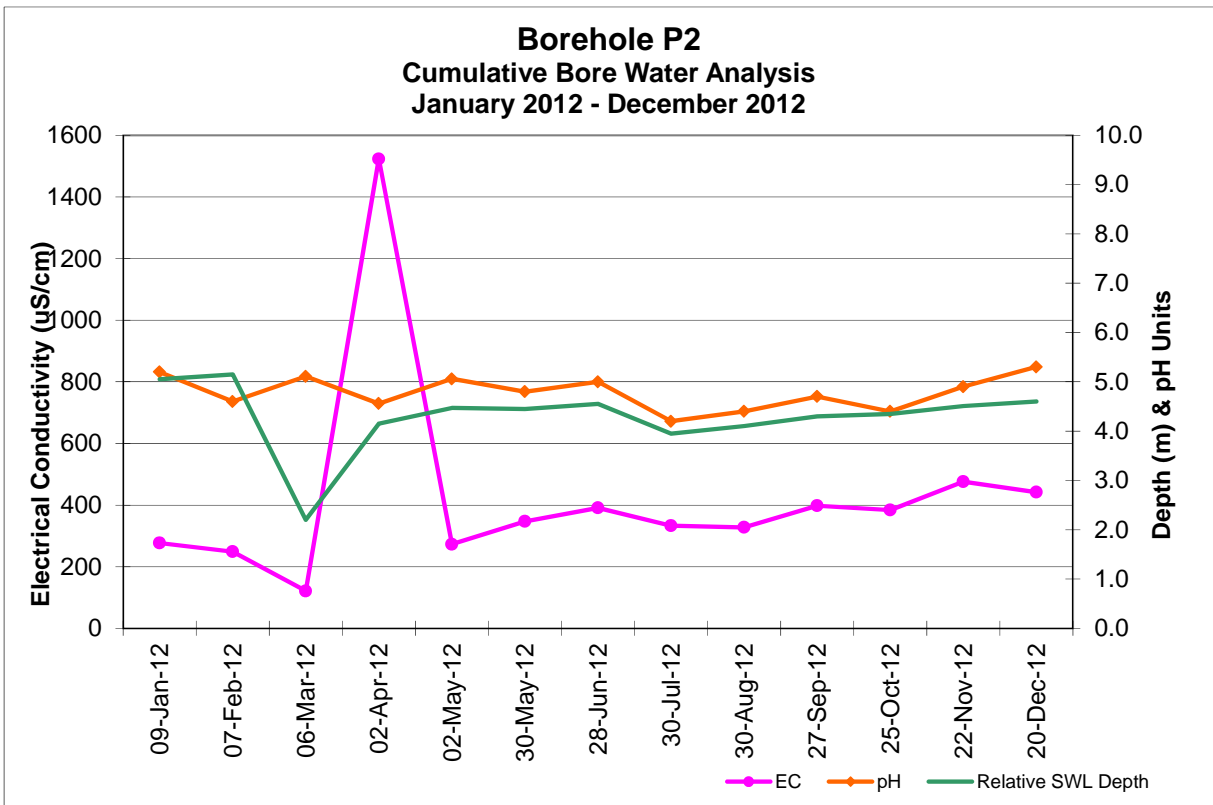
Figure 3 Groundwater Monitoring Bore P2 Results Jan – Dec 2012

Groundwater samples collected during the January – December 2012 period generally show water quality results which comply with the Action Trigger Levels for contingency action implementation, as stated in the Groundwater Management Program. The exceptions were bores P2, P3 and P6 which showed variations in the relative Standing Water Levels throughout the year. These three bores exhibited standing water levels which were outside of the Action Trigger Levels during all monitoring events during 2012. These bores were found to have higher water levels (contain more water) than the depths listed in their respective Action Thresholds.

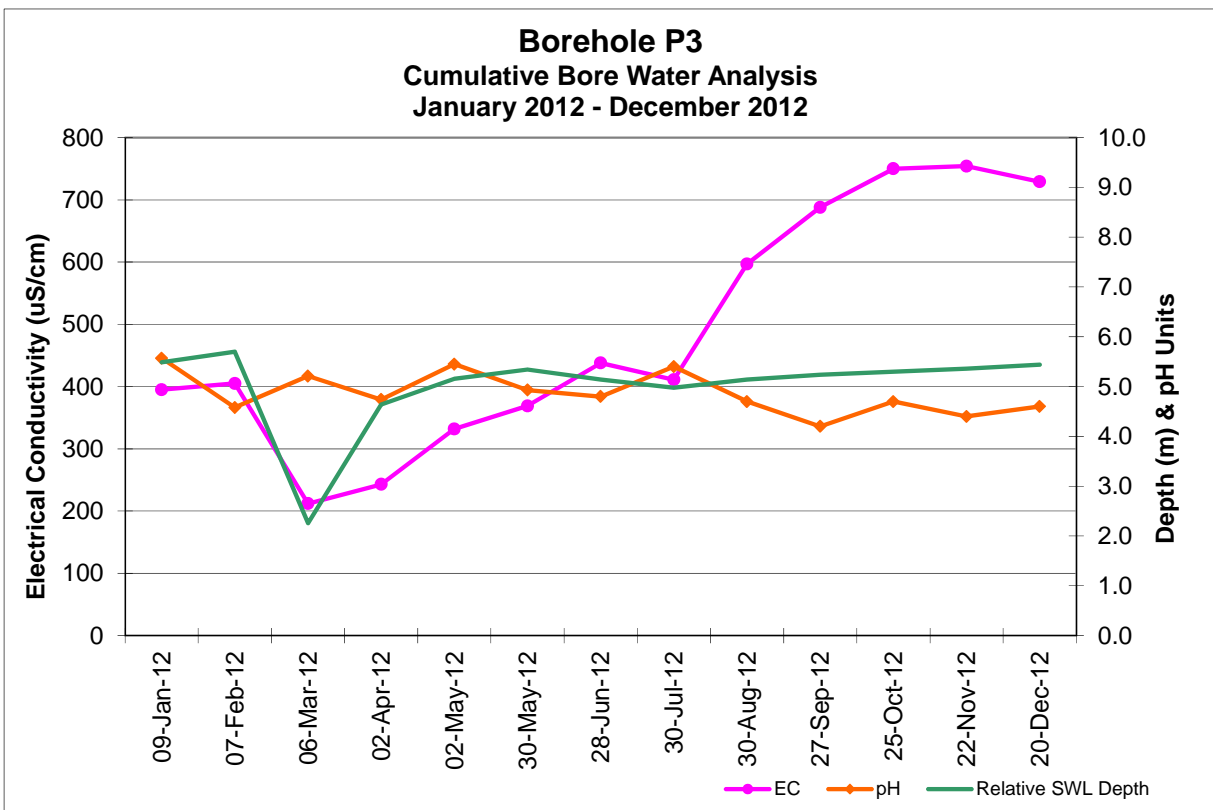
Figure 4 Groundwater Monitoring Bore P3 Results Jan – Dec 2012

A similar trending is shown in Bore P3. There is a considerable increase in water within the bore in March 2012, then stable levels are observed throughout the rest of the year. Again, for the whole of the year the standing water level within the bore was outside the action threshold of $<6.2\text{m}$.

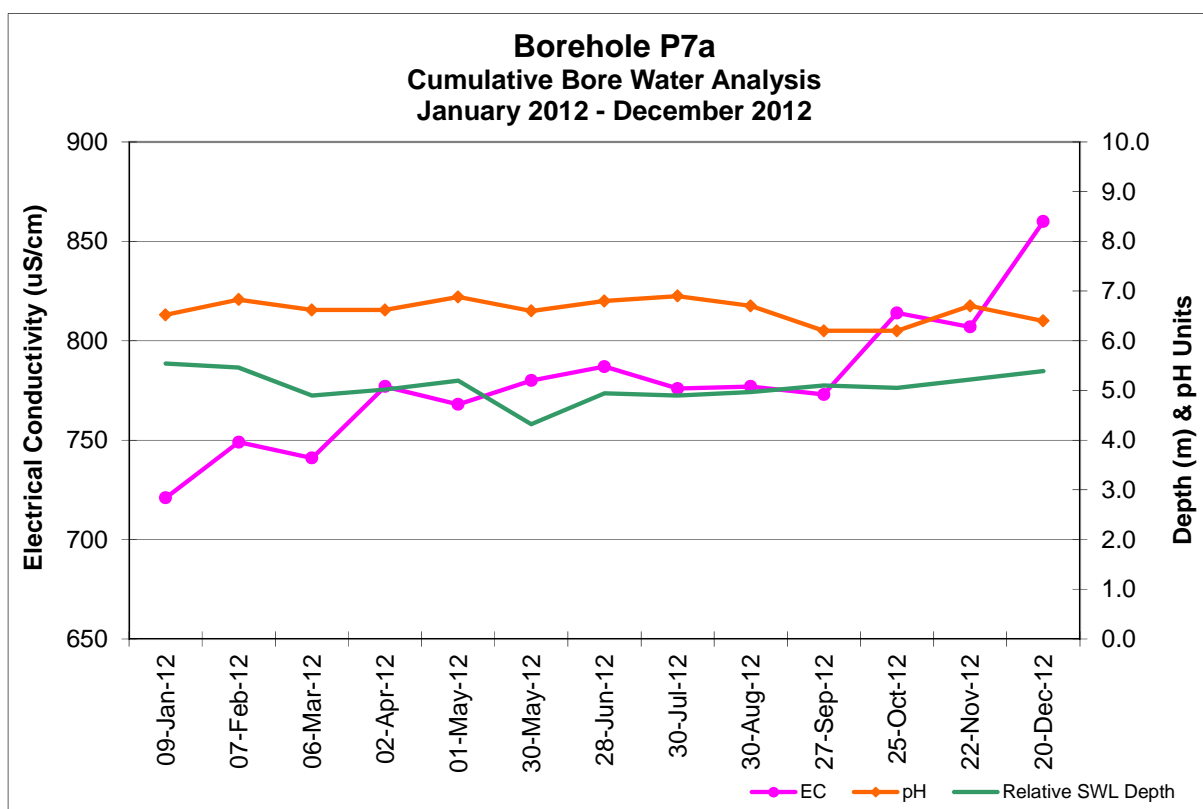
Figure 8 Groundwater Depth Bore P7a Jan – Dec 2012

The water level in bore P7a shows an increase in water levels in March 2012, which has also been observed in the rest of the bores. Water levels are shown to remain steady before another decrease in groundwater depth was observed in May 2012. For the second half of the year, groundwater depths remain stable.

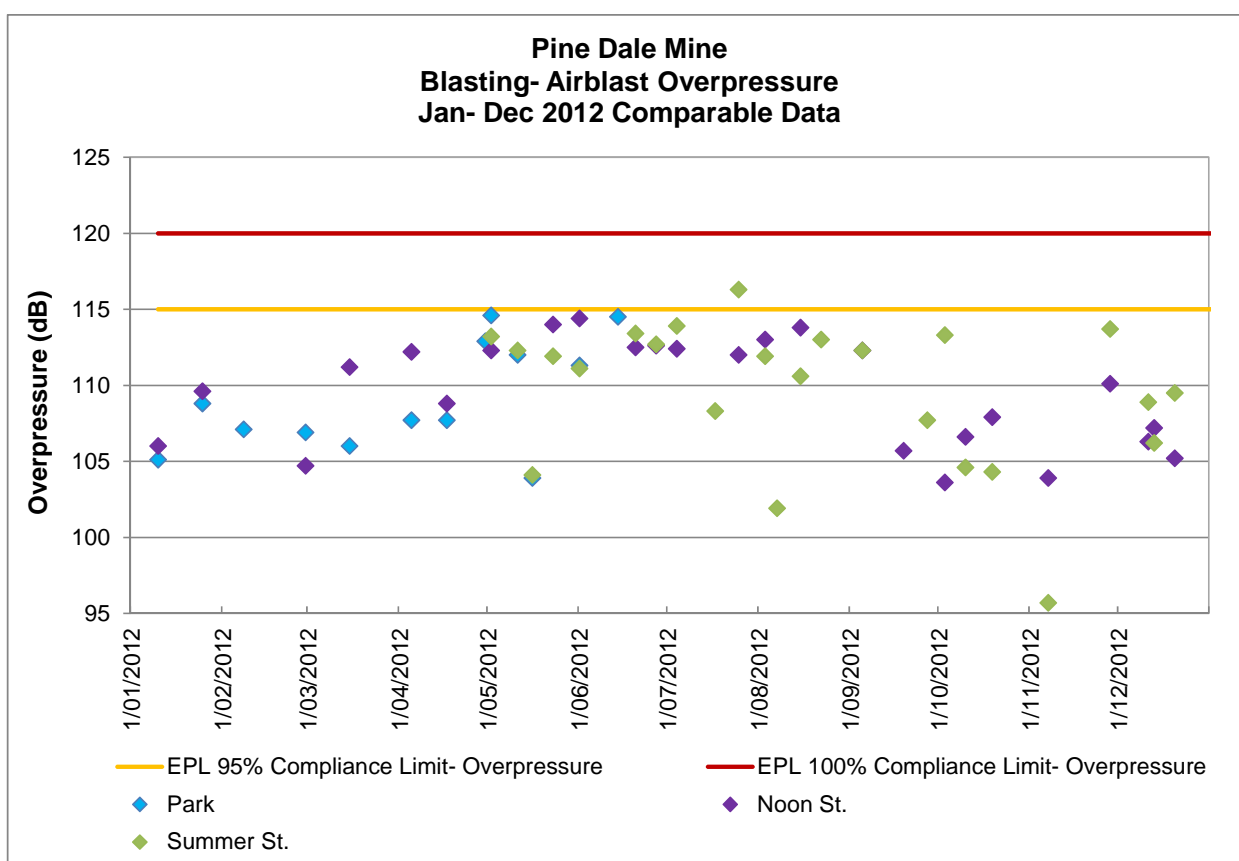
**Figure 9** Blasting Operations: Airblast Overpressure Results Summary

There was one instance, at Summer Street, where the airblast overpressure level was greater than the specified compliance level of 115dB (Lin Peak). The Pine Dale Mine EPL stipulates this level cannot be exceeded for more than 5% of the blasts during the reporting period. However, as this was the only exceedance recorded during 2012, the airblast overpressure level recorded was not in breach of EPL compliance conditions, as the assessment criteria of 115dB (Lin Peak) was not exceeded for more than 5% of the blasts conducted during the 2012 period.

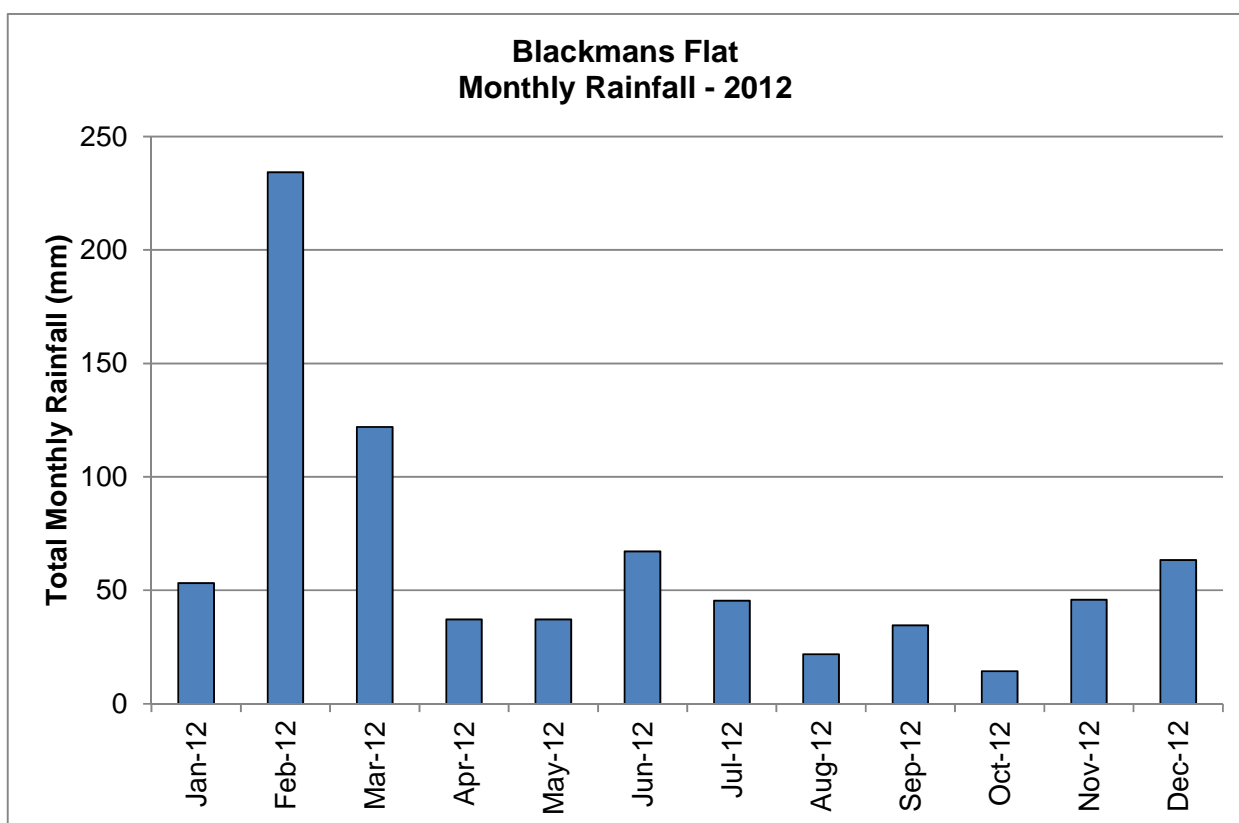
Figure 11 Blackmans Flat Rainfall Jan – Dec 2012

The increase in water within all bore holes is shown to correlate with total monthly rainfall received during February and the beginning of March 2012. Rainfall in these months is considerably higher than the remainder of the year. The increase, then subsequent decrease in water levels as low rainfall is observed throughout the remainder of the year can be observed across all bores, with the exception of P6.
