# **Annual Environmental Management Report**

**2019**

**Enhance Place Mine**

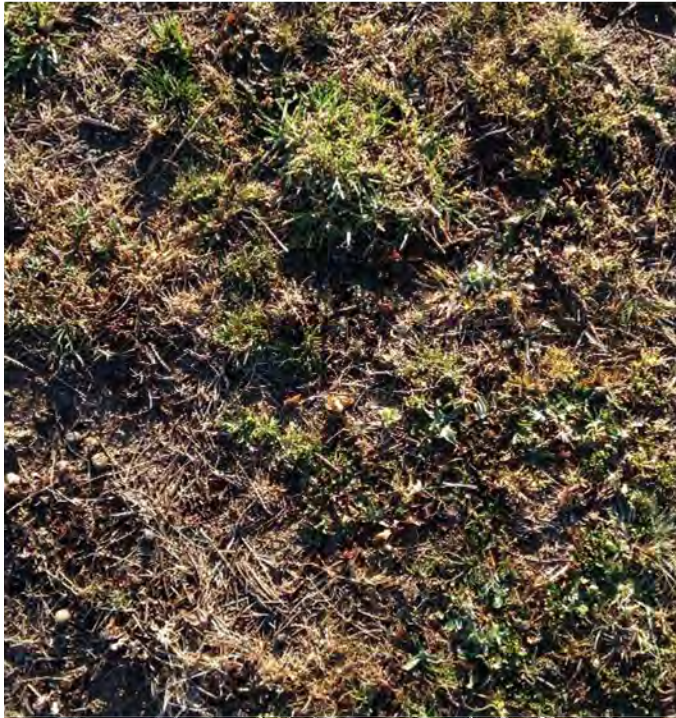
**Species composition at pasture rehabilitation areas** – Pasture rehabilitation areas are established with a mix of 70% perennial grasses and 20% annual legumes and are representative of species composition at the analogue pasture site. An example of rehabilitated pasture is shown in Figure 3.

Figure 3 Pasture composition representative of rehabilitated pasture areas

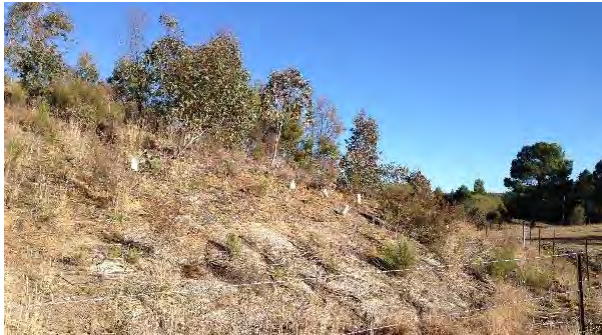
**Groundcover at treed rehabilitation areas** – Transect 7 supports groundcover of 90%. Transect 8 supports groundcover of 70%.

Figure 4 Vegetation structure and groundcover at transect 7

Canopy cover is absent in treed rehabilitation areas. A sparse mid-storey of isolated juvenile trees and shrubs exists over a sparse, low, shrubby understorey (seen in Figure 4 and Figure 5). Groundcover is a sparse mix of broadleaf herbs and grasses. Changes in vegetation structure over time (as shown in Appendix B) are not considered significant.

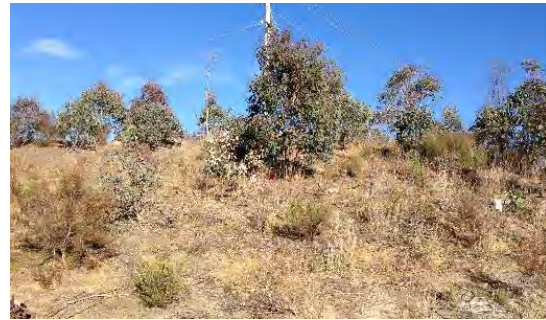
Figure 5 Vegetation structure and groundcover at transect 8

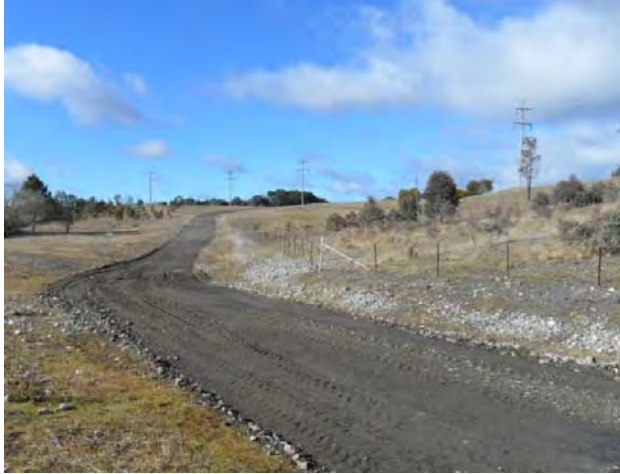
Site access trails have been constructed, gates have been installed and fences have been erected. Recent trail work has improved trail surfaces, grade and surface water drainage (see Figure 7).

Figure 7 Recently graded trail

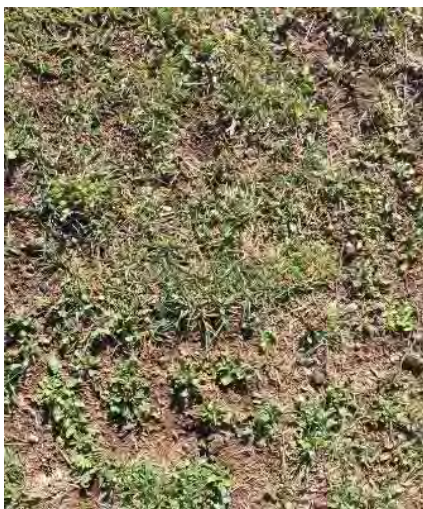
Figure 3 Pasture composition representative of rehabilitated pasture areas

**Species composition at pasture rehabilitation areas** – Pasture rehabilitation areas are established with a mix of 70% perennial grasses and 20% annual legumes and are representative of species composition at the analogue pasture site. An example of rehabilitated pasture is shown in Figure 3.

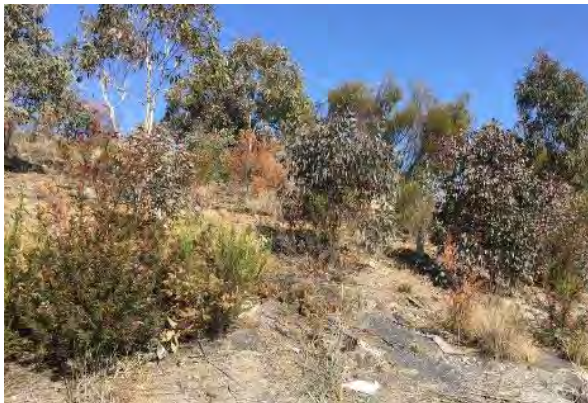
Figure 4 Vegetation structure and groundcover at transect 7

**Canopy cover at treed rehabilitation areas** - Canopy cover is developing in treed rehabilitation areas. A sparse mid-storey of isolated juvenile trees to 5m height and shrubs to 1.5m height exist over a sparse, low, shrubby understorey (seen in Figure 4 and Figure 5). Groundcover is a sparse mix of broadleaf herbs and grasses.

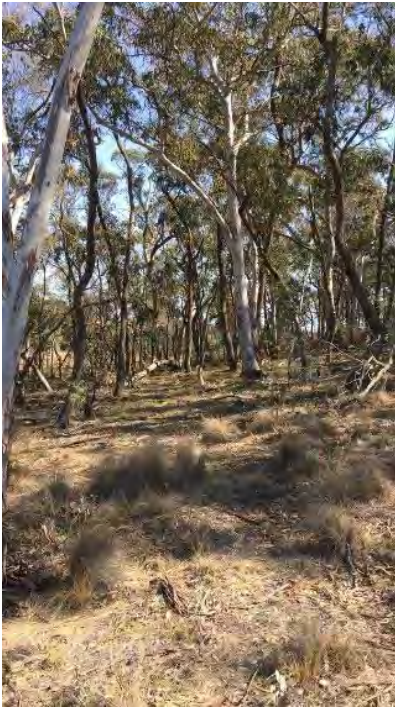
Figure 6 Vegetation structure of treed analogue site (Pine Dale Mine)

**Treed analogue site** - The treed analogue site is characterised by a canopy to 12m height with 20% canopy cover over a sparse shrubby mid-storey to 3m height and isolated shrubs to 1.5m height in the understorey. Groundcover consists of grasses and herbs with a cover of >95% (Figure 6).

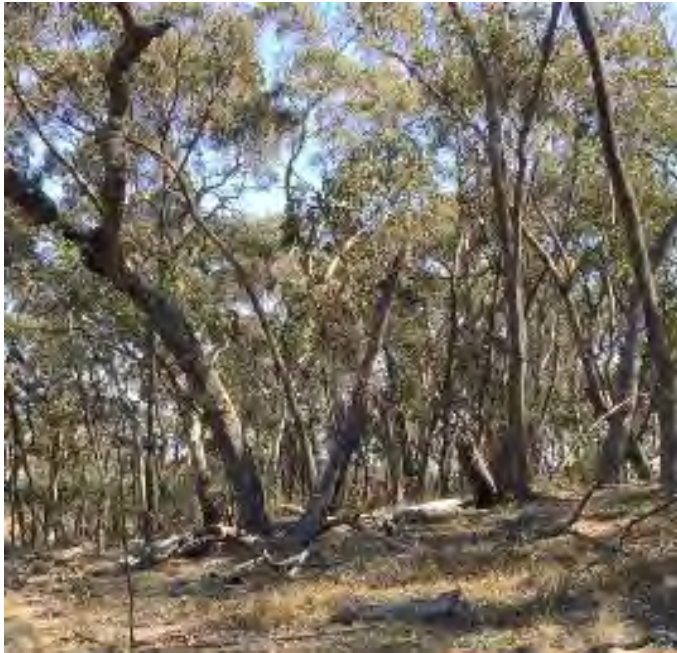
Figure 1 Vegetation structure of treed analogue site (Pine Dale Mine)

The treed analogue site is characterised by a canopy to 14 m height with 20% canopy cover over a sparse shrubby mid-storey to 3 m height and isolated shrubs to 1.5 m height in the understorey. Groundcover consists of grasses and herbs with a cover of >95% (Figure 2).

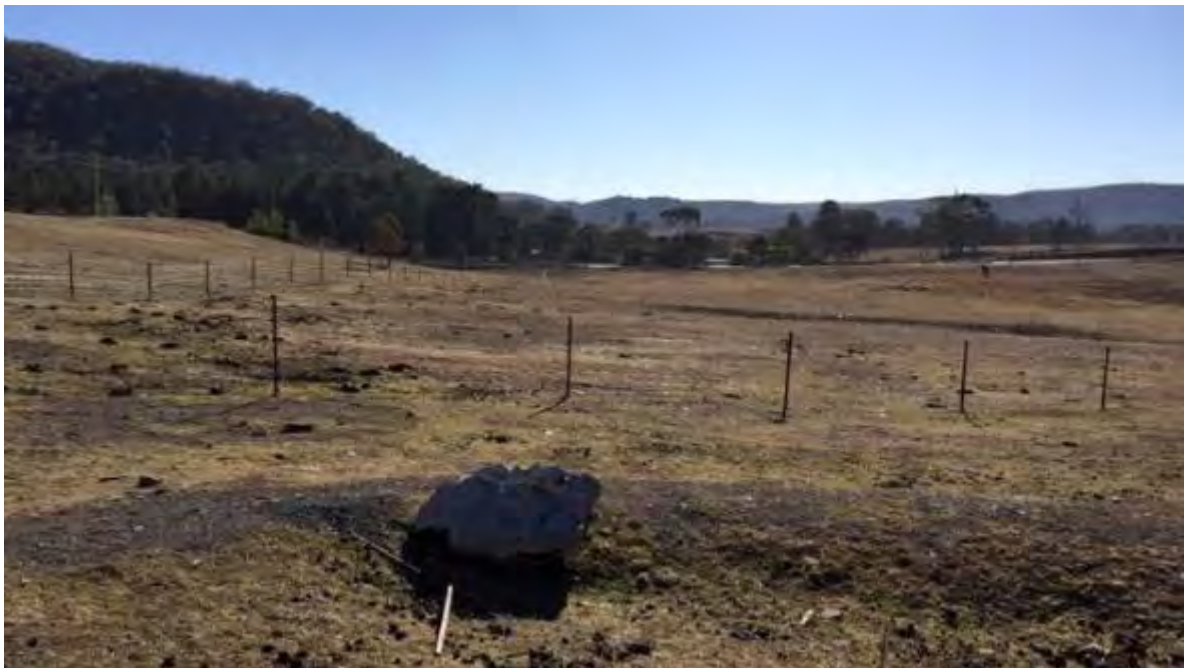
Quadrat 2 from southwest looking northeast 2018 (image taken from adjacent paddock due to presence of livestock next to the monitoring point)

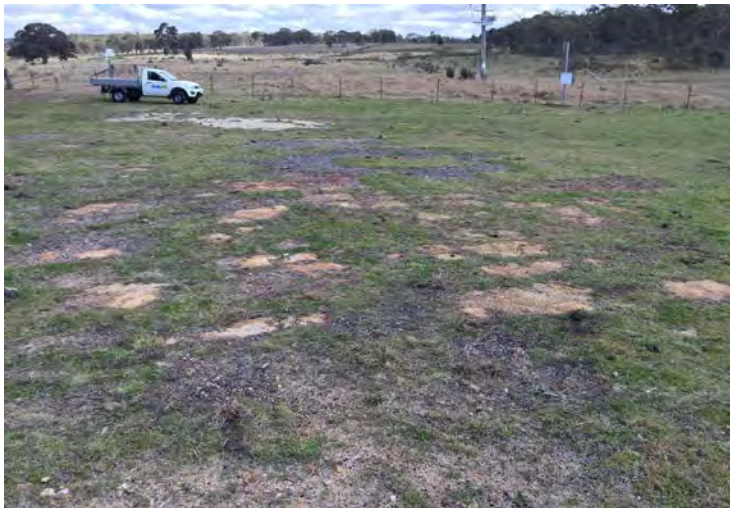
Figure 4 Patchy exposed soils in south-western corner of pasture area

There is some evidence of active, minor to moderate wind erosion where pastures are poorly established or absent (see Figure 4 and Figure 5). Minor rilling is occurring on exposed soils of the sediment retention basins and can be seen in Figure 6.

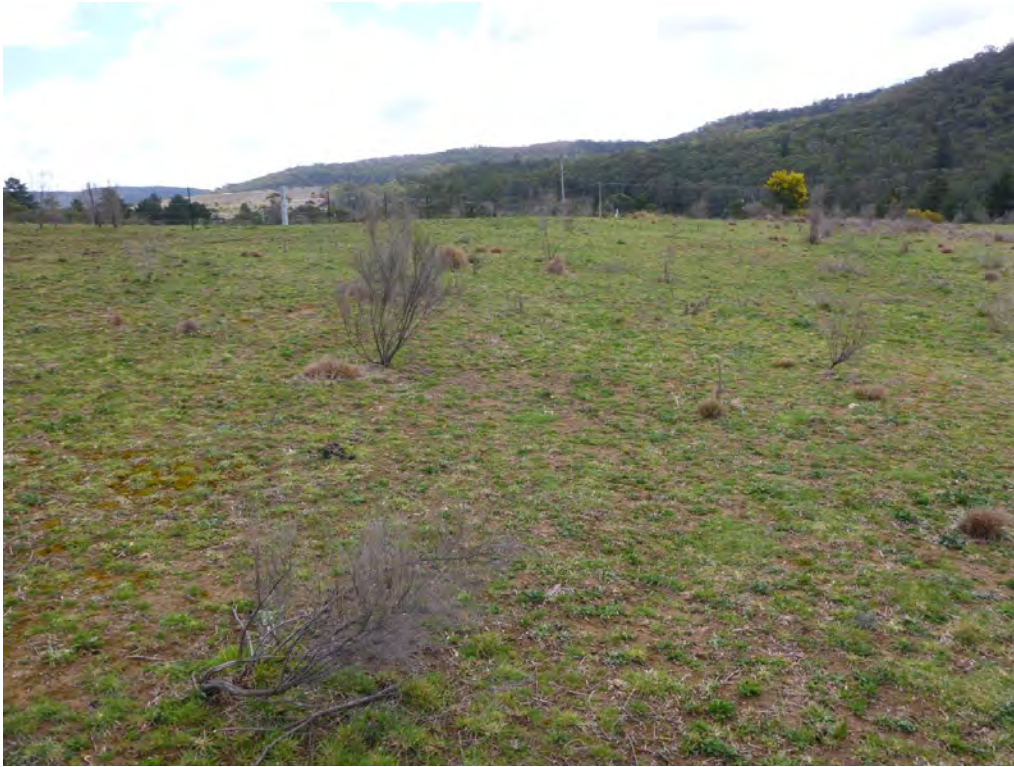
**Photo 3    Rehabilitated Site EP1 September 2014**

Overgrazing is still a major land management issue here, however increase in perennial grass pasture density have been achieved nonetheless.

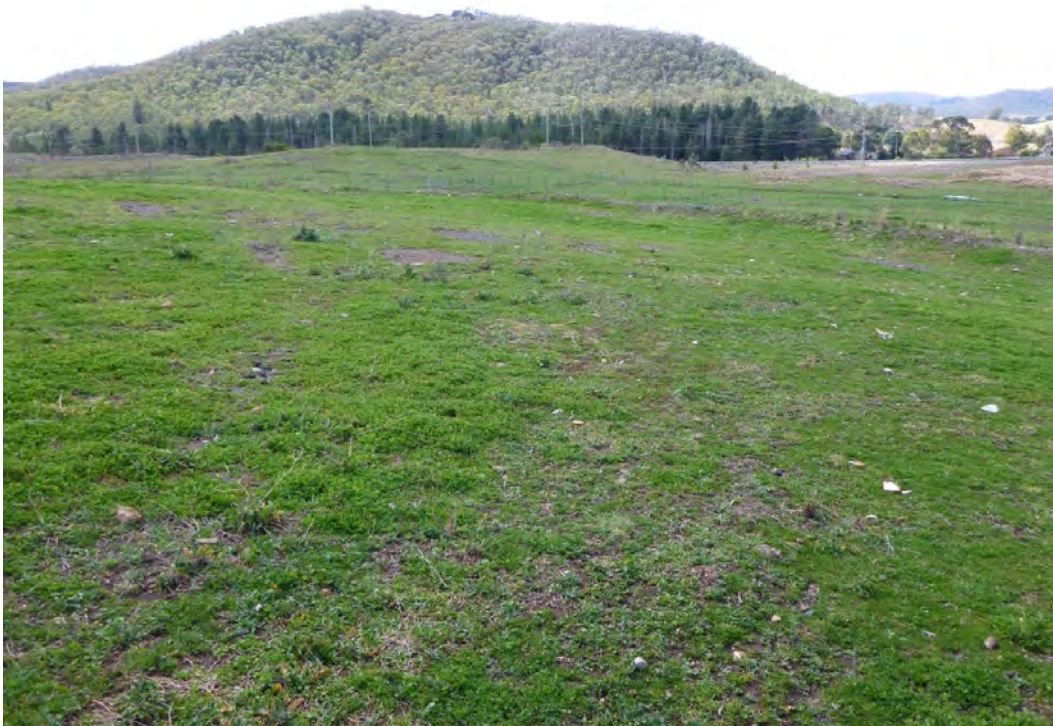
**Photo 5    Rehabilitated Site EP3 September 2014**

Overgrazing is still a major land management issue here, however increase in perennial grass pasture density have been achieved nonetheless.

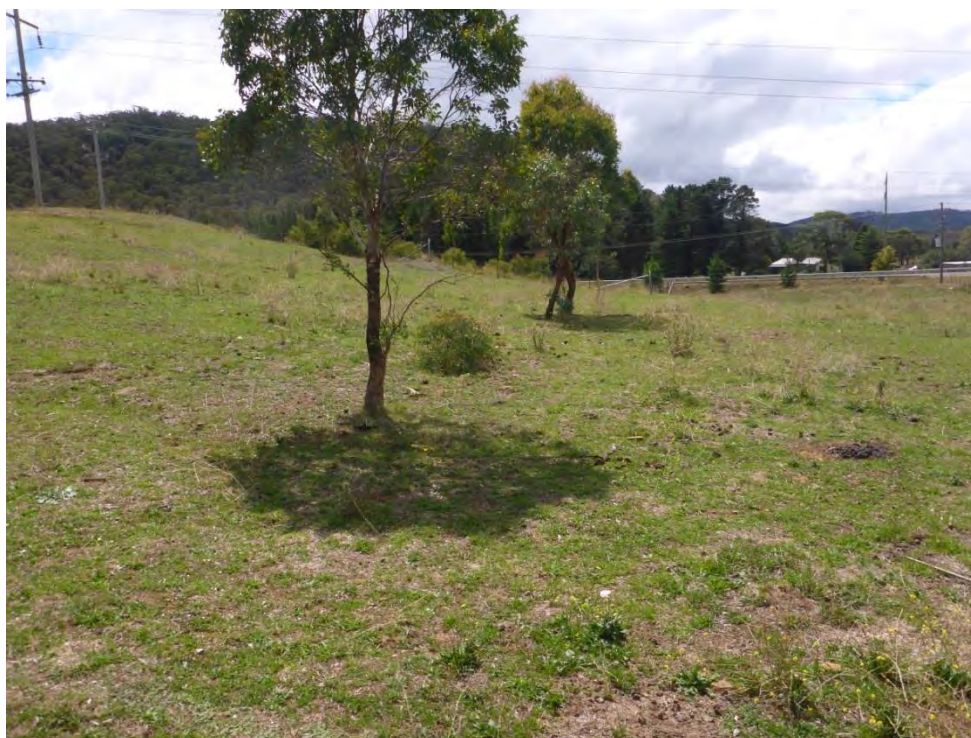
**Photo 7 Rehabilitated Site EP5 March 2018**

**Photo 7** shows the general landscape setting for Site EP5 within the Morris Property at Enhance Place Mine during the 2018 inspections. Pasture at Site EP5 is dominated by perennial grasses fescue and phalaris, the herb plantain with some medic present in the sward, and greater than 90% groundcover.

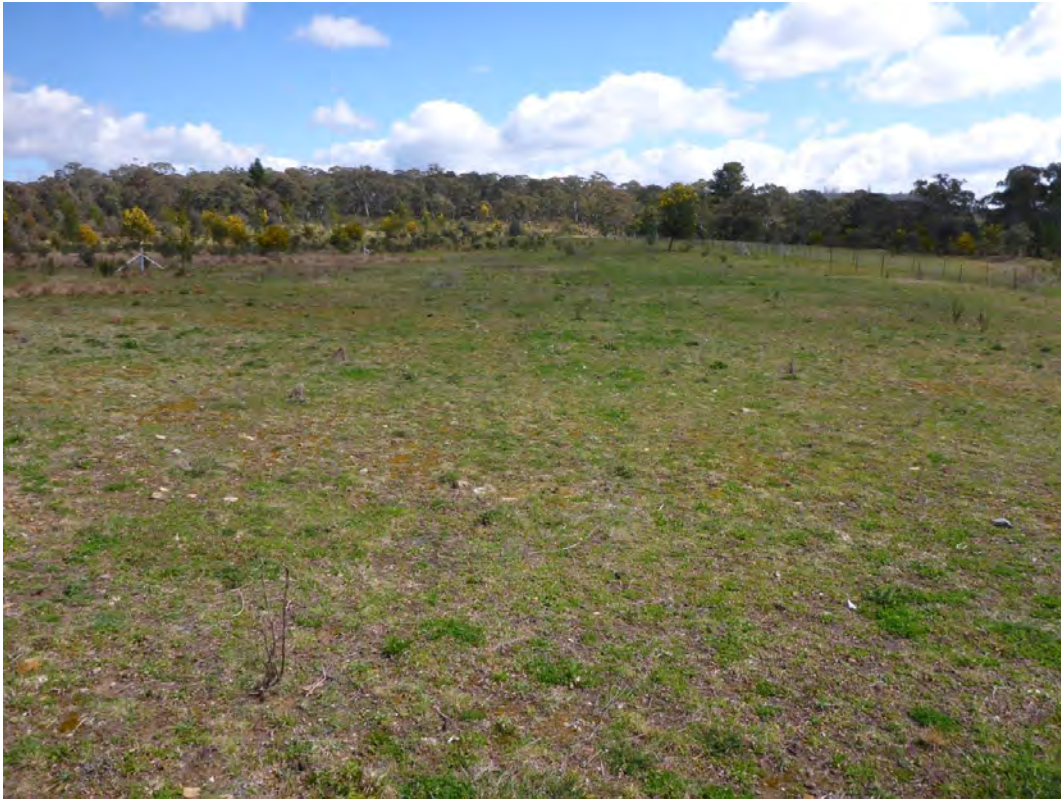
**Photo 8    Rehabilitated Site EP2 September 2014**

The Crown Land Block adjacent to the Morris property is grazed only by kangaroos with domestic stock being excluded. In 2014 EP2 had sufficient groundcover and a desirable pasture species composition with no further remediation work recommended.

**Photo 8** and **Photo 9** show the general landscape setting for Site EP2 within the Crown Land at Enhance Place Mine during the 2014 and 2018 inspections, with greater than 80% groundcover.

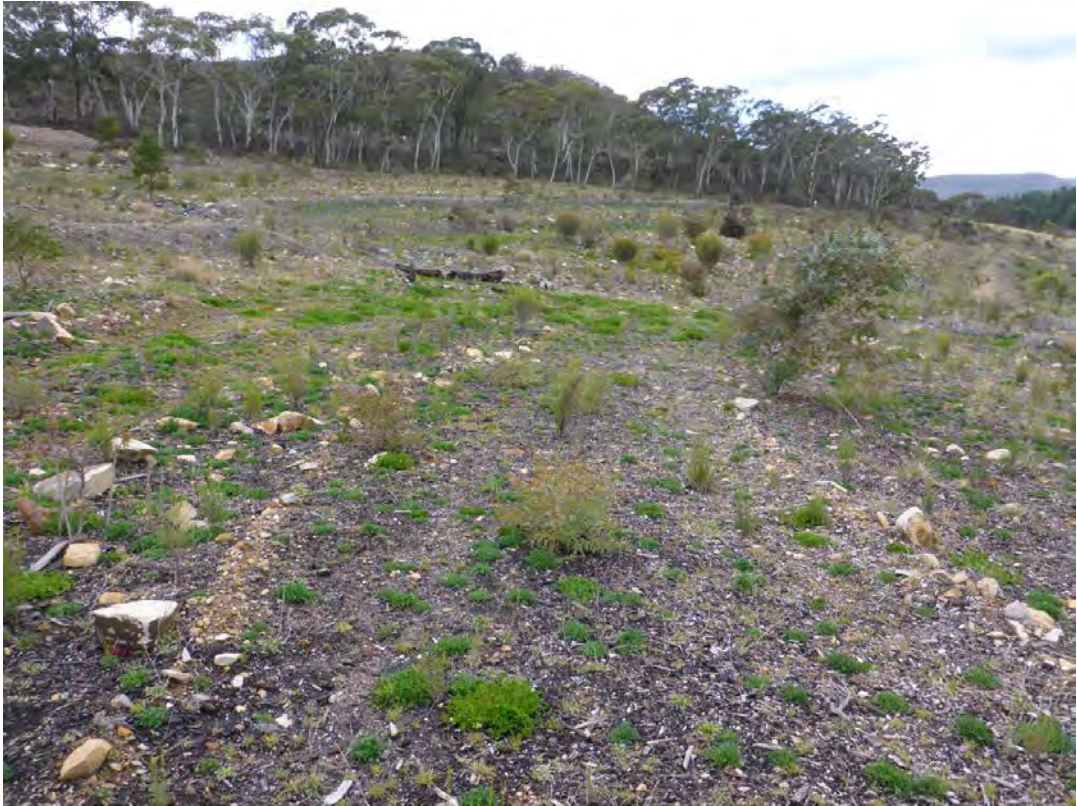
**Plate 1: Rehabilitated Site PD5 September 2014**

Increased growth of eucalypts can clearly be seen while groundcover consists of couch, phalaris and fescue perennial grasses with greater than 80% groundcover.

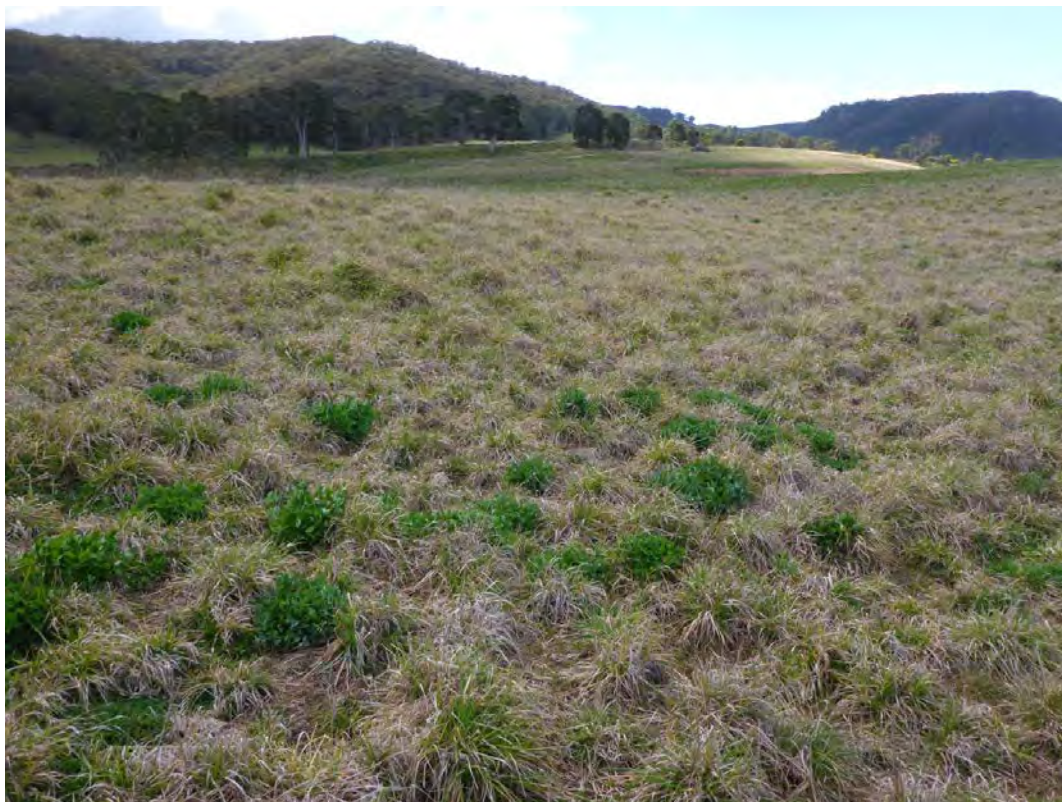
**Plate 5: Rehabilitated Site PD1 September 2014**

Pasture at Site PD1 is dominated by perennial cocksfoot and paspalum grass pasture with some sub clover and arrowleaf clover present in the sward, with greater than 90% groundcover. There is no African lovegrass present. Again the difference in pasture growth between autumn and spring can clearly be seen.

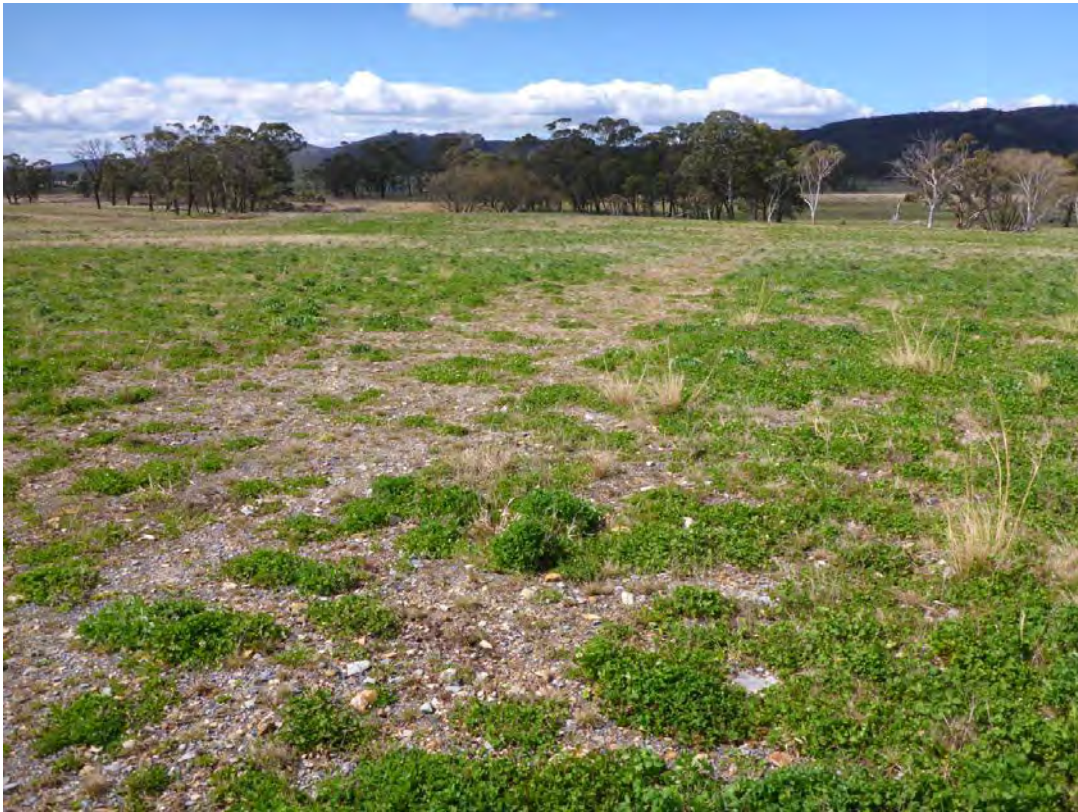
**Plate 7: Rehabilitated Site PD2 September 2014**

Pasture at Site PD2 is dominated by perennial cocksfoot and paspalum grass pasture with the herb plantain and some arrowleaf clover present in the sward, with greater than 80% groundcover. There are isolated African lovegrass tussocks present which comprise less than 5% of the pasture sward. Significant increase in perennial grass groundcover can be seen between the two inspection periods.

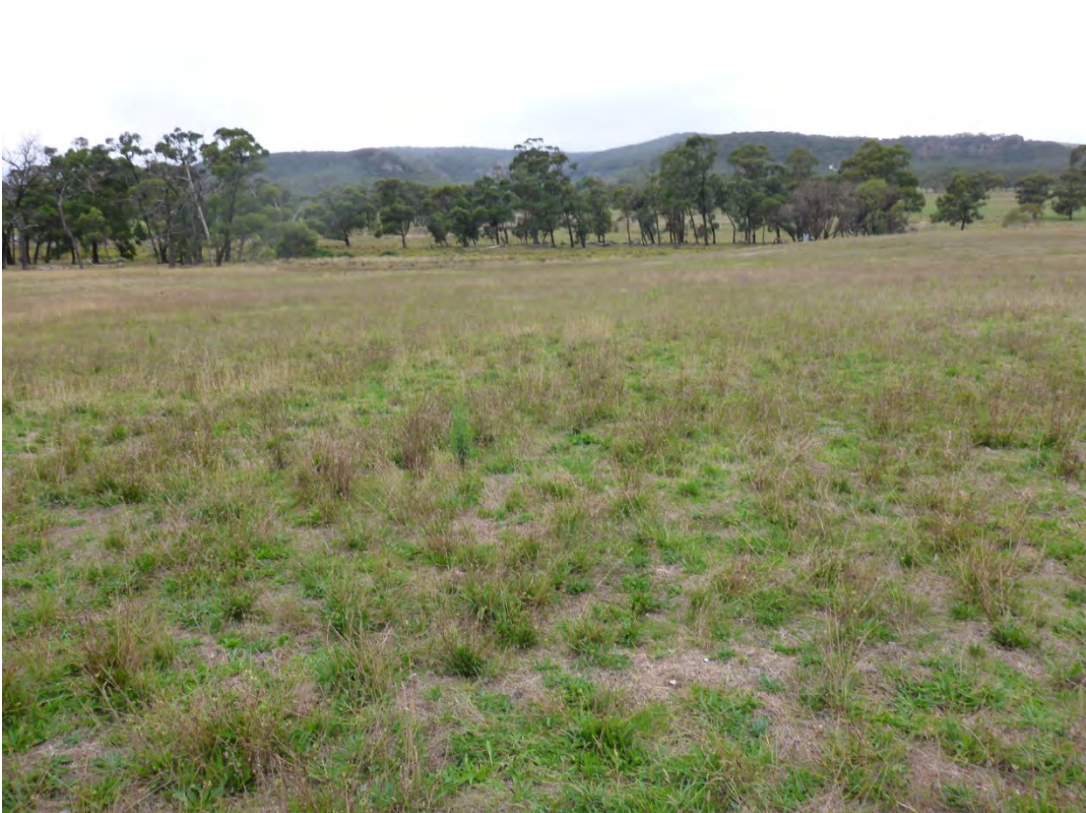
**Plate 10: Rehabilitated Site PD7 March 2018**

**Plate 10** shows the general landscape setting for Site PD7 within Area C at Pine Dale Mine during the 2018 inspection. Pasture at Site PD6 is dominated by perennial grasses phalaris, fescue and paspalum along with the herb plantain and arrowleaf clover. There is greater than 90% groundcover with only isolated tussocks of African lovegrass, which comprises less than 5% of the pasture sward.

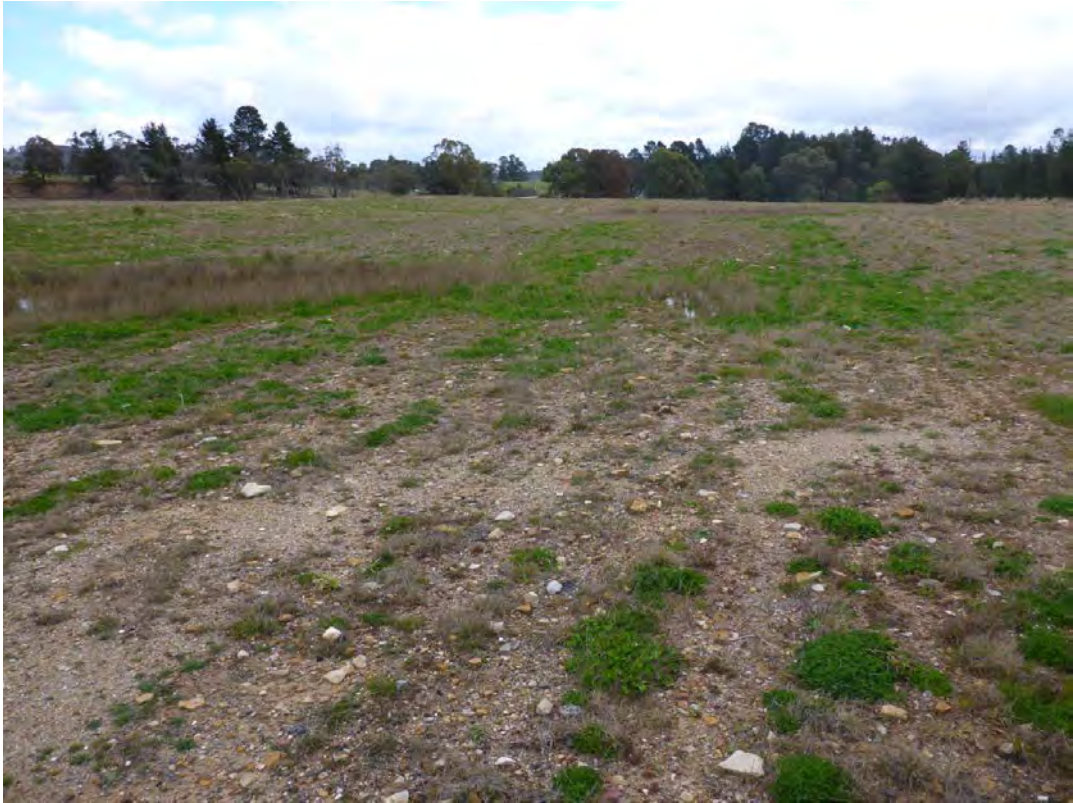
**Plate 11: Rehabilitated Site PD4 September 2014**

Pasture at Site PD4 is dominated by perennial grasses cocksfoot, fescue and paspalum with some arrowleaf clover present in the sward, and greater than 90% groundcover. There are isolated African lovegrass tussocks present which comprise less than 5% of the pasture sward. Significant increase in perennial grass groundcover can be seen between the two inspection periods.

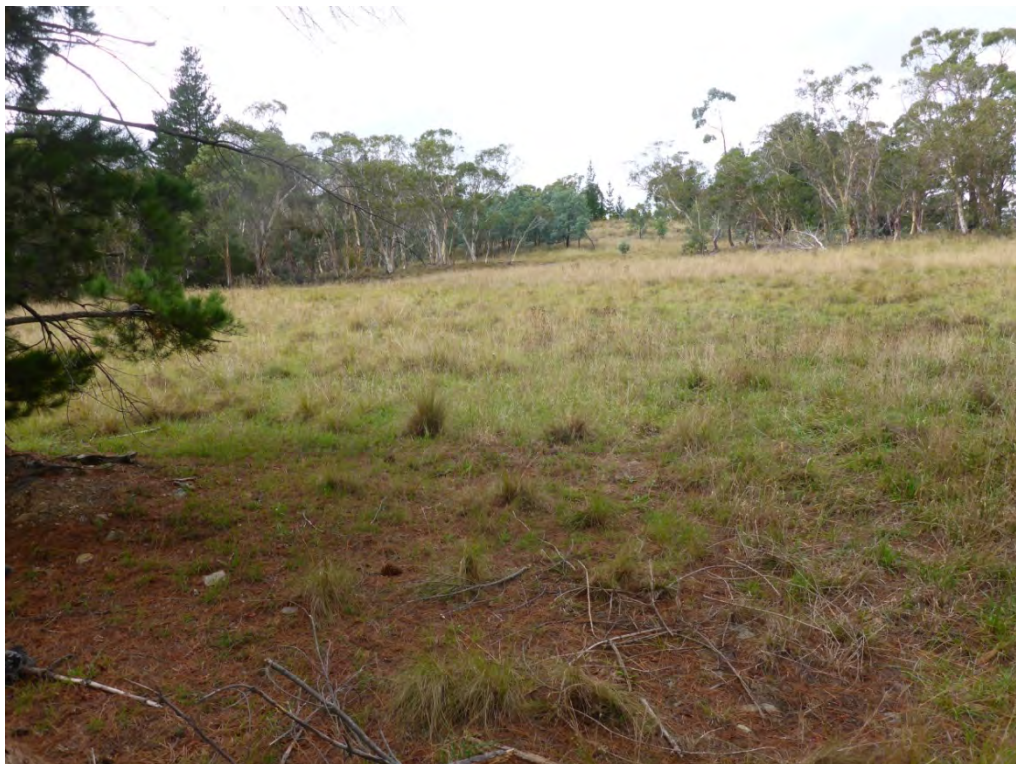
**Plate 13: Analogue Site PD8 March 2018**

**Plate 13** shows the general landscape setting for Site PD8 within Area 8 at Pine Dale Mine during the 2018 inspection. Pasture at Site PD8 is dominated by perennial phalaris and fescue with some arrowleaf clover present in the sward, with greater than 90% groundcover. There are isolated African lovegrass tussocks present which comprise less than 5% of the pasture sward.

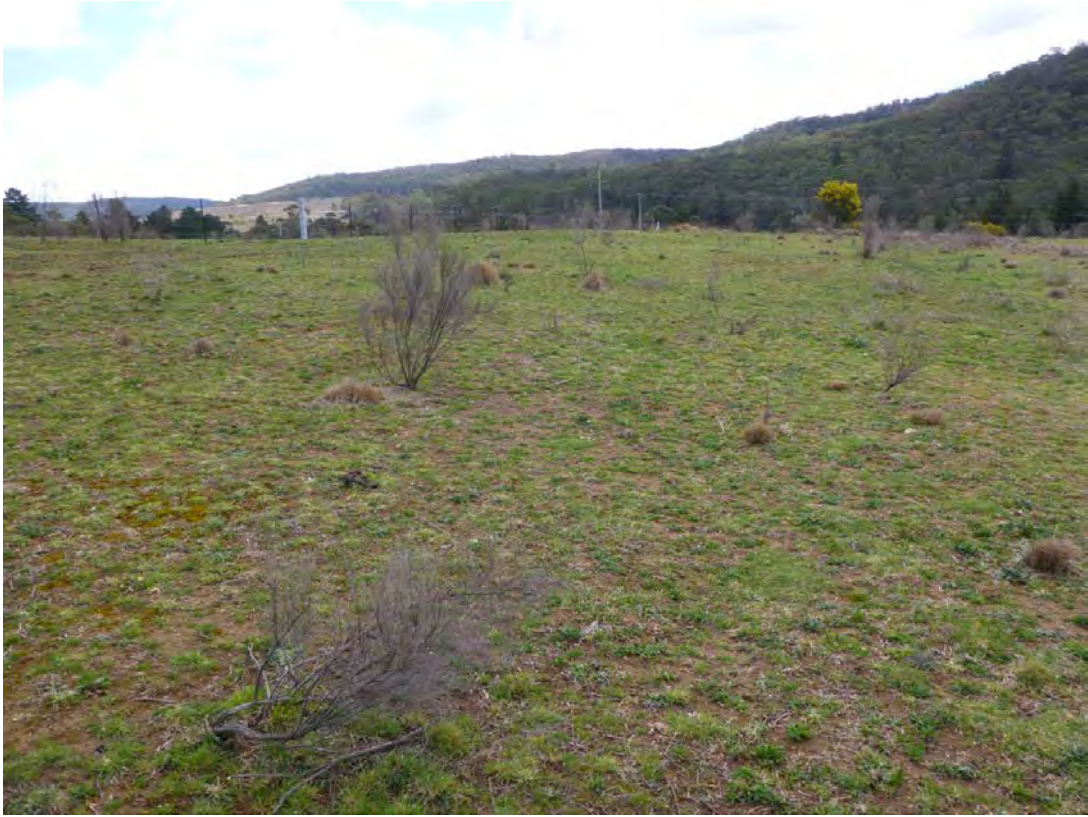
**Plate 16: Rehabilitated Site EP1 September 2014**

Overgrazing is still a major land management issue here, however increase in perennial grass pasture density have been achieved nonetheless.

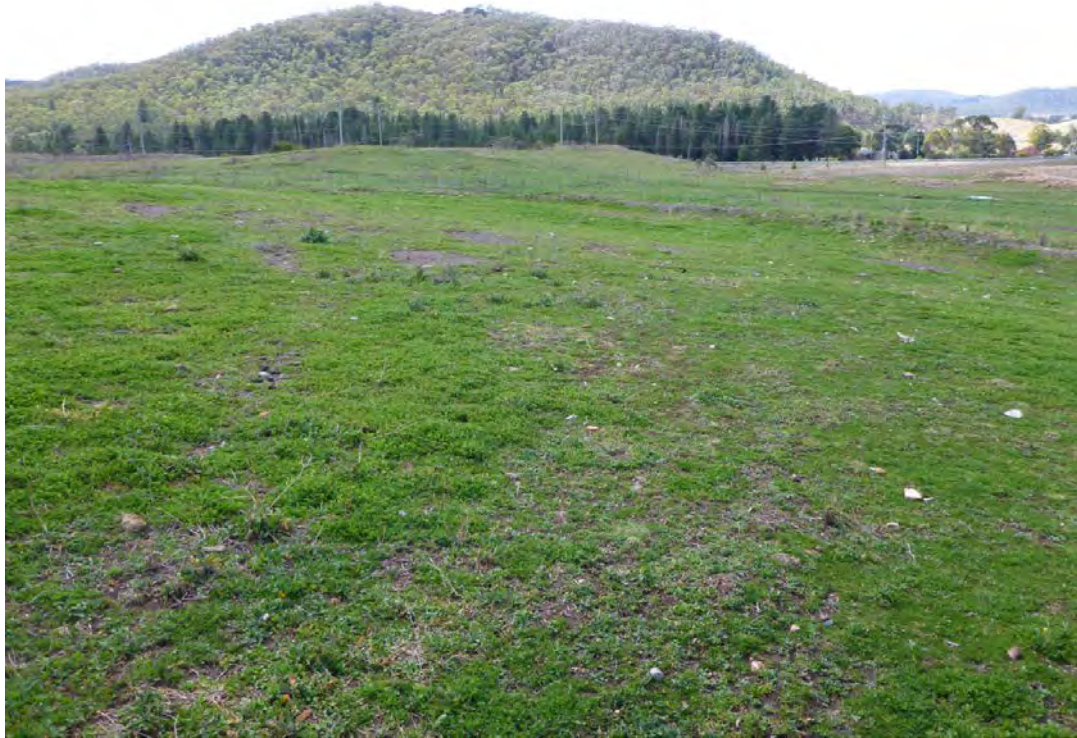
**Plate 18: Rehabilitated Site EP3 September 2014**

Overgrazing is still a major land management issue here, however increase in perennial grass pasture density have been achieved nonetheless.

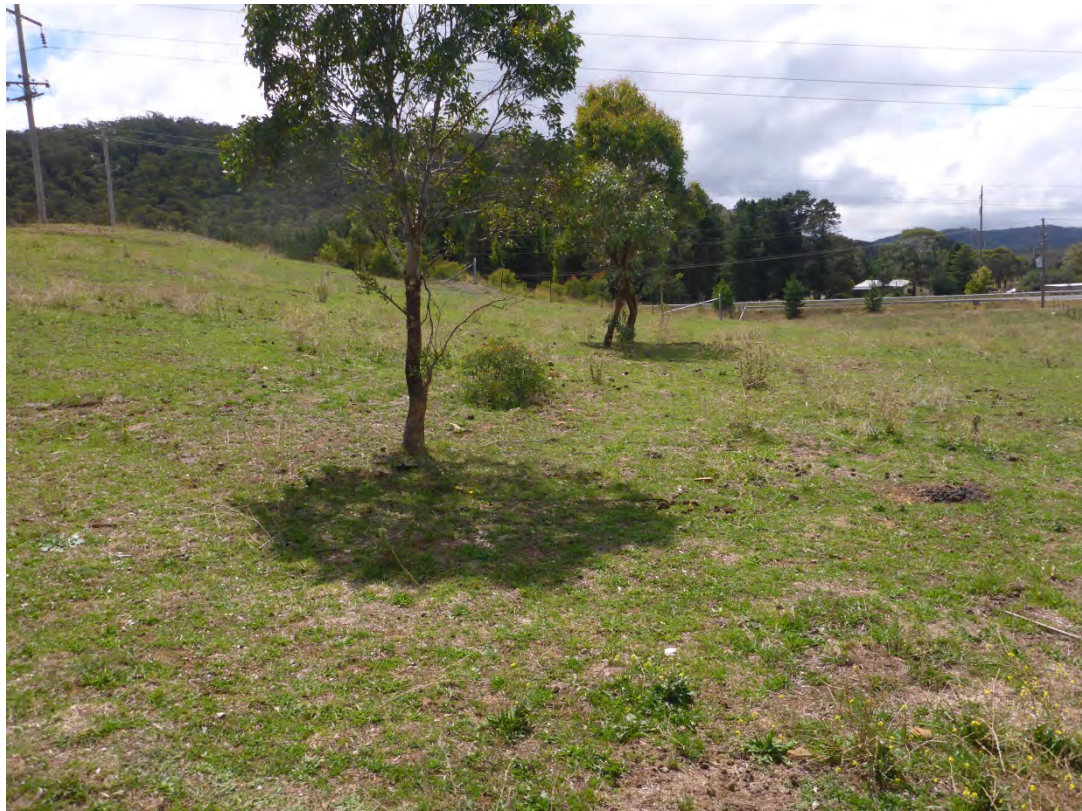
**Plate 20: Rehabilitated Site EP5 March 2018**

**Plate 20** shows the general landscape setting for Site EP5 within the Morris Property at Enhance Place Mine during the 2018 inspections. Pasture at Site EP5 is dominated by perennial grasses fescue and phalaris, the herb plantain with some medic present in the sward, and greater than 90% groundcover.

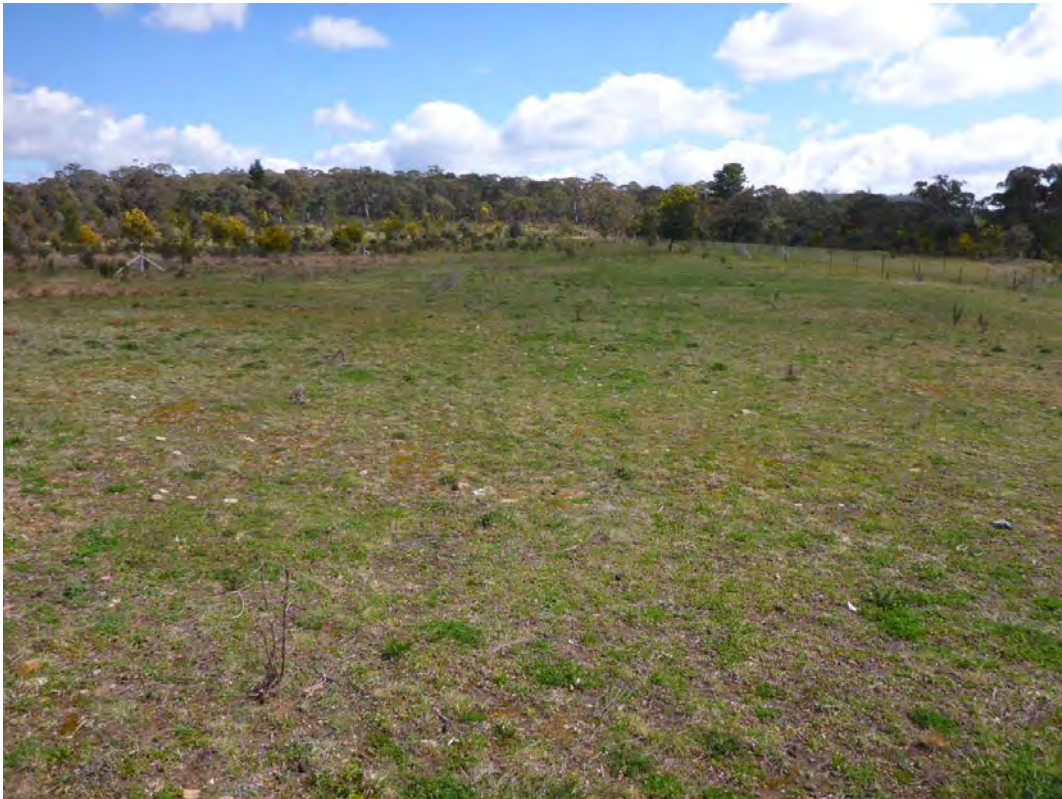
**Plate 21: Rehabilitated Site EP2 September 2014**

**Plate 21** and **Plate 22** show the general landscape setting for Site EP2 within the Morris Property at Enhance Place Mine during the 2014 and 2018 inspections, with greater than 80% groundcover.
