ENHANCE PLACE MINE

2020

**ANNUAL ENVIRONMENTAL
MANAGEMENT REPORT**

(Small Mine Version)

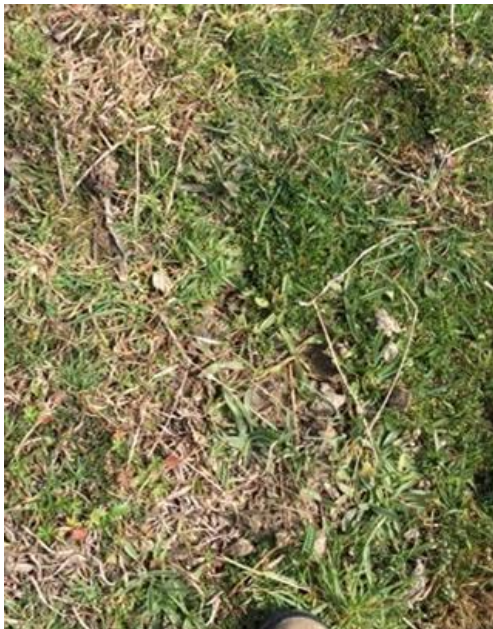
Figure 2 Pasture composition at the Pasture Analogue site

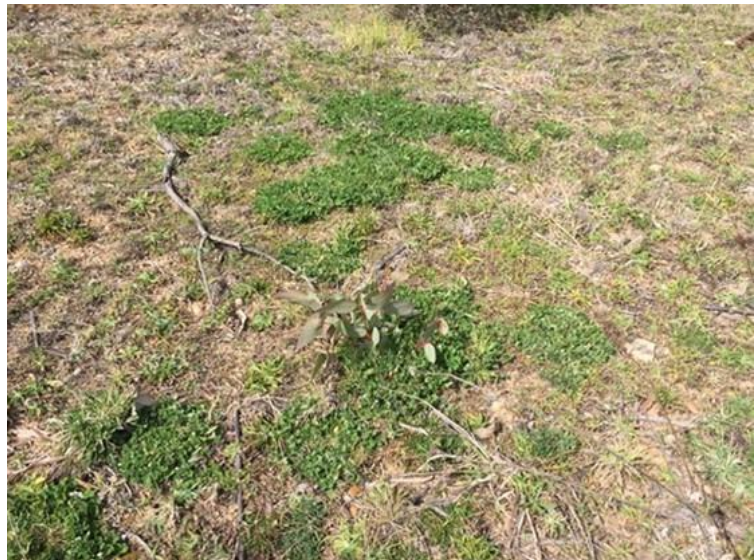
Figure 3 Typical pasture composition at Quadrat 1

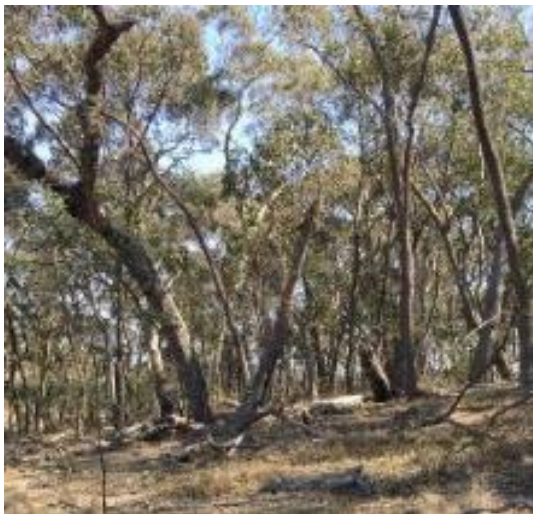
In 2019 the treed analogue site was characterised by a canopy to 14 m height with 20% canopy cover over a sparse shrubby mid-storey to 3 m height and isolated shrubs to 1.5 m height in the understorey. Groundcover consisted of grasses and herbs with a cover of >95% (Figure 4).

Figure 4 Vegetation structure of treed analogue site (Transect 7) in 2019

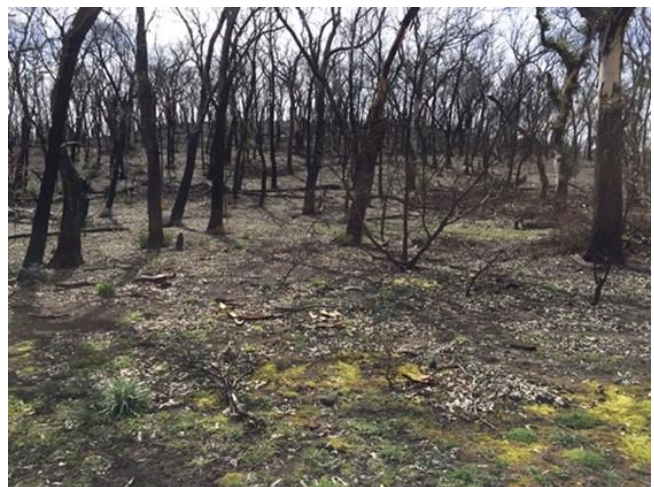
Figure 5 Vegetation structure of treed analogue site (Pine Dale Mine) 2020 shows the vegetation structure at the treed analogue site in 2020. Many of the standing trees are showing evidence of new growth however the presence of epicormic growth is not an indicator of long-term survival of the tree. Recently fallen timber is contributing to ground cover. The trees are providing no appreciable canopy cover. The shrub layer is very sparse. Ground cover is actively growing. Regeneration of woody plants is occurring across the site.

Figure 5 Vegetation structure of treed analogue site (Pine Dale Mine) 2020

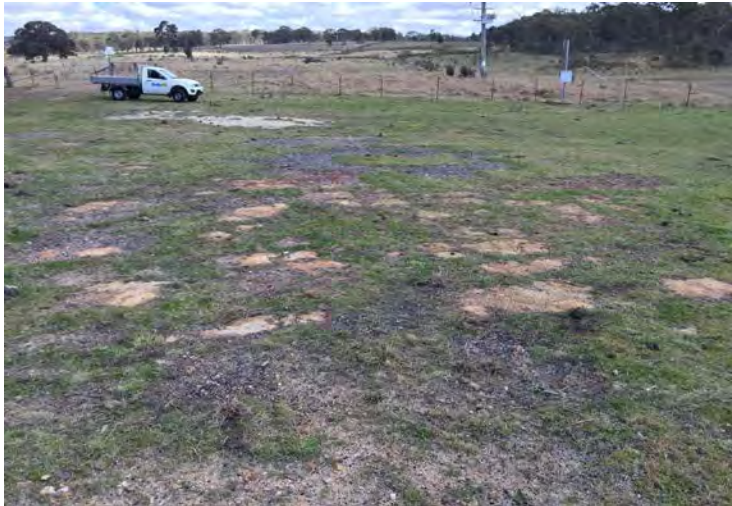
There is some evidence of active, minor to moderate wind erosion where pastures are poorly established or absent (see Figure 4 and Figure 5). Minor rilling is occurring on exposed soils of the sediment retention basins and can be seen in Figure 6.

Figure 4 Patchy exposed soils in south-western corner of pasture area

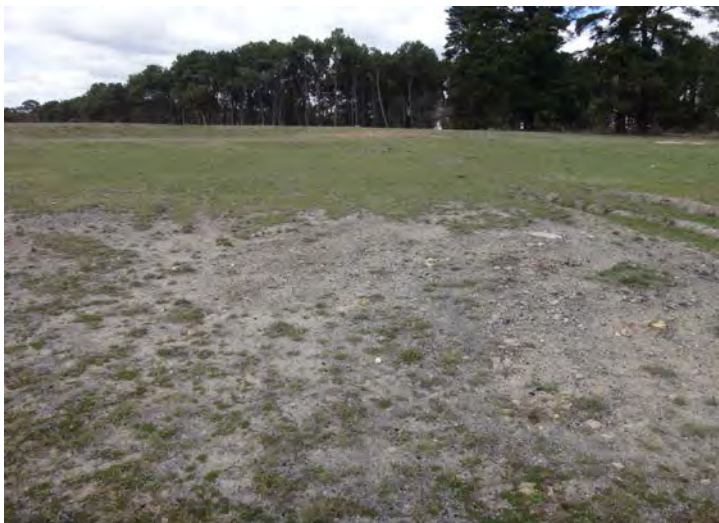
Figure 5 Exposed soils in southern portion of pasture area

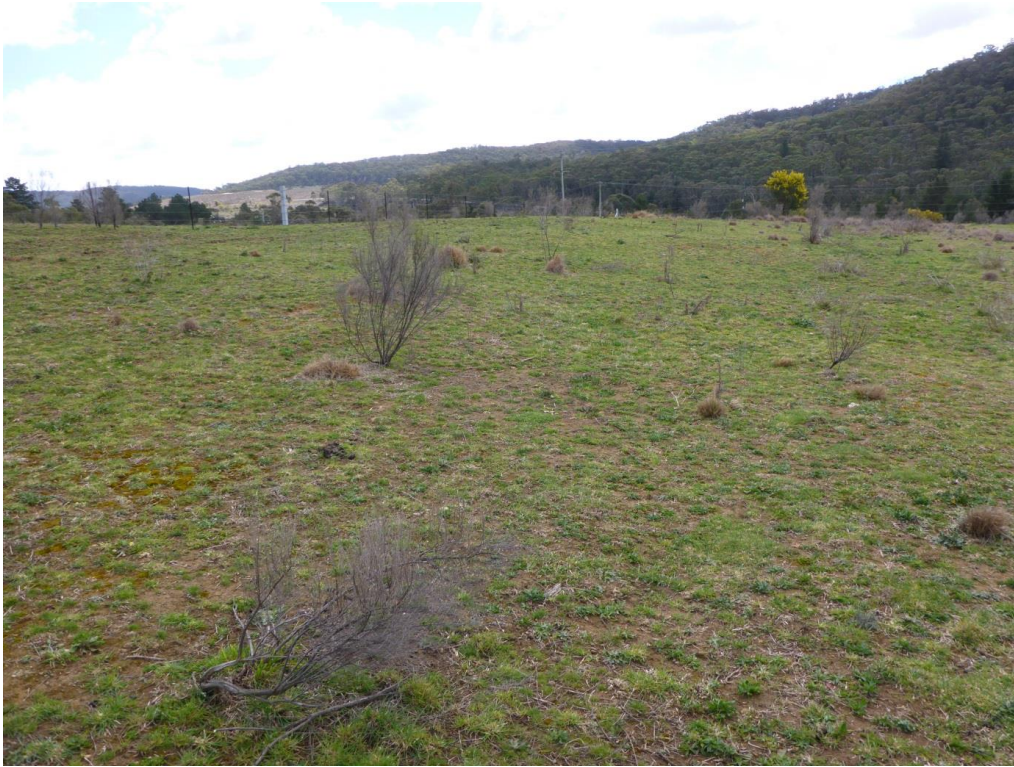
Overgrazing is still a major land management issue here, however increase in perennial grass pasture density have been achieved nonetheless.

Photo 3 Rehabilitated Site EP1 September 2014

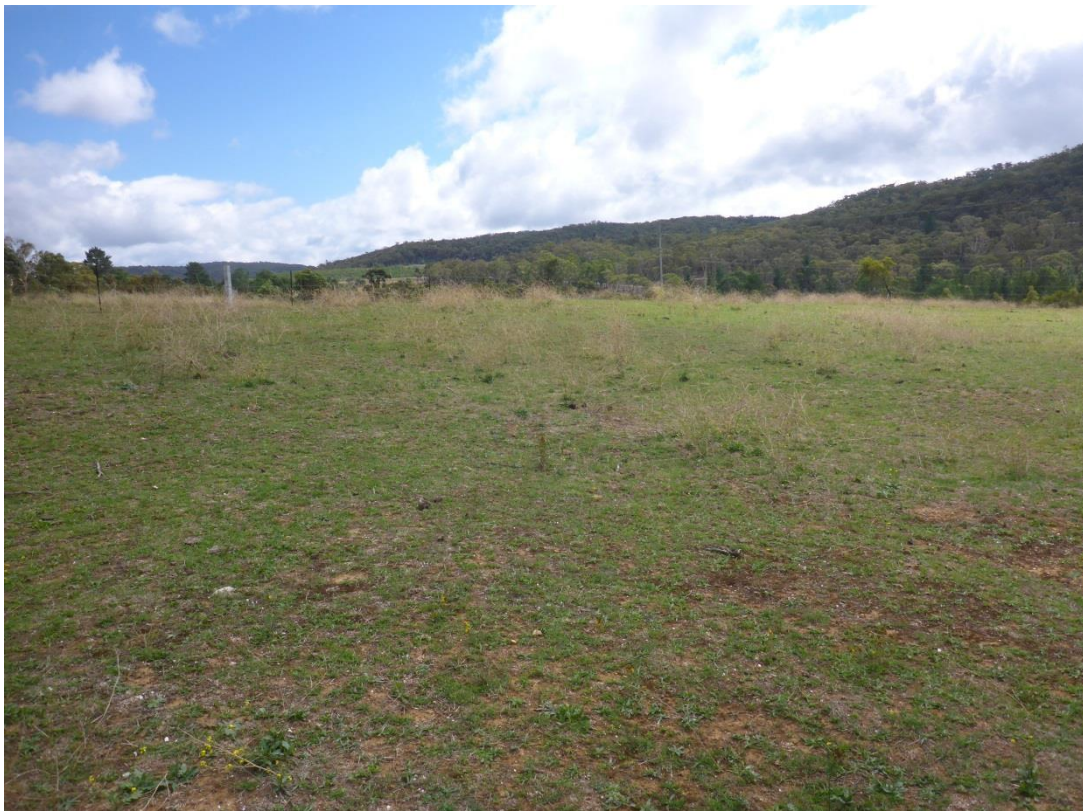
Photo 4 Rehabilitated Site EP1 March 2018

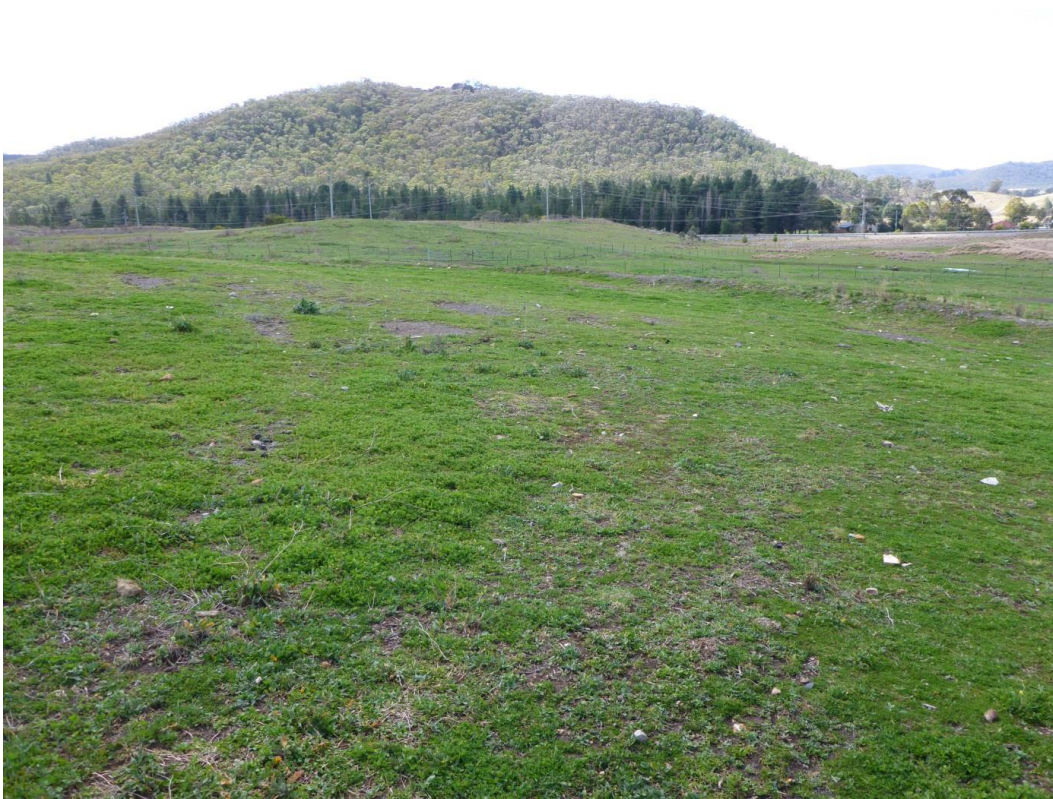
Overgrazing is still a major land management issue here, however increase in perennial grass pasture density have been achieved nonetheless.

Photo 5 Rehabilitated Site EP3 September 2014

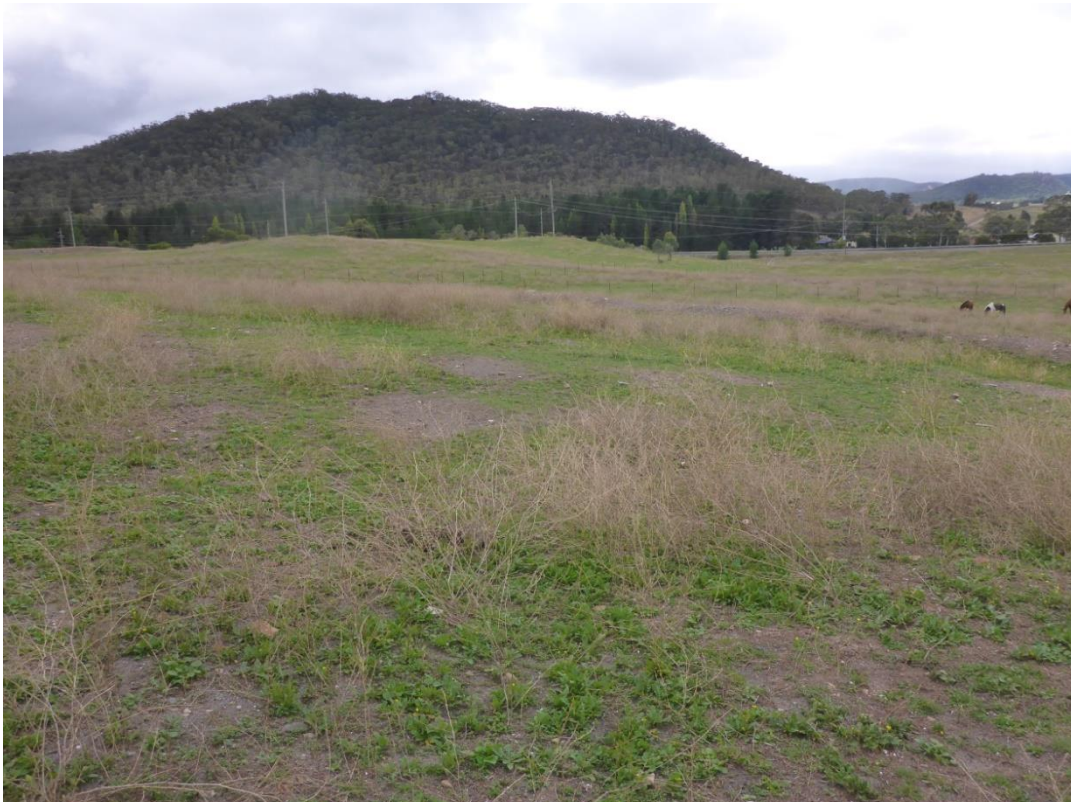
Photo 6 Rehabilitated Site EP3 March 2018

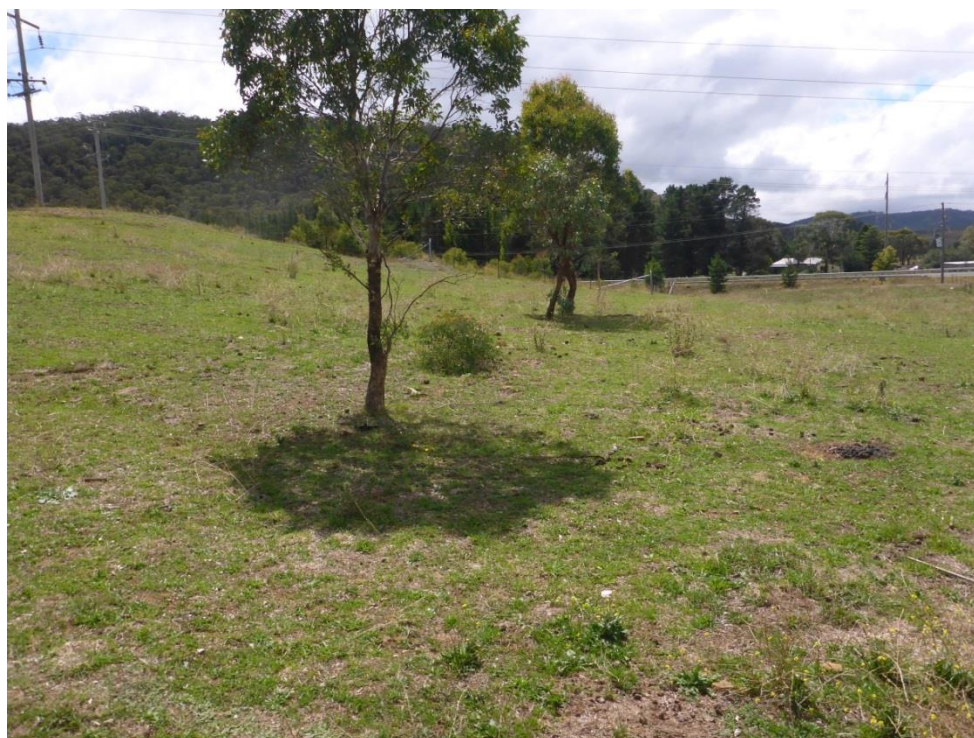
Photo 7 shows the general landscape setting for Site EP5 within the Morris Property at Enhance Place Mine during the 2018 inspections. Pasture at Site EP5 is dominated by perennial grasses fescue and phalaris, the herb plantain with some medic present in the sward, and greater than 90% groundcover.

Photo 7 Rehabilitated Site EP5 March 2018

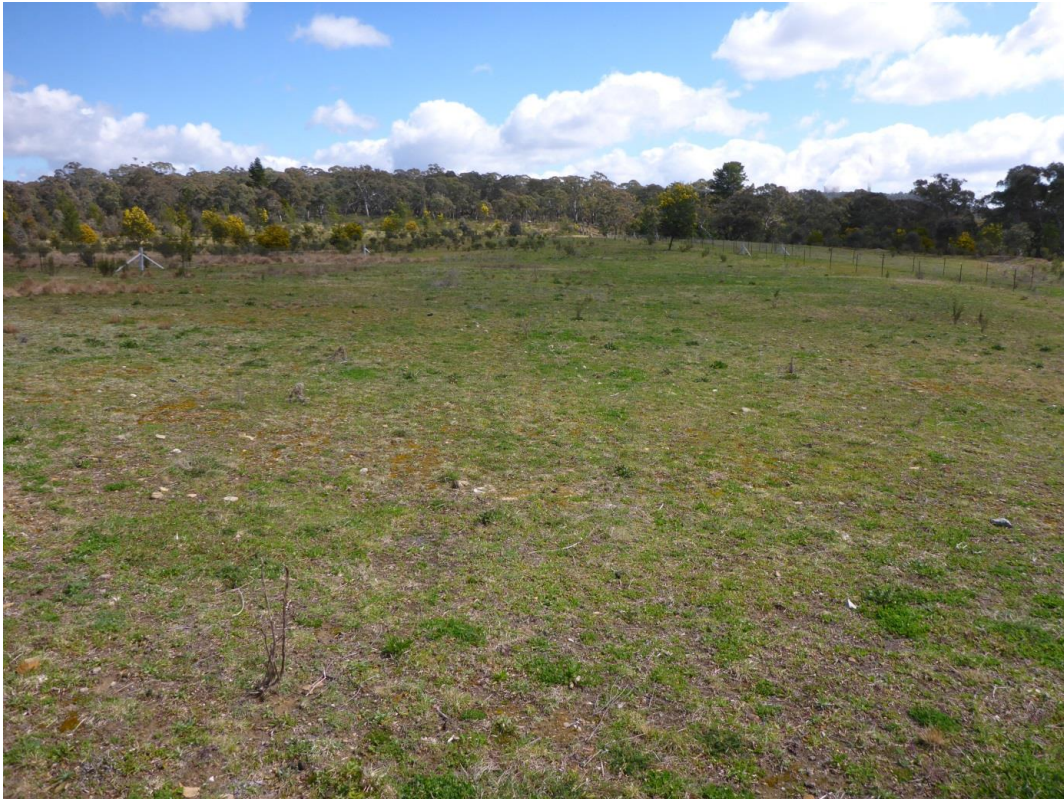
Photo 8 and **Photo 9** show the general landscape setting for Site EP2 within the Crown Land at Enhance Place Mine during the 2014 and 2018 inspections, with greater than 80% groundcover.

Photo 8 Rehabilitated Site EP2 September 2014

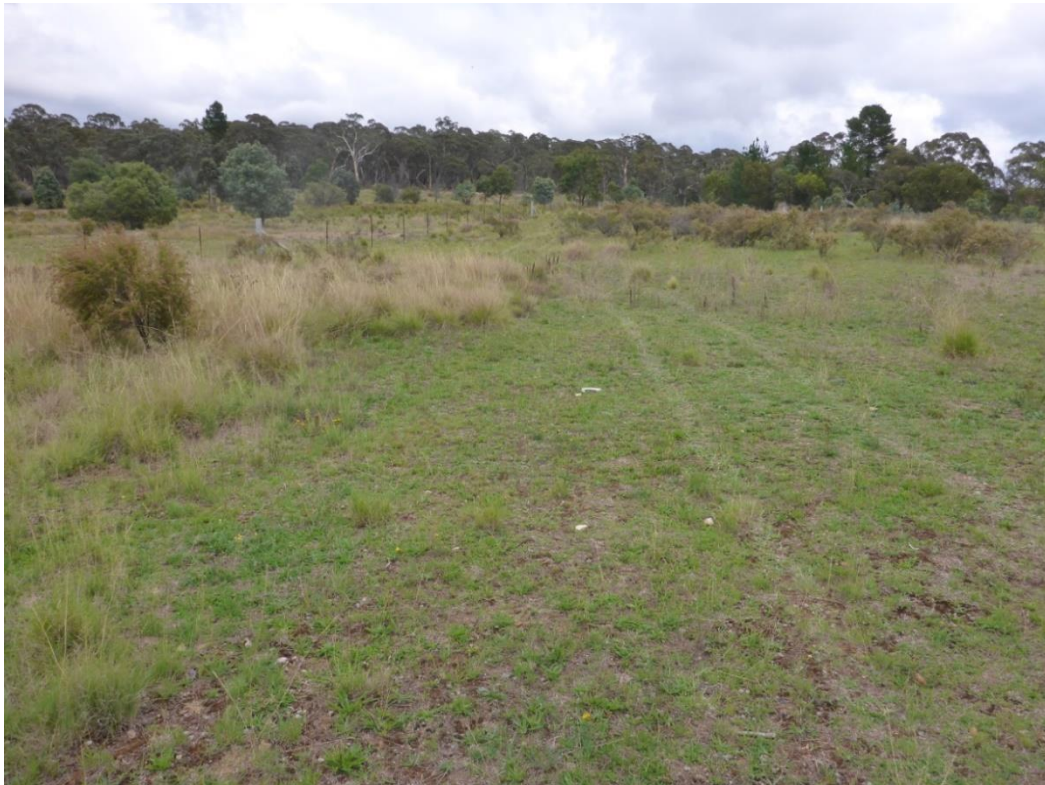
Photo 9 Rehabilitated Site EP2 March 2018

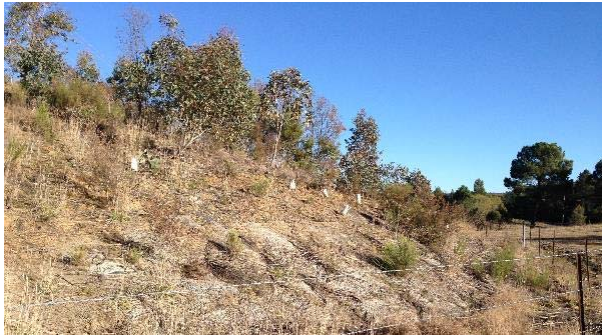
Groundcover at treed rehabilitation areas – Transect 7 supports groundcover of 90%. Transect 8 supports groundcover of 70%.

Figure 4 Vegetation structure and groundcover at transect 7

Canopy cover is absent in treed rehabilitation areas. A sparse mid-storey of isolated juvenile trees and shrubs exists over a sparse, low, shrubby understorey (seen in Figure 4 and Figure 5). Groundcover is a sparse mix of broadleaf herbs and grasses. Changes in vegetation structure over time (as shown in Appendix B) are not considered significant.

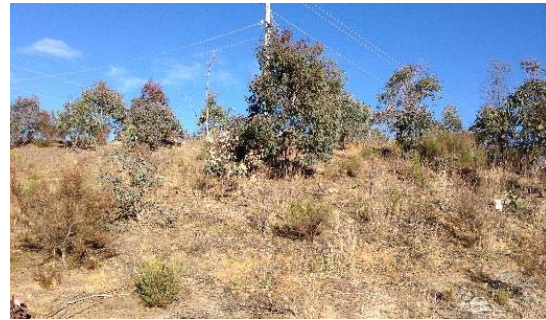
Figure 5 Vegetation structure and groundcover at transect 8

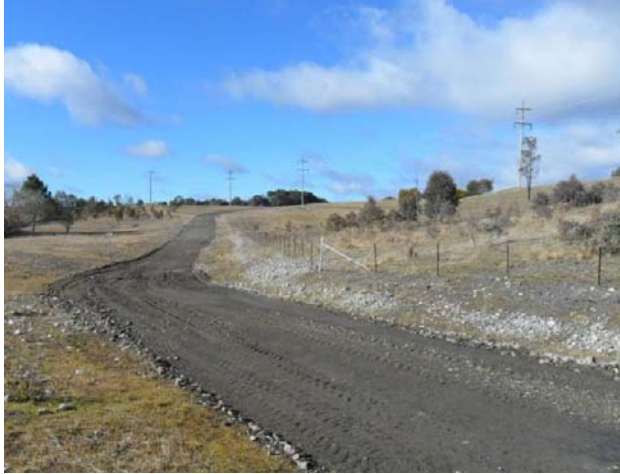
Site access trails have been constructed, gates have been installed and fences have been erected. Recent trail work has improved trail surfaces, grade and surface water drainage (see Figure 7).

Figure 7 Recently graded trail

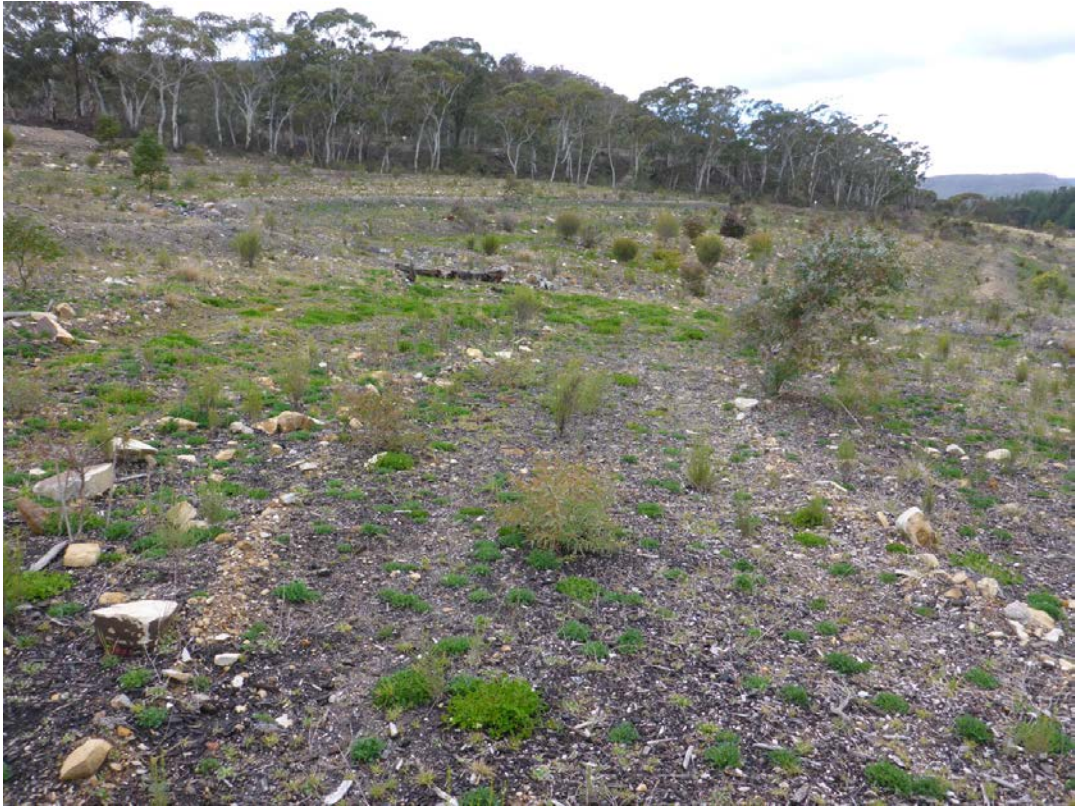
Plate 1: Rehabilitated Site PD5 September 2014

Increased growth of eucalypts can clearly be seen while groundcover consists of couch, phalaris and fescue perennial grasses with greater than 80% groundcover.

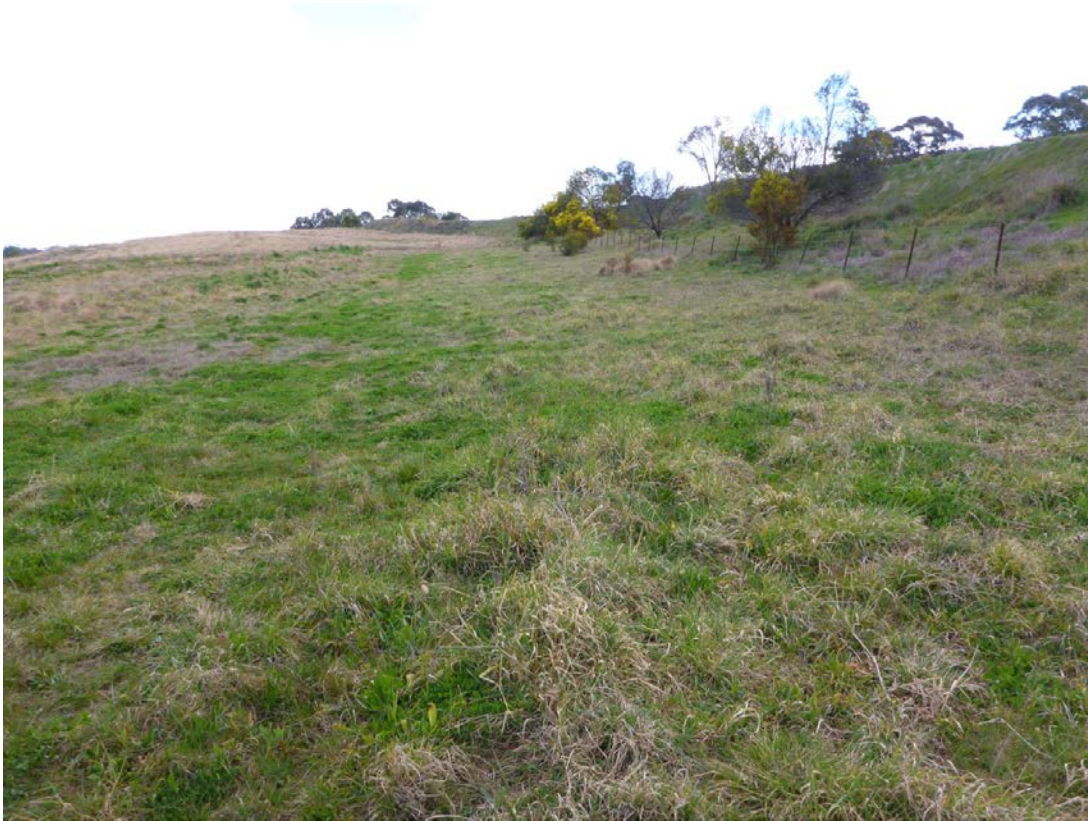
Plate 3: Analogue Site PD3 September 2014

Topsoil consists of a sandy clay loam over a medium clay subsoil. This area supports a perennial grass and clover pasture, including cocksfoot, tall fescue, phalaris, sub clover, with some annual ryegrass. These pasture species have a winter and spring growth habit, with the difference in pasture mass clearly evident between the 2014 (September) and 2018 (March) inspections.

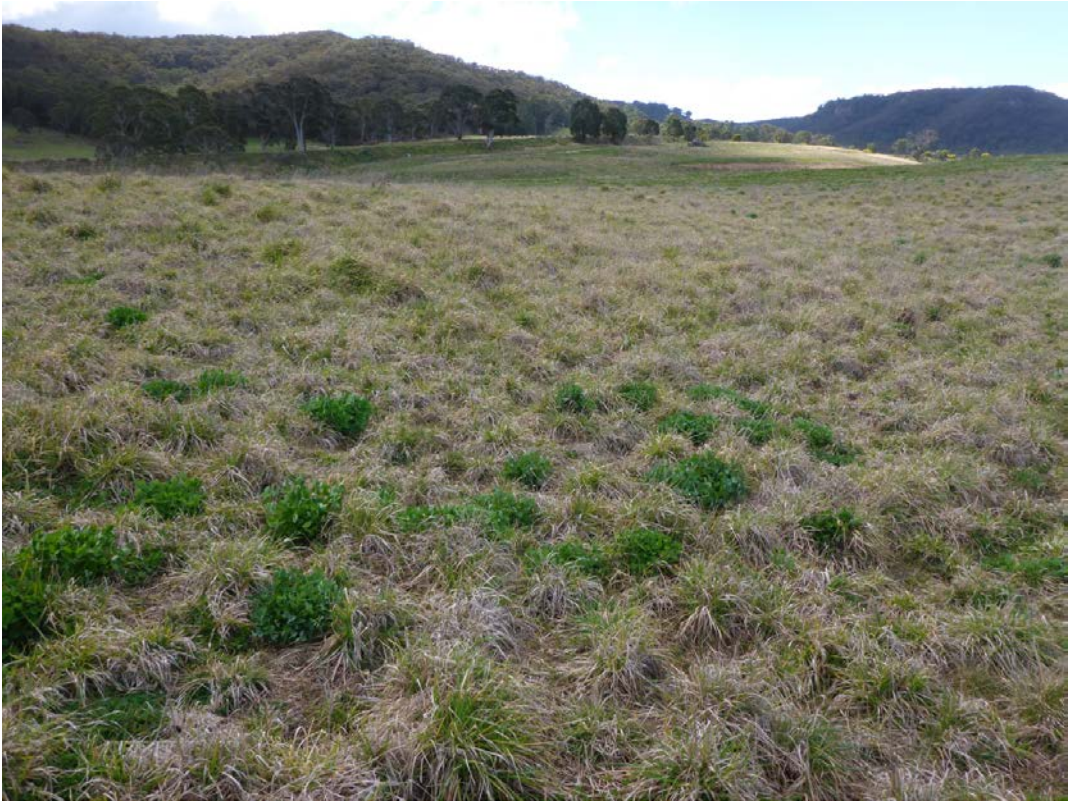
Plate 5: Rehabilitated Site PD1 September 2014

Pasture at Site PD1 is dominated by perennial cocksfoot and paspalum grass pasture with some sub clover and arrowleaf clover present in the sward, with greater than 90% groundcover. There is no African lovegrass present. Again the difference in pasture growth between autumn and spring can clearly be seen.

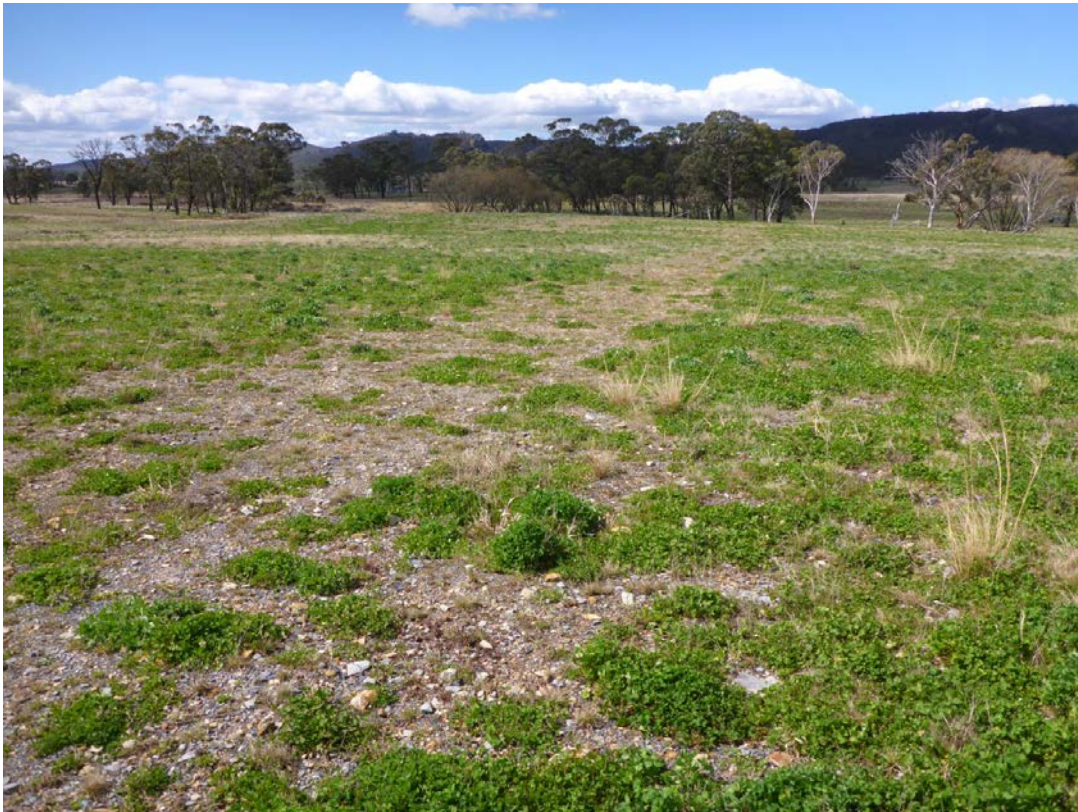
Plate 7: Rehabilitated Site PD2 September 2014

Pasture at Site PD2 is dominated by perennial cocksfoot and paspalum grass pasture with the herb plantain and some arrowleaf clover present in the sward, with greater than 80% groundcover. There are isolated African lovegrass tussocks present which comprise less than 5% of the pasture sward. Significant increase in perennial grass groundcover can be seen between the two inspection periods.

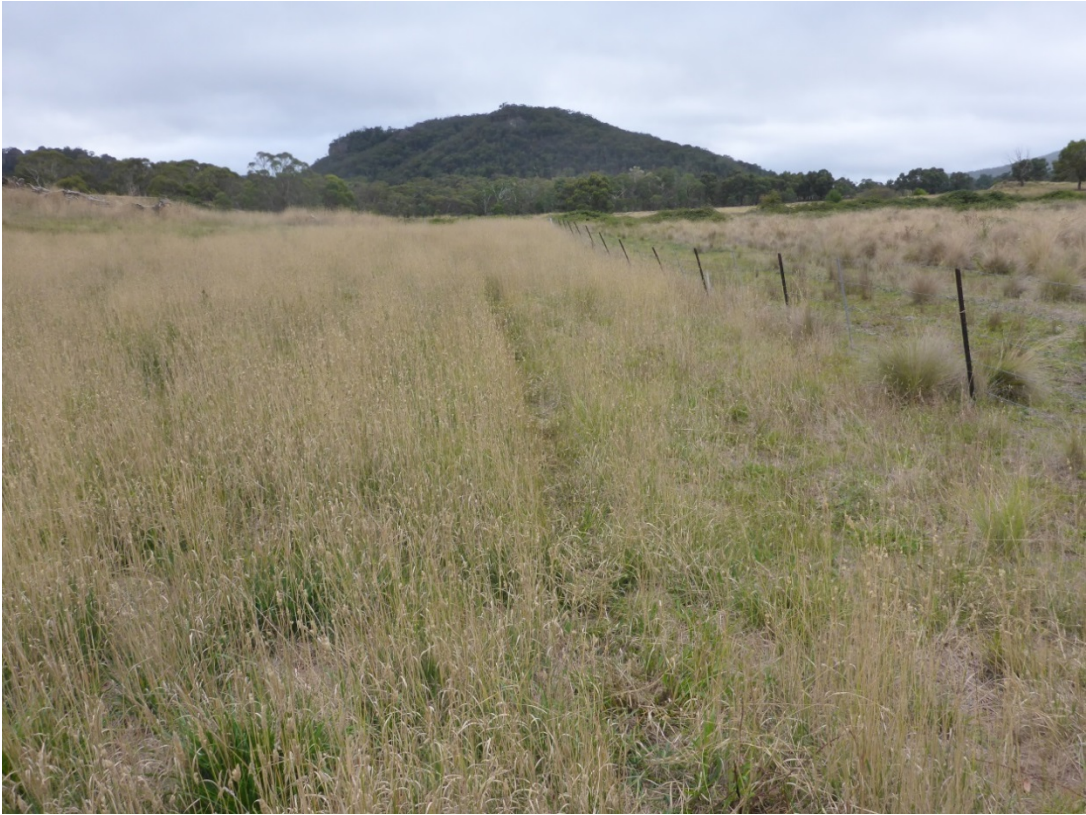
Plate 9: Analogue Site PD6 March 2018

Plate 9 shows the general landscape setting for Site PD6 within Area C at Pine Dale Mine during the 2018 inspection. Pasture at Site PD6 is dominated by the perennial grasses phalaris and fescue

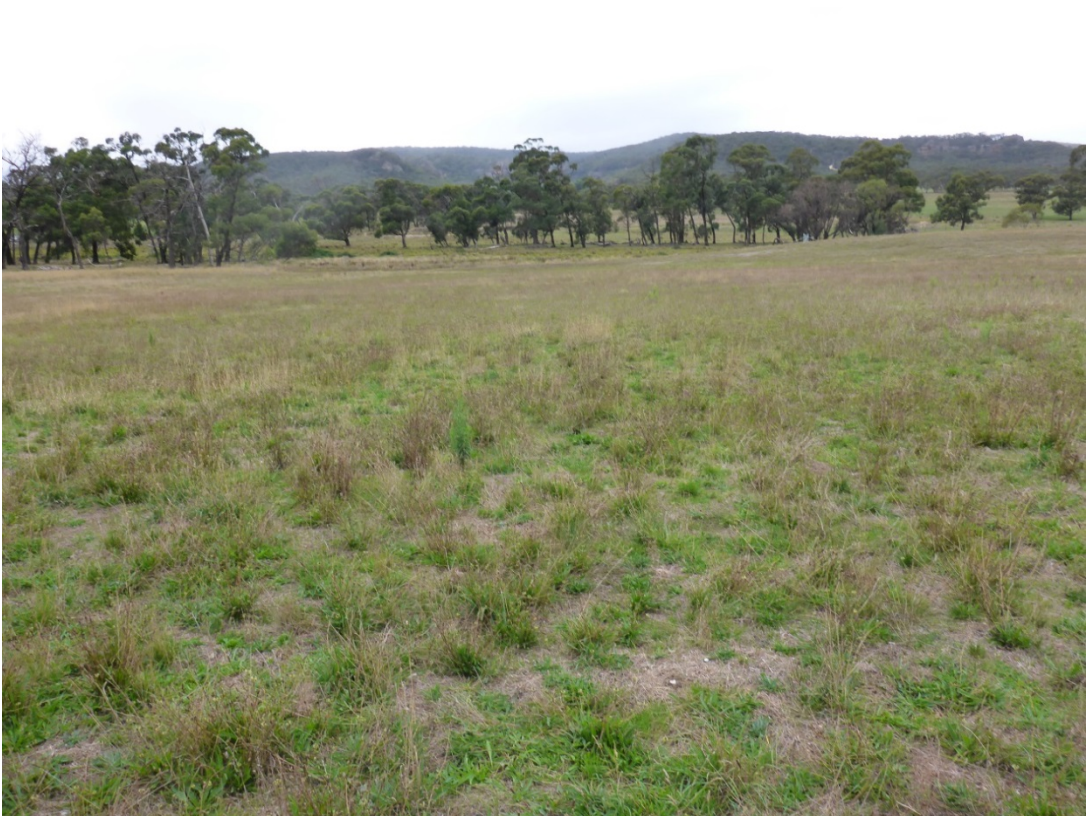
Plate 10: Rehabilitated Site PD7 March 2018

Plate 10 shows the general landscape setting for Site PD7 within Area C at Pine Dale Mine during the 2018 inspection. Pasture at Site PD6 is dominated by perennial grasses phalaris, fescue and paspalum along with the herb plantain and arrowleaf clover. There is greater than 90% groundcover with only isolated tussocks of African lovegrass, which comprises less than 5% of the pasture sward.

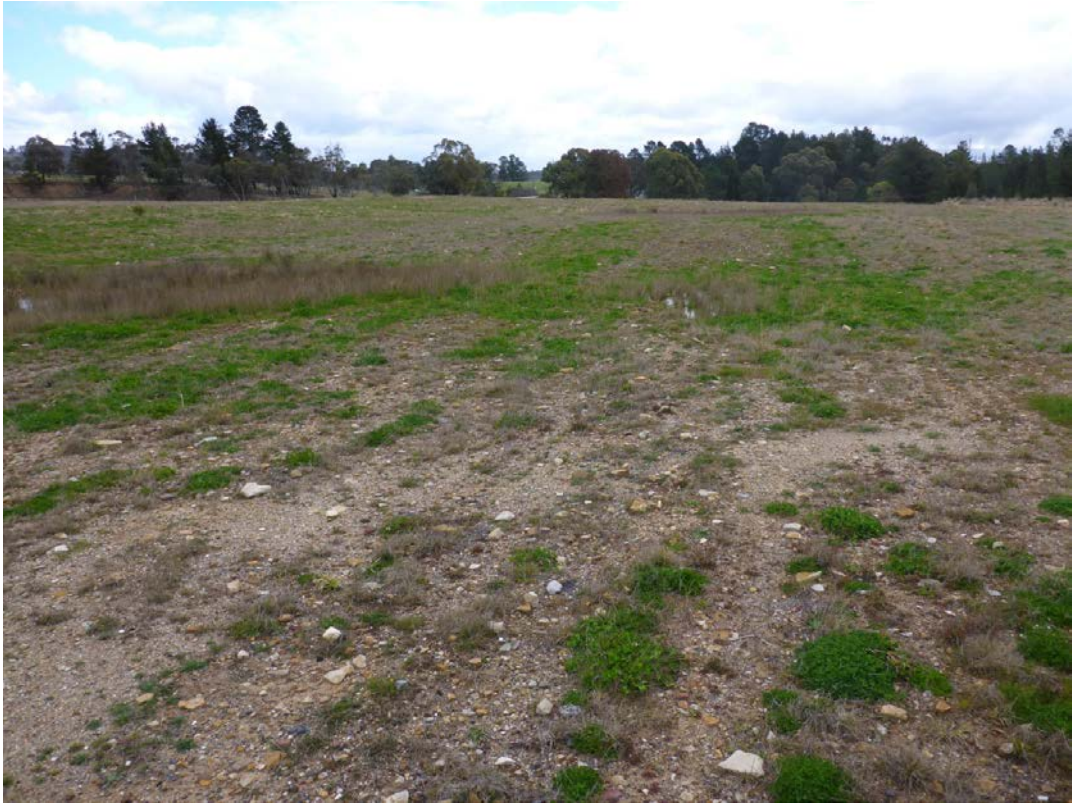
Plate 11: Rehabilitated Site PD4 September 2014

Pasture at Site PD4 is dominated by perennial grasses cocksfoot, fescue and paspalum with some arrowleaf clover present in the sward, and greater than 90% groundcover. There are isolated African lovegrass tussocks present which comprise less than 5% of the pasture sward. Significant increase in perennial grass groundcover can be seen between the two inspection periods.

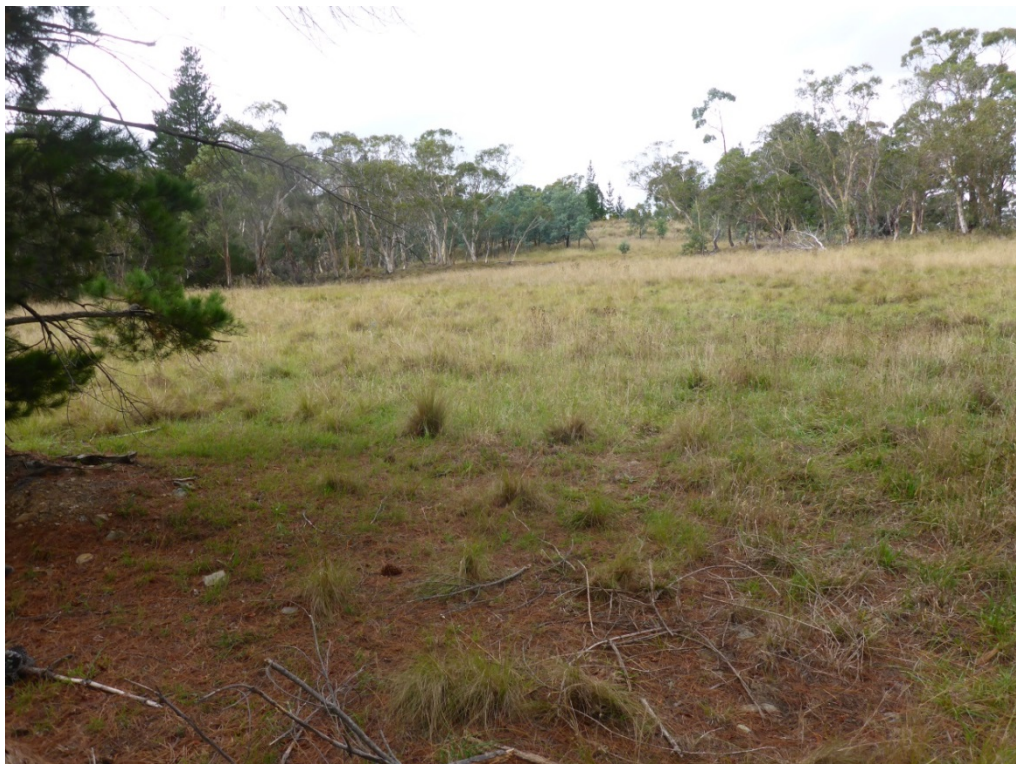
Plate 13: Analogue Site PD8 March 2018

Plate 13 shows the general landscape setting for Site PD8 within Area 8 at Pine Dale Mine during the 2018 inspection. Pasture at Site PD8 is dominated by perennial phalaris and fescue with some arrowleaf clover present in the sward, with greater than 90% groundcover. There are isolated African lovegrass tussocks present which comprise less than 5% of the pasture sward.

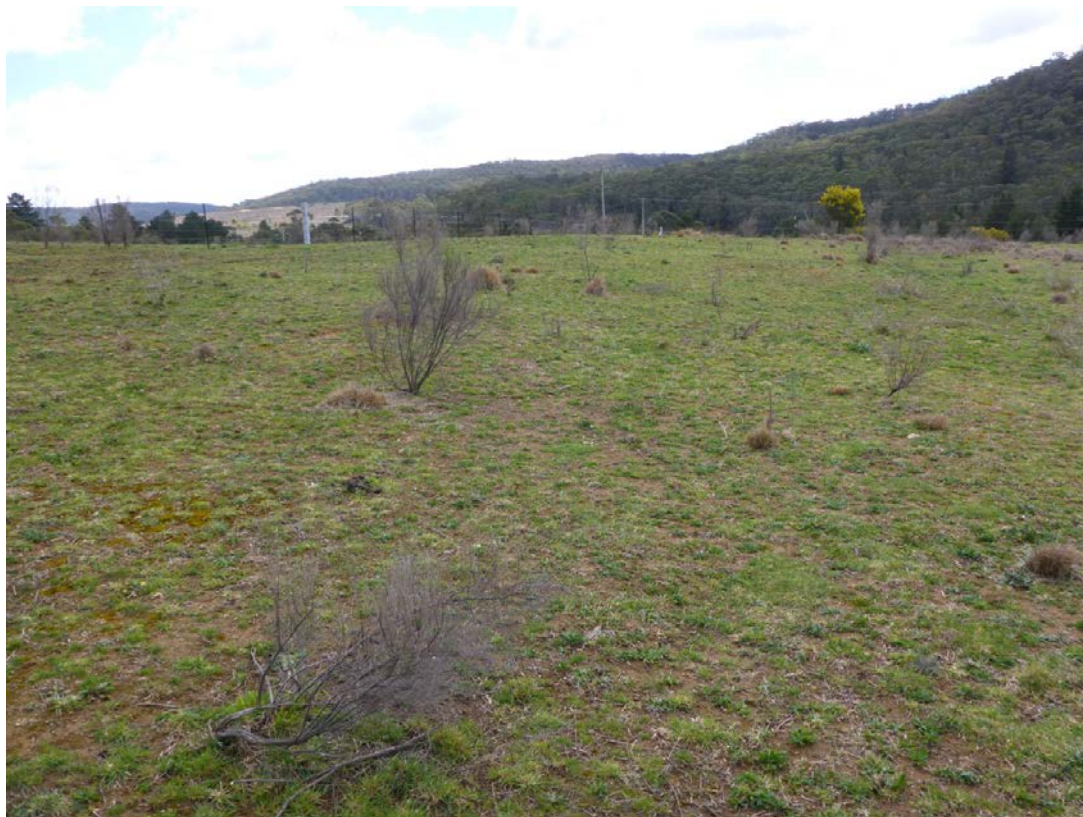
Plate 16: Rehabilitated Site EP1 September 2014

Overgrazing is still a major land management issue here, however increase in perennial grass pasture density have been achieved nonetheless.

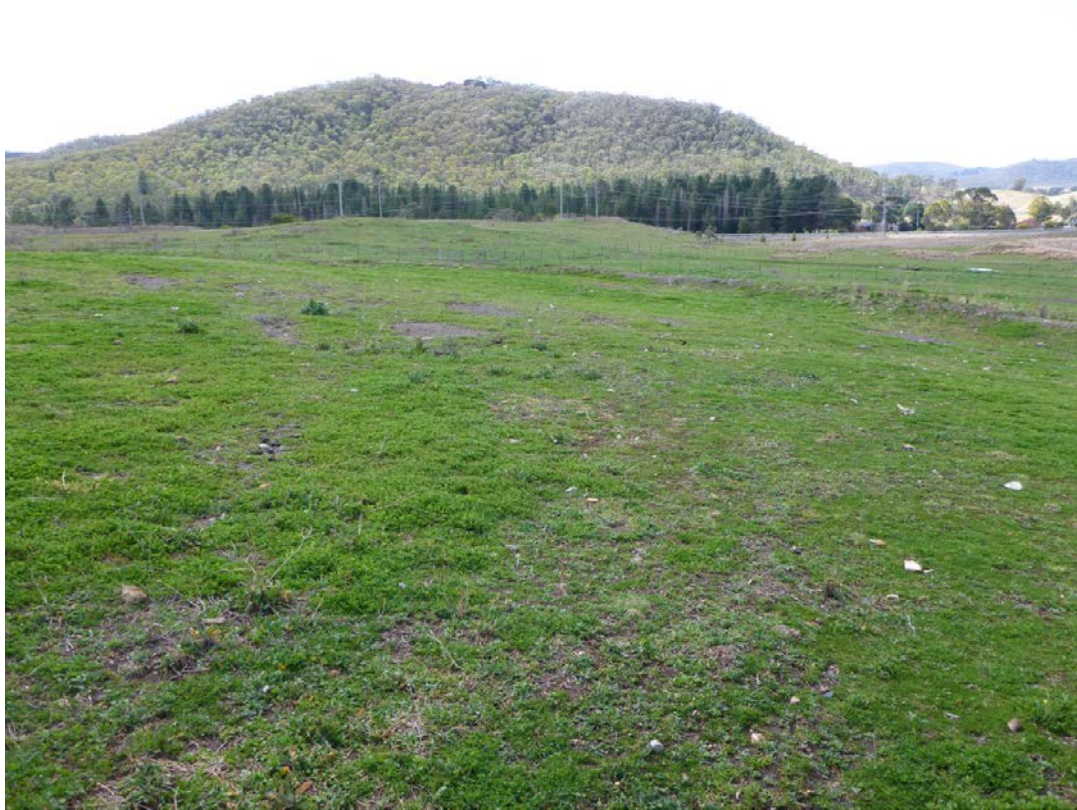
Plate 18: Rehabilitated Site EP3 September 2014

Overgrazing is still a major land management issue here, however increase in perennial grass pasture density have been achieved nonetheless.

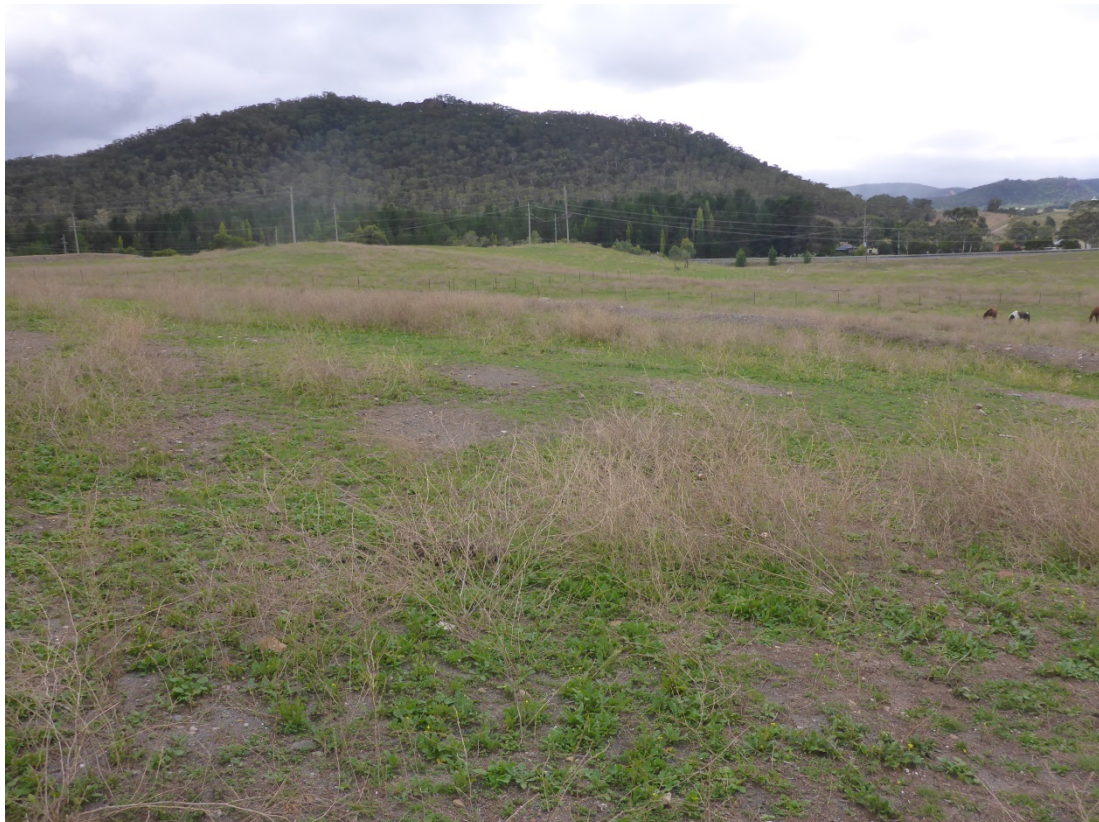
Plate 19: Rehabilitated Site EP3 March 2018

Plate 18 and **Plate 19** show the general landscape setting for Site EP3 within the Morris Property at Enhance Place Mine during the 2014 and 2018 inspections.

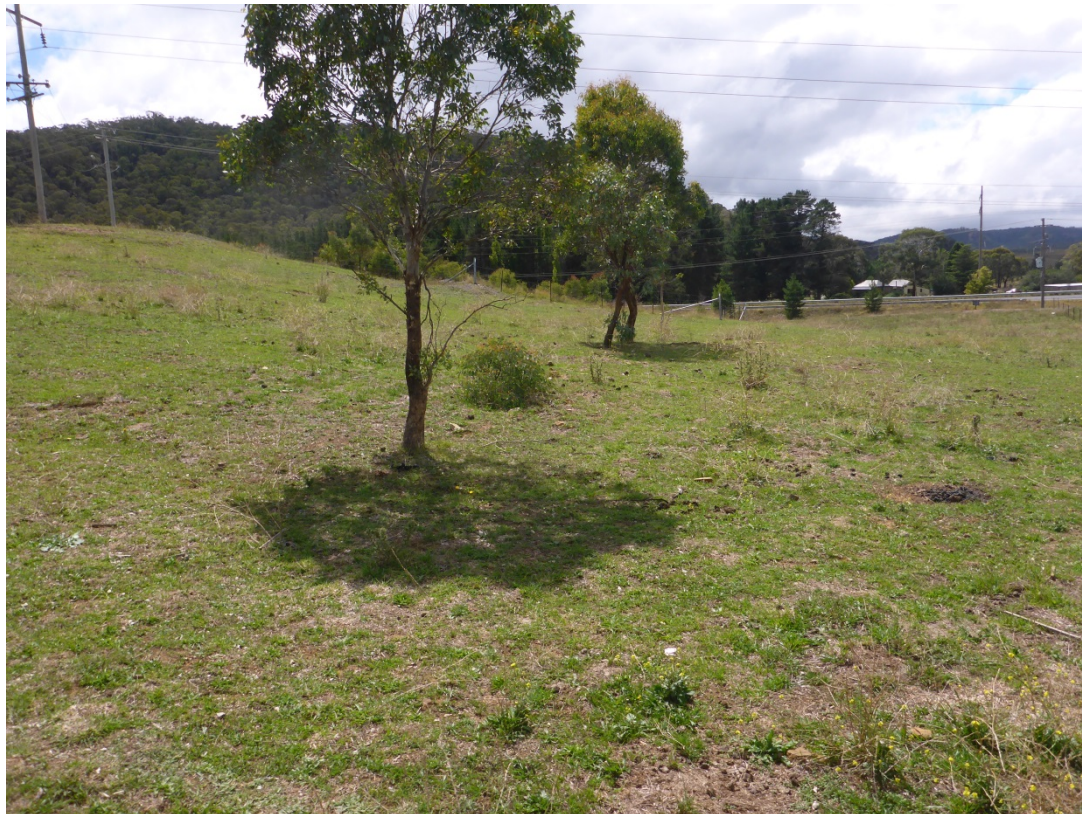
Plate 20: Rehabilitated Site EP5 March 2018

Table 20 below shows soil nutrient levels at Site EP5 from the 2018 inspection. Grazing completion targets were met for all soil elements.

Plate 20 shows the general landscape setting for Site EP5 within the Morris Property at Enhance Place Mine during the 2018 inspections. Pasture at Site EP5 is dominated by perennial grasses fescue and phalaris, the herb plantain with some medic present in the sward, and greater than 90% groundcover.

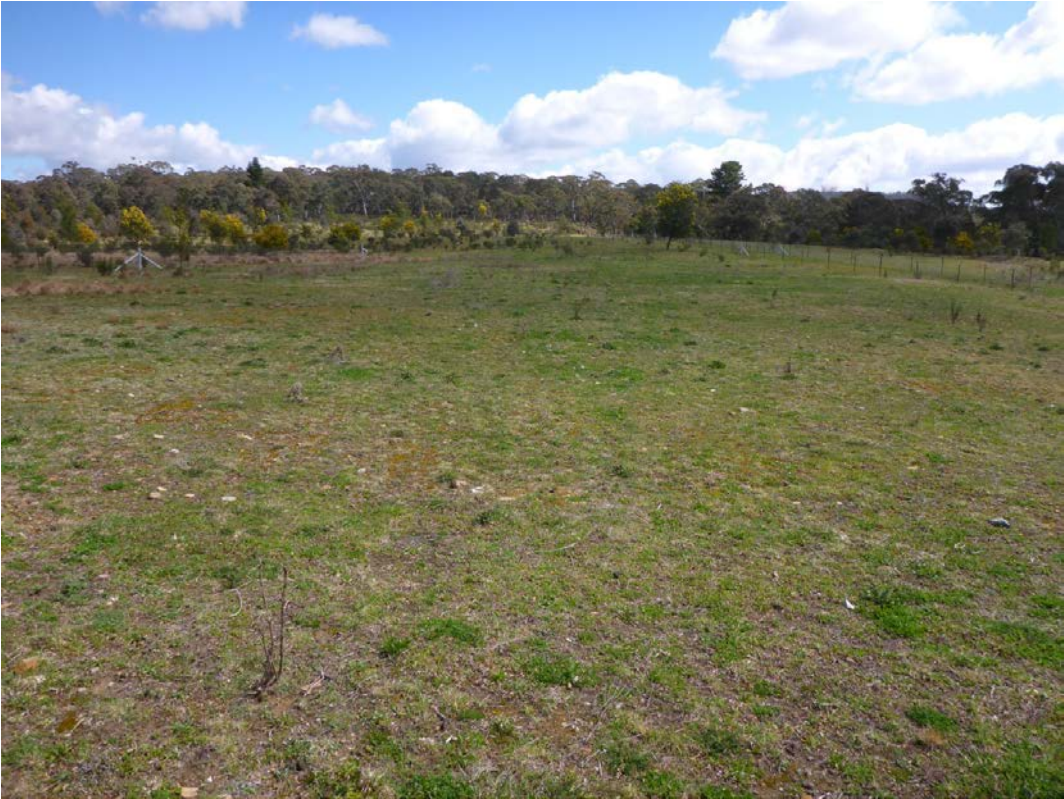
Plate 21: Rehabilitated Site EP2 September 2014

The Crown Land Block adjacent to the Morris property is grazed only by kangaroos with domestic stock being excluded. In 2014 EP2 had sufficient groundcover and a desirable pasture species composition with no further remediation work recommended.

Plate 21 and **Plate 22** show the general landscape setting for Site EP2 within the Morris Property at Enhance Place Mine during the 2014 and 2018 inspections, with greater than 80% groundcover.

The Crown Land (EP 2) Block does not require any remedial action as it has satisfactory pasture groundcover and appears to be only grazed by kangaroos. It is recommended that this area continues to be monitored against agreed rehabilitation completion criteria
