ENHANCE PLACE MINE

2021

**ANNUAL ENVIRONMENTAL
MANAGEMENT REPORT**

(Small Mine Version)

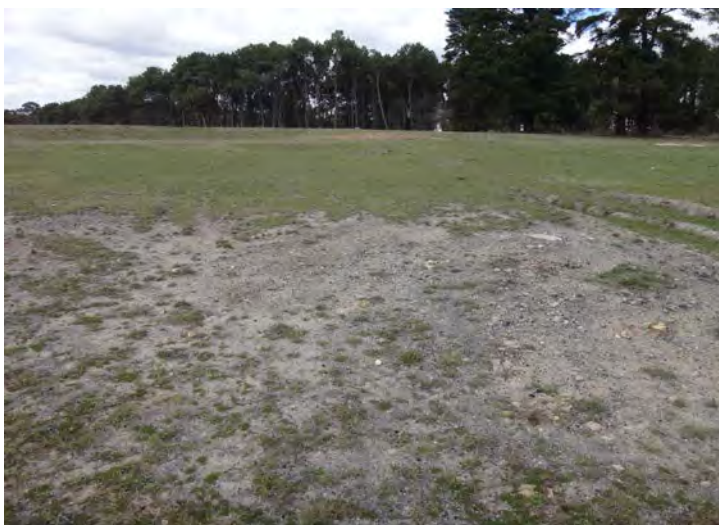
There is some evidence of active, minor to moderate wind erosion where pastures are poorly established or absent (see Figure 4 and Figure 5). Minor rilling is occurring on exposed soils of the sediment retention basins and can be seen in Figure 6.

Figure 5 Exposed soils in southern portion of pasture area

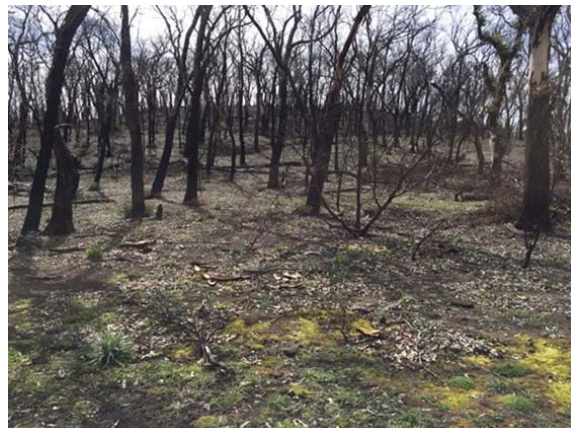
Figure 5 Vegetation structure of treed analogue site (Pine Dale Mine) 2020 shows the vegetation structure at the treed analogue site in 2020. Many of the standing trees were showing evidence of new growth however the presence of epicormic growth is not an indicator of long-term survival of the tree. Recently fallen timber was contributing to ground cover. The trees provided no appreciable canopy cover. The shrub layer was very sparse. Ground cover was actively growing and regeneration of woody plants was occurring across the site.

Figure 5 Vegetation structure of treed analogue site (Pine Dale Mine) 2020

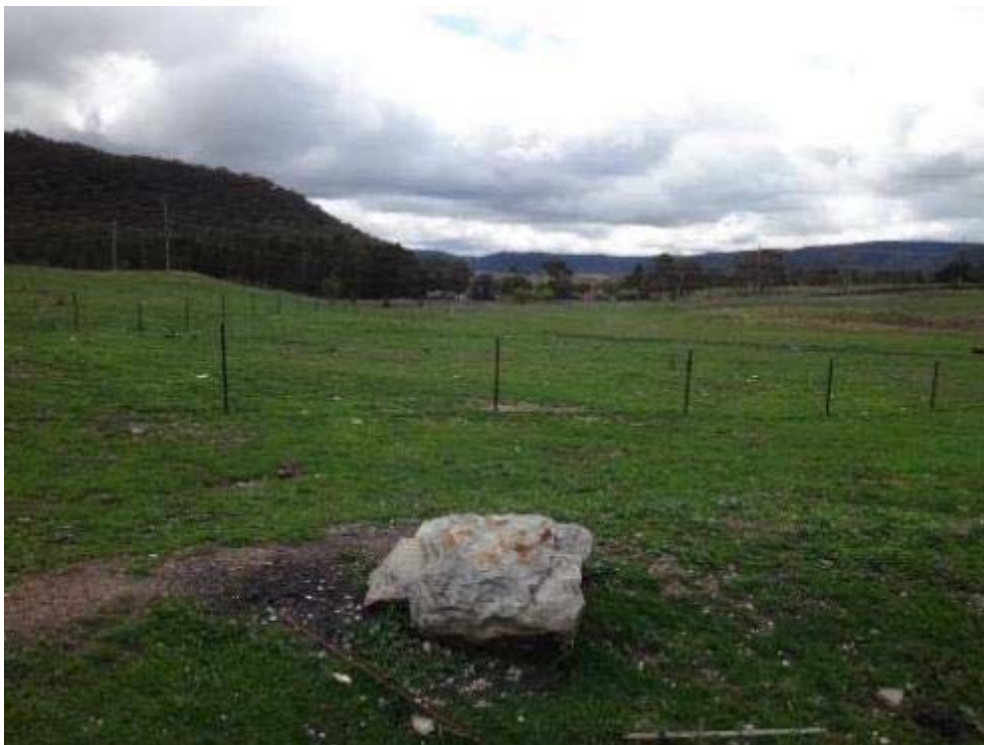
Quadrat 2 from southwest looking northeast 2016

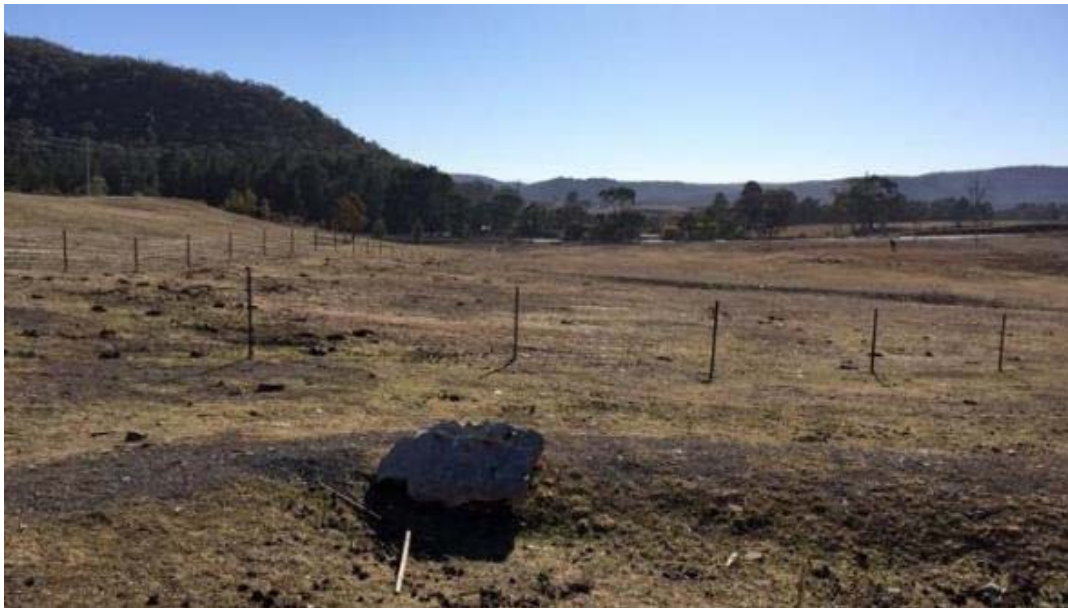
Quadrat 2 from southwest looking northeast 2019

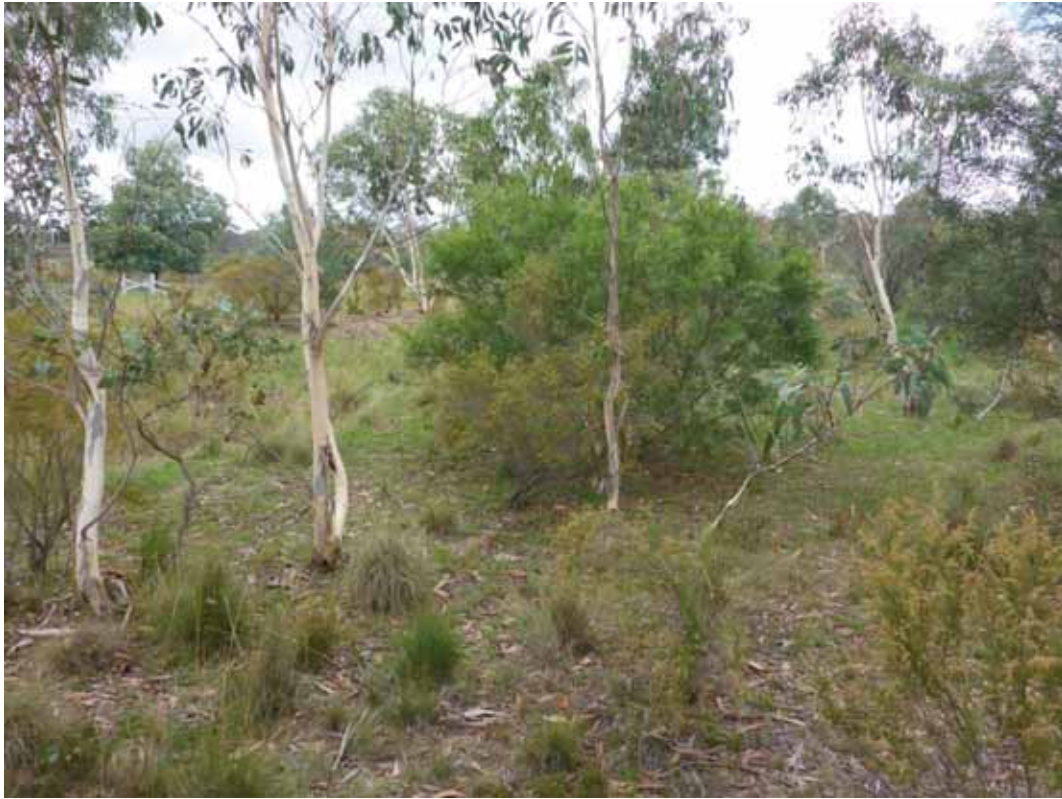
Photo 1 Analogue Site EP4 March 2018

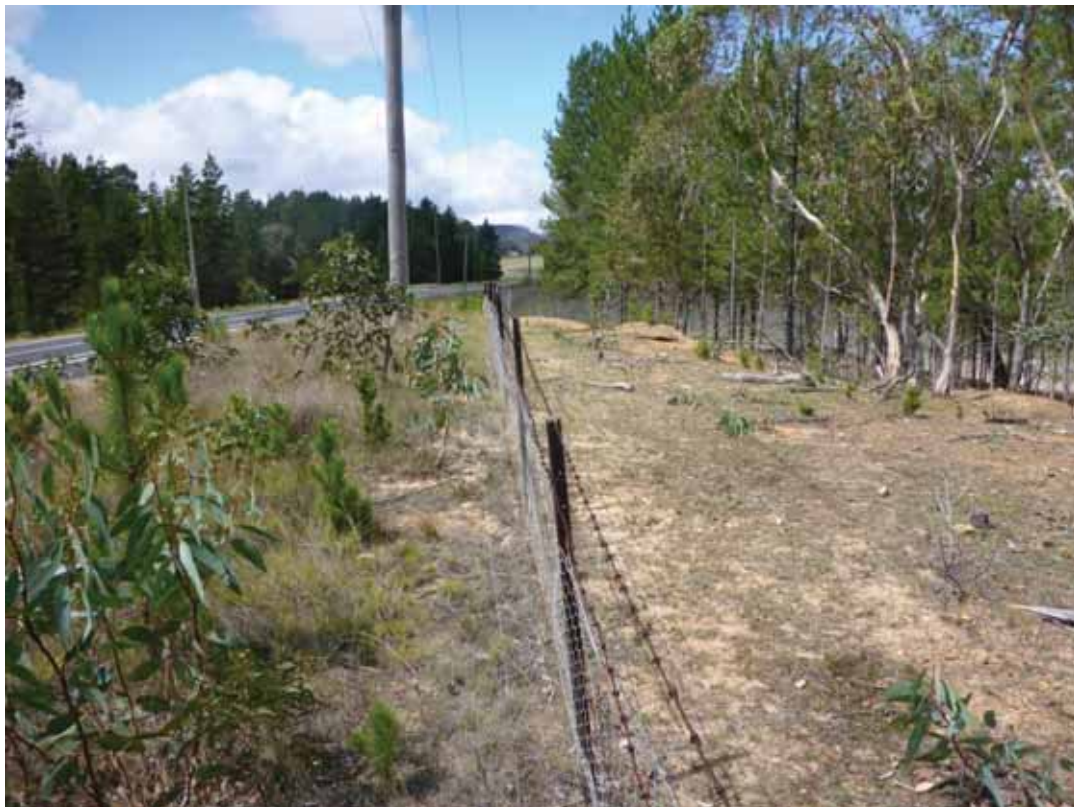
Photo 2 Analogue Site EP6 March 2018

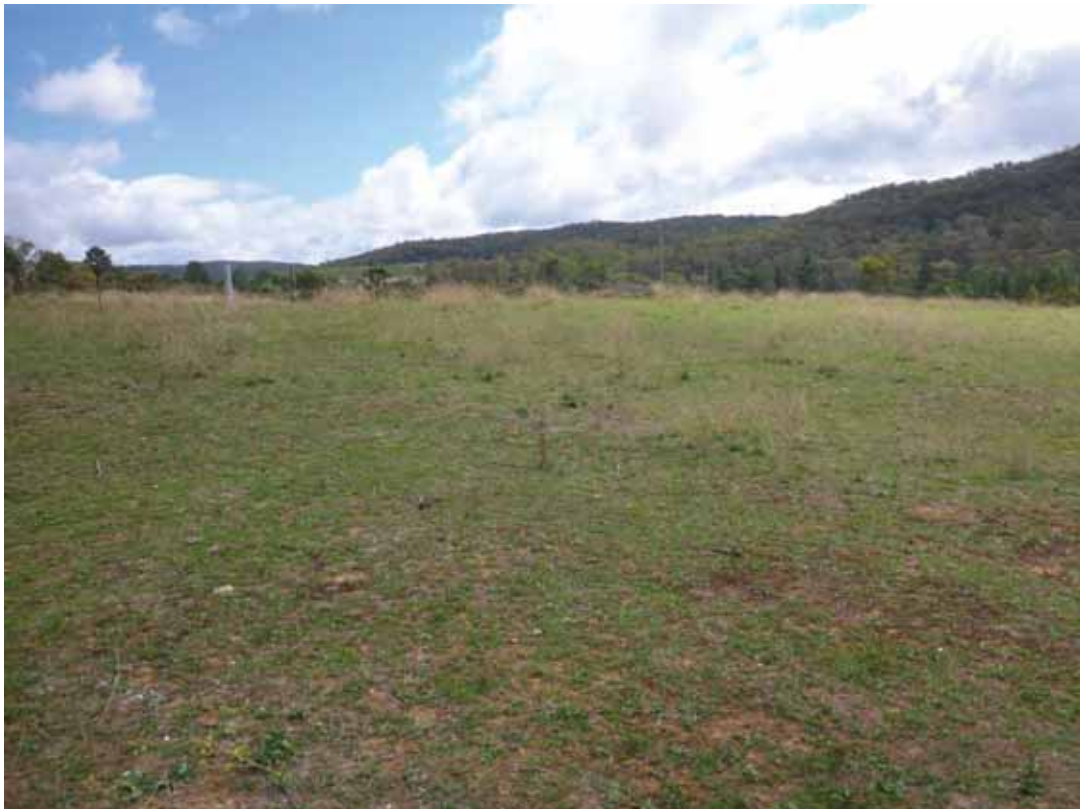
Photo 4 Rehabilitated Site EP1 March 2018

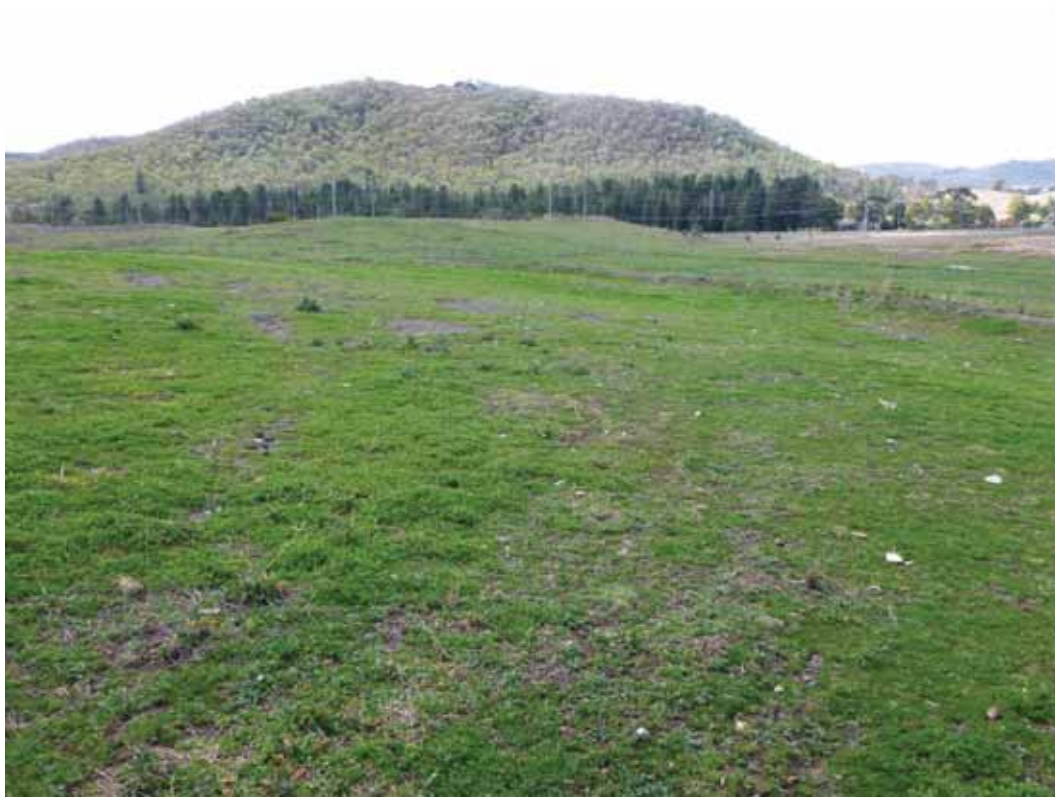
Photo 5 and **Photo 6** show the general landscape setting for Site EP3 within the Morris Property at Enhance Place Mine during the 2014 and 2018 inspections.

Overgrazing is still a major land management issue here, however increase in perennial grass pasture density have been achieved nonetheless.

Photo 5 Rehabilitated Site EP3 September 2014

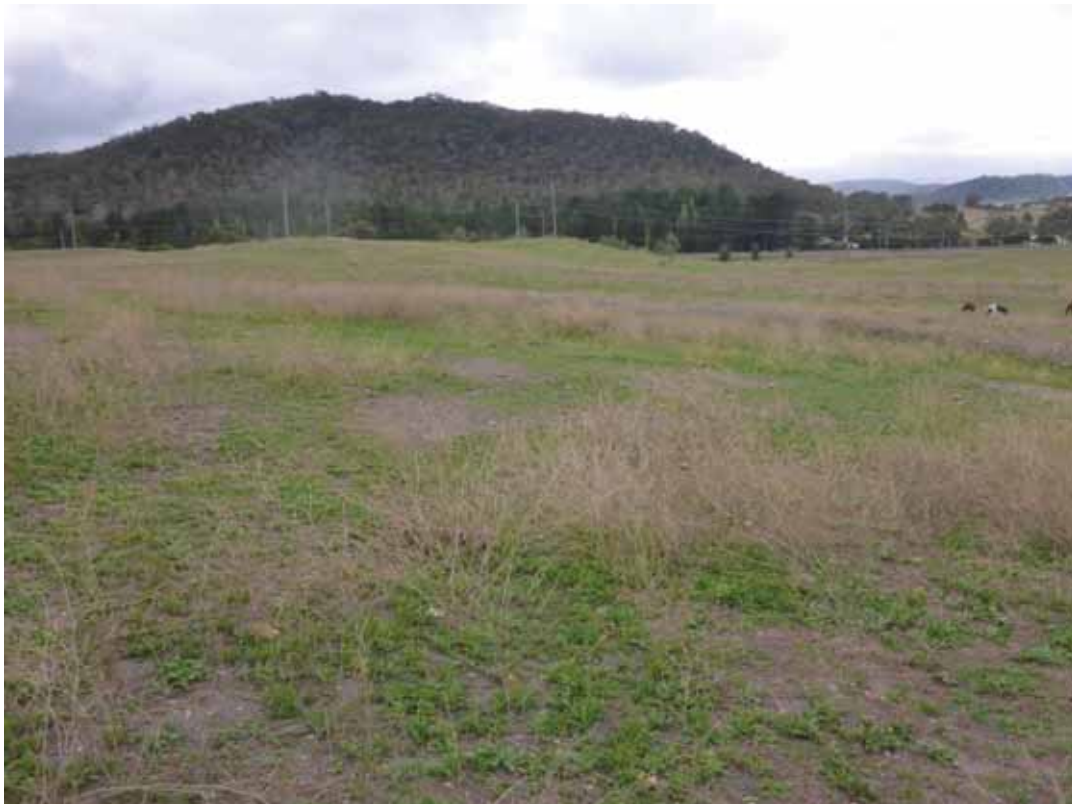
Photo 6 Rehabilitated Site EP3 March 2018

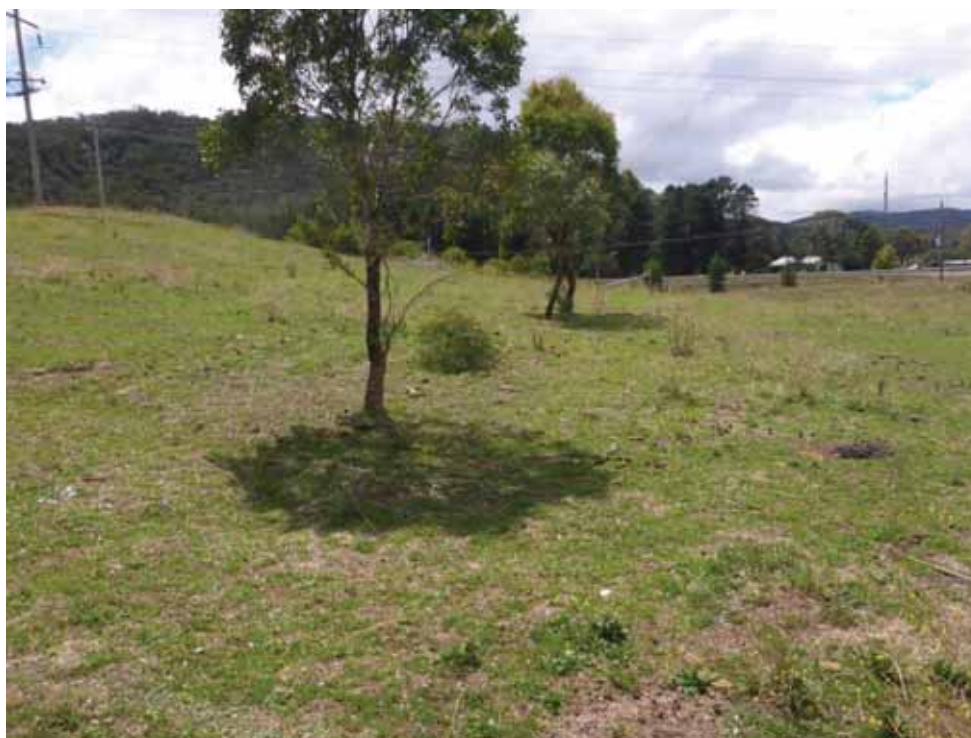
Photo 7 shows the general landscape setting for Site EP5 within the Morris Property at Enhance Place Mine during the 2018 inspections. Pasture at Site EP5 is dominated by perennial grasses fescue and phalaris, the herb plantain with some medic present in the sward, and greater than 90% groundcover.

Photo 7 Rehabilitated Site EP5 March 2018

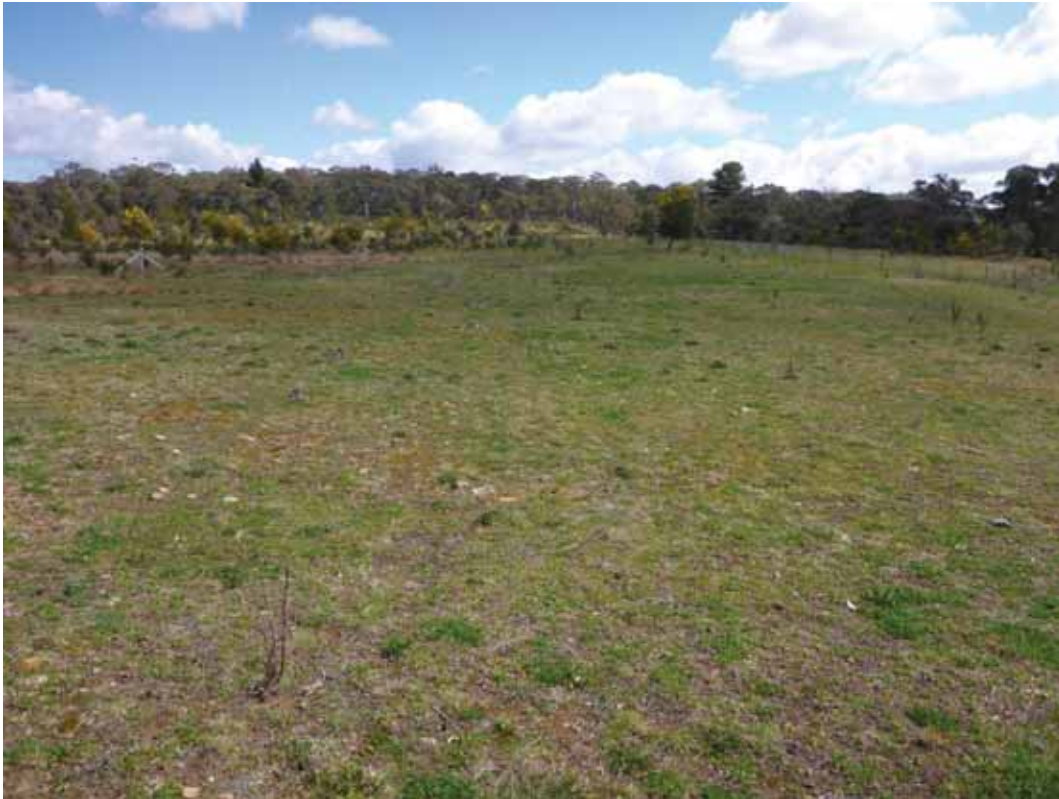
Photo 8 and **Photo 9** show the general landscape setting for Site EP2 within the Crown Land at Enhance Place Mine during the 2014 and 2018 inspections, with greater than 80% groundcover.

Photo 8 Rehabilitated Site EP2 September 2014

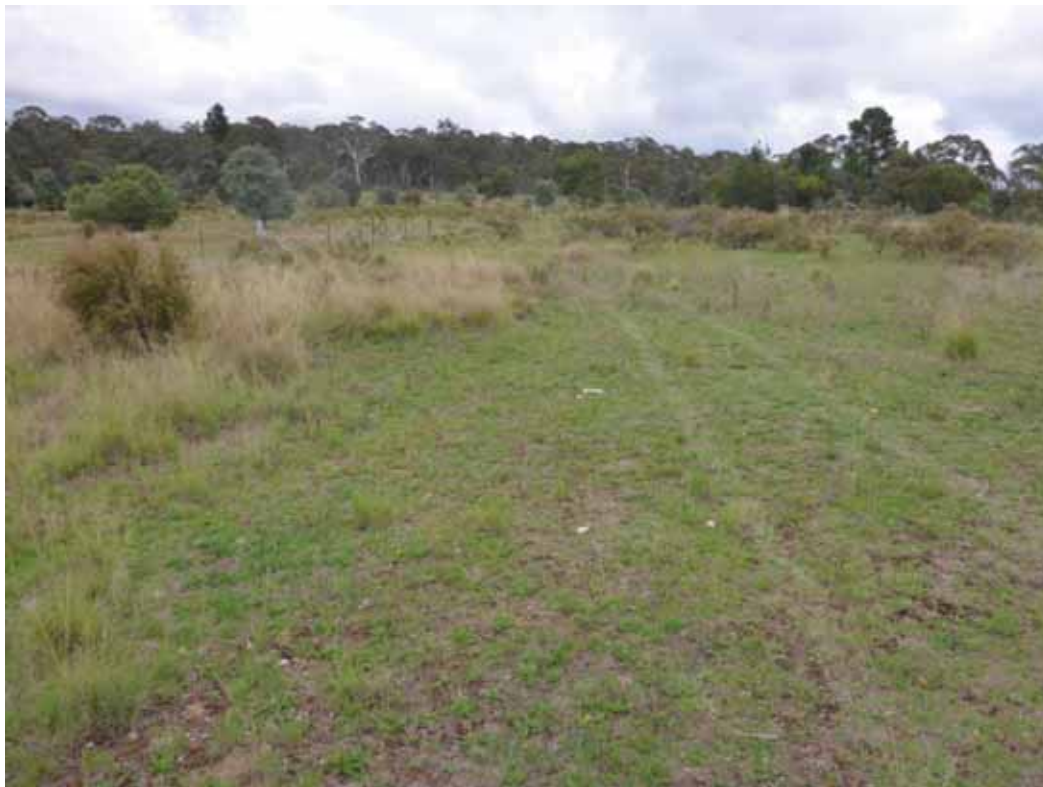
Photo 9 Rehabilitated Site EP2 March 2018

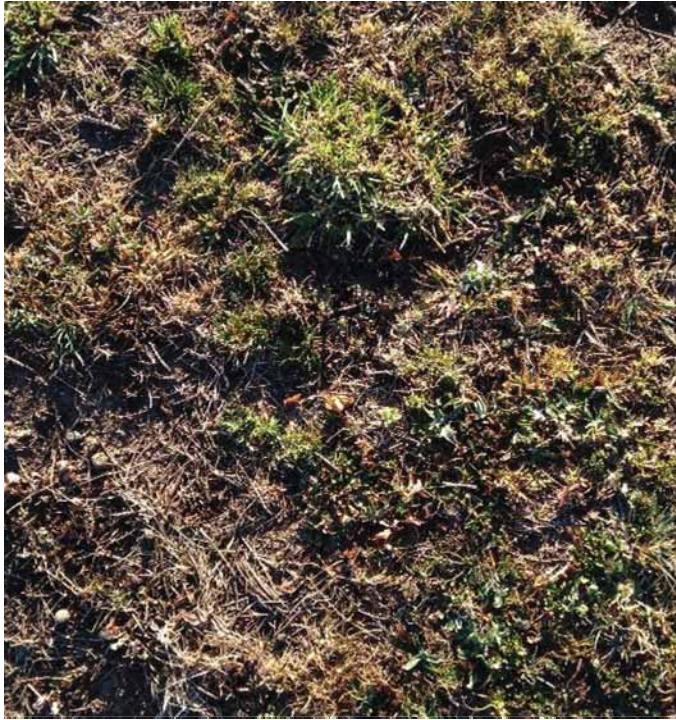
Species composition at pasture rehabilitation areas – Pasture rehabilitation areas are established with a mix of 70% perennial grasses and 20% annual legumes and are representative of species composition at the analogue pasture site. An example of rehabilitated pasture is shown in Figure 3.

Figure 3 Pasture composition representative of rehabilitated pasture areas

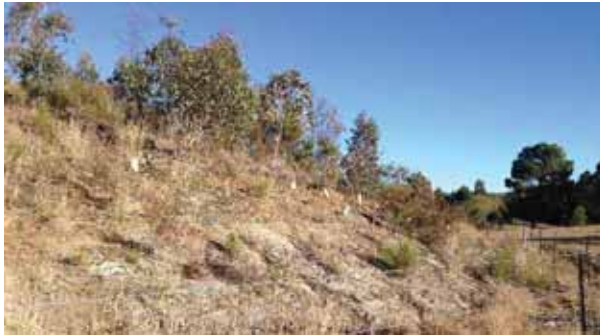
The areas of transects 7 and 8 (represented in Figure 4 and 11) support scattered juvenile trees and sparse mixed native shrub layers. The ground layers are dominated by mixed native grasses.

Groundcover at treed rehabilitation areas – Transect 7 supports groundcover of 90%. Transect 8 supports groundcover of 70%.

Figure 4 Vegetation structure and groundcover at transect 7

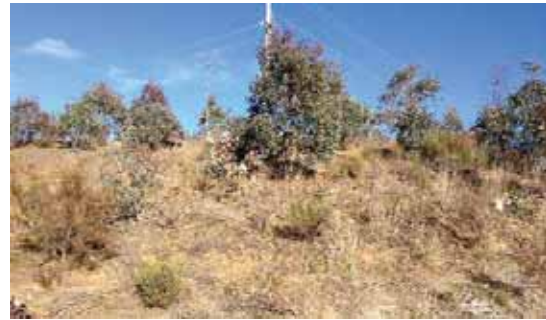
Figure 5 Vegetation structure and groundcover at transect 8

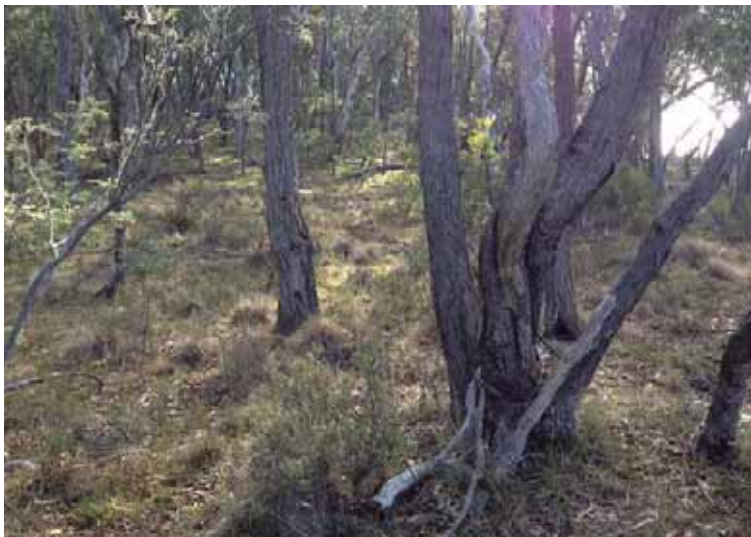
Figure 6 Vegetation structure of treed analogue site (Pine Dale Mine)

The treed analogue site is characterised by a canopy to 12m height with 40% canopy cover over a sparse shrubby mid-storey to 3m height and isolated shrubs to 1.5m height in the understorey. Groundcover consists of grasses and herbs with a cover of >90% (Figure 6).

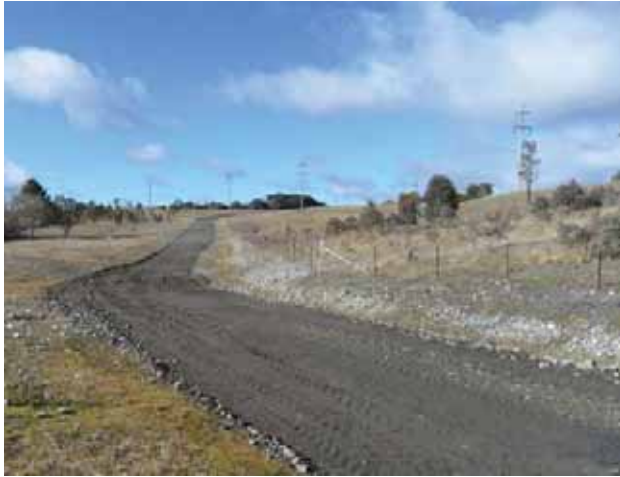
Figure 7 Recently graded trail

Site access trails have been constructed, gates have been installed and fences have been erected. Recent trail work has improved trail surfaces, grade and surface water drainage (see Figure 7).

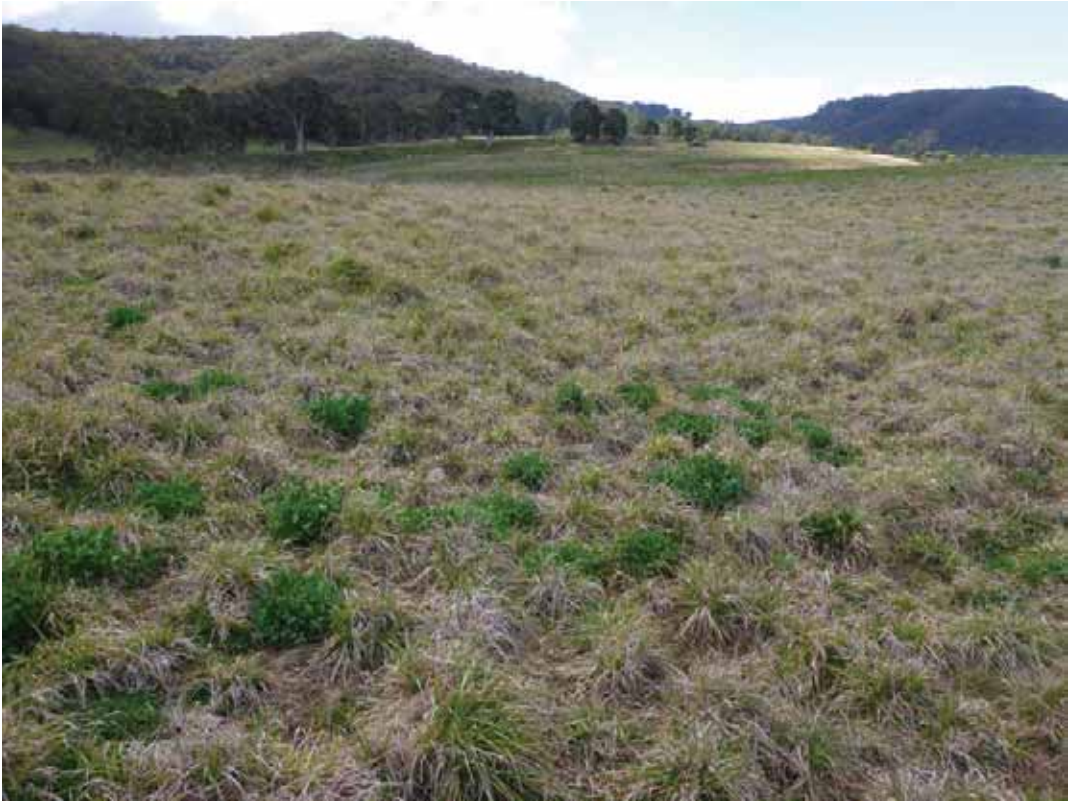
Plate 5: Rehabilitated Site PD1 September 2014

Pasture at Site PD1 is dominated by perennial cocksfoot and paspalum grass pasture with some sub clover and arrowleaf clover present in the sward, with greater than 90% groundcover. There is no African lovegrass present. Again the difference in pasture growth between autumn and spring can clearly be seen.

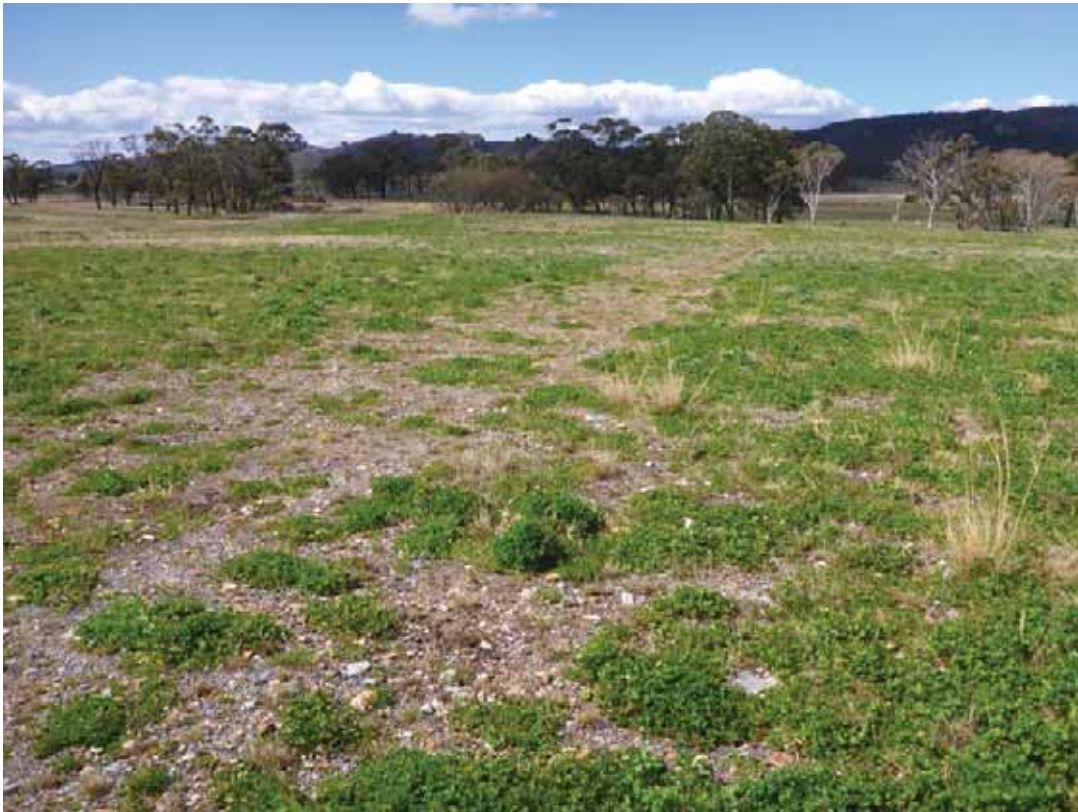
Plate 7: Rehabilitated Site PD2 September 2014

Pasture at Site PD2 is dominated by perennial cocksfoot and paspalum grass pasture with the herb plantain and some arrowleaf clover present in the sward, with greater than 80% groundcover. There are isolated African lovegrass tussocks present which comprise less than 5% of the pasture sward. Significant increase in perennial grass groundcover can be seen between the two inspection periods.

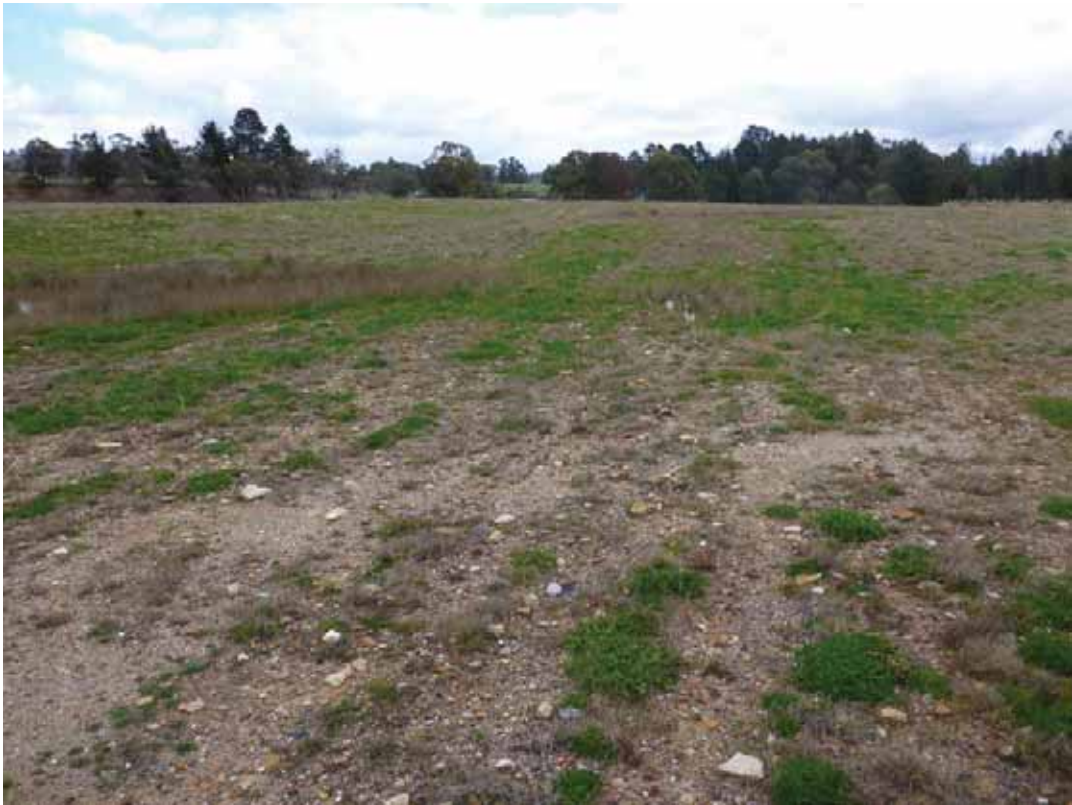
Plate 11: Rehabilitated Site PD4 September 2014

Pasture at Site PD4 is dominated by perennial grasses cocksfoot, fescue and paspalum with some arrowleaf clover present in the sward, and greater than 90% groundcover. There are isolated African lovegrass tussocks present which comprise less than 5% of the pasture sward. Significant increase in perennial grass groundcover can be seen between the two inspection periods.

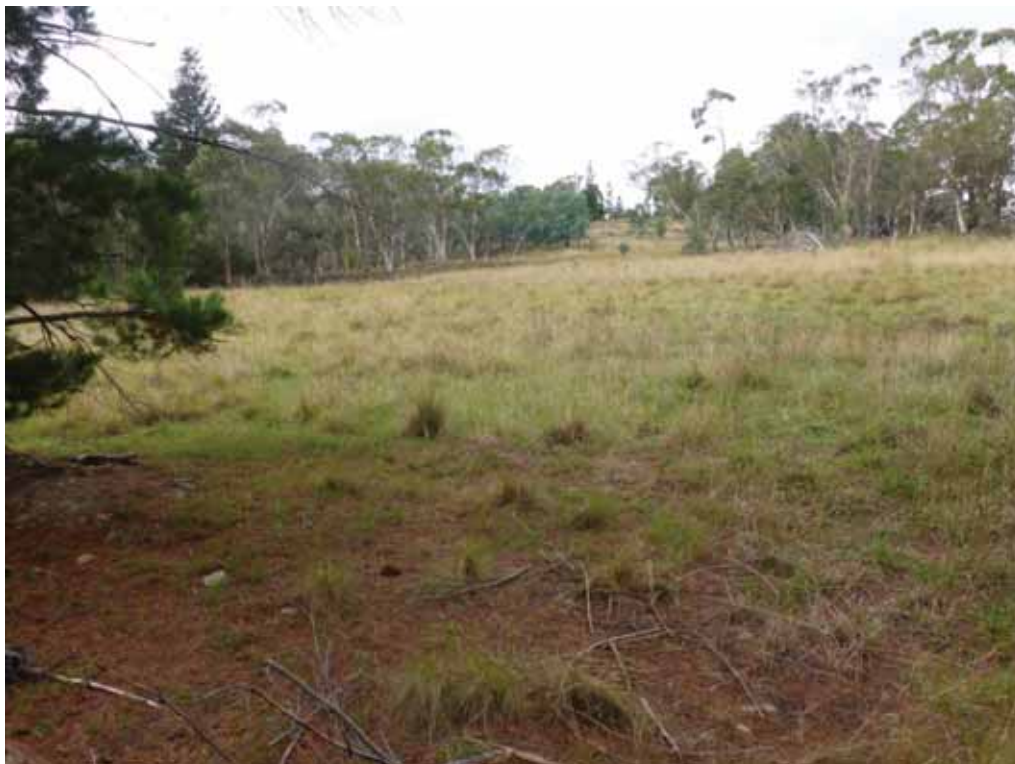
Plate 13: Analogue Site PD8 March 2018

Plate 13 shows the general landscape setting for Site PD8 within Area 8 at Pine Dale Mine during the 2018 inspection. Pasture at Site PD8 is dominated by perennial phalaris and fescue with some arrowleaf clover present in the sward, with greater than 90% groundcover. There are isolated African lovegrass tussocks present which comprise less than 5% of the pasture sward.

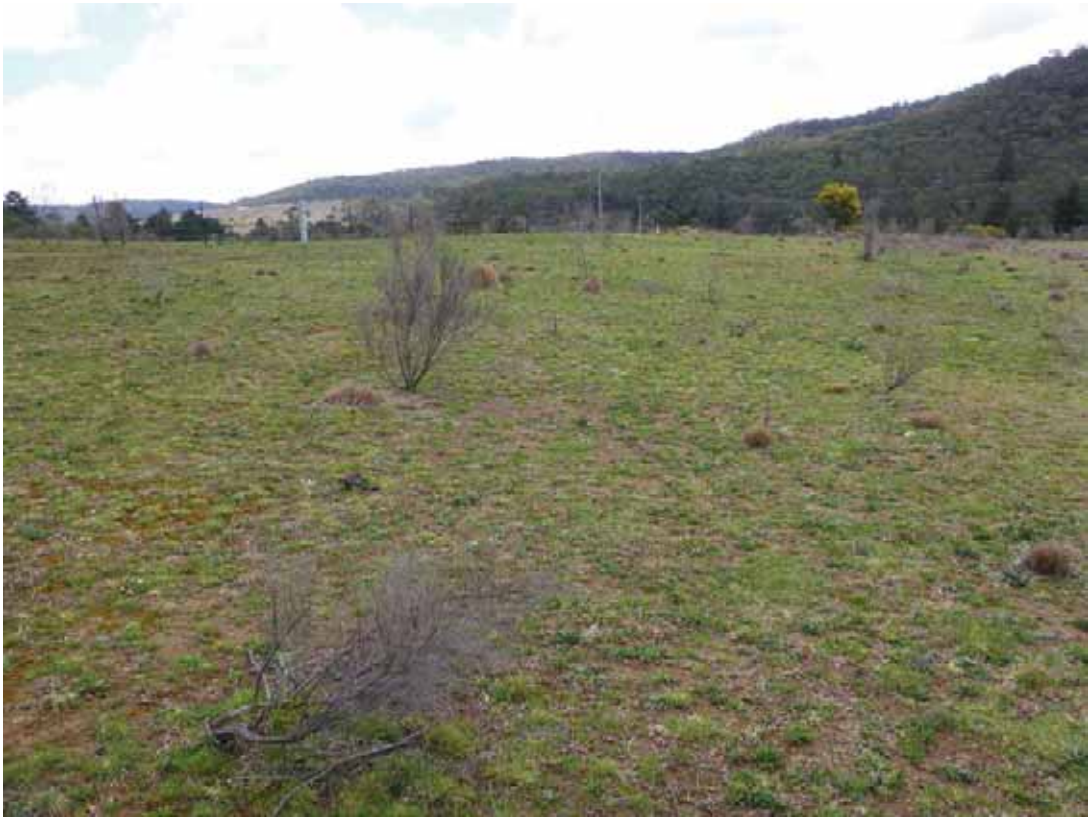
Overgrazing is still a major land management issue here, however increase in perennial grass pasture density have been achieved nonetheless.

Plate 16: Rehabilitated Site EP1 September 2014

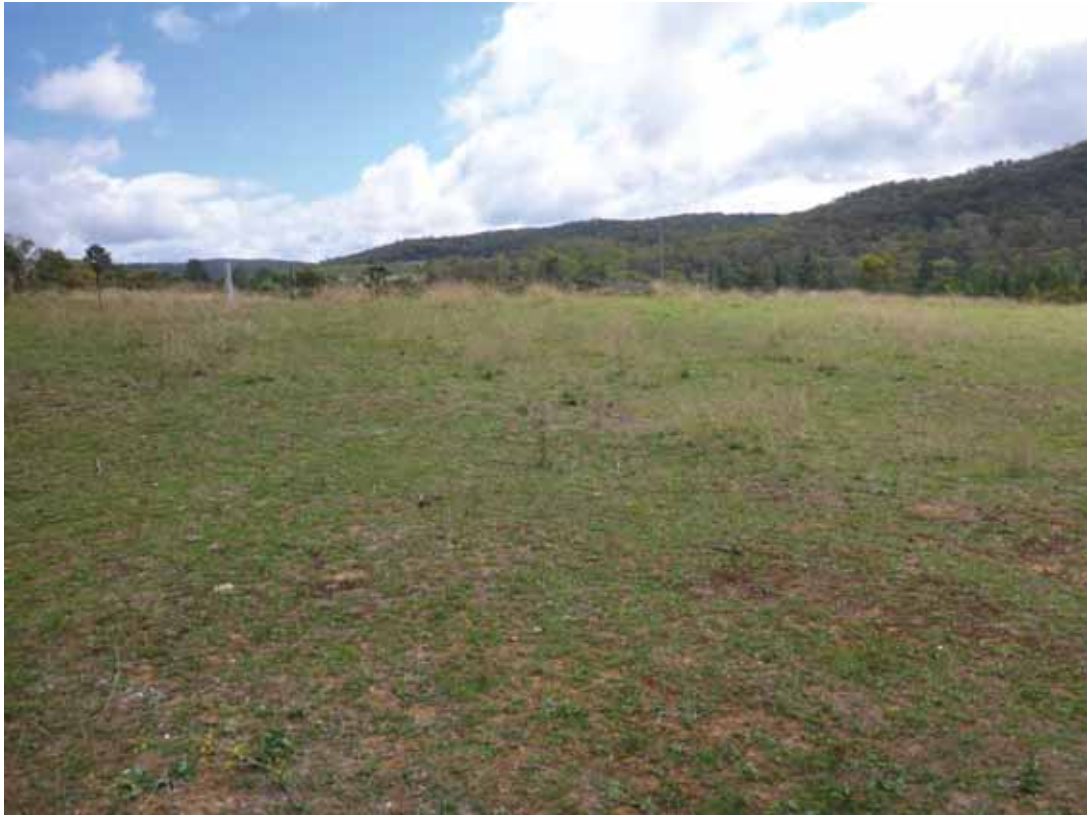
Plate 17: Rehabilitated Site EP1 March 2018

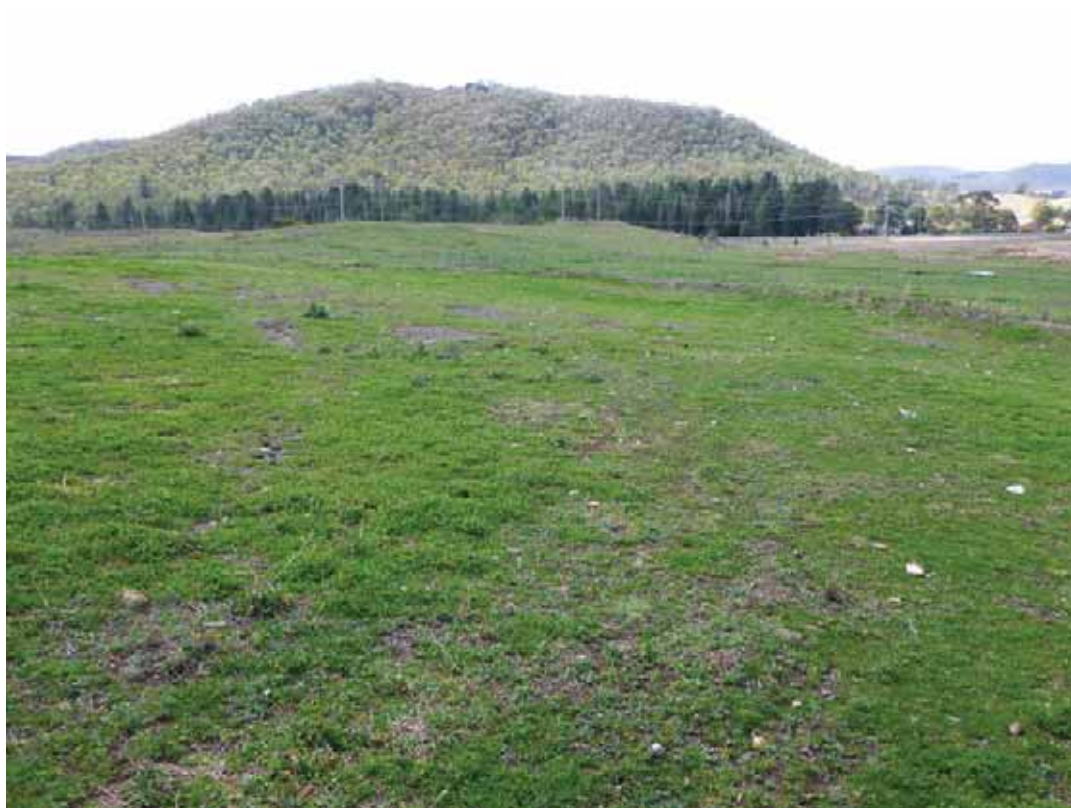
Overgrazing is still a major land management issue here, however increase in perennial grass pasture density have been achieved nonetheless.

Plate 18: Rehabilitated Site EP3 September 2014

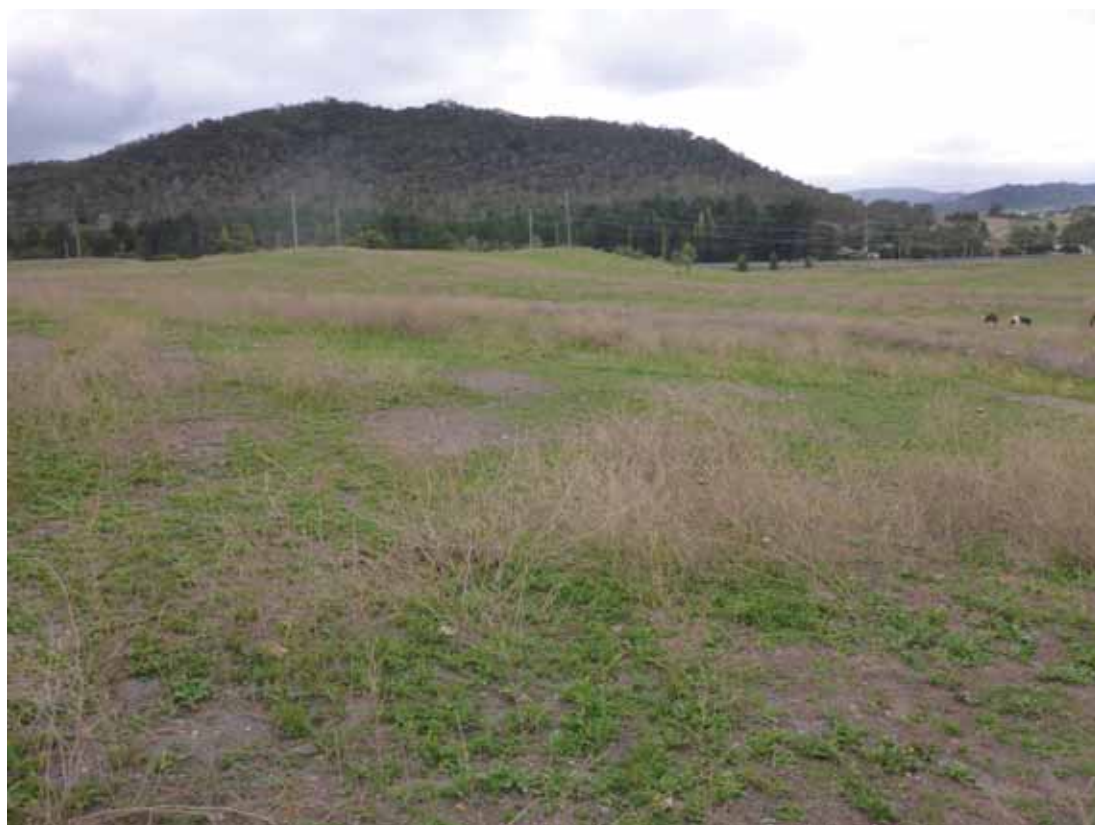
Plate 19: Rehabilitated Site EP3 March 2018

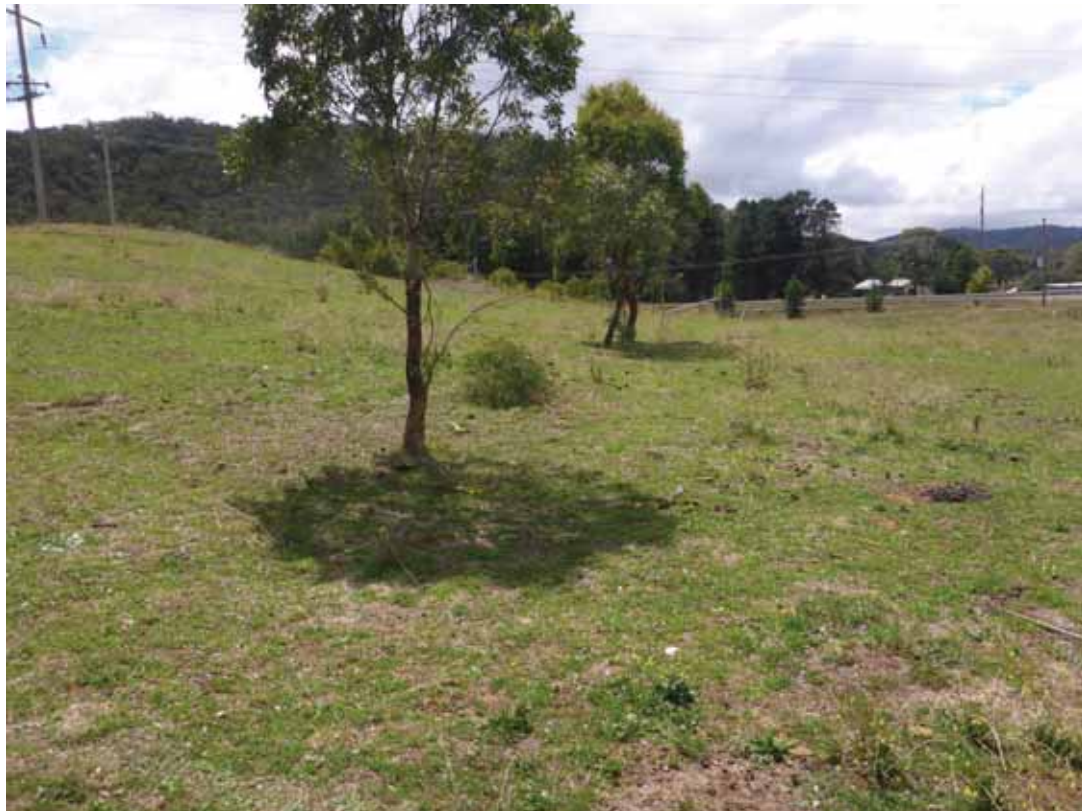
Plate 20 shows the general landscape setting for Site EP5 within the Morris Property at Enhance Place Mine during the 2018 inspections. Pasture at Site EP5 is dominated by perennial grasses fescue and phalaris, the herb plantain with some medic present in the sward, and greater than 90% groundcover.

Plate 20: Rehabilitated Site EP5 March 2018

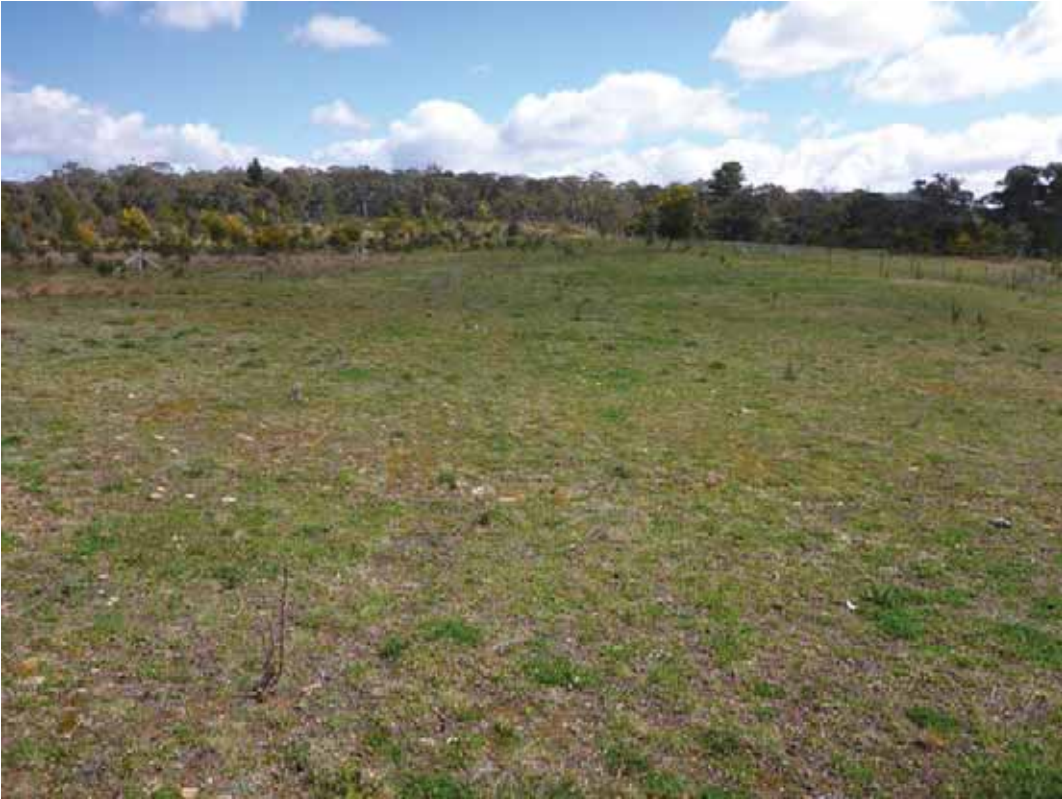
The Crown Land Block adjacent to the Morris property is grazed only by kangaroos with domestic stock being excluded. In 2014 EP2 had sufficient groundcover and a desirable pasture species composition with no further remediation work recommended.

Plate 21: Rehabilitated Site EP2 September 2014

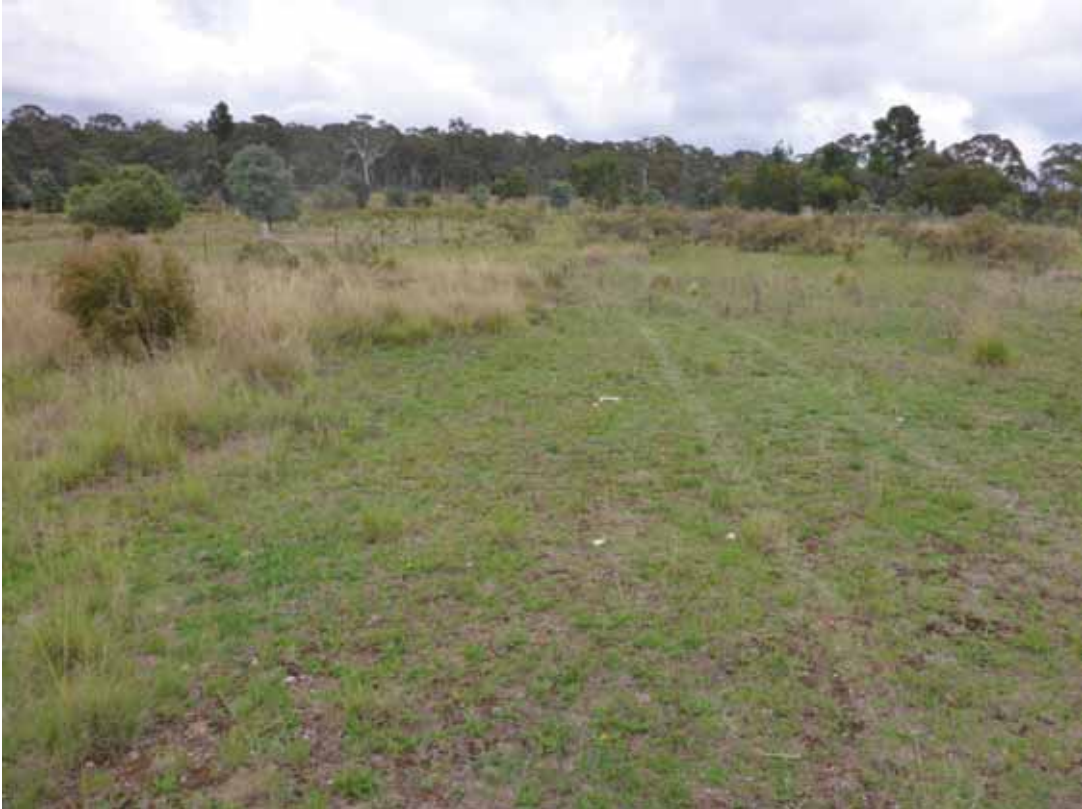
Plate 21 and **Plate 22** show the general landscape setting for Site EP2 within the Morris Property at Enhance Place Mine during the 2014 and 2018 inspections, with greater than 80% groundcover.

Plate 22: Rehabilitated Site EP2 March 2018

The Crown Land (EP 2) Block does not require any remedial action as it has satisfactory pasture groundcover and appears to be only grazed by kangaroos. It is recommended that this area continues to be monitored against agreed rehabilitation completion criteria
