Independent Environmental Audit 2014

Pine Dale Mine / Yarraboldy Extension

15 October 2014
43177926/IEA/01

Prepared for:
Enhance Place Pty Ltd

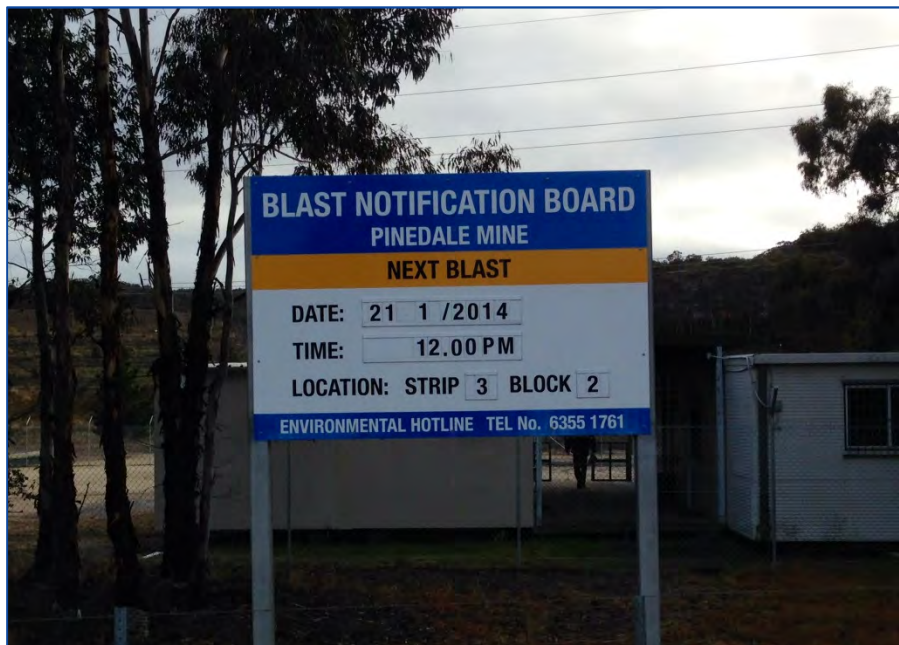
Plate 6-1 Pine Dale Blast Board and Environmental Hotline Telephone Number

Complaints can be made via two phone numbers, 02 6355 1761 or 02 6355 7893. The 02 6355 7893 number is advertised on the Pine Dale website, the 02 6355 1761 is advertised to residents as the 'Environmental Hotline' on the blast notification information board at the entrance to the Site office. Both numbers report to the Site office and but only one is forwarded to the Mine manger's mobile phone. URS consider that the two telephone numbers could be potentially confusing to the community. **Plate 6-1** shows the blast notification board and one of the environmental hotline telephone numbers.
